## Offsite Culvert – Drainage Report

59-61 Oak Grove,  
Cricklewood,  
London.  
NW2 3LR

10<sup>th</sup> April 2015

Ref: 2/5932.1/Culvert

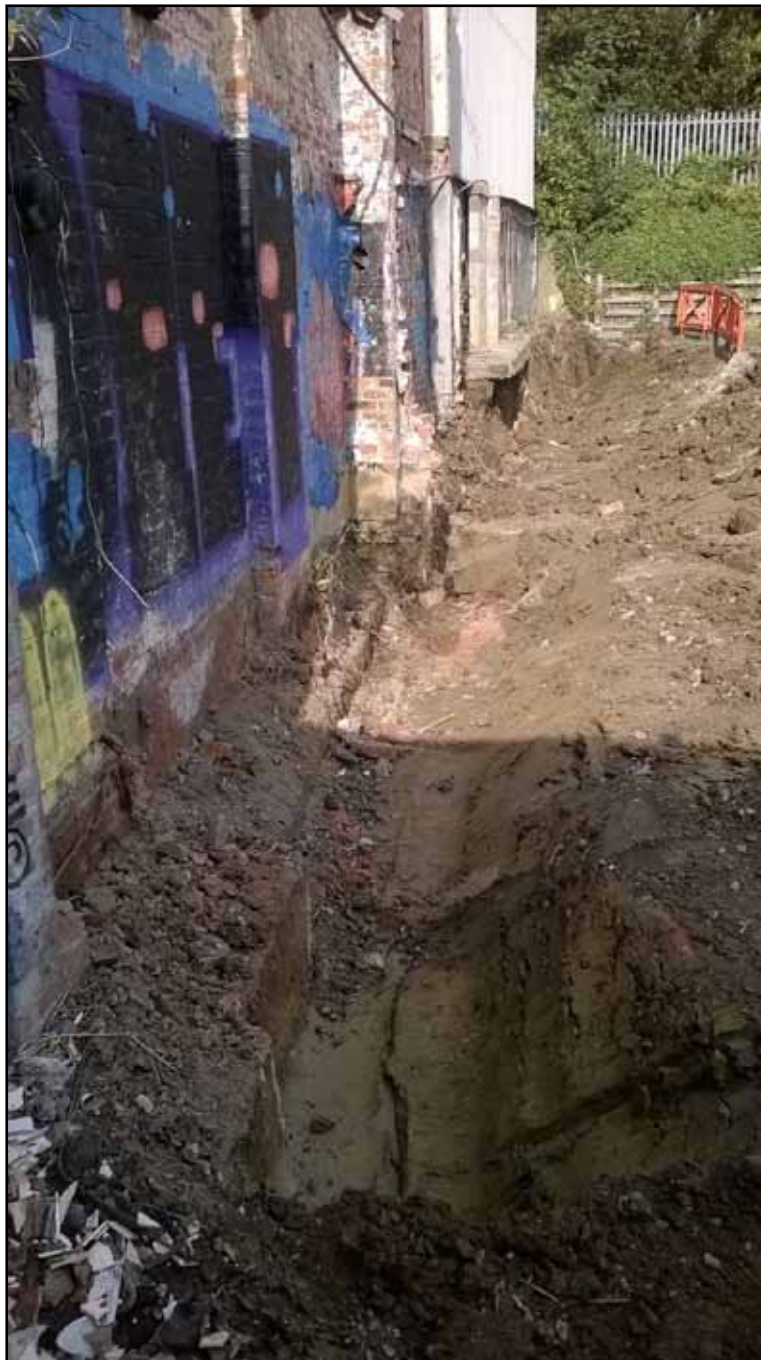
**Photo 1**

1.4.4 The ground bearing slab for the Car Garage has been noted to extend out into the Pocket site and it had been agreed as part of the Party Wall Award that this trespassing slab can be cut back. Beneath the slab was a clay layer which originally remained stable (Refer picture 1).

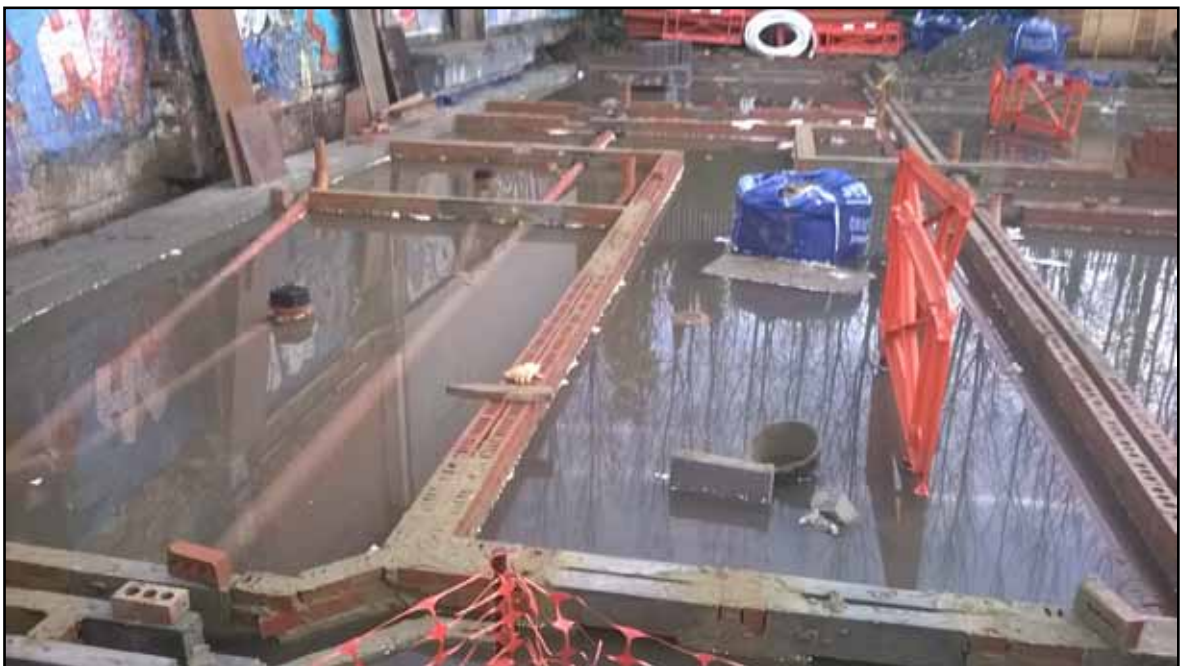
**Photo 3**

- 1.4.11 Due to the quantity of water entering the site from the uncovered culvert, Hutton Group had commenced dewatering of the site to enable the works to continue using pumps. The sump pumps have been used continuously since the 14<sup>th</sup> November 2014 (Refer picture 3).

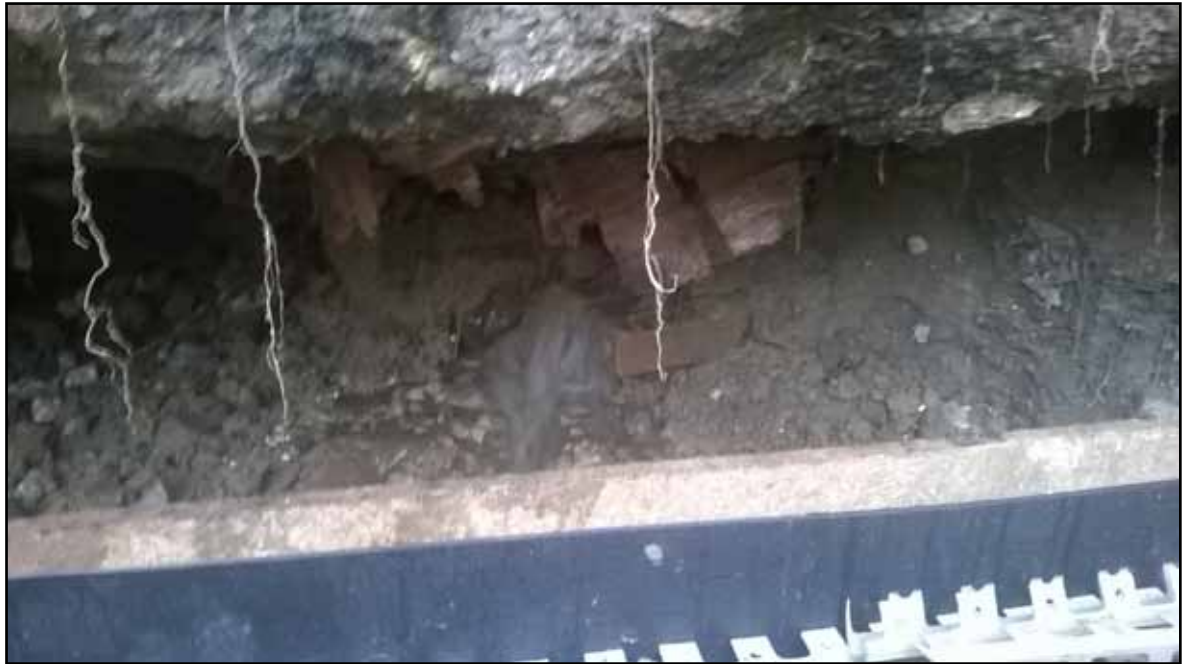
**Photo 4**

1.4.7 It was only after the undertaking of excavation works on site that the culvert was found to be leaking by Hutton Group and that the leak was prevalent with water from the culvert crossing over the party wall line from the Oakdale Motors site onto the Pocket Living site. (Refer picture 4).
