ARBORICULTURAL ASSESSMENT REPORT

For:	Client:	Oriel Services Limited
	Insurer:	[REDACTED]
Site:	Policyholder:	[REDACTED]
	Risk Address:	57 Aberdare Gardens, London, NW6 3AL
Refs:	OCA Ref:	58215
	Client Ref:	7885746
	Insurer Ref:	[REDACTED]

Report By:	James Allnutt		
Title:	Arborist	Date:	31 March 2015

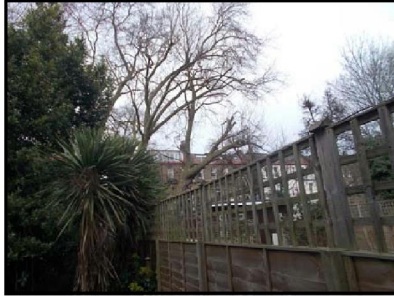
Roots have been recovered from TP1 and have been formally identified as *Platanus*. Given the size, species, and proximity to the location of the trial pit/borehole we consider that these roots have emanated from London Planes T1, T2, & T9.

1. T1 right, T2 left behind the policyholder's garden.

Tree No:	Species	Works Required
T1	London Plane	Fell as close to ground level as practicable and treat stump
T2	London Plane	Fell as close to ground level as practicable and treat stump
T3	Willow	Fell as close to ground level as practicable and treat stump
T4	Willow	Fell as close to ground level as practicable and treat stump
T8	Laurel	Fell as close to ground level as practicable and treat stump
T9	London Plane	Fell as close to ground level as practicable and treat stump

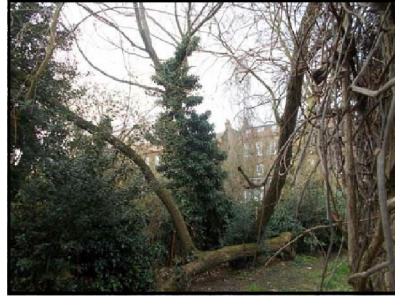
No roots relating to Willow or Laurel were recovered during investigations. However, given its size and proximity to the insured property we consider that it is likely that roots from Willows T3 & T4 as well as Laurel T8 have also extended beneath the depth of foundations.

2. T3 stem laying horizontally with T4 showing ivy on stem.

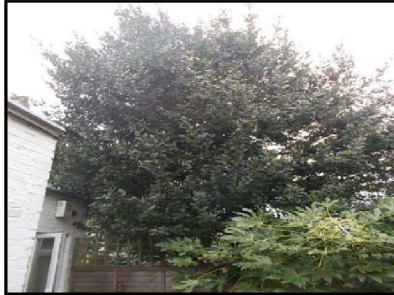
3. View showing T8.

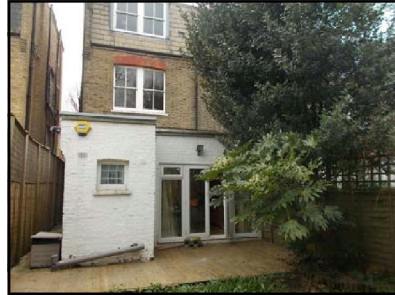
4. Rear of the property showing S1 and T8.

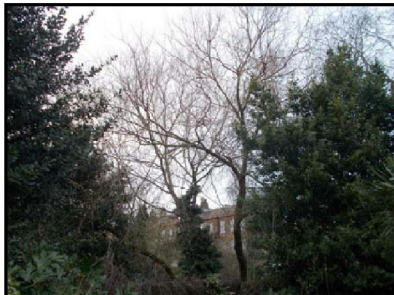
5. T4 left of centre and T3 right of centre.
