**REFURBISHMENT & DEMOLITION  
ASBESTOS SURVEY  
REPORT  
AND  
MATERIALS ASSESSMENT**

**252-268 BELSIZE ROAD  
LONDON  
NW6 4BT**

Project Number:		<b>S1/AS/414</b>	Site:	<b>252-268 Belsize Road London NW6 4BY</b>	Lead Surveyor:	<b>R Chand</b>
Survey Type:		<b>Refurbishment and demolition</b>	Sampling Strategy:	<b>HSG264</b>	Date:	<b>25/11/2014</b>

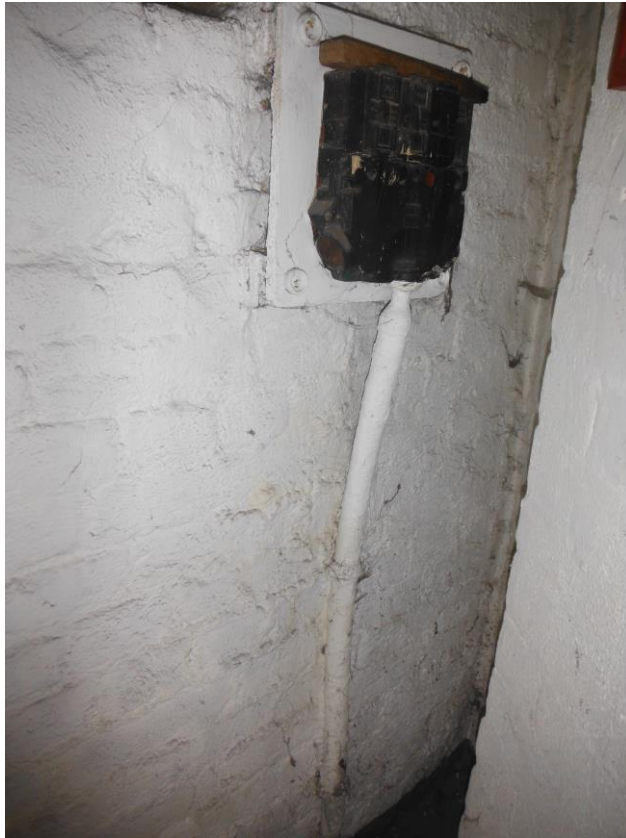
Photo 1 Ground floor loading bay – Non asbestos bitumen rope lining to mains electrical cable

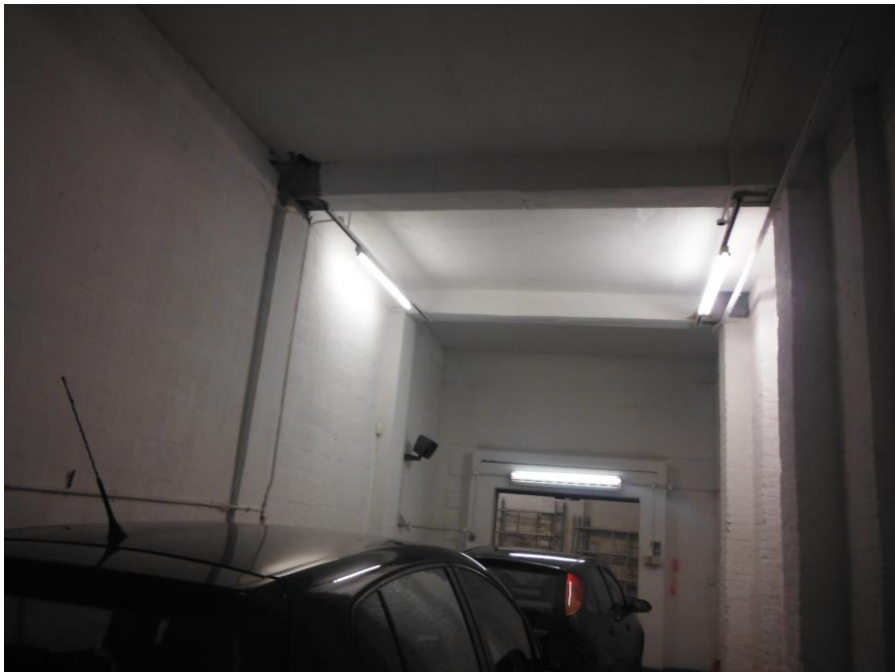
Photo 2 Ground floor loading bay – Non asbestos textured coating to ceiling

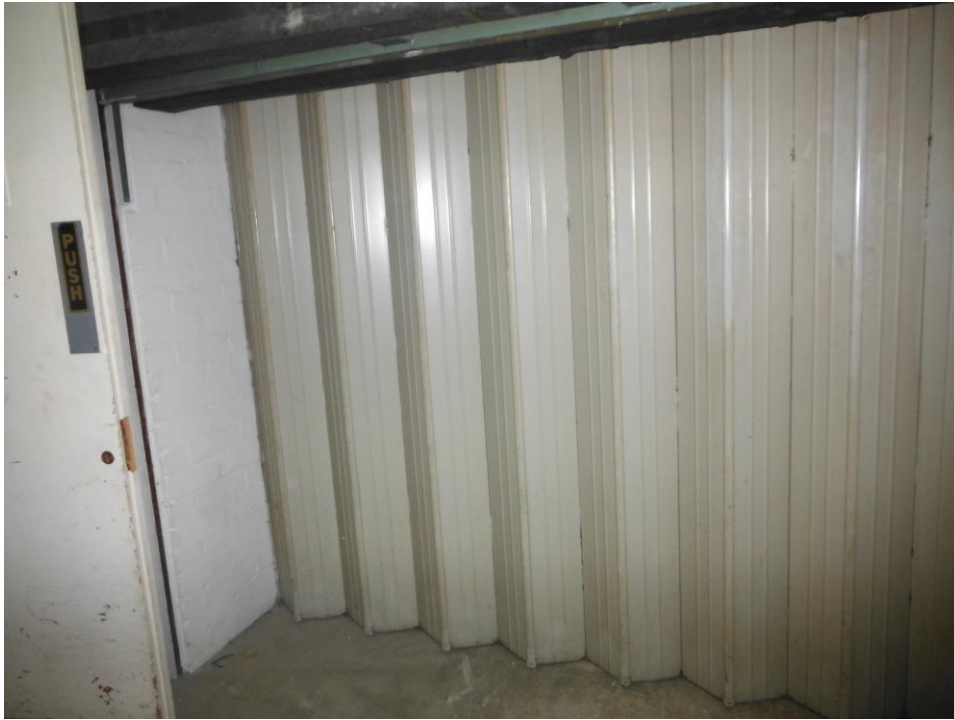
Photo 3 Lift shaft (not accessed)

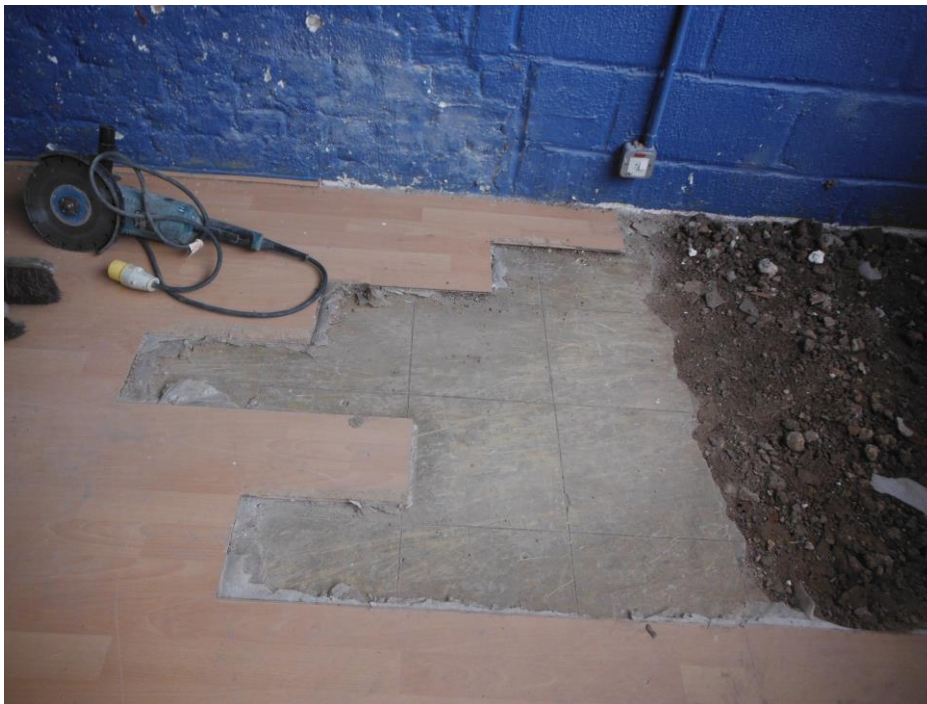
Photo 4 Ground floor – 2<sup>nd</sup> workshop room – Asbestos floor tiles (assumed throughout)

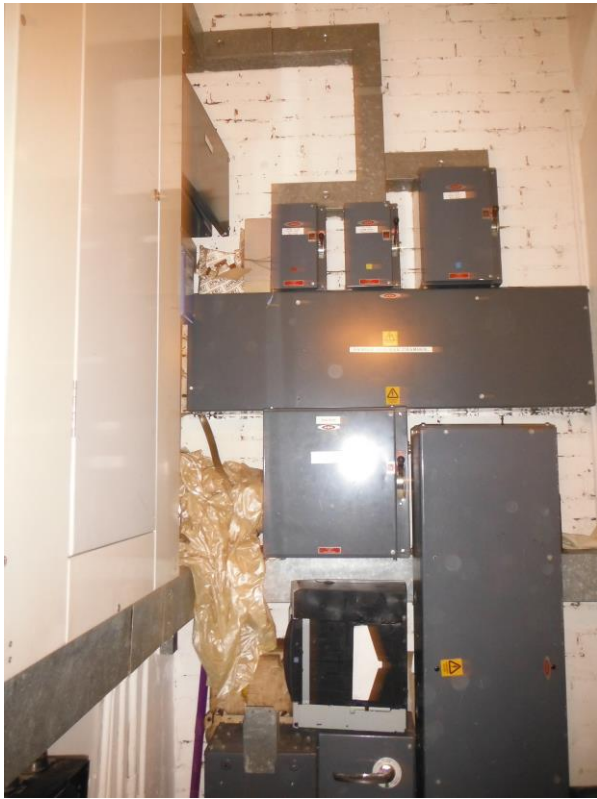
Photo 5 Ground floor Electrical switch room (plant not accessed)  
Asbestos tape pads to fuses (assumed)

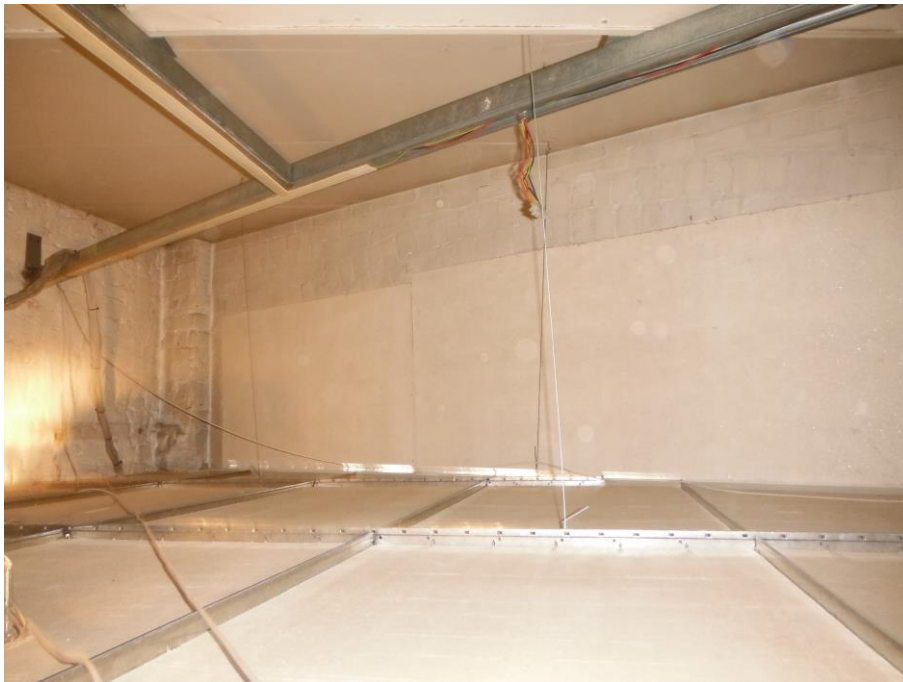
Photo 6 Ground floor 2<sup>nd</sup> workshop room  
Non asbestos supalux panels above windows in ceiling void

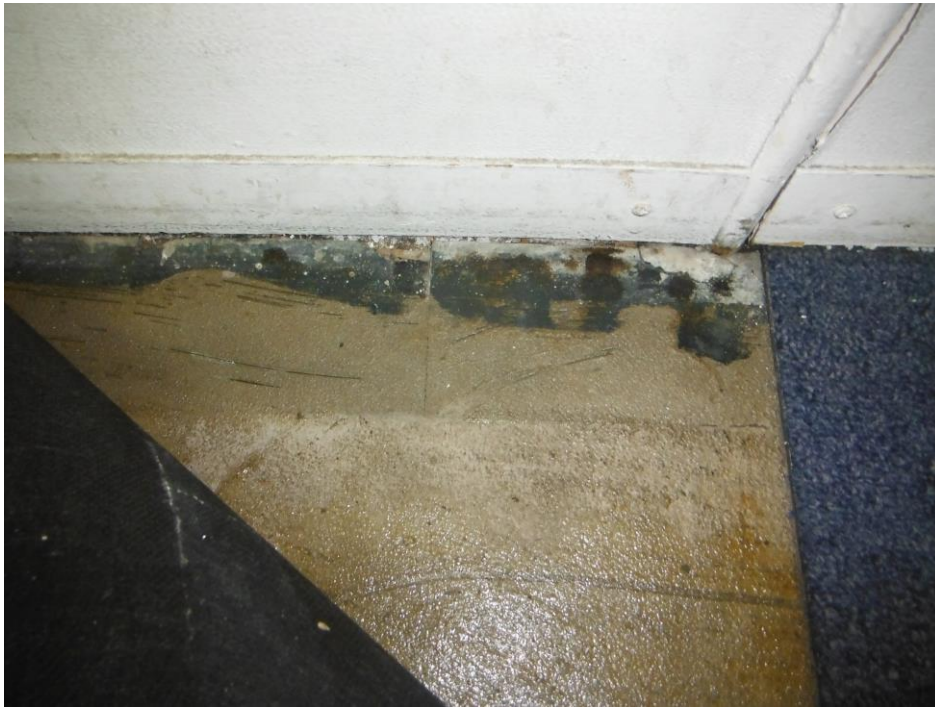
Photo 7 Ground floor reception room - Asbestos floor tiles (assume throughout)

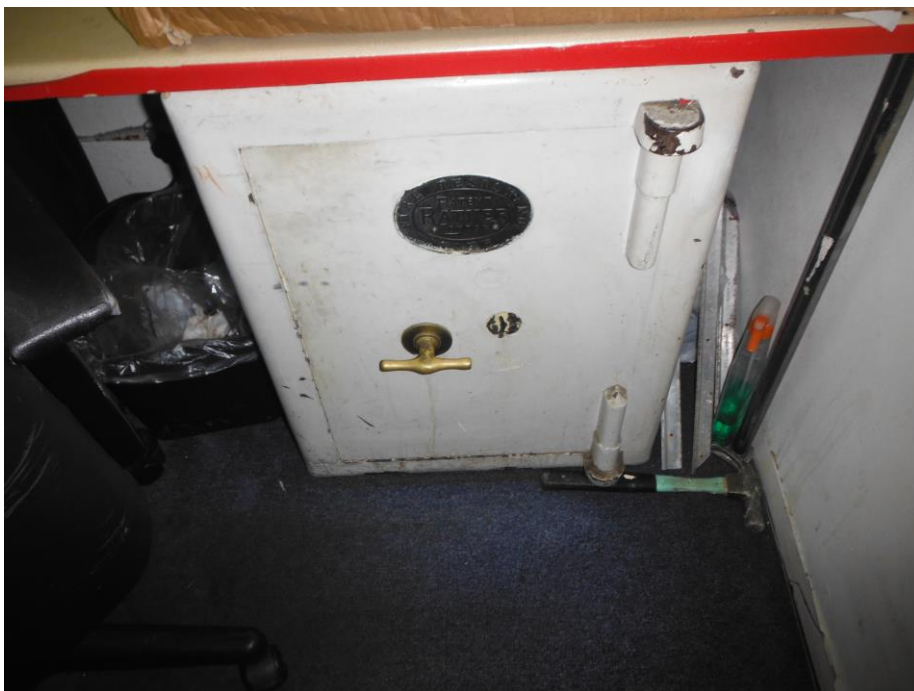
Photo 8 Ground floor reception room – safe not accessed  
Asbestos internal linings (assumed)

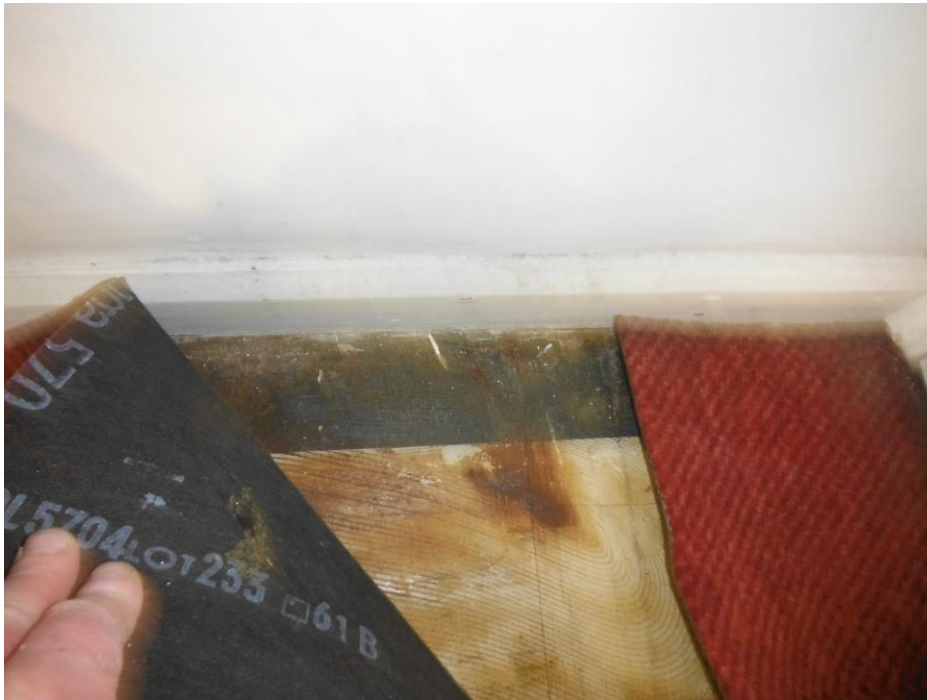
Photo 9 Ground floor waiting area - Asbestos floor tiles (assume throughout)

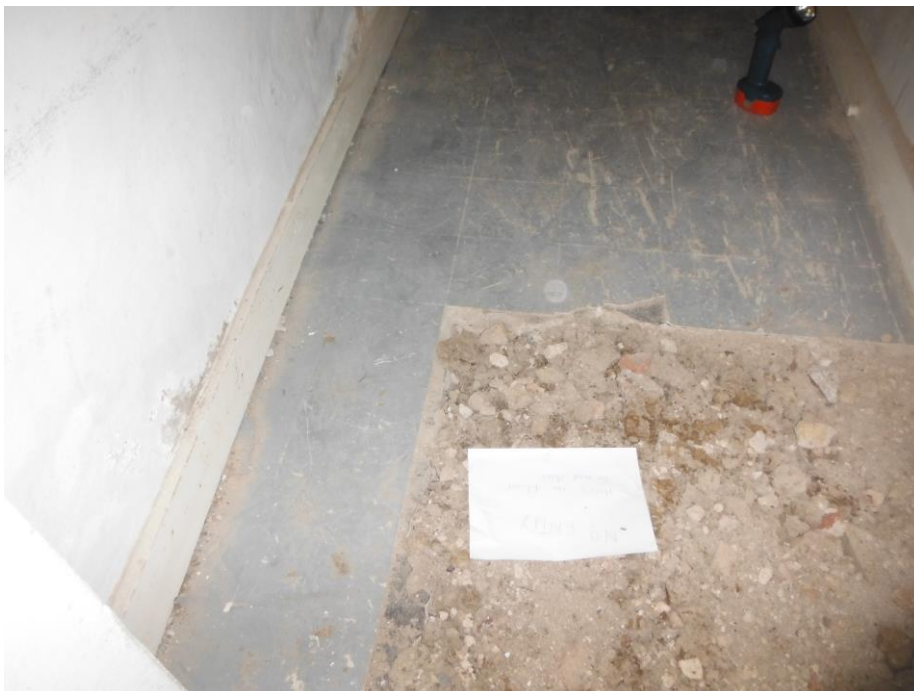
Photo 10 Ground floor lobby adjacent electrical switch room  
Asbestos floor tiles (assume throughout)

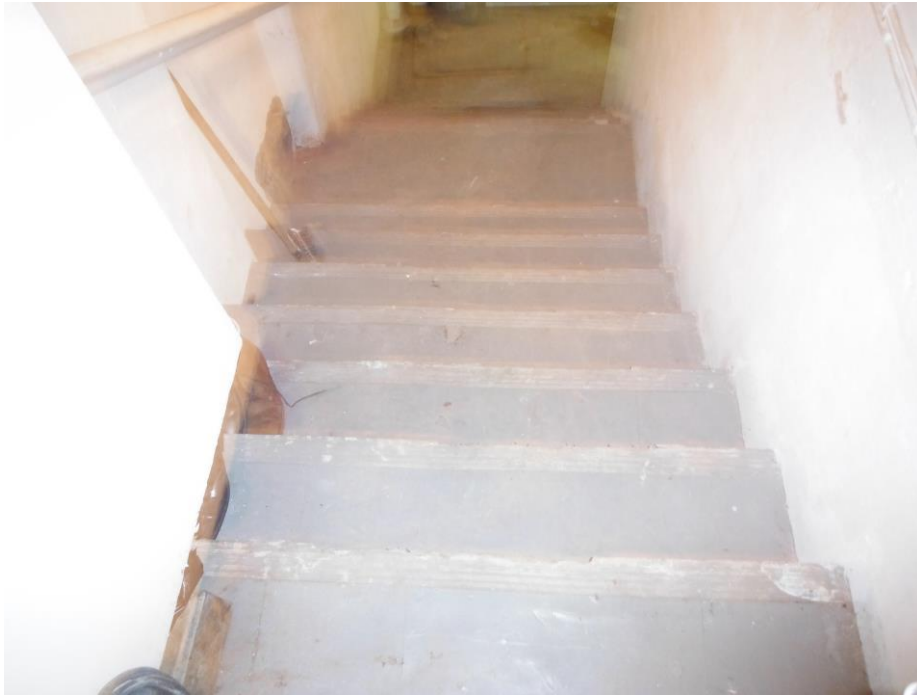
Photo 11 Stairwell to basement - Asbestos floor tiles (assume throughout)

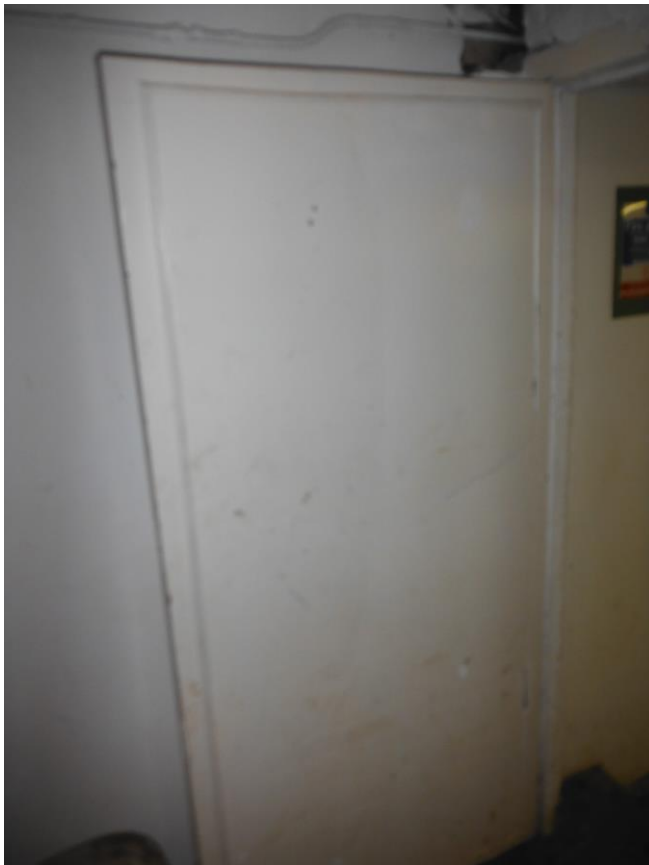
Photo 12 Basement - Asbestos cement panels lining door

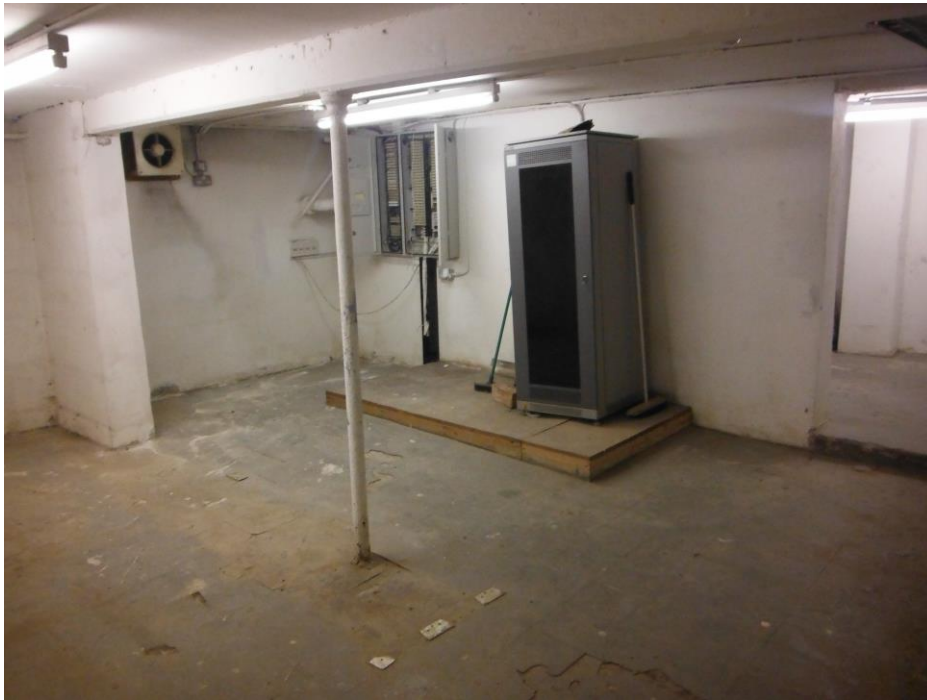
Photo 13 Basement - Asbestos floor tiles (assume throughout)

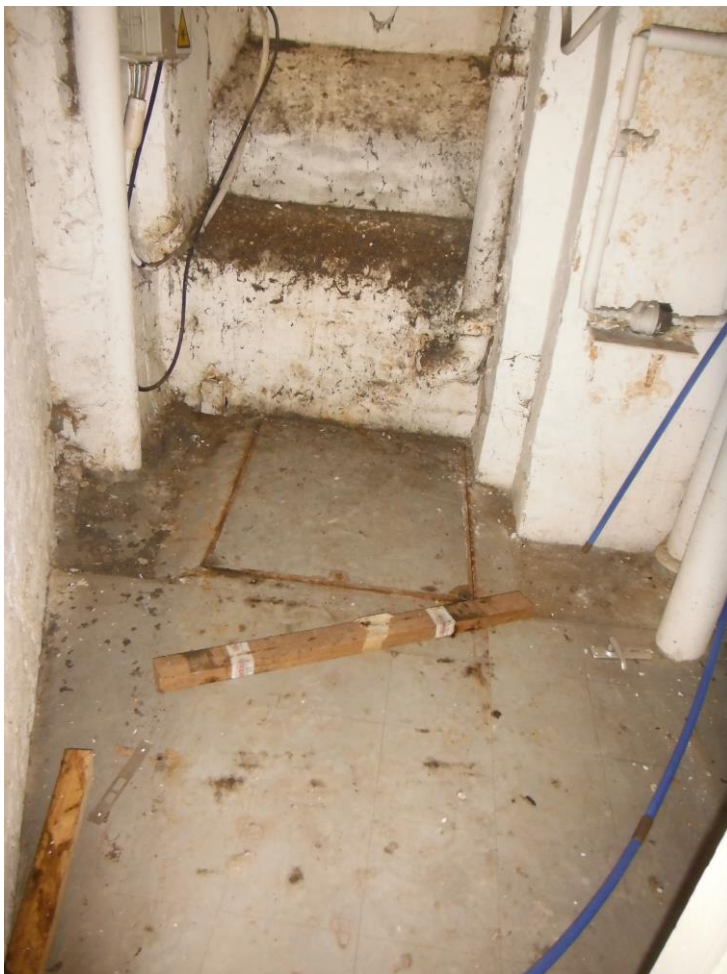
Photo 14 Basement - Asbestos floor tiles (assume throughout)

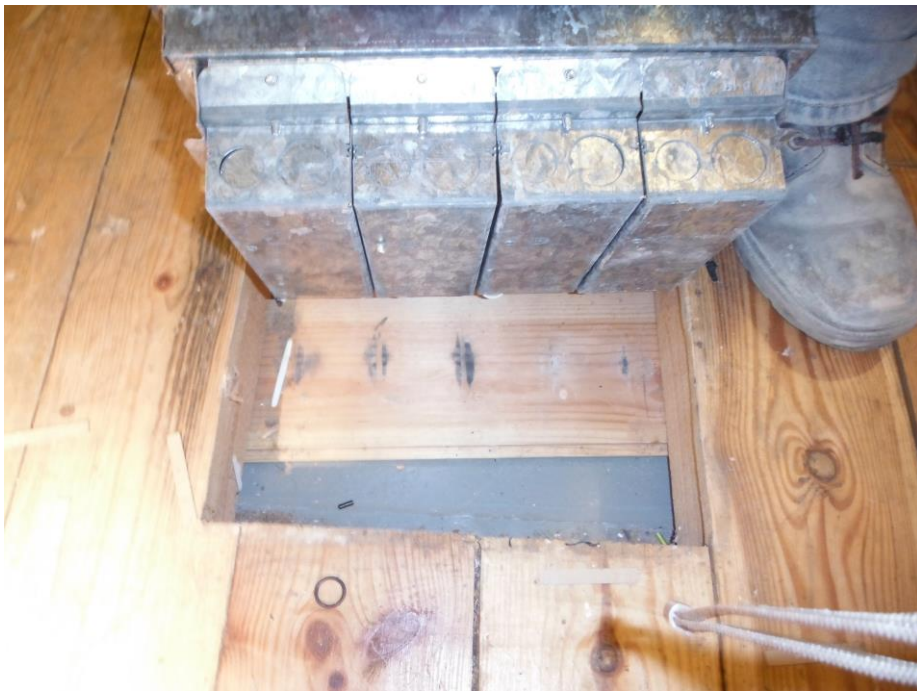
Photo 16 Ground floor Room 16 – View of concrete lower floor below wood floor.

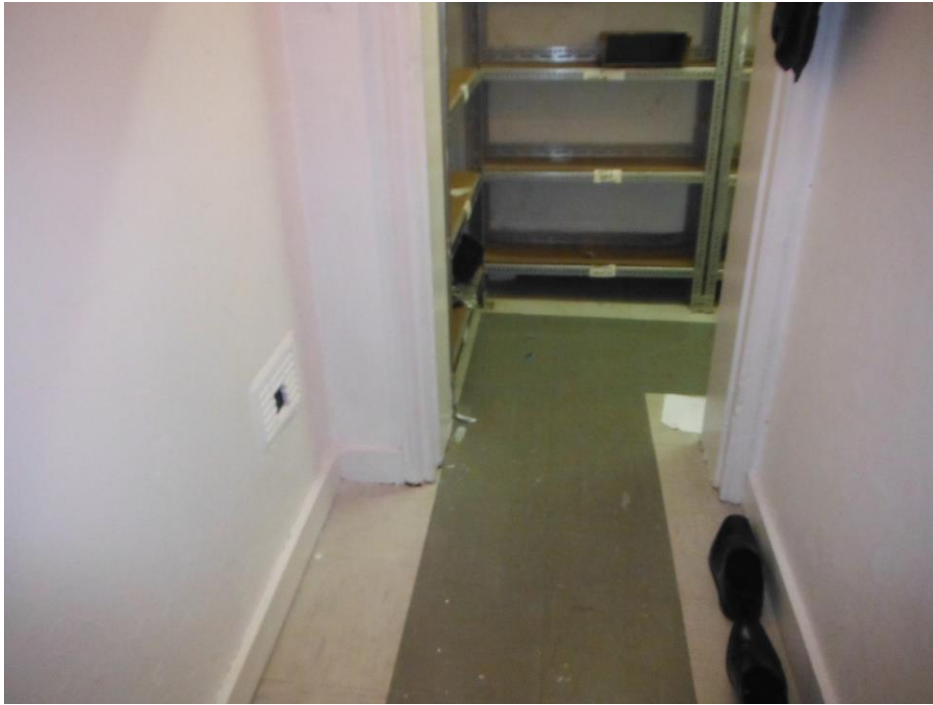
Photo 17 Ground floor room 16 – RHS store room – Asbestos floor tiles

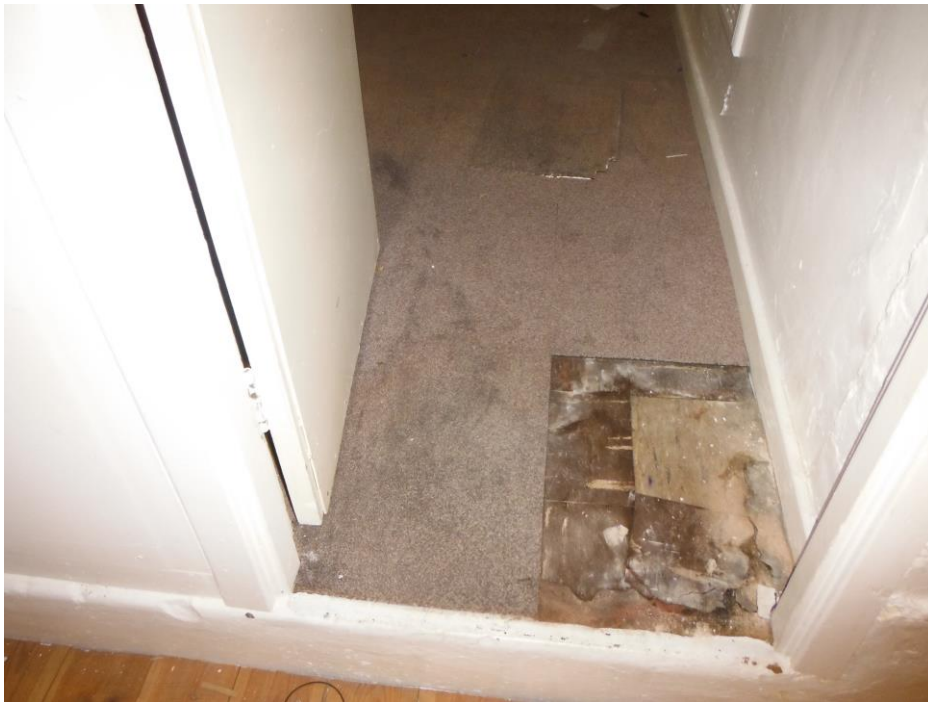
Photo 18 Ground floor room 16 – LHS store room – Asbestos floor tiles below carpet

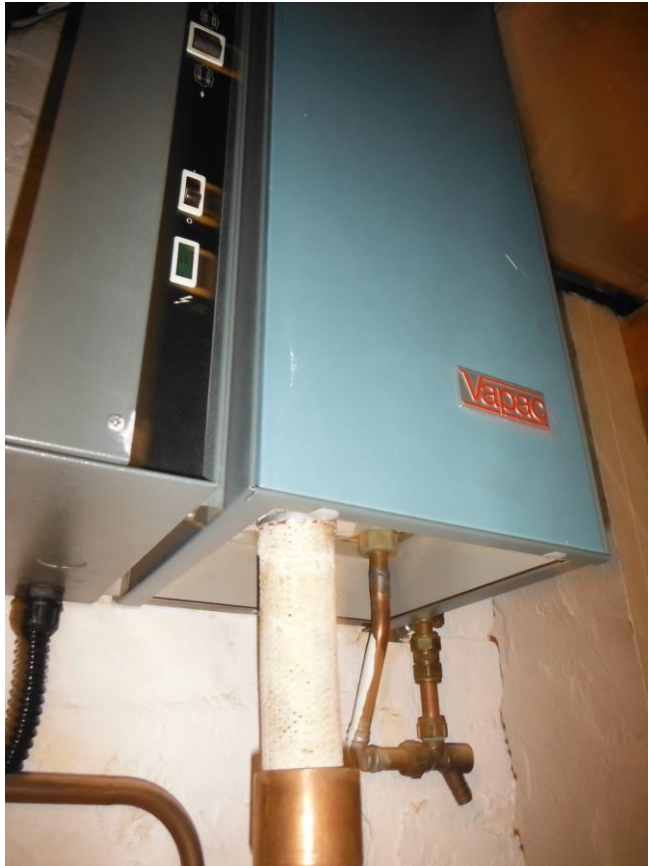
Photo 19 Room 16 Switch cupboard – Non asbestos rope lining to Vapac unit

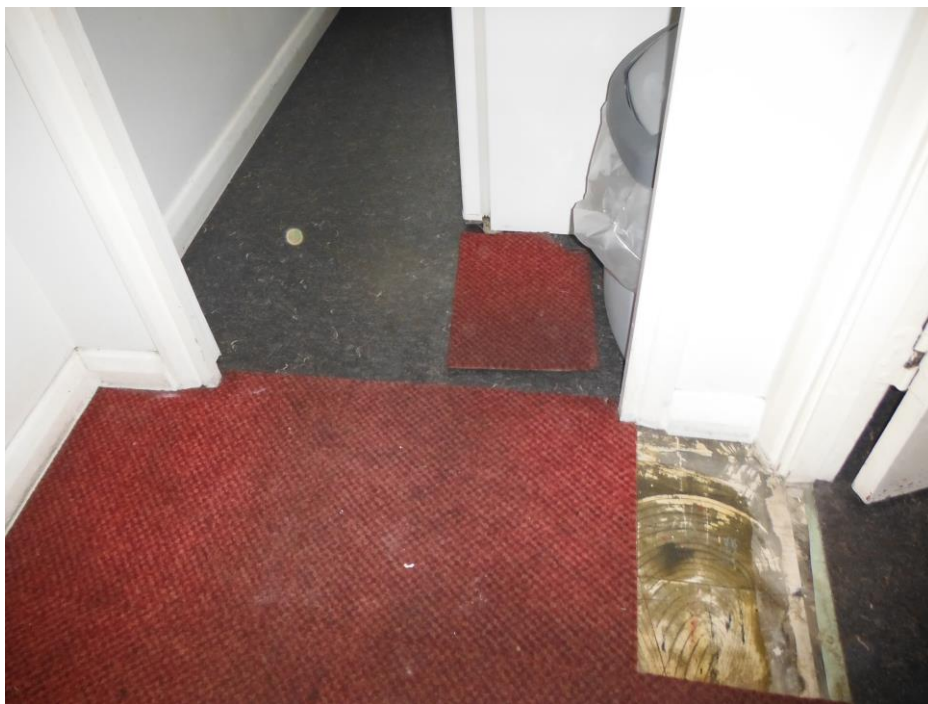
Photo 20 1<sup>st</sup> floor lobby adjacent kitchen  
Asbestos floor tiles below carpet (assume throughout)

1 <sup>st</sup> floor Lobby adjacent kitchen	Floor tiles (assumed throughout)

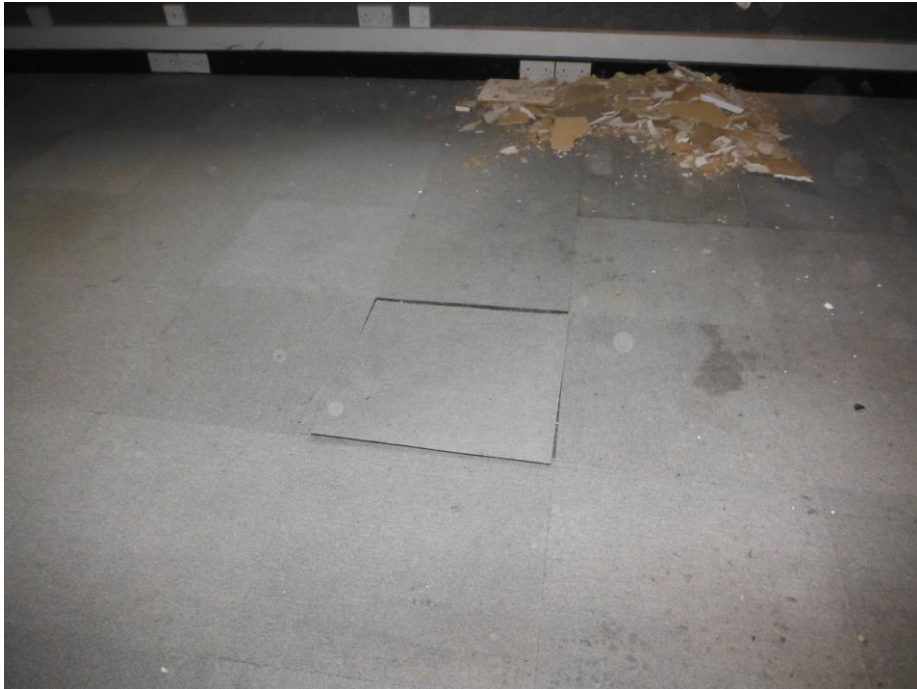
Photo 21 1<sup>st</sup> floor Room 107 – Asbestos floor tiles below carpet (assume throughout)

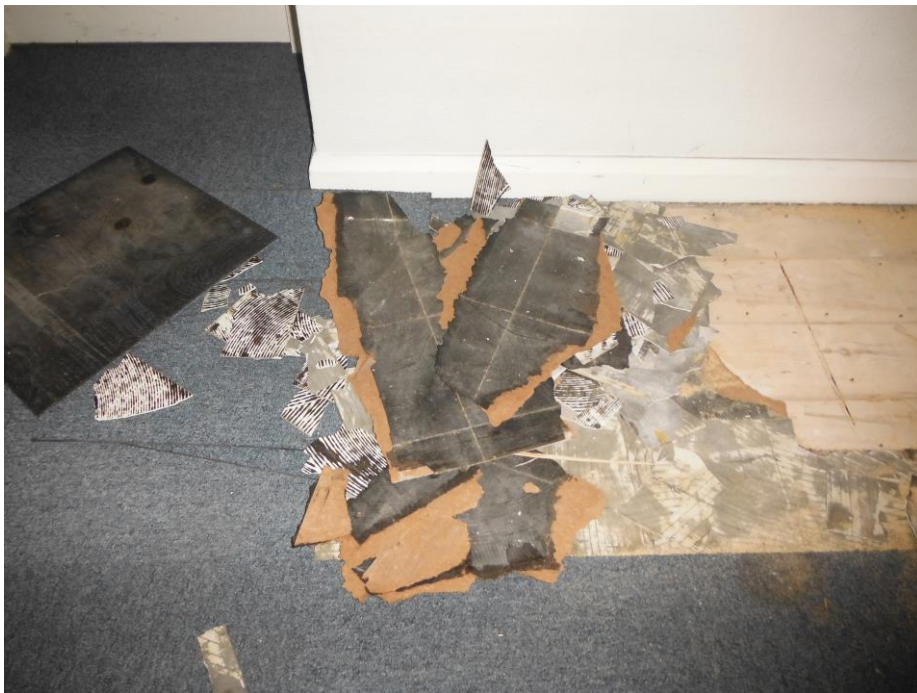
Photo 22 1<sup>st</sup> floor Lobby adjacent room 105 – Asbestos floor tiles debris

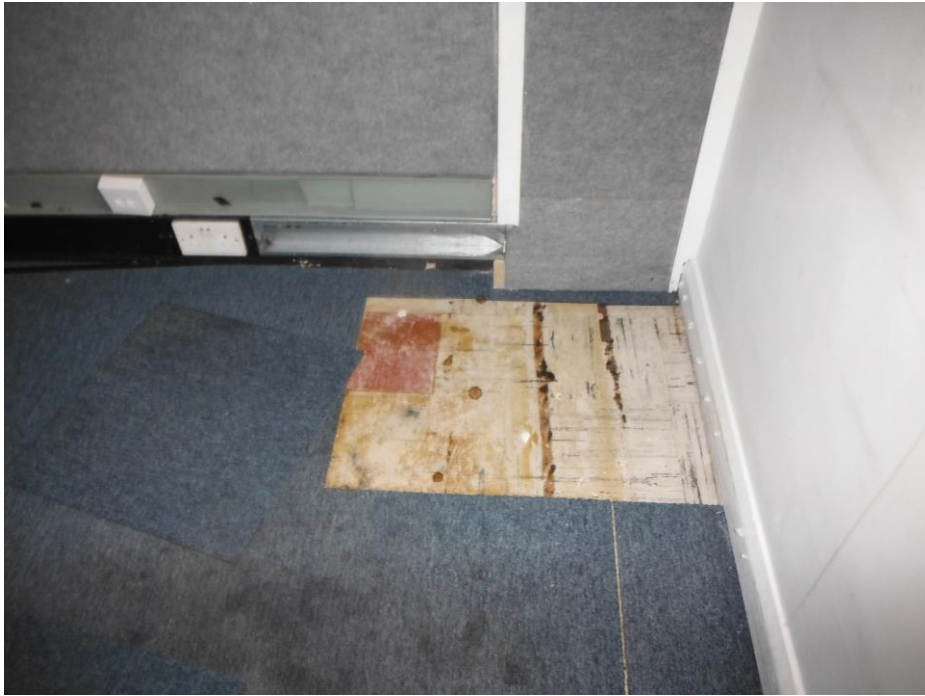
Photo 23 1<sup>st</sup> floor Room 104 – Asbestos floor tiles below carpet (assume throughout)

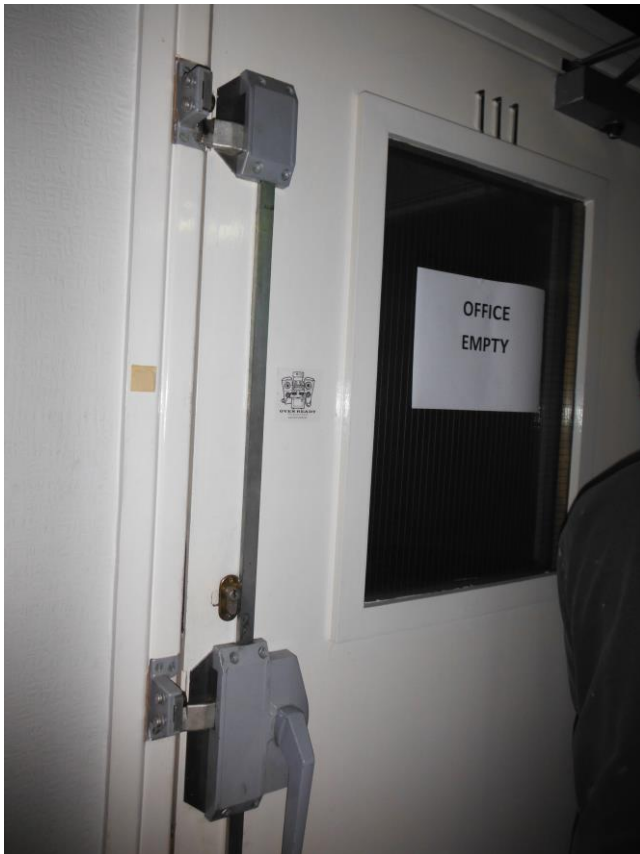
Photo 24 1<sup>st</sup> floor room 111 (not accessed)

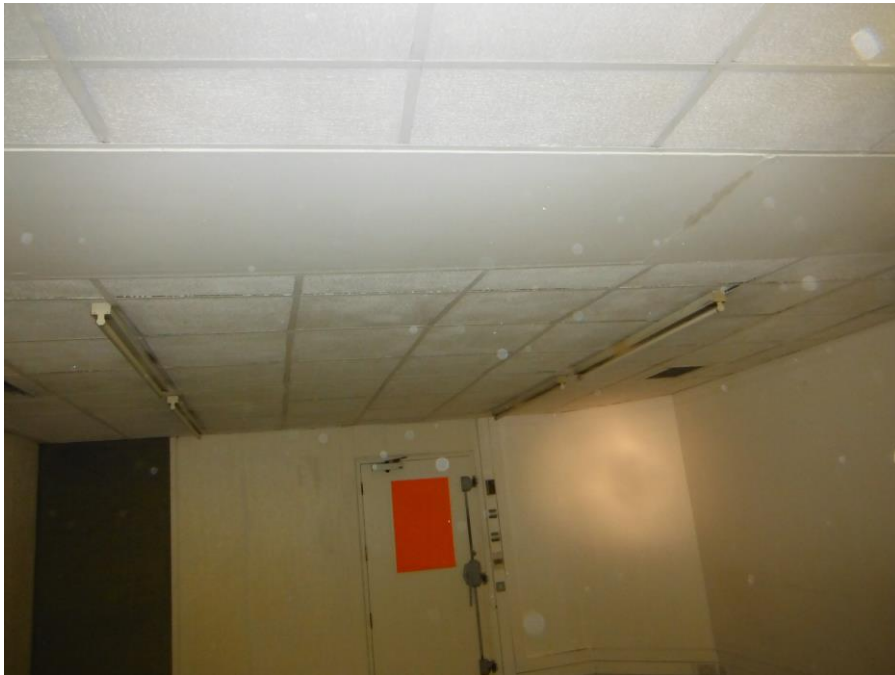
Photo 25 1<sup>st</sup> floor room 112 – Non asbestos textured coating to suspended ceiling.

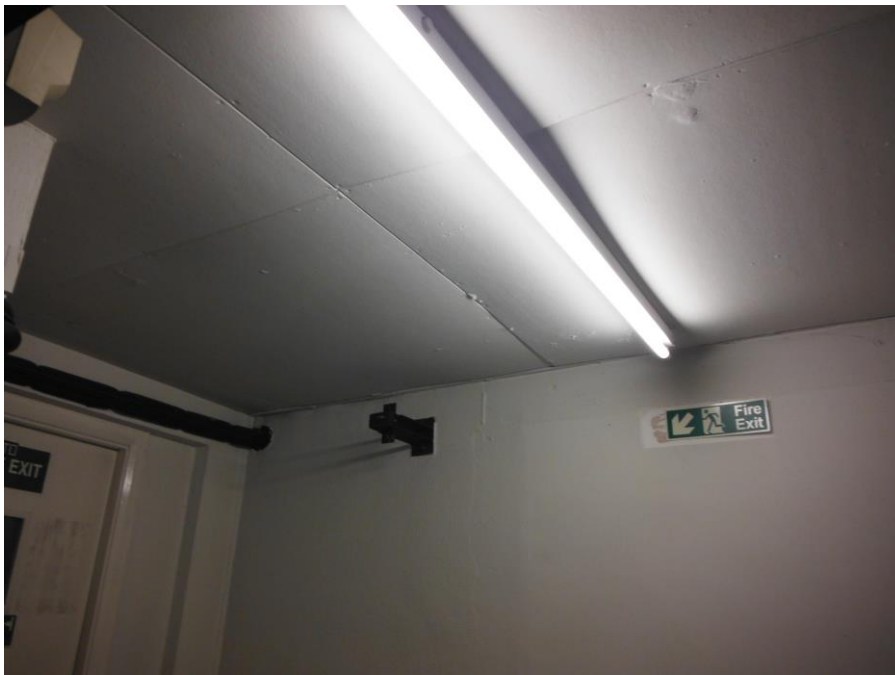
Photo 26 1<sup>st</sup> floor landing to fire escape  
Asbestos bevelled edged fibreboard ceiling tiles (assumed throughout)

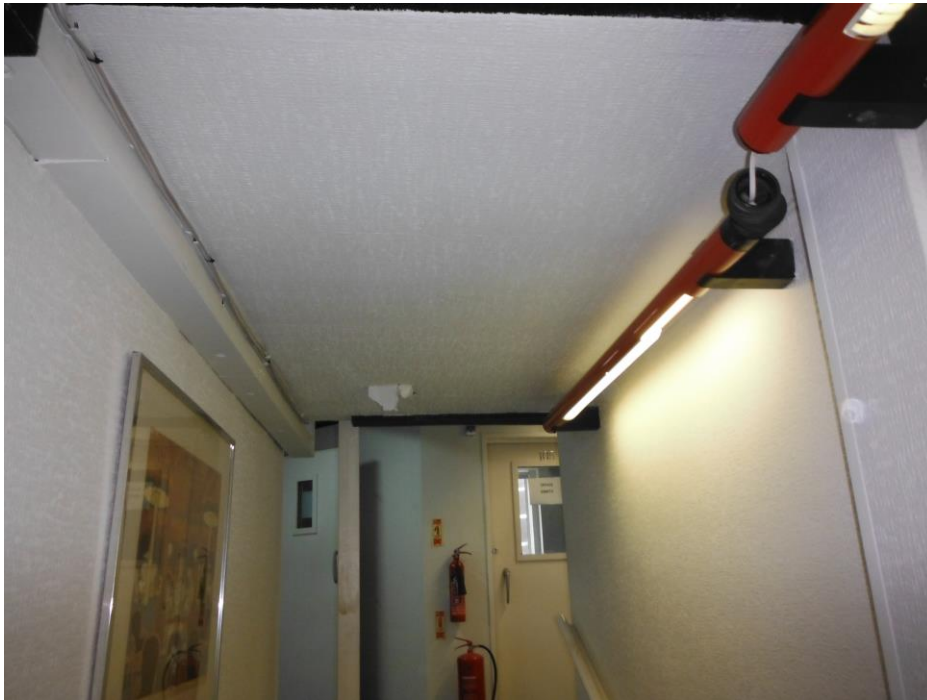
Photo 27 1<sup>st</sup> floor landing to fire escape - Asbestos insulating board ceiling panels

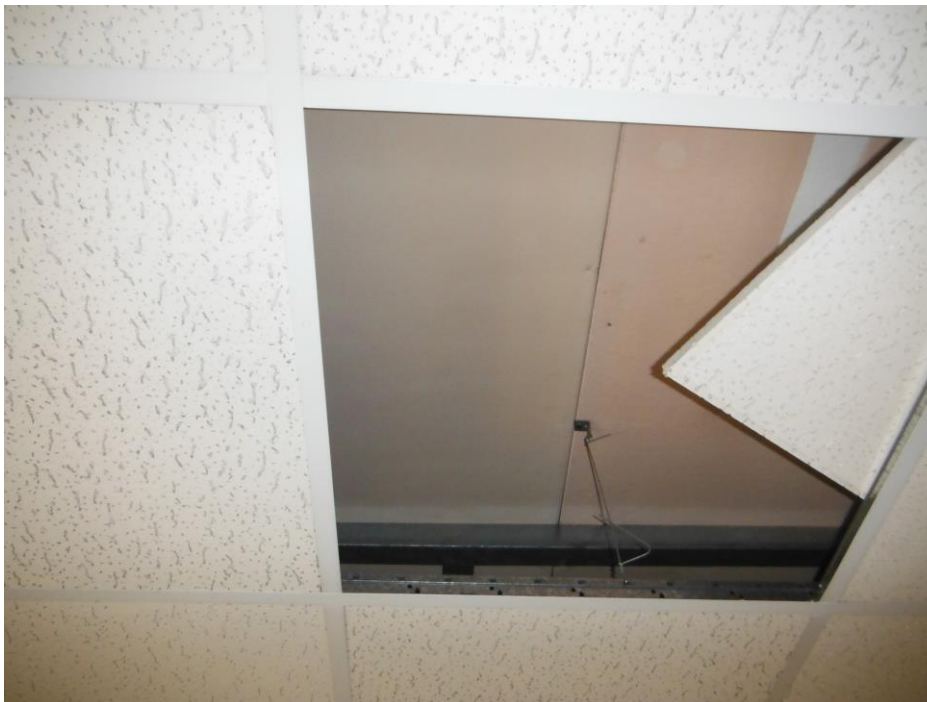
Photo 28 1<sup>st</sup> floor Room 116 - Asbestos bevelled edged fibreboard ceiling tiles above suspended ceiling (assumed throughout)

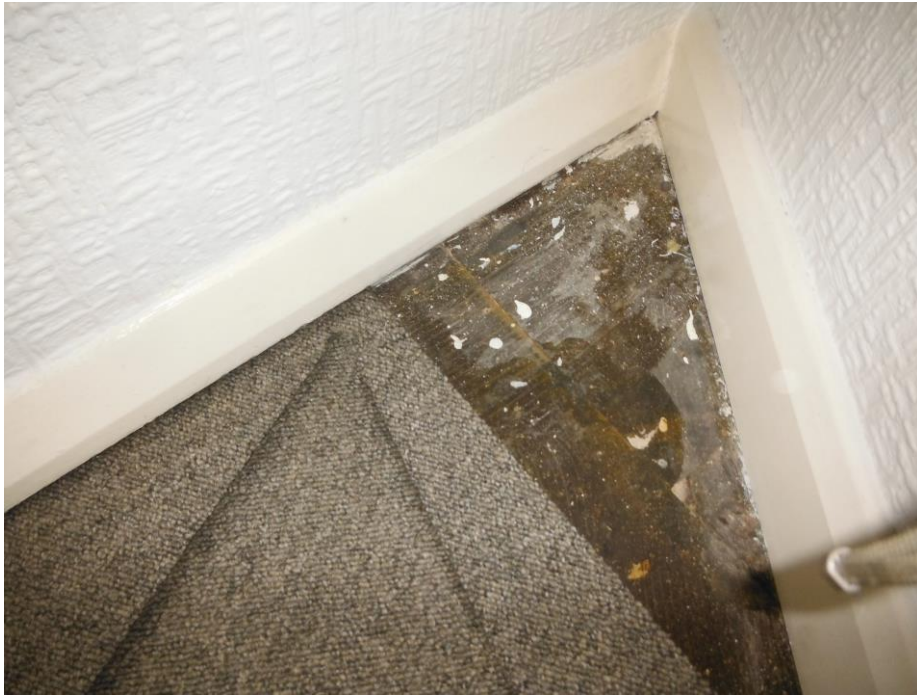
Photo 29 2<sup>nd</sup> floor Room 205 Far triangular room  
Asbestos floor tiles below carpet (assumed throughout)

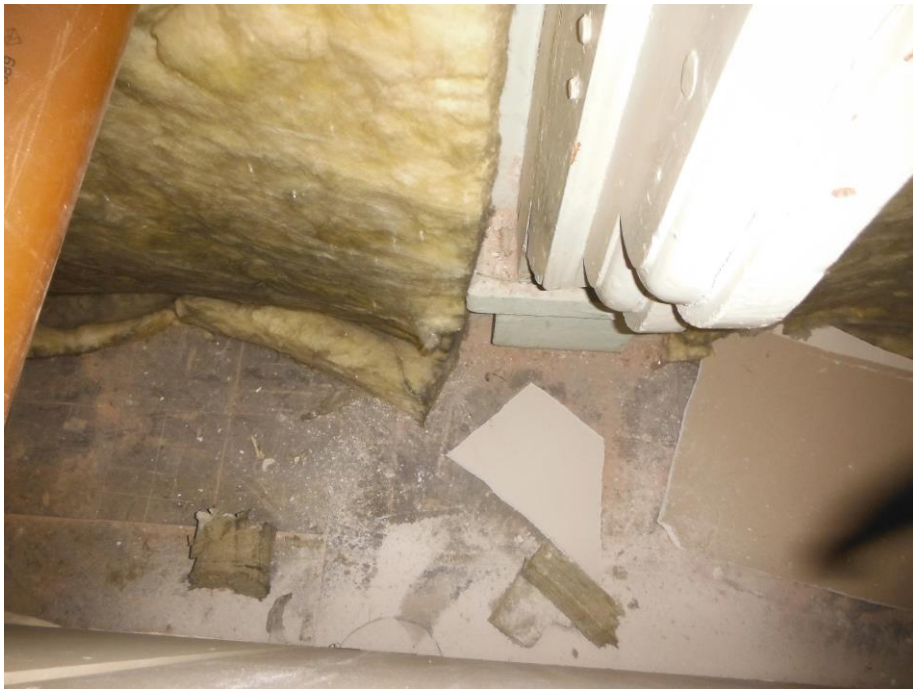
Photo 30 2<sup>nd</sup> floor Room 202  
Asbestos floor tiles within voids in sides of room (assume throughout)

2 <sup>nd</sup> floor Open plan office room 201	Floor tiles (assumed throughout)	
2 <sup>nd</sup> floor Room 202 (sides of room)	Floor tiles (assumed throughout)

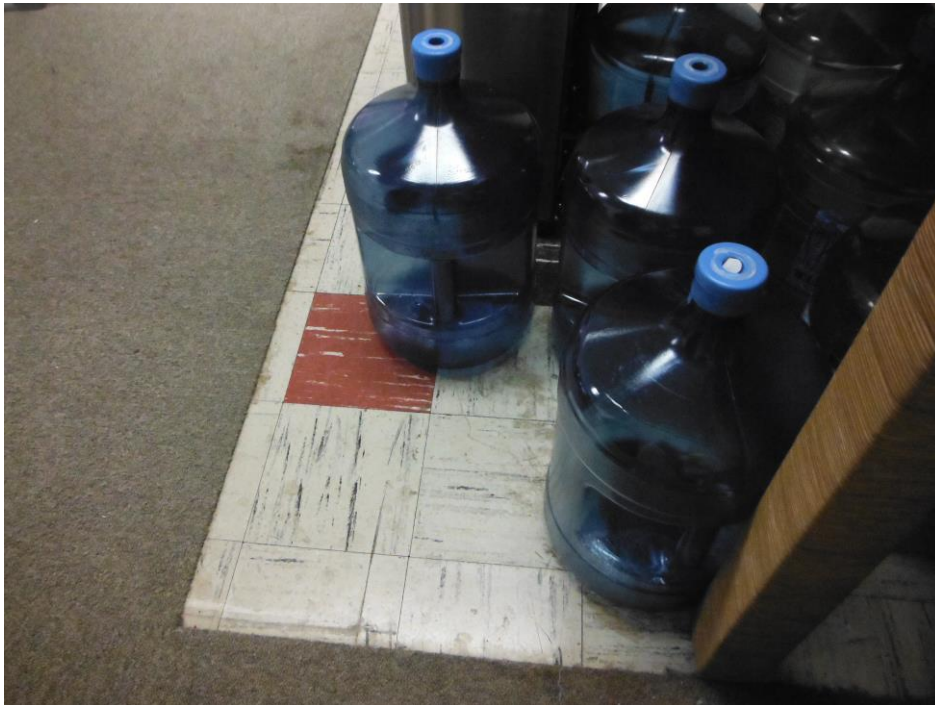
Photo 31 2<sup>nd</sup> floor Open plan office room 201 – Asbestos floor tiles (assumed throughout)

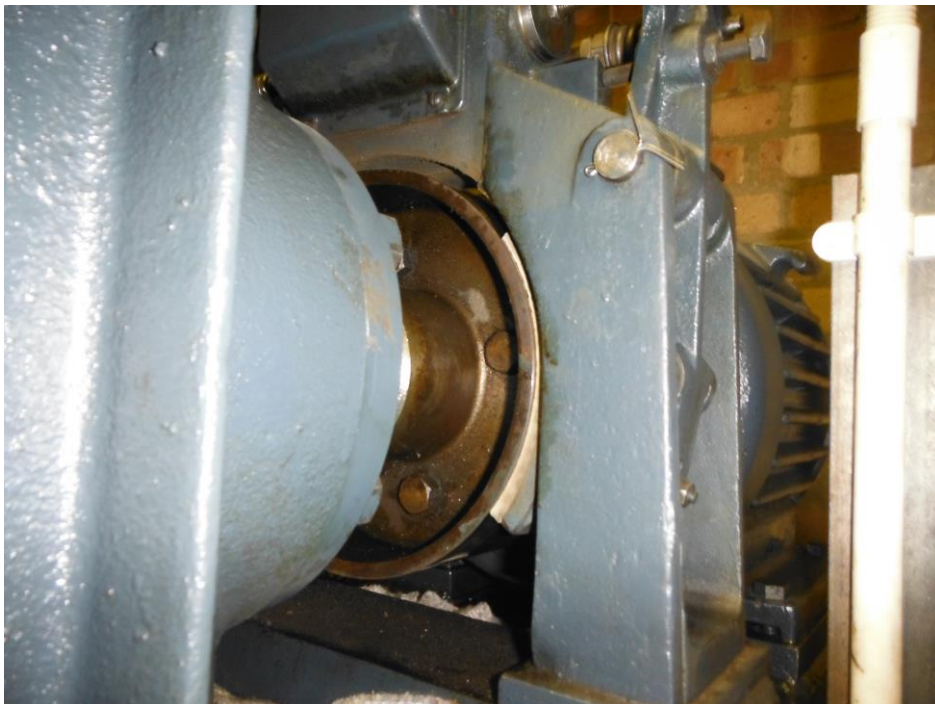
Photo 32 Roof space Lift motor room – Asbestos cement brake shoe linings (assumed)

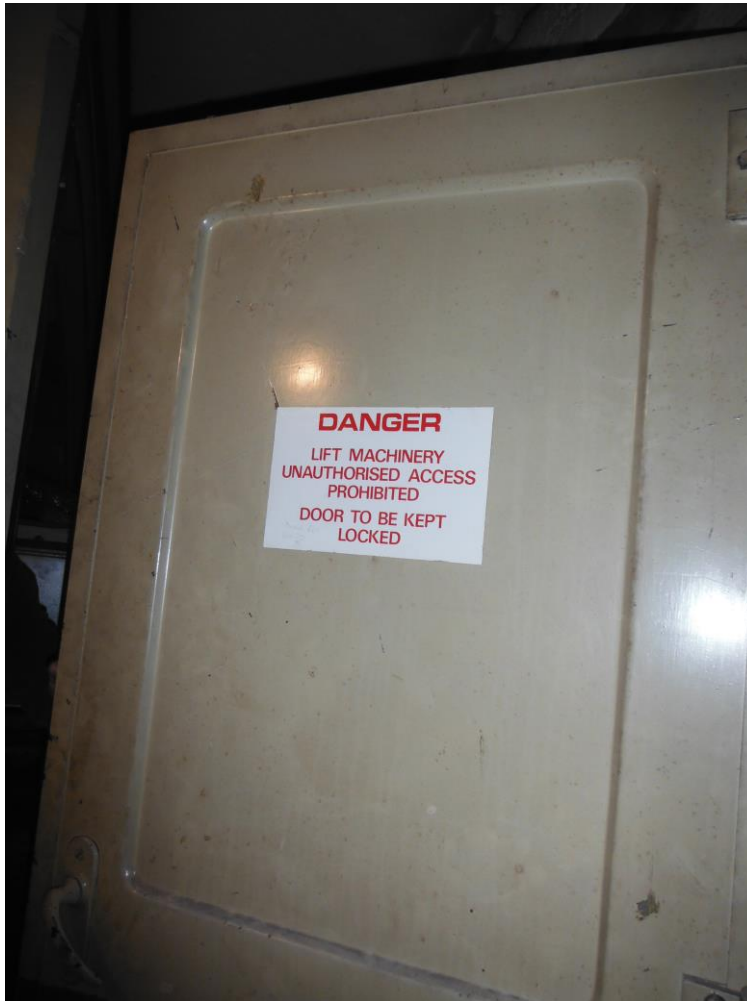
Photo 33 Roof space Lift motor room – Asbestos fire door (assumed)
