REPORT ON ARBORICULTURAL IMPLICATIONS OF SUBSIDENCE

**13 TORRIANO AVENUE,
LONDON
NW5 2SN.**

REF: B1239944

19TH APRIL 2013

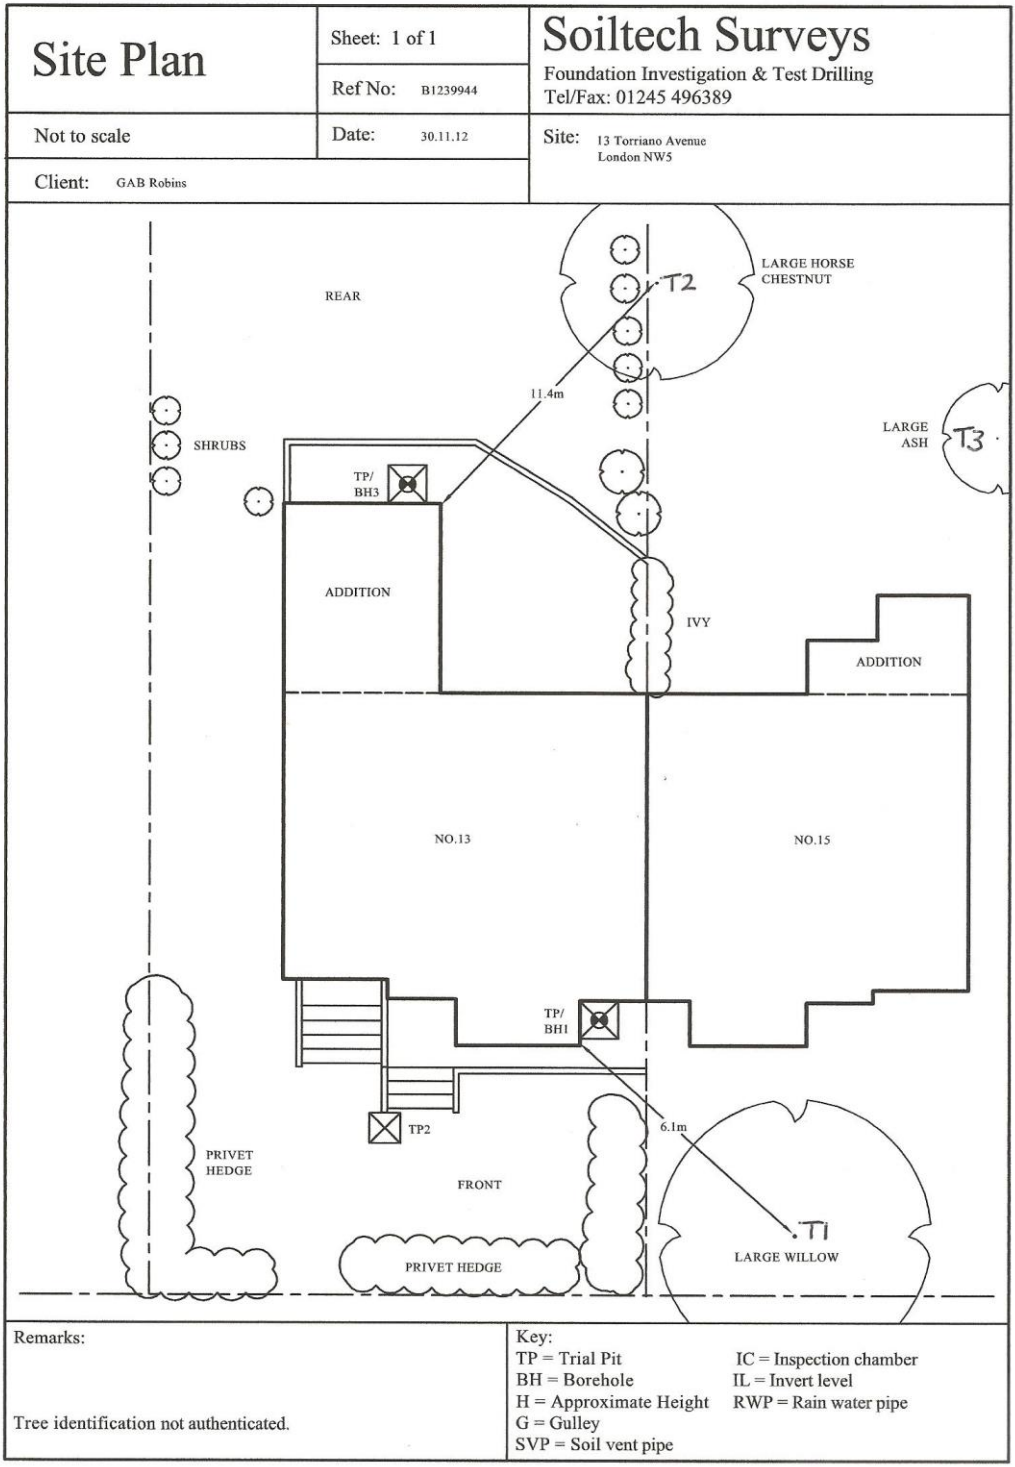
3.3.1. Three trees were recorded in the gardens of the adjacent property 15 Torriano Avenue. See amended Soiltech Site Plan for location of trees surveyed. Data on these trees is included in Appendix 1.
