# Barton Engineers

### Structural Survey

32 Torrington Square  
London, WC1E 7JL

July 2015

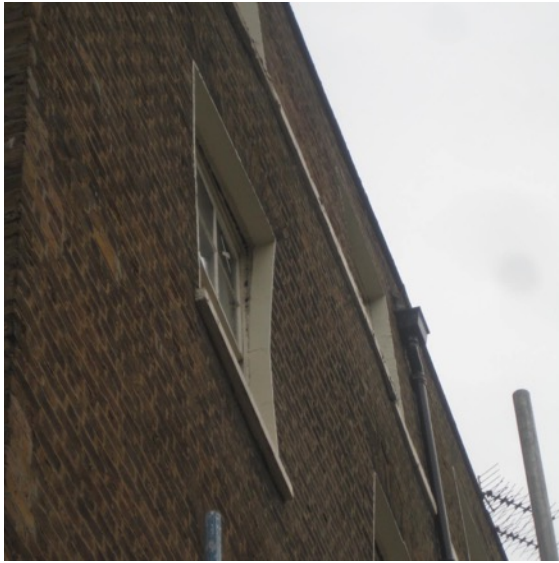
The front facade contains a significant outwards bow between the second floor and roof level, centred in the middle of the facade. In addition, it appears that a brick above the head of one of the second floor windows has been displaced.

Outwards Bow of Front Facade

The front facade masonry has delaminated above the mid height of the second floor windows. The horizontal mortar joint just above third floor level on the inside face of the facade has failed and the entire thickness of the front wall has bowed outwards. This type of delamination of brickwork walls is not uncommon for this type of construction, but the localised outward movement of the facade is relatively large, and gives serious cause for concern. The remainder of the front wall, below the cill of the second floor window down to ground floor level, appears unaffected, and the sketch below which summarises our conclusions.

- We would recommend that urgent works are carried out to restrain the front facade panel bowing outwards from the flank and party walls, to prevent further movements of the brickwork.

Based on the magnitude of the delamination and the failure of the horizontal mortar joint above the third floor level, we recommend that the front facade above the second floor is rebuilt up to the roof parapet level. Adequate tying of the brickwork to the floor and roof structures will have to be provided. The roof and floor structures, bearing on the part of the facade to be rebuilt, will need to be temporarily propped during the works.

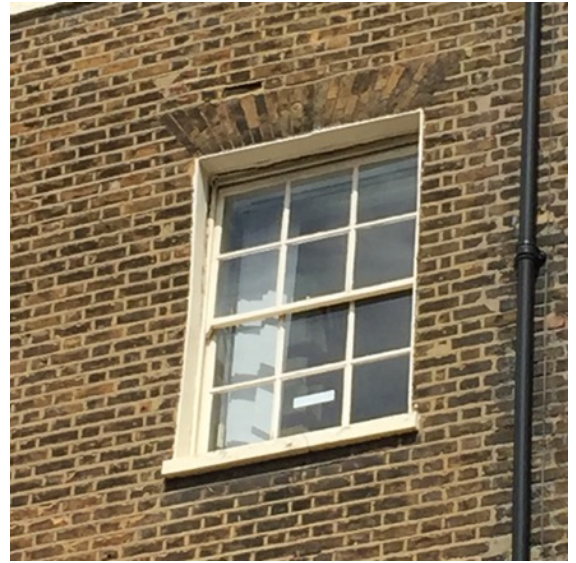
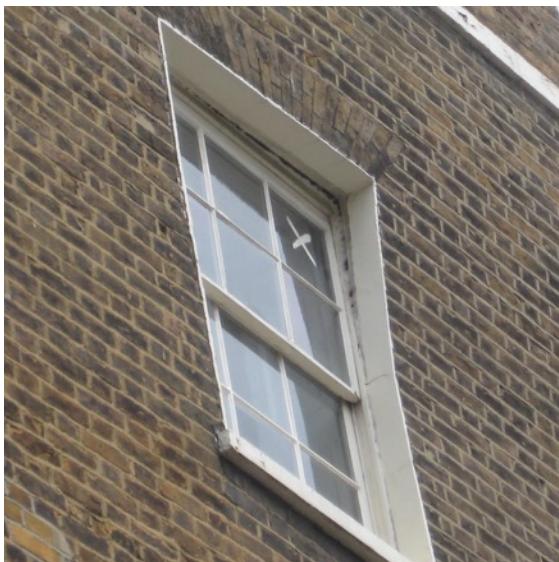
The window reveals at second and third floor levels are in poor condition, with paint peeling off the reveals. Both second floor window reveals also contain a crack at mid height on either side of the central pier. Above the mid height of the second floor window, the outer part of the facade appears to have moved significantly outwards, leaving a large gap between the brickwork and the outer face of the window frame.

Close Up View of Front Facade

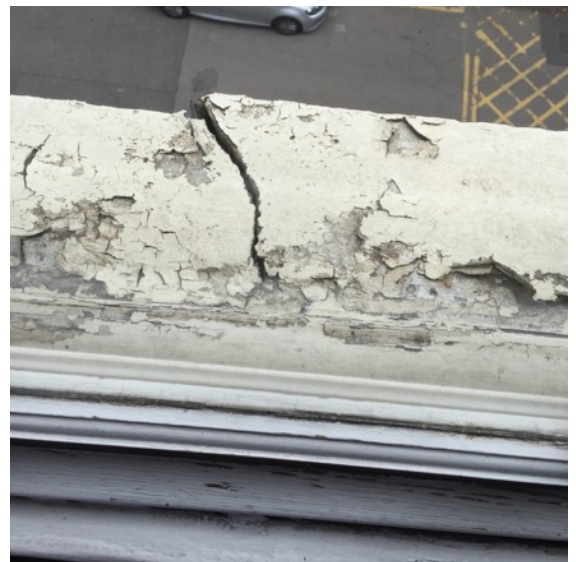
At third floor, there is no gap between the outer face of the window frame and the outer part of the facade. However, there is a significant 30 mm wide vertical crack between the facade and the internal partition between the two front rooms. A large crack was also observed through the middle of both cills of the third floor windows, with part of the cill on the side of the middle pier, displaced outwards. On the inside of the front wall, a significant outward bow is clearly visible between third floor level and the ceiling.

Crack Through Third Floor Window Cill

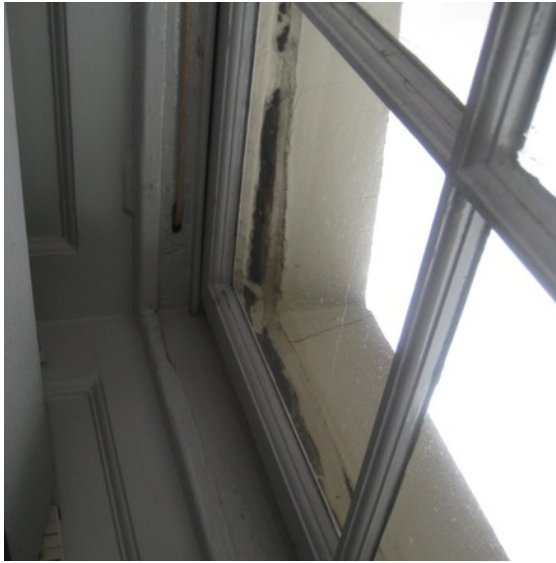
Delamination of Front Facade

horizontal separation in the masonry wall has occurred at this level.

The floor opening at third floor level also showed that there is a horizontal step in the inner brick course of the front wall, just above the top of the floor joists, and a significant vertical gap could be observed between the inner brick leaf and the remainder of the wall structure below. Clearly a

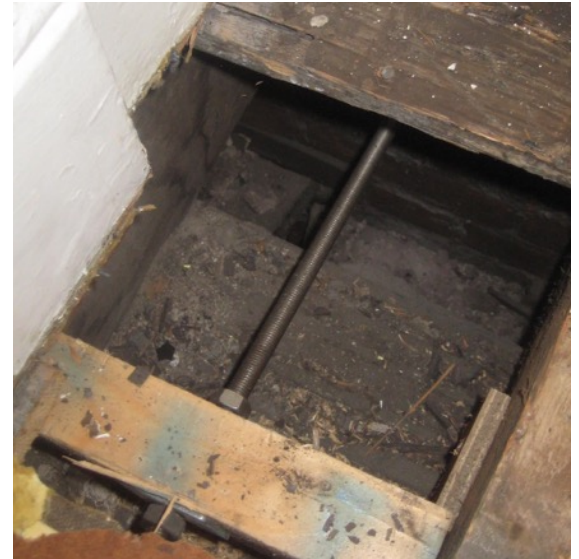
Second Floor Wall Ties

The floor opening up investigations uncovered recent remedial works to the facade. These comprised steel ties embedded in the front wall and fixed back to timber blocking pieces installed between the existing floor joists. These ties did not appear to pass through the full thickness of the front wall. At second floor level, these ties were formed using steel rods, whilst steel helical bar ties were used at third floor level.

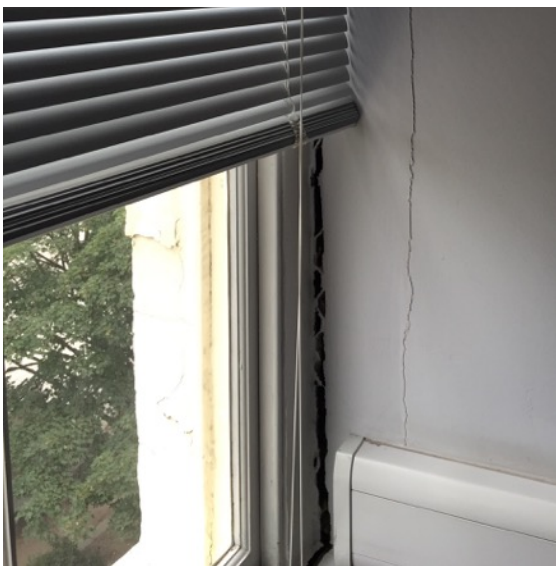
Crack Between Front Facade and Partition at Third Floor

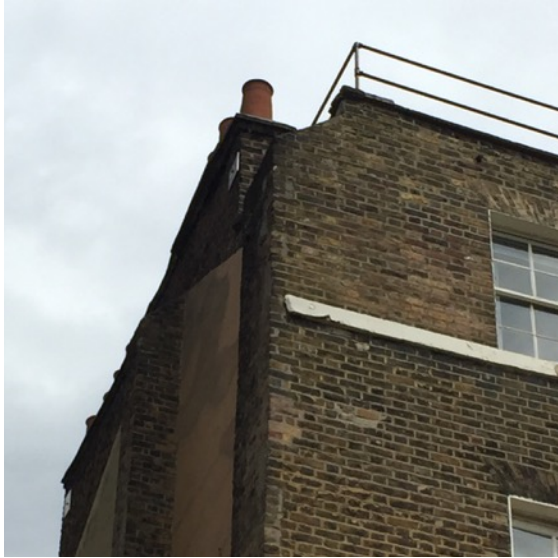
The remainder of the front facade below the second floor level appears to be in reasonable condition. There is, however, evidence that original bricks have been replaced in some small areas next to the flank wall of the property,

Front Facade Previous Repair Works

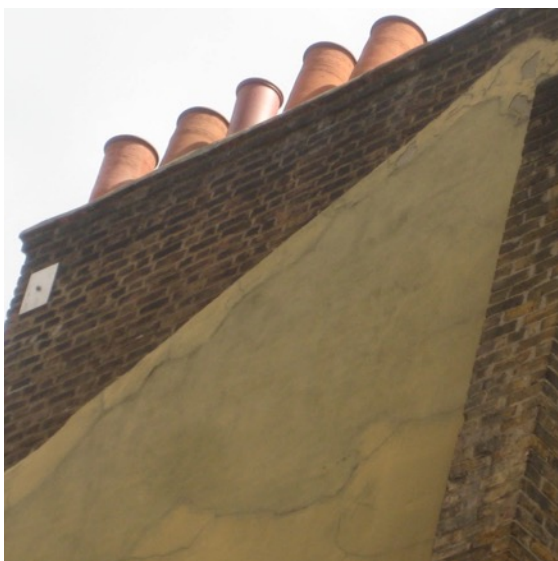
The flank wall is rendered between the brickwork buttresses, and there are numerous cracks in this render. The exposed brickwork in the flank wall appears to have no significant defects. There are no windows on this elevation.

Cracks in Flank Wall Render

Numerous cracks were observed in the render of the flank walls but there was no sign of loose parts of render having fallen off the wall. A close inspection will be necessary to confirm the possible causes for the cracks and the extent of the damage.

- Regarding the render of the flank wall, we recommend that a close inspection is carried out to identify the extent of the cracks and if there are any loose parts of render. Samples of the render could be taken for testing to determine its composition. This inspection and testing will be necessary to assess the appropriate remedial works required. It may be that the cracks in the render only need to be infilled and a thin layer of render applied, or the render may need to be removed and replaced.

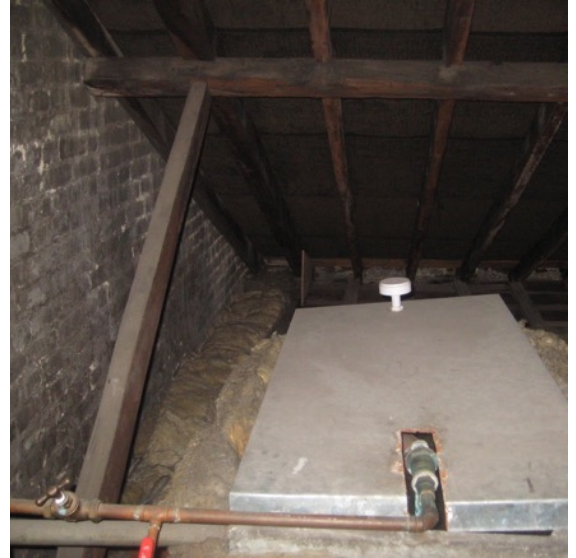
Loft Water Tanks

Only a limited part of the loft was accessible, adjacent to the loft hatch, and the inspection of the loft was carried out from that location. The roof structure that could be examined appeared to contain no significant defects. There are three water tanks bearing on the loft joist structure, and it is not known if these are still in use or not.

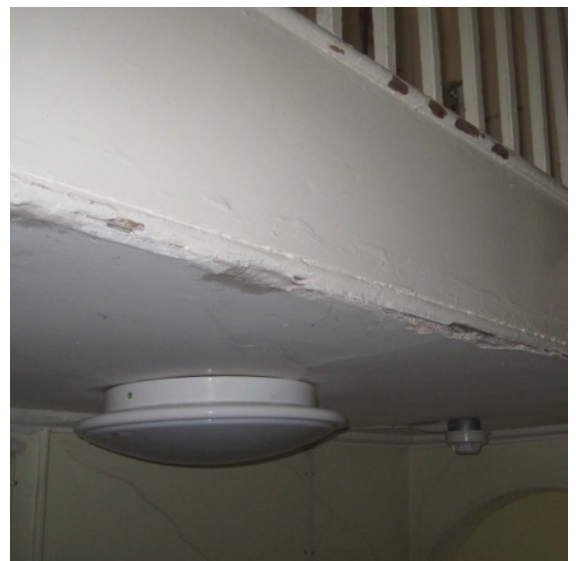
Generally, there was no evidence of significant cracks in the ceilings, except to the soffit of the third floor landing. In this location, cracks were observed in the ceiling between the light fittings and the edge of the ceiling panel. It also appears that the ceiling in this area has dropped and the edge of the ceiling along the stair void is damaged.

Ceiling Beneath Third Floor Landing

The ceiling on the underside of the third floor stair has dropped and its edges are damaged. The pattern of the cracks in the ceiling indicates that the observed damage may have been caused by the installation of light fittings.

Prior to the works to the front facade and any internal works taking place, the support of the existing ceilings is to be strengthened to reduce the risk of damage and potential collapse of the ceiling due to the movements of the existing floors both historically and during the works. This could be done by removing the floor finishes and installing additional support brackets to the ceiling, and within the existing plaster thickness, which are fixed to the floor joists.

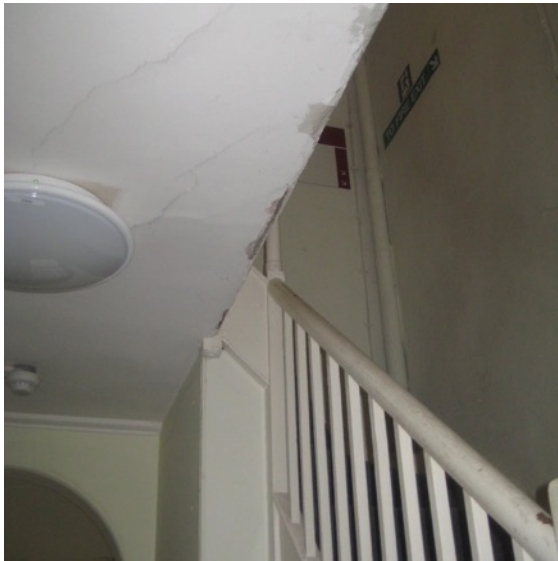
Cracks in Ceiling

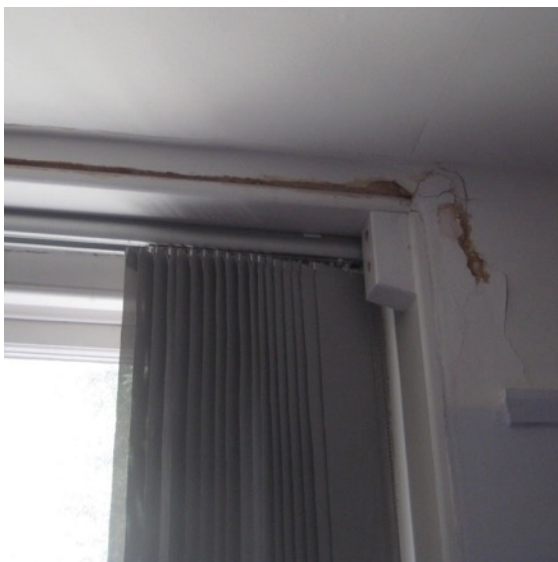
In Room 304 at third floor level (rear room along flank wall), there is evidence of water ingress at the junction between the rear facade and the flank wall, and also above the window.

Water Ingress at Head of Window

The water ingress observed on the inside of the rear facade at ceiling level of Room 304 could be due to a leak through the flashing of the roof on the face of the masonry parapet, or could have been caused by water ingress through cracks in the masonry parapet. A close inspection of the roof and parapets will be required to confirm this.

- We recommend that a close inspection of the roof parapet along the rear facade is carried out to identify any damage to the roof flashing or to the masonry parapet which could have caused the water ingress observed at third floor level. The plaster finish should also be removed

at these locations to expose the brickwork and the lintel above the window. This would show any damage of these elements which could explain what was observed.

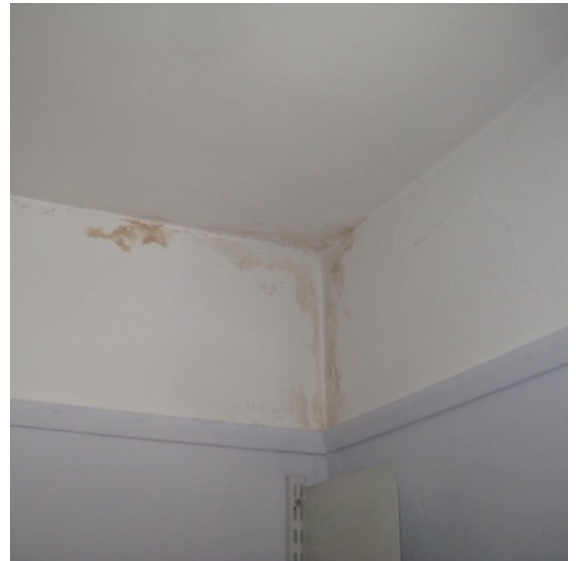
Water Ingress at Corner of Rear/Flank Walls

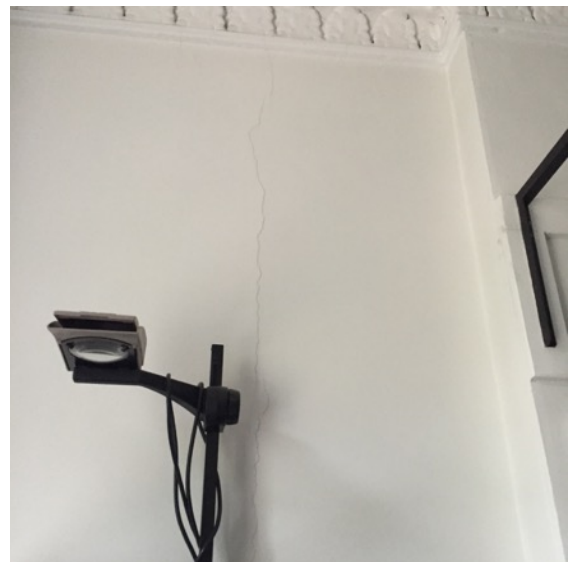
In the first floor front room, there is a vertical crack in the plaster finish to both side walls.

The cracks in the walls described above, between first and third floor levels, could be due to historic thermal movements of the masonry walls causing cracking of the plaster finishes.

Crack in First Floor Flank Wall

- The cracks observed in the walls, except for the cracks to the front facade, are probably due to historic thermal movements of the masonry wall and the cracks only need to be infilled and the plaster made good.

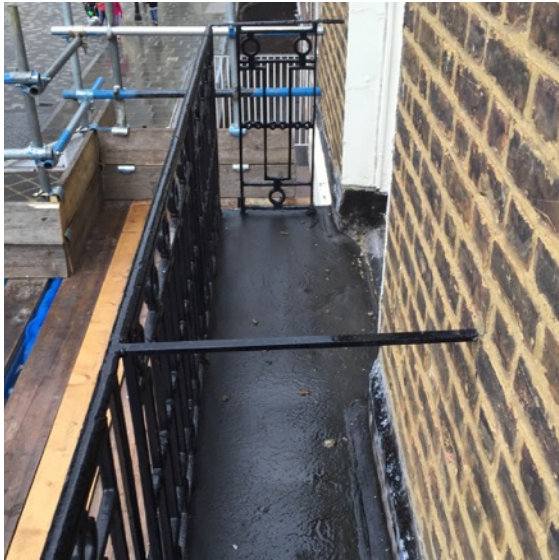
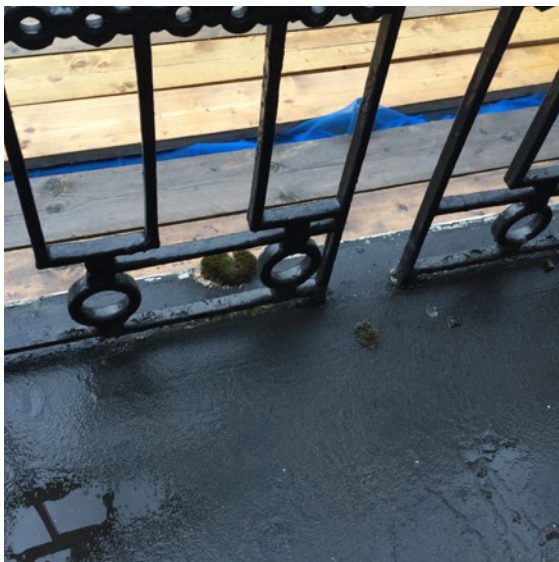
The front balcony could only be surveyed from the first floor level, as the scaffold erected along the front facade prevented inspection from street level. There was no evidence of corrosion of the metal railings and there was no sign of significant cracks in the waterproofing layer over the stone slab. However, there was evidence of plant growth in the stone slab along its edges, which indicates that the edge of the stone slab might be chipped in these locations.

First Floor Balcony

- The stone slabs of the first floor balcony should be cleaned to remove any plant growth, and the stone slab repaired in these locations to avoid further damage.

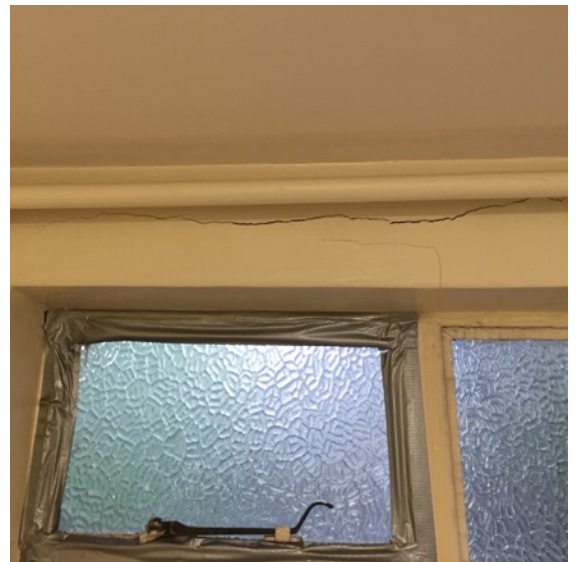
Cracks in the finishes could be observed above a window on the first floor and there was also evidence of dampness on the inner face of the flank wall at lower ground level.

Crack above rear extension window

The cracks observed above one of the window could be a sign of the timber lintel being rotten or of damage to the masonry at its end bearing.

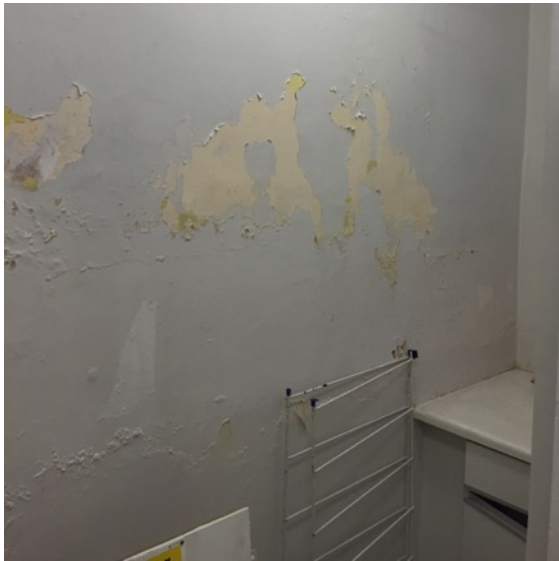
Dampness on rear extension wall

The dampness of the lower ground floor wall is evidence of water ingress through the brickwork. The location of the dampness on the inside matches the location of the external steel staircase on the outside. The stone finishes on the treads about the face of the wall and weeds could be seen at the junction between the wall and the edge of the treads. This seems to confirm that rain water on the treads finds its way through the brickwork, causing the dampness on the inner face of the wall.

- To reduce the dampness to the rear extension wall, we would recommend that the finishes to the external stair are modified to allow for a sufficient gap between the edge of the stone and the brickwork wall.

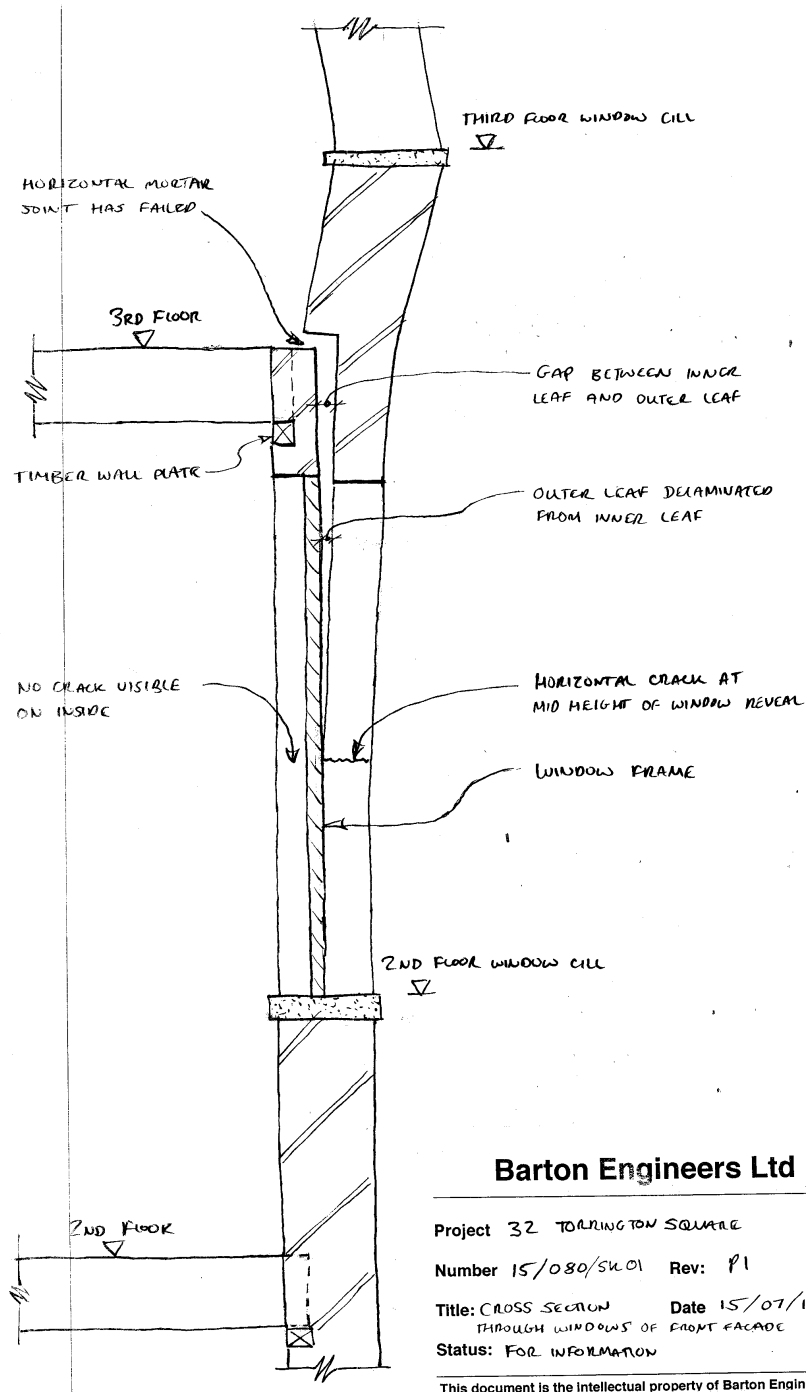
Number 15/080/SK.01 Rev: P1

Title: CROSS SECTION THROUGH WINDOWS OF FRONT FACADE Date 15/07/15

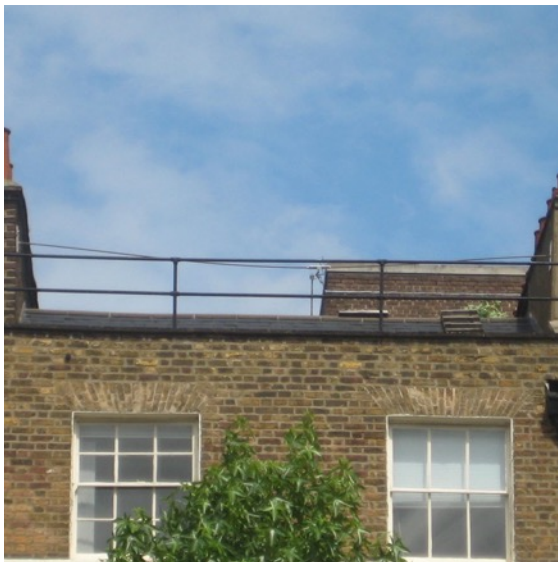
Observations of the chimney stacks from the opposite side of the street suggest that they both lean outwards in opposite direction to the roof of the property. The steel ties which have been installed to tie the chimney stacks together seem to have been an attempt to restrain the chimney stacks against one another. However, the ties appear to be loose and therefore it can be concluded that the ties do not seem to currently serve any structural purpose.

View of Chimney Stacks and Tie

- A close inspection of the chimney stacks is recommended to measure if any movements have occurred and to identify any damage to the brickwork. This will be required to determine if any repairs are needed.

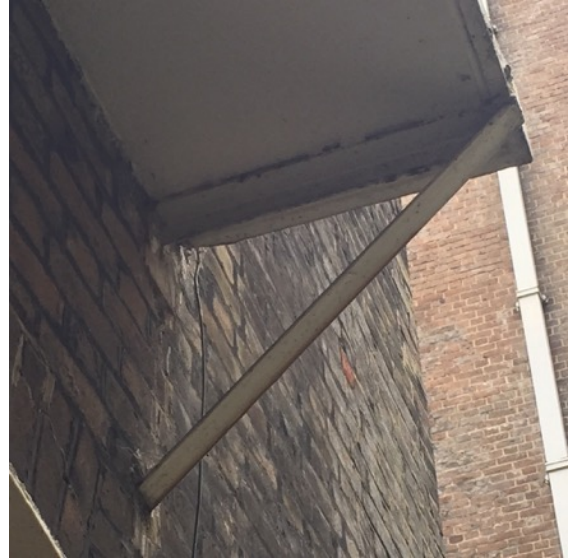
The stains observed on the metal brackets supporting the rear balcony are evidence that corrosion of the metal brackets has occurred, but there is no sign of extensive corrosion.

Rear Balcony Brackets

- The metal brackets supporting the rear balcony should be repainted to prevent further corrosion.

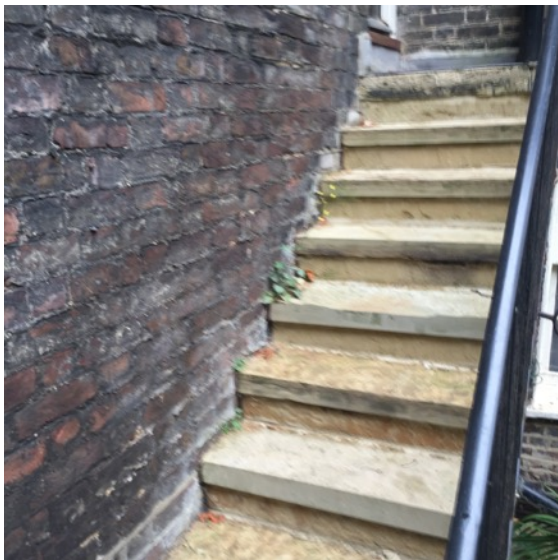
Rear External Stair
