Tree Hazard Report

- 1.1 This report is to assess the Horse chestnut tree for its health and any potential hazards. Also, to recommend future management procedures.
- 1.2 This report was commissioned by Mr Atkinson of Chestnut Cottage, the Vale of Health, London NW3 1AZ.

- 2.1 This report is a visual assessment of *Aesculus hippocastanum* situated at the front of the property
- 2.2 Visual inspection was carried out on 14th August 2015. There is to be a follow up aerial inspection which will be added to this original report.
- 2.3 The visual inspection and the report were conducted by Simon Causer.

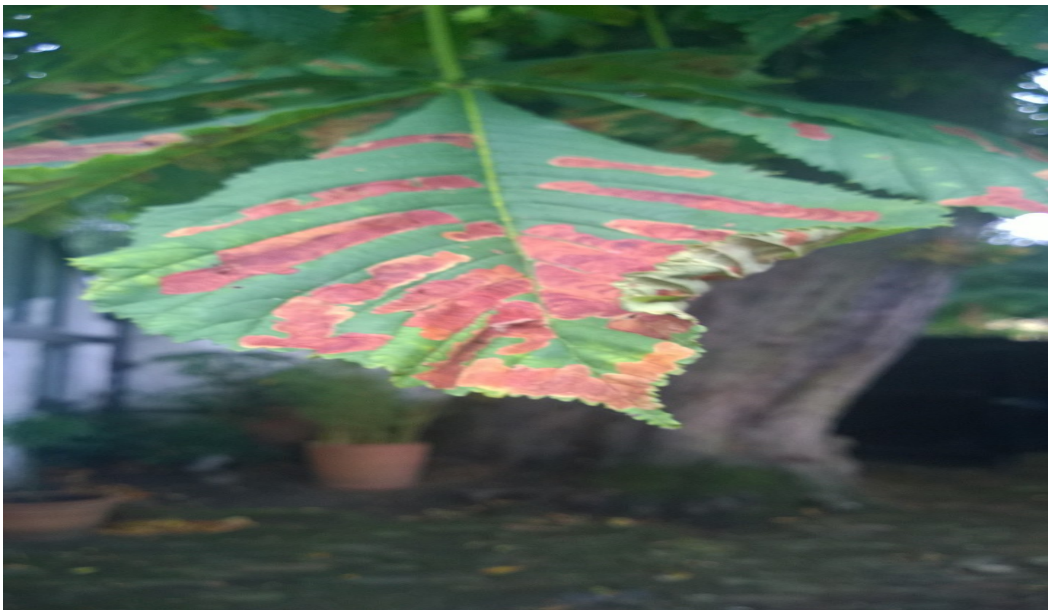
6.8 See Photo 5 – for an image of a leaf showing leaf miner damage.

- 5.7 The foliage on the crown is full but does appear to show signs of leaf miner *Cameraria ohridella* this can have an effect on the trees ability to photosynthesise , which has an effect on the trees ability to creating energy in the form of starch, which is used in growing and sealing off wounds.
