REPORT ON ARBORICULTURAL IMPLICATIONS OF SUBSIDENCE

**42 ELSWORTHY ROAD,
LONDON,
NW3 3DL.**

REF: B1507326

13TH JUNE 2015

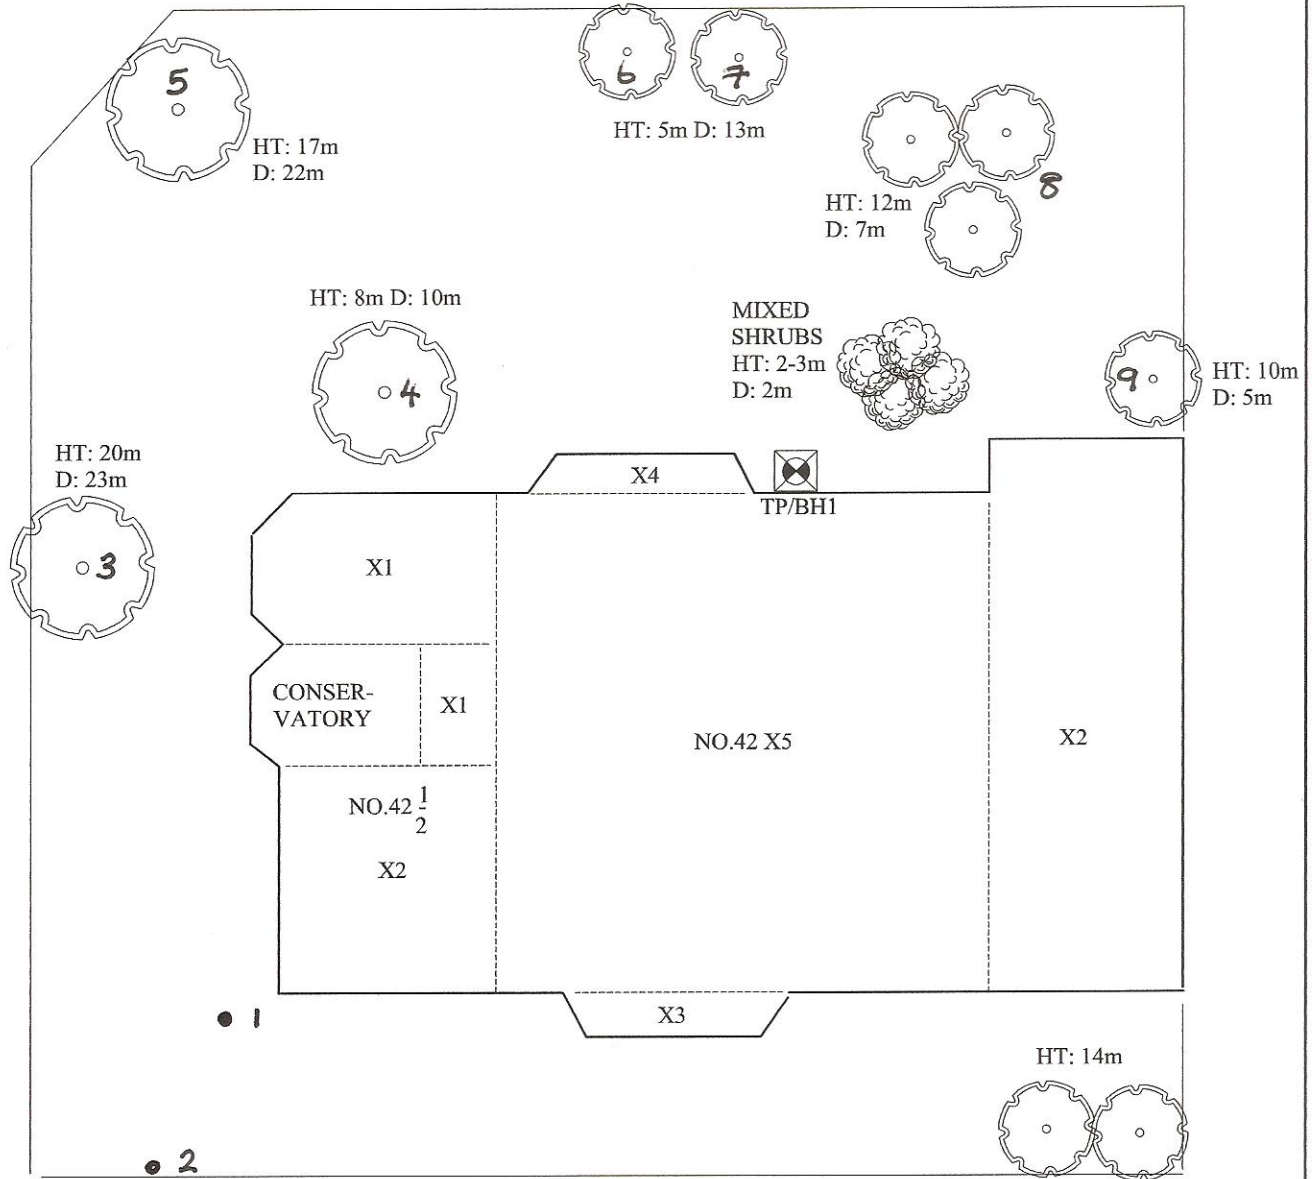
ON SITE TREE IDENTIFICATION FOR GUIDANCE ONLY. NOT AUTHENTICATED.
