Report No: SD5239  
Date: JANUARY 2014  
Edition 1

## MANAGEMENT SURVEY REPORT

24 – 28 HATTON WALL  
BLACK BULL YARD  
LONDON  
EC1N 8JH

BOULTBEE LAND PLC  
36 BROAD STREET  
HEREFORD  
HR4 9AR

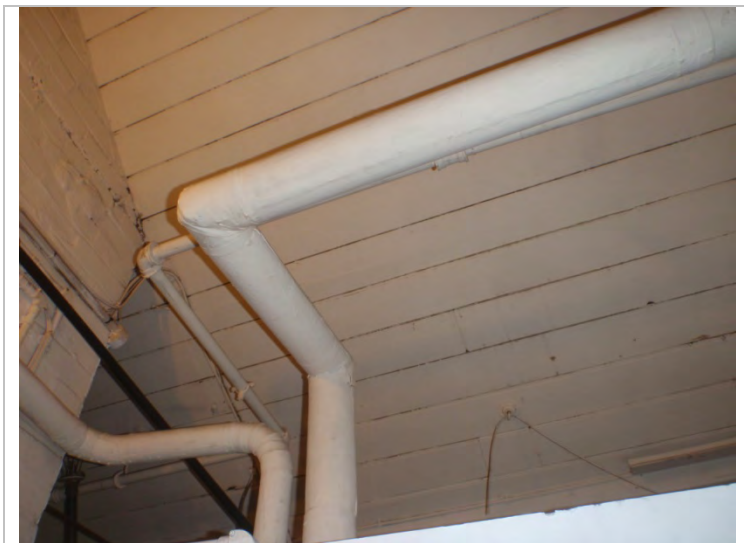
Sample Ref:	B001/542104	Survey Type:	Management
Area:	n/a	Product Type:	Thermal insulation 3
Floor:	3 <sup>rd</sup> floor	Damage:	Low damage 1
Location:	Lobby 1	Surface Treatment:	Unsealed 3
Product:	Insulation	Asbestos Type:	Amosite 2
Asbestos:	Yes	Accessibility:	Medium
14 Day Notification:	Yes	Identification:	Identified
Next Inspection:	July 2014	Material Assessment:	Medium risk 9
Quantity:	2 linear meters	Priority Assessment:	Very low risk 4
		Risk Assessment:	Medium risk 13
Action:	<b>Encapsulate, label &amp; manage</b>

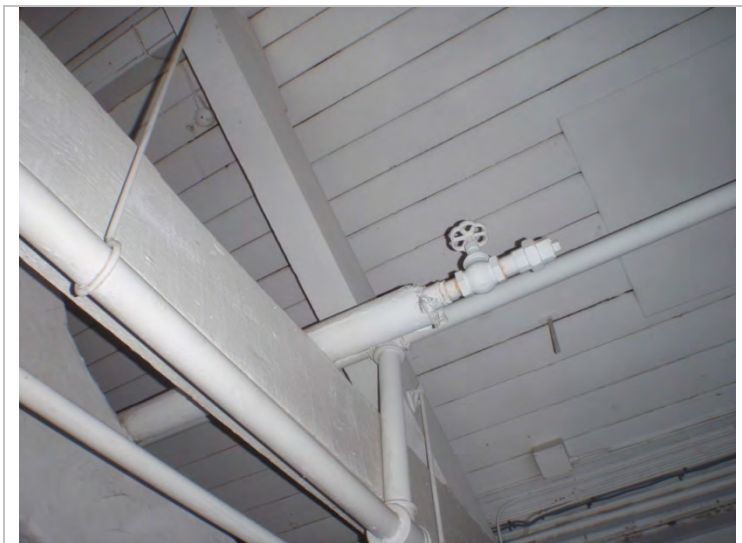
Sample Ref:	As B001/542104	Survey Type:	Management
Area:	n/a	Product Type:	Thermal insulation 3
Floor:	3 <sup>rd</sup> floor	Damage:	Low damage 1
Location:	Unit 301	Surface Treatment:	Unsealed 3
Product:	Insulation	Asbestos Type:	Amosite 2
Asbestos:	Yes	Accessibility:	Medium
14 Day Notification:	Yes	Identification:	Strongly presumed
Next Inspection:	Immediate action	Material Assessment:	Medium risk 9
Quantity:	4 linear meters	Priority Assessment:	Low risk 6
		Risk Assessment:	High risk 15

Encapsulate, label & manage

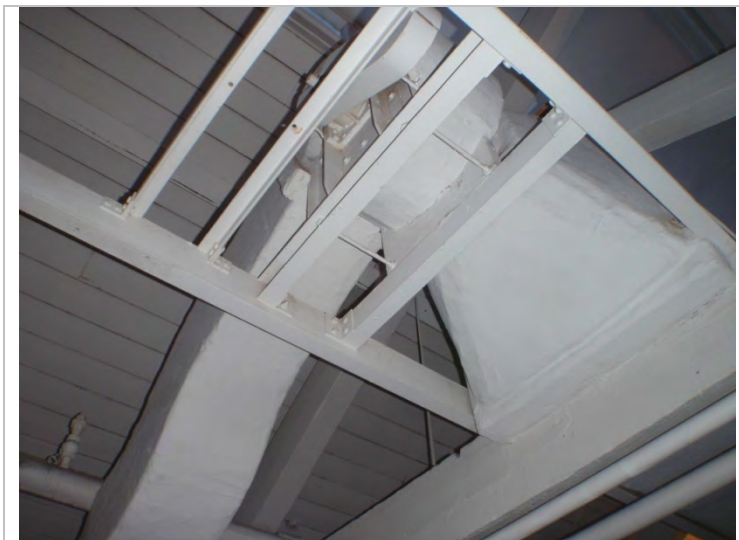
Sample Ref:	As B001/542104	Survey Type:	Management
Area:	n/a	Product Type:	Thermal insulation 3
Floor:	3 <sup>rd</sup> floor	Damage:	Low damage 1
Location:	Unit 301	Surface Treatment:	Unsealed 3
Product:	Insulation	Asbestos Type:	Amosite 2
Asbestos:	Yes	Accessibility:	Medium
14 Day Notification:	Yes	Identification:	Strongly presumed
Next Inspection:	Immediate action	Material Assessment:	Medium risk 9
Quantity:	8 linear meters	Priority Assessment:	Low risk 6
		Risk Assessment:	High risk 15

Encapsulate, label & manage

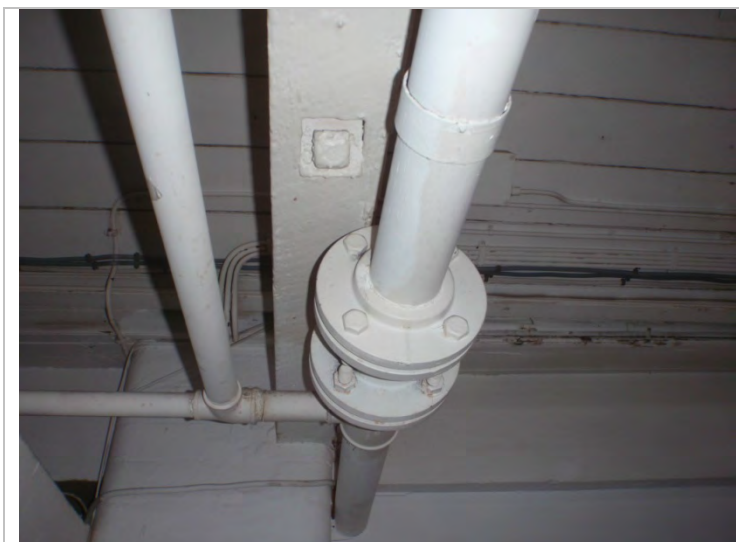
Sample Ref:	Vis001	Survey Type:	Management	
Area:	n/a	Product Type:	Gaskets	2
Floor:	3 <sup>rd</sup> floor	Damage:	Good condition	0
Location:	Unit 301	Surface Treatment:	Sealed	0
Product:	Gaskets	Asbestos Type:	Chrysotile	1
Asbestos:	Yes	Accessibility:	Difficult	
14 Day Notification:	No	Identification:	Strongly presumed	
Next Inspection:	January 2015	Material Assessment:	Very low risk	3
Quantity:	x 2	Priority Assessment:	Very low risk	1
		Risk Assessment:	Very low risk	4

Label & manage

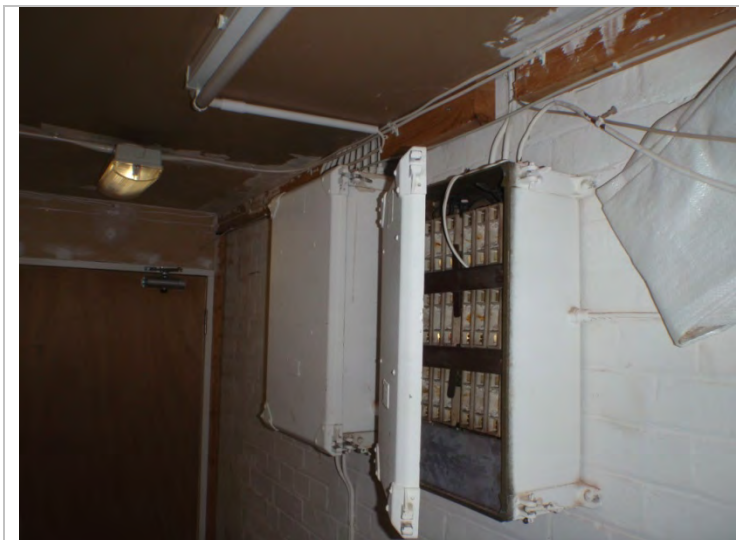
Sample Ref:	B002/524105	Survey Type:	Management
Area:	n/a	Product Type:	Woven textiles 2
Floor:	3 <sup>rd</sup> floor	Damage:	Low damage 1
Location:	Fire exit corridor	Surface Treatment:	Unsealed 1
Product:	Flash guards	Asbestos Type:	Chrysotile 1
Asbestos:	Yes	Accessibility:	Difficult
14 Day: Notification	No	Identification:	Identified
Next Inspection:	January 2015	Material Assessment:	Low risk 5
Quantity:	2 x units	Priority Assessment:	Very low risk 2
		Risk Assessment:	Low risk 7

Label & manage

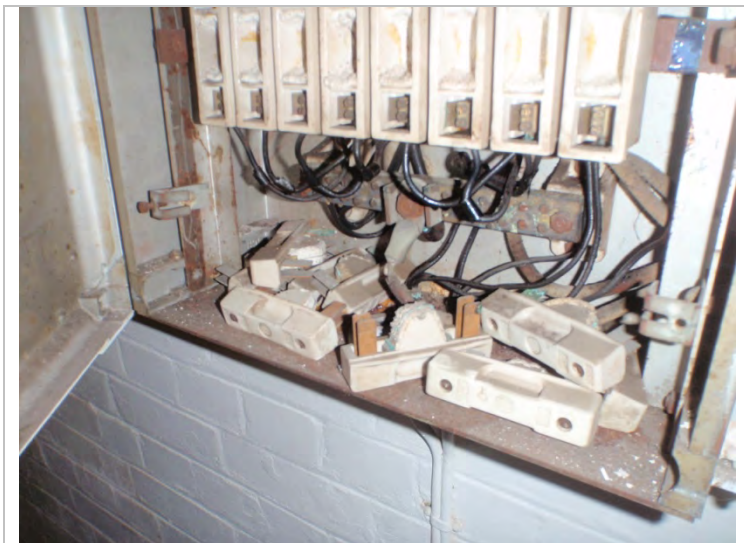
Sample Ref:	As B002/524105	Survey Type:	Management
Area:	n/a	Product Type:	Woven textiles 2
Floor:	3 <sup>rd</sup> floor	Damage:	Low damage 1
Location:	Fire exit corridor	Surface Treatment:	Unsealed 1
Product:	Loose flash guards	Asbestos Type:	Chrysotile 1
Asbestos:	Yes	Accessibility:	Difficult
14 Day Notification:	No	Identification:	Strongly presumed
Next Inspection:	January 2015	Material Assessment:	Low risk 5
Quantity:	1 x unit	Priority Assessment:	Very low risk 2
		Risk Assessment:	Low risk 7

Loose flash guards within 1 x electrical unit

Remove following HSE guidelines

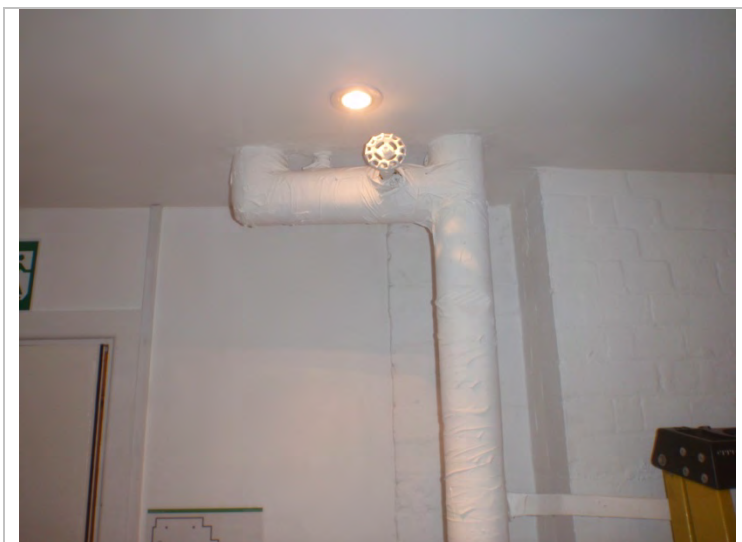
Sample Ref:	As B001/542104	Survey Type:	Management	
Area:	n/a	Product Type:	Thermal insulation	3
Floor:	3 <sup>rd</sup> floor	Damage:	Good condition	0
Location:	Lobby 2	Surface Treatment:	Sealed	1
Product:	Insulation	Asbestos Type:	Amosite	2
Asbestos:	Yes	Accessibility:	Medium	
14 Day: Notification	Yes	Identification:	Strongly presumed	
Next Inspection:	July 2014	Material Assessment:	Low risk	6
Quantity:	2 linear meters	Priority Assessment:	Low risk	6
		Risk Assessment:	Medium risk	12
Action:	<b>Label &amp; manage</b>

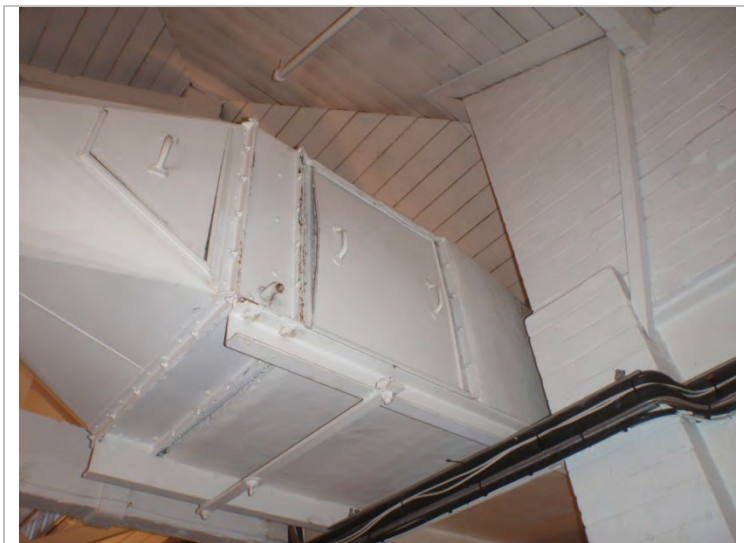
Sample Ref:	B003/542106	Survey Type:	Management
Area:	n/a	Product Type:	n/a
Floor:	3 <sup>rd</sup> floor	Damage:	n/a
Location:	Unit 302	Surface Treatment:	n/a
Product:	Insulation	Asbestos Type:	NADIS
Asbestos:	No	Accessibility:	n/a
14 Day Notification:	n/a	Identification:	Identified
Next Inspection:	n/a	Material Assessment:	0
Quantity:	n/a	Priority Assessment:	0
		Risk Assessment:	0
Action:	No action

Comments: Plaster insulation to ducting

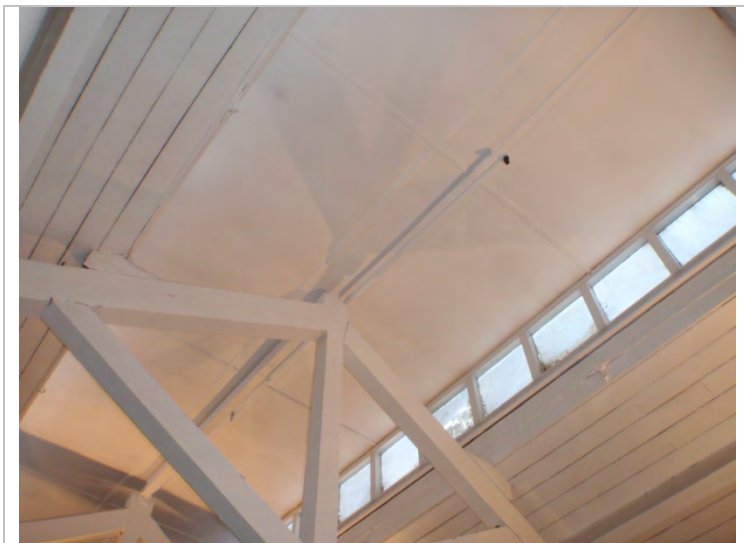
Comments: No access to high level panels to underside of roof due to height restrictions & personnel below

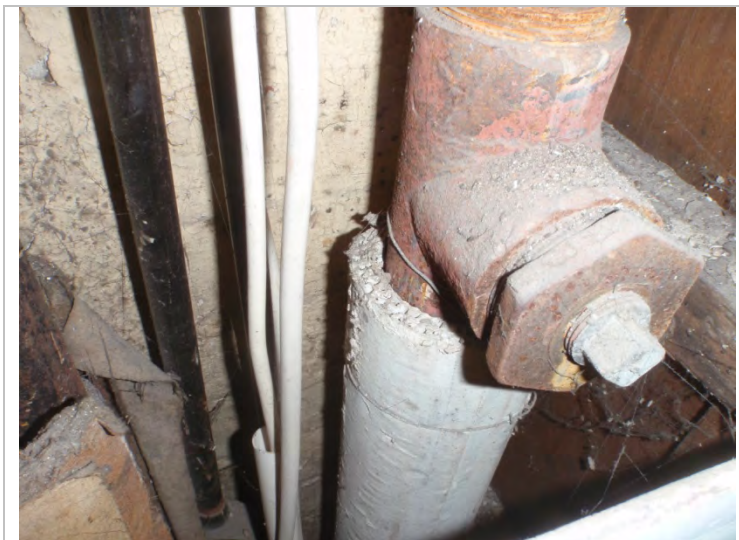
Sample Ref:	B004/542107	Survey Type:	Management
Area:	n/a	Product Type:	Asbestos paper 2
Floor:	2 <sup>nd</sup> floor	Damage:	Low damage 1
Location:	Lobby 1	Surface Treatment:	Enclosed 1
Product:	Paper insulation	Asbestos Type:	Chrysotile 1
Asbestos:	Yes	Accessibility:	Difficult
14 Day: Notification	Yes	Identification:	Identified
Next Inspection:	January 2015	Material Assessment:	Low risk 5
Quantity:	3 linear meters	Priority Assessment:	Very low risk 3
		Risk Assessment:	Low risk 8

Label & manage

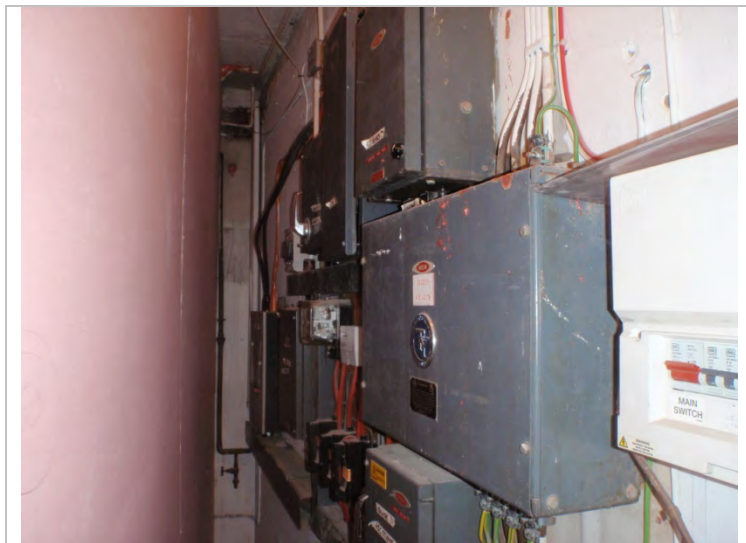
Sample Ref:	As B002/542105	Survey Type:	Management	
Area:	n/a	Product Type:	Woven textiles	2
Floor:	2 <sup>nd</sup> floor	Damage:	Good condition	0
Location:	Electrical cupboard	Surface Treatment:	Enclosed	1
Product:	Flash guards	Asbestos Type:	Chrysotile	1
Asbestos:	Yes	Accessibility:	Difficult	
14 Day Notification:	No	Identification:	Strongly presumed	
Next Inspection:	January 2015	Material Assessment:	Very low risk	4
Quantity:	6 x units	Priority Assessment:	Very low risk	2
		Risk Assessment:	Low risk	6

Label & manage

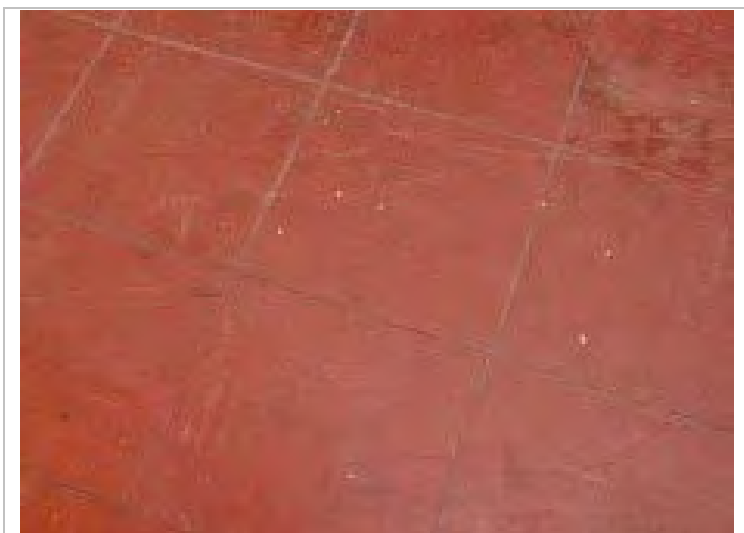
Sample Ref:	B005/542108	Survey Type:	Management	
Area:	n/a	Product Type:	Vinyl floor tiles	1
Floor:	2 <sup>nd</sup> floor	Damage:	Good condition	0
Location:	Lobby 2	Surface Treatment:	Sealed	0
Product:	Floor tiles	Asbestos Type:	Chrysotile	1
Asbestos:	Yes	Accessibility:	Easy	
14 Day Notification:	No	Identification:	Identified	
Next Inspection:	January 2015	Material Assessment:	Very low risk	2
Quantity:	2 m <sup>2</sup>	Priority Assessment:	Very low risk	2
		Risk Assessment:	Very low risk	4
Action:	Label & manage

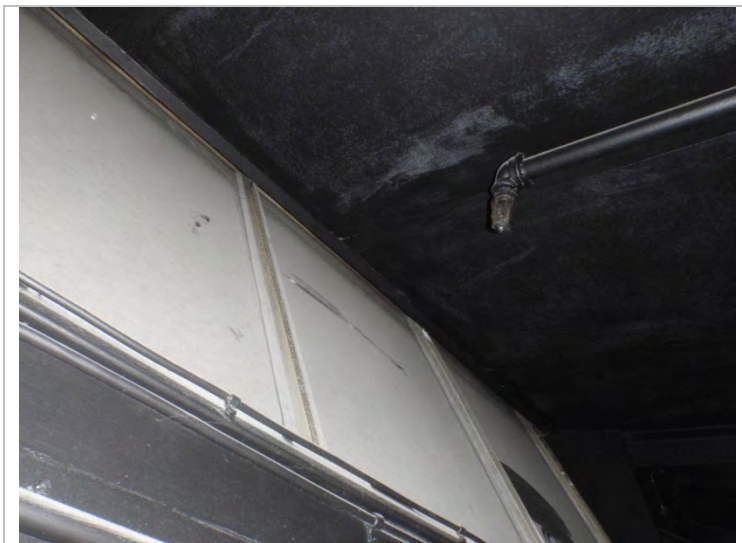
Sample Ref:	Vis002	Survey Type:	Management	
Area:	n/a	Product Type:	Rope	2
Floor:	2 <sup>nd</sup> floor	Damage:	Good condition	0
Location:	w/c lobby	Surface Treatment:	Enclosed	1
Product:	Rope gaskets	Asbestos Type:	Chrysotile	1
Asbestos:	Yes	Accessibility:	Difficult	
14 Day Notification:	No	Identification:	Strongly presumed	
Next Inspection:	January 2015	Material Assessment:	Very low risk	4
Quantity:	2 linear meters	Priority Assessment:	Very low risk	1
		Risk Assessment:	Low risk	5

No access to skylight construction without causing damage  
– possible rope gaskets to skylights

Label & manage

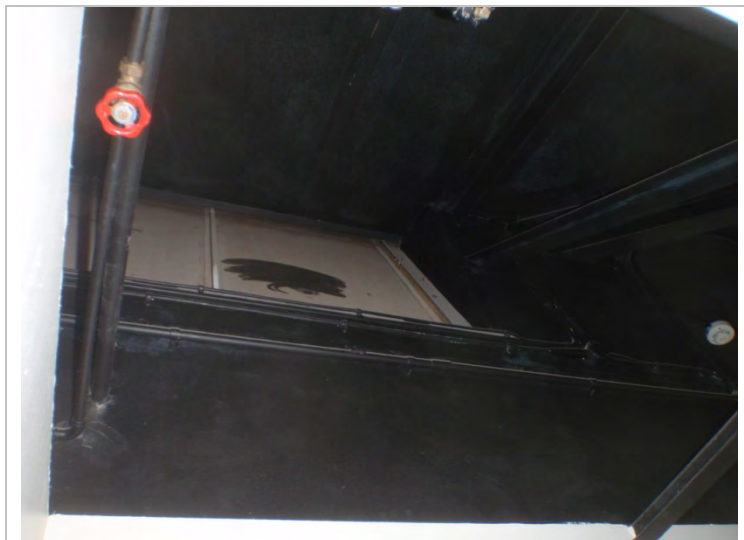
Sample Ref:	Vis003	Survey Type:	Management	
Area:	n/a	Product Type:	Rope	2
Floor:	2 <sup>nd</sup> floor	Damage:	Good condition	0
Location:	Female w/c	Surface Treatment:	Enclosed	1
Product:	Rope gaskets	Asbestos Type:	Chrysotile	1
Asbestos:	Yes	Accessibility:	Difficult	
14 Day Notification:	No	Identification:	Strongly presumed	
Next Inspection:	January 2015	Material Assessment:	Very low risk	4
Quantity:	2 linear meters	Priority Assessment:	Very low risk	1
		Risk Assessment:	Low risk	5

No access to skylight construction without causing damage  
– possible rope gaskets to skylights

Label & manage

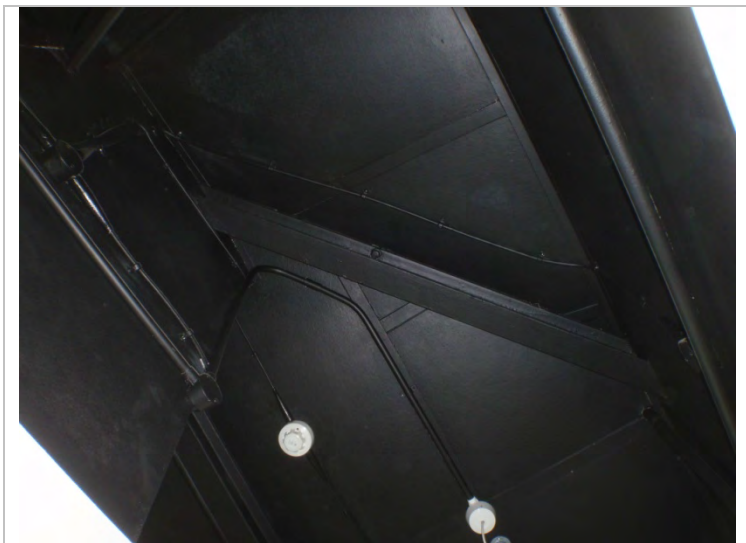
Sample Ref:	B006/542109	Survey Type:	Management
Area:	n/a	Product Type:	n/a
Floor:	2 <sup>nd</sup> floor	Damage:	n/a
Location:	Female w/c	Surface Treatment:	n/a
Product:	Roof panels	Asbestos Type:	NADIS
Asbestos:	No	Accessibility:	n/a
14 Day Notification:	n/a	Identification:	Identified
Next Inspection:	n/a	Material Assessment:	0
Quantity:	n/a	Priority Assessment:	0
		Risk Assessment:	0
Action:	No action

Comments: Insulation board (fibreboard) panels to underside of roof

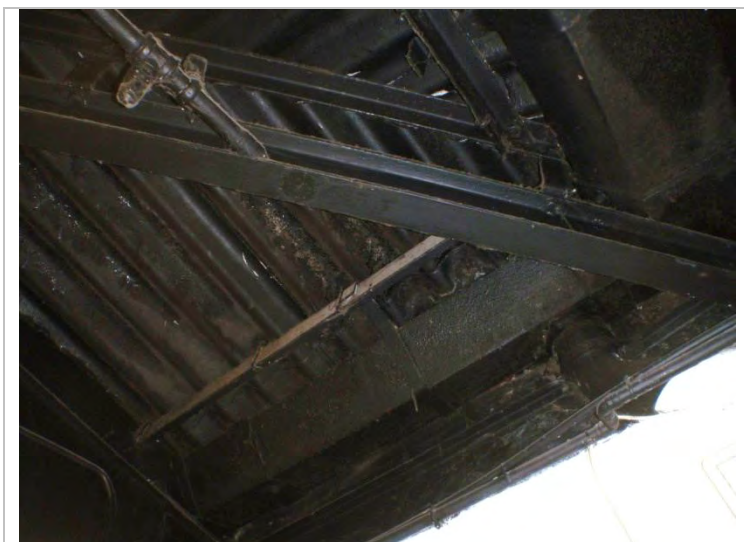
Sample Ref:	B014/542117	Survey Type:	Management	
Area:	n/a	Product Type:	Asbestos cement	1
Floor:	2 <sup>nd</sup> floor	Damage:	Good condition	0
Location:	Male w/c	Surface Treatment:	Painted	1
Product:	Roof sheets	Asbestos Type:	Chrysotile	1
Asbestos:	Yes	Accessibility:	Medium	
14 Day: Notification	No	Identification:	Identified	
Next Inspection:	January 2015	Material Assessment:	Very low risk	3
Quantity:	7 m <sup>2</sup>	Priority Assessment:	Very low risk	2
		Risk Assessment:	Low risk	5
Action:	Label & manage

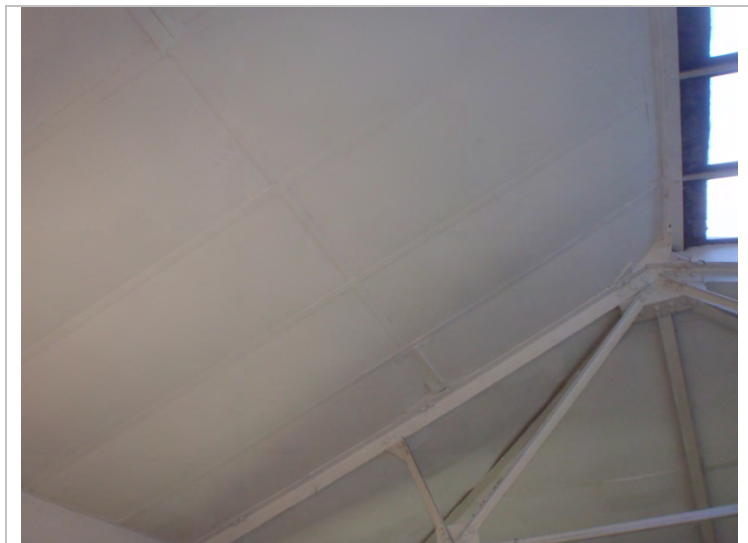
View of insulation board (fibreboard) panels to underside of roof  
(non-asbestos product)

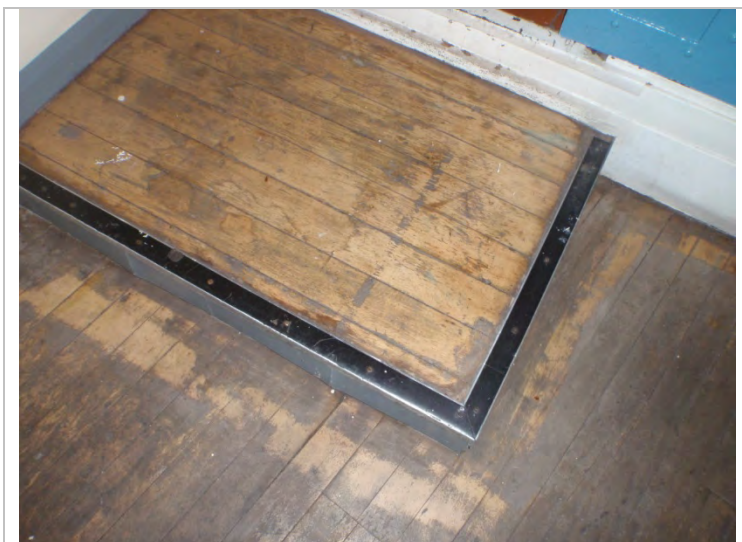
Sample Ref:	B007/542110	Survey Type:	Management	
Area:	n/a	Product Type:	Reinforced plastic	1
Floor:	2 <sup>nd</sup> floor	Damage:	Good condition	0
Location:	Corridor 1	Surface Treatment:	Sealed	0
Product:	Stair nosings	Asbestos Type:	Chrysotile	1
Asbestos:	Yes	Accessibility:	Easy	
14 Day Notification:	No	Identification:	Identified	
Next Inspection:	January 2015	Material Assessment:	Very low risk	2
Quantity:	x 2	Priority Assessment:	Very low risk	2
		Risk Assessment:	Very low risk	4

Label & manage

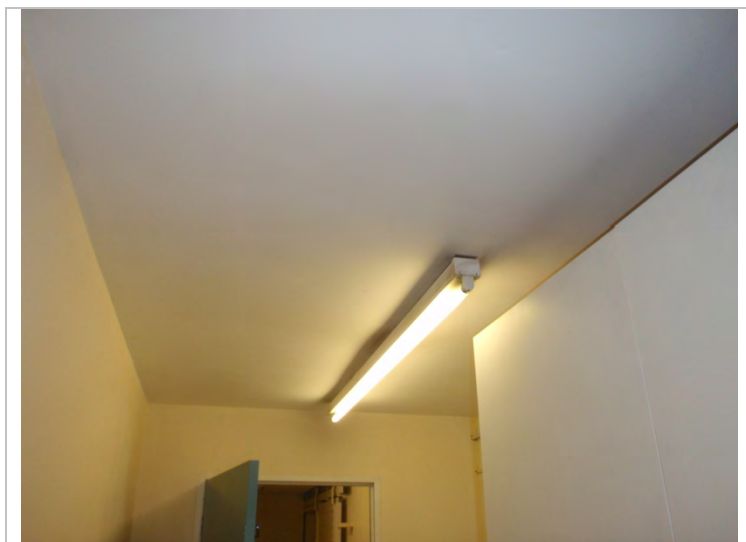
Sample Ref:	As B009/542112	Survey Type:	Management
Area:	n/a	Product Type:	Asbestos insulation board 2
Floor:	2 <sup>nd</sup> floor	Damage:	Good condition 0
Location:	Corridor 3	Surface Treatment:	Painted 1
Product:	Roof panels	Asbestos Type:	Chrysotile & Amosite 2
Asbestos:	Yes	Accessibility:	Difficult
14 Day: Notification	Yes	Identification:	Strongly presumed
Next Inspection:	July 2014	Material Assessment:	Low risk 5
Quantity:	6 m <sup>2</sup>	Priority Assessment:	Very low risk 4
		Risk Assessment:	Medium risk 9
Action:	Label & manage

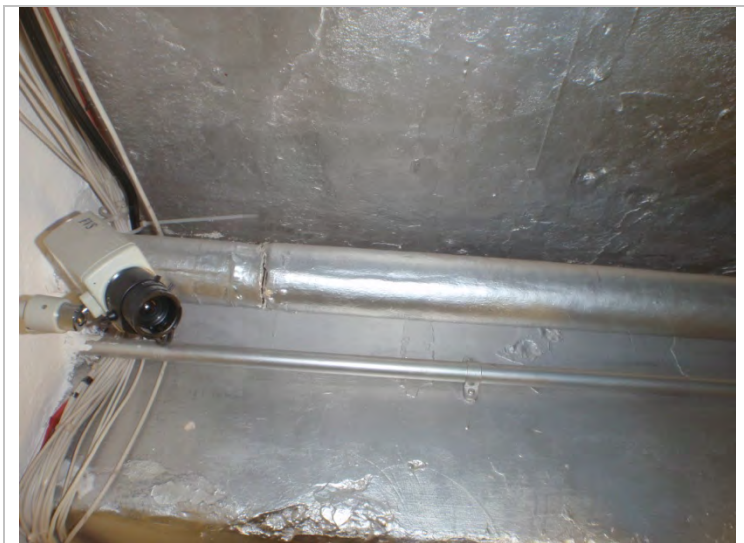
Sample Ref:	B010/542113	Survey Type:	Management
Area:	n/a	Product Type:	n/a
Floor:	1 <sup>st</sup> floor	Damage:	n/a
Location:	Corridor 2	Surface Treatment:	n/a
Product:	Insulation	Asbestos Type:	NADIS
Asbestos:	No	Accessibility:	n/a
14 Day: Notification	n/a	Identification:	Identified
Next Inspection:	n/a	Material Assessment:	0
Quantity:	n/a	Priority Assessment:	0
		Risk Assessment:	0
Action:	<b>No action</b>

MMMF insulation to pipework also present within adjacent lobby

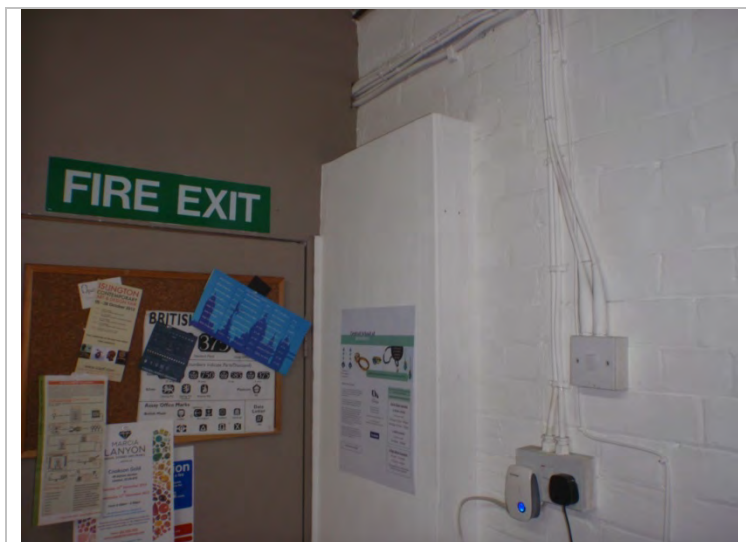
Sample Ref:	B011/542114	Survey Type:	Management
Area:	n/a	Product Type:	n/a
Floor:	1 <sup>st</sup> floor	Damage:	n/a
Location:	Unit 105	Surface Treatment:	n/a
Product:	Boxing	Asbestos Type:	NADIS
Asbestos:	No	Accessibility:	n/a
14 Day Notification:	n/a	Identification:	Identified
Next Inspection:	n/a	Material Assessment:	0
Quantity:	n/a	Priority Assessment:	0
		Risk Assessment:	0
Action:	No action

Comments: Plasterboard boxing

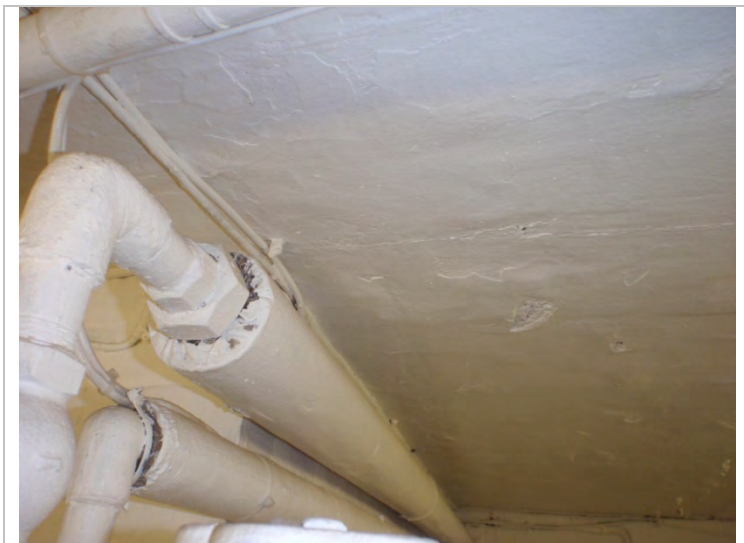
Sample Ref:	As B004/542107	Survey Type:	Management	
Area:	n/a	Product Type:	Asbestos paper	2
Floor:	1 <sup>st</sup> floor	Damage:	Good condition	0
Location:	Unit 109	Surface Treatment:	Painted	1
Product:	Paper insulation	Asbestos Type:	Chrysotile	1
Asbestos:	Yes	Accessibility:	Medium	
14 Day Notification:	Yes	Identification:	Strongly presumed	
Next Inspection:	January 2015	Material Assessment:	Very low risk	4
Quantity:	2 linear meters	Priority Assessment:	Very low risk	4
		Risk Assessment:	Low risk	8
Action:	Label & manage

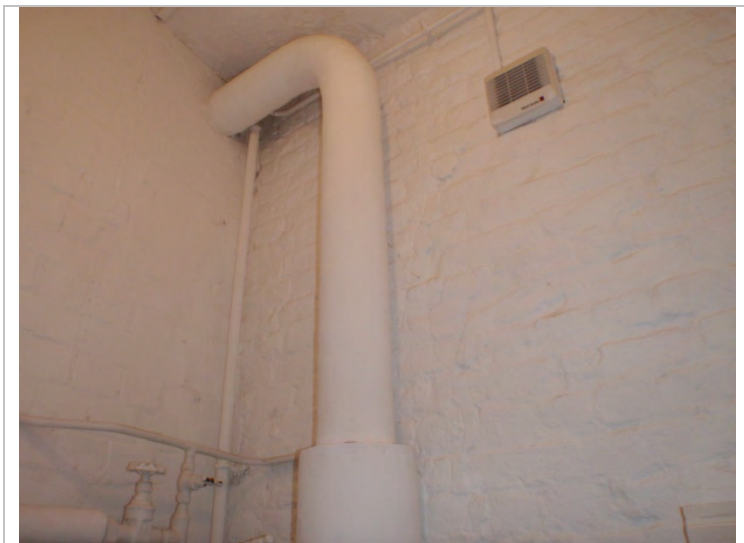
Sample Ref:	B012/542115	Survey Type:	Management	
Area:	n/a	Product Type:	n/a	
Floor:	1 <sup>st</sup> floor	Damage:	n/a	
Location:	w/c (unit 110)	Surface Treatment:	n/a	
Product:	Insulation	Asbestos Type:	NADIS	
Asbestos:	No	Accessibility:	n/a	
14 Day Notification	n/a	Identification:	Identified	
Next Inspection:	n/a	Material Assessment:		0
Quantity:	n/a	Priority Assessment:		0
		Risk Assessment:		0
Action:	No action

Bitumen & cork insulation to pipework

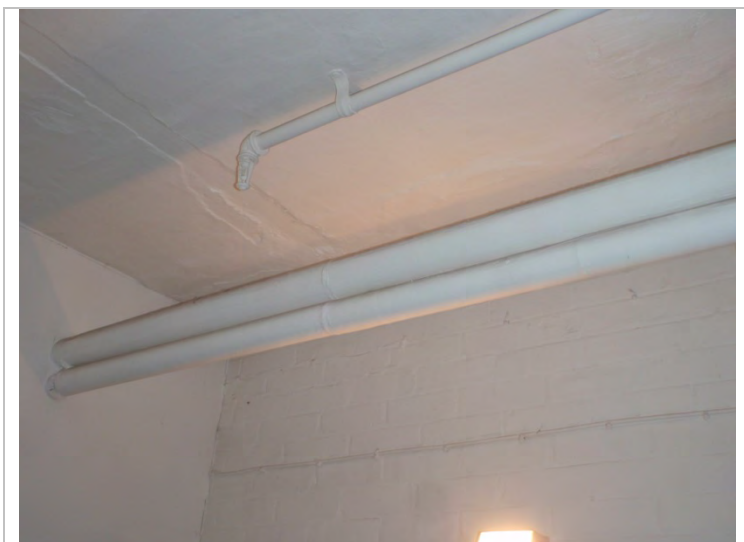
Sample Ref:	As B014/542117	Survey Type:	Management	
Area:	n/a	Product Type:	Asbestos paper	2
Floor:	1 <sup>st</sup> floor	Damage:	Good condition	0
Location:	Unit 104B	Surface Treatment:	Painted	1
Product:	Paper insulation	Asbestos Type:	Chrysotile	1
Asbestos:	Yes	Accessibility:	Medium	
14 Day Notification:	Yes	Identification:	Strongly presumed	
Next Inspection:	January 2015	Material Assessment:	Very low risk	4
Quantity:	2 x 4 linear meters	Priority Assessment:	Very low risk	4
		Risk Assessment:	Low risk	8
Action:	Label & manage

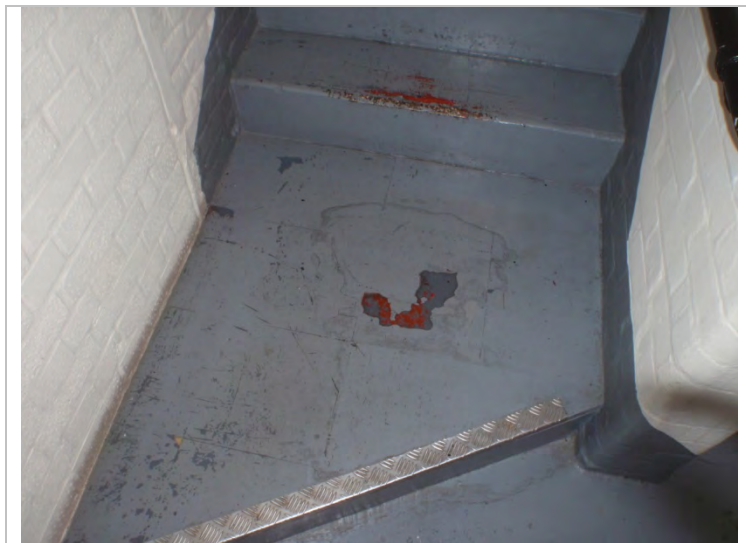
Sample Ref:	B015/542118	Survey Type:	Management	
Area:	n/a	Product Type:	n/a	
Floor:	1 <sup>st</sup> floor	Damage:	n/a	
Location:	Stairwell 2	Surface Treatment:	n/a	
Product:	Floor tiles	Asbestos Type:	NADIS	
Asbestos:	No	Accessibility:	n/a	
14 Day Notification	n/a	Identification:	Identified	
Next Inspection:	n/a	Material Assessment:		0
Quantity:	n/a	Priority Assessment:		0
		Risk Assessment:		0
Action:	No action

Floor tiles (brown)

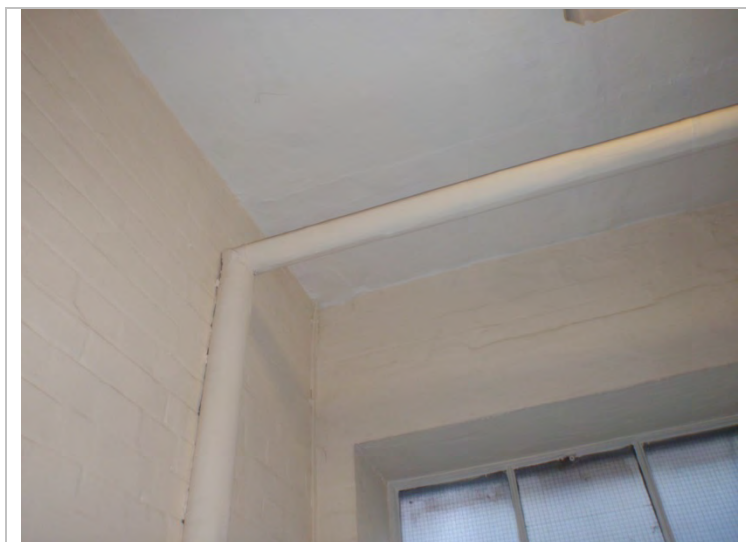
Sample Ref:	As B014/542117	Survey Type:	Management	
Area:	n/a	Product Type:	Asbestos paper	2
Floor:	1 <sup>st</sup> floor	Damage:	Good condition	0
Location:	Stairwell 2	Surface Treatment:	Painted	1
Product:	Paper insulation	Asbestos Type:	Chrysotile	1
Asbestos:	Yes	Accessibility:	Medium	
14 Day: Notification	Yes	Identification:	Strongly presumed	
Next Inspection:	January 2015	Material Assessment:	Very low risk	4
Quantity:	4 linear meters	Priority Assessment:	Very low risk	4
		Risk Assessment:	Low risk	8
Action:	Label & manage

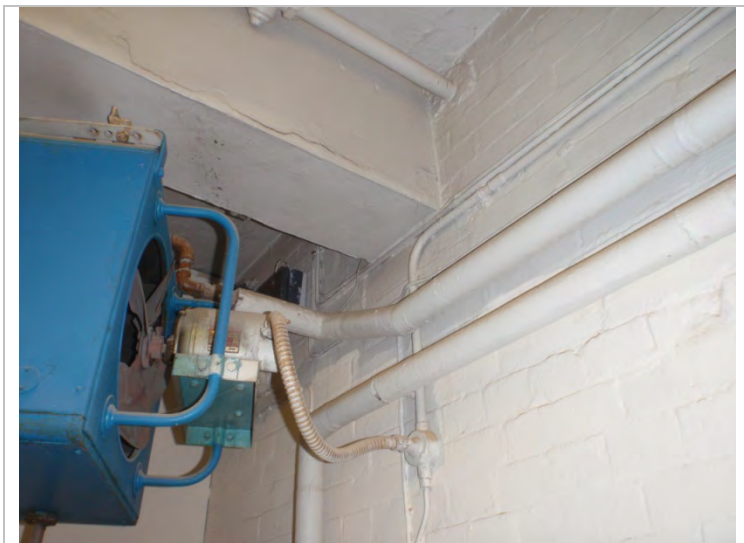
Comments: View of MMMF insulation to pipework, typical throughout all of Unit G03 (non-asbestos product)

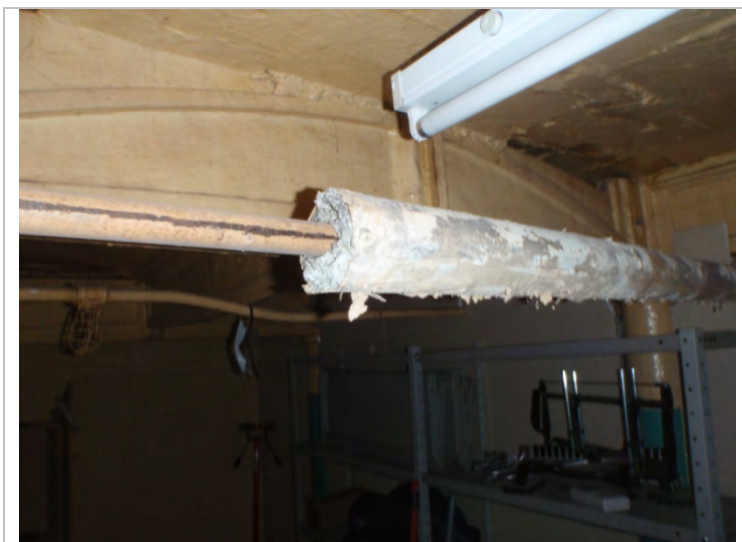
Sample Ref:	As B014/542117	Survey Type:	Management	
Area:	n/a	Product Type:	Asbestos paper	2
Floor:	Basement	Damage:	Medium damage	2
Location:	Unit B16	Surface Treatment:	Unsealed	2
Product:	Paper insulation	Asbestos Type:	Chrysotile	1
Asbestos:	Yes	Accessibility:	Medium	
14 Day Notification:	Yes	Identification:	Strongly presumed	
Next Inspection:	Immediate action	Material Assessment:	Medium risk	7
Quantity:	1 linear meter	Priority Assessment:	Low risk	5
		Risk Assessment:	Medium risk	12
Action:	Encapsulate, label & manage

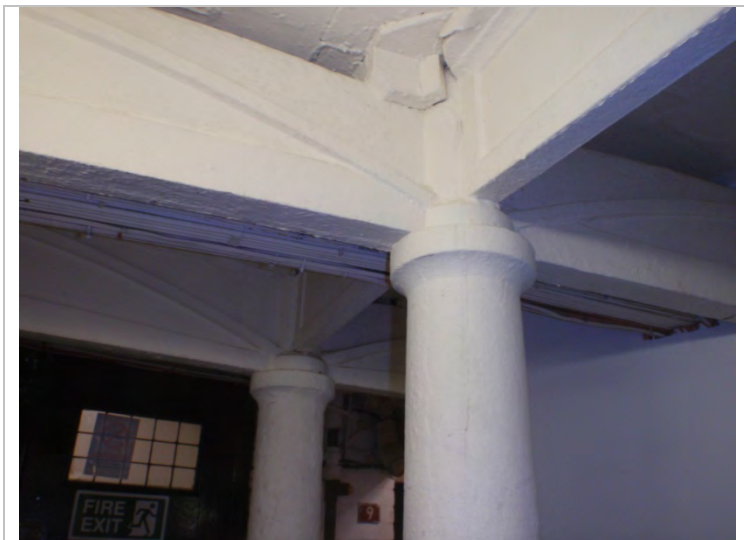
Sample Ref:	B016/542119	Survey Type:	Management
Area:	n/a	Product Type:	n/a
Floor:	Basement	Damage:	n/a
Location:	Corridor 1	Surface Treatment:	n/a
Product:	Textured coating	Asbestos Type:	NADIS
Asbestos:	No	Accessibility:	n/a
14 Day: Notification	n/a	Identification:	Identified
Next Inspection:	n/a	Material Assessment:	0
Quantity:	n/a	Priority Assessment:	0
		Risk Assessment:	0
Action:	No action

Textured coating to ceiling & steelwork, typical throughout basement

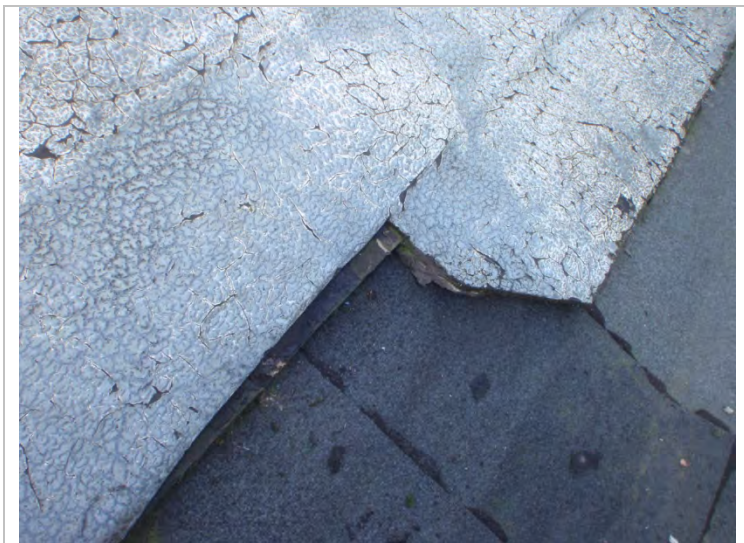
Sample Ref:	B019/542122	Survey Type:	Management	
Area:	n/a	Product Type:	Asbestos cement	1
Floor:	External	Damage:	Good condition	0
Location:	Pitched roofs 2 & 3	Surface Treatment:	Enclosed	1
Product:	Roof tiles	Asbestos Type:	Chrysotile	1
Asbestos:	Yes	Accessibility:	Difficult	
14 Day Notification:	No	Identification:	Identified	
Next Inspection:	January 2015	Material Assessment:	Very low risk	3
Quantity:	280 m <sup>2</sup>	Priority Assessment:	Very low risk	1
		Risk Assessment:	Very low risk	4
Action:	<b>Manage</b>

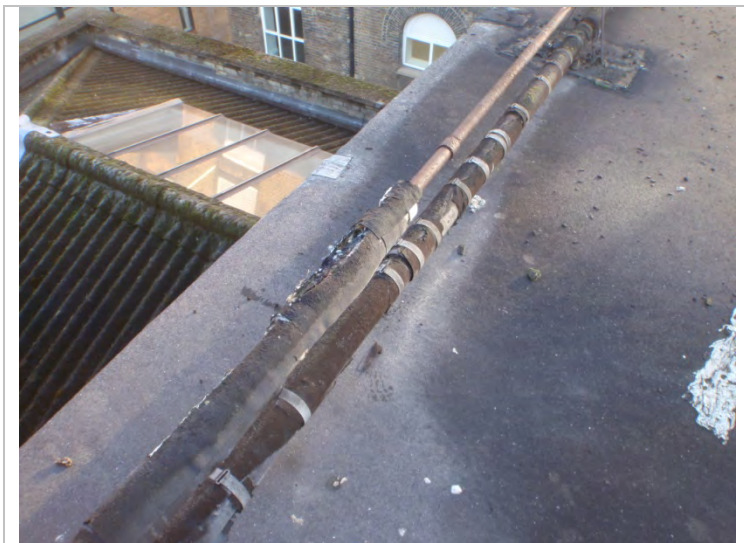
Comments: Bitumen wrap to MMMF insulated & cork pipework
