P3075 BULL & LAST PUBLIC HOUSE, NW5 1QS

REVIEW OF INFORMATION IN RESPECT OF FORMER CELLAR HATCH

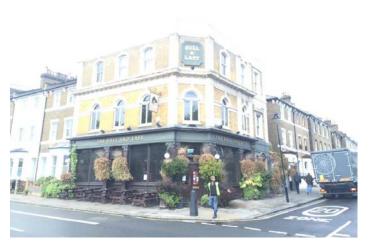
Photograph 1 - External View

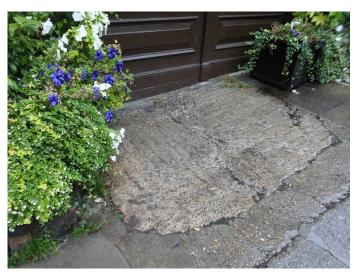
Photograph 2 – View of pavement adjacent in front of Woodsome Road elevation

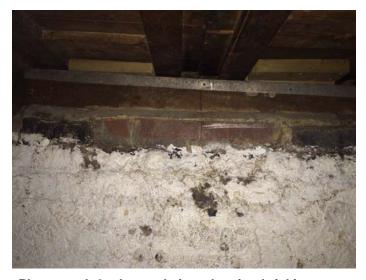
Photograph 3 – Internal view showing bricking up to line of internal cellar hatch

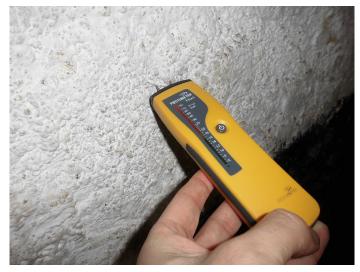
Photograph 4 - High damp readings taken to wall on line of hatch

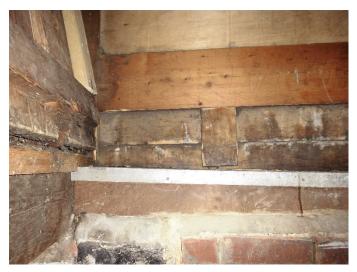
Photograph 5 - Detail of Internal Cellar Hatch

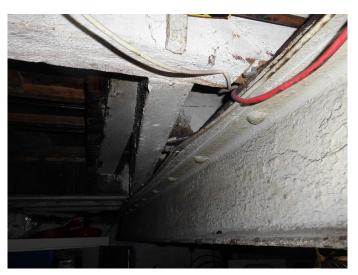
Photograph 6 – Framing around internal cellar hatch
