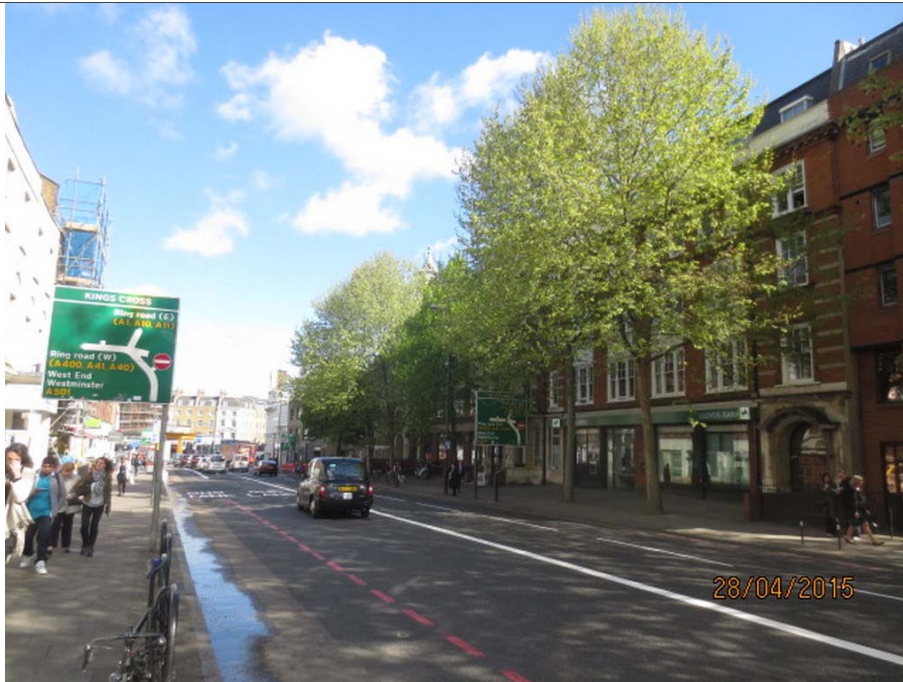
01: Front elevation – general view

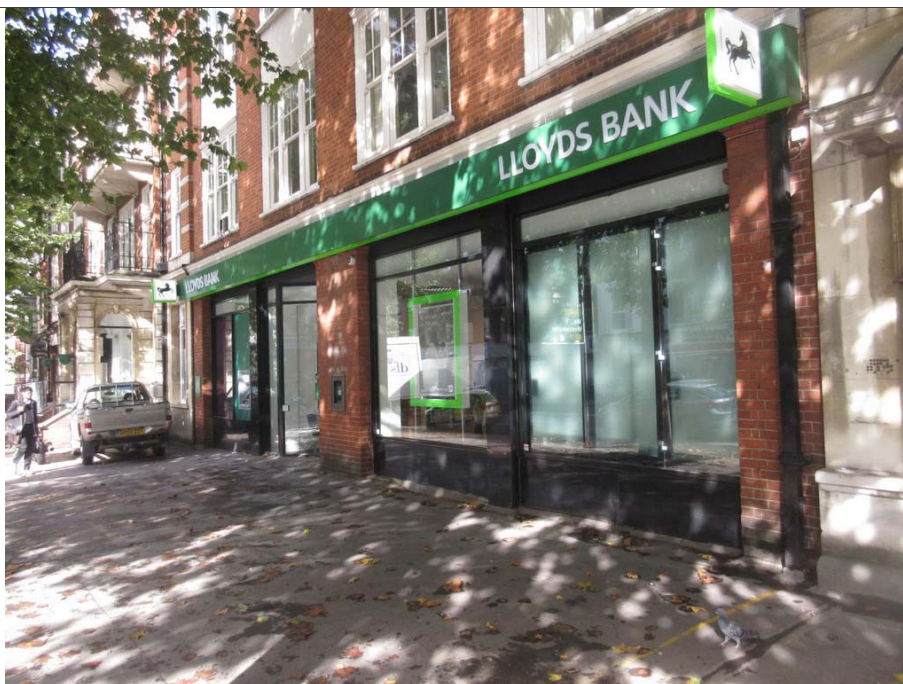
02: Front elevation – shop front of Lloyds bank incorporating powder coated aluminium door and windows

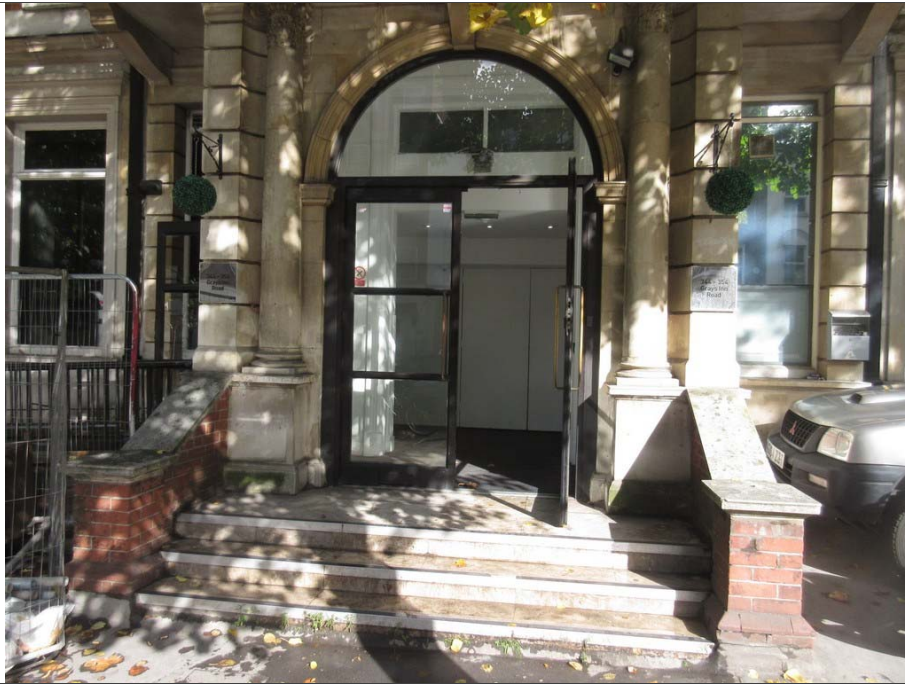
03: Front elevation – main entrance to serviced offices

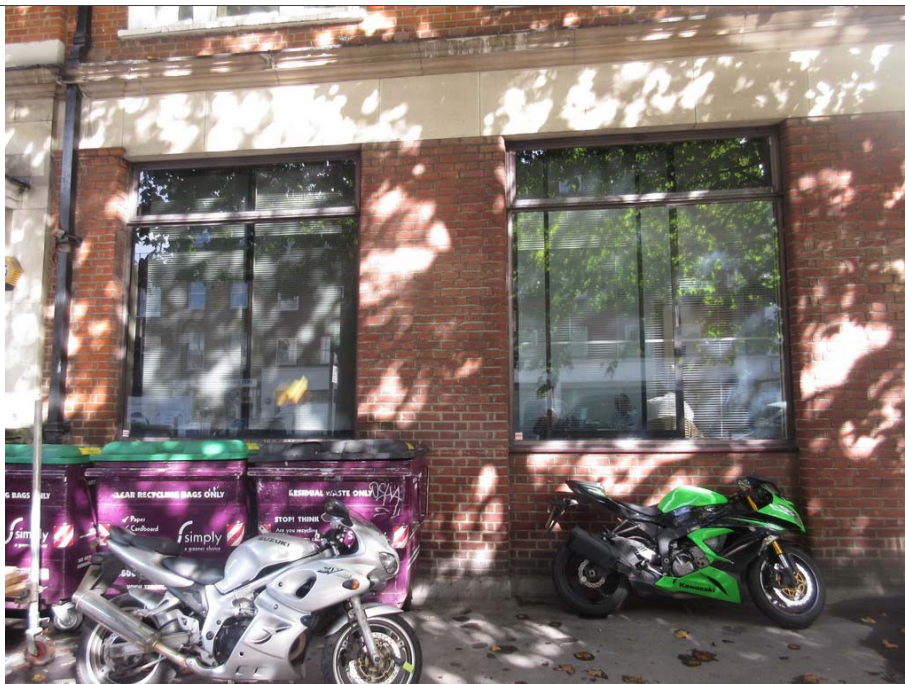
04: Front elevation – powder coated aluminium windows to ground floor

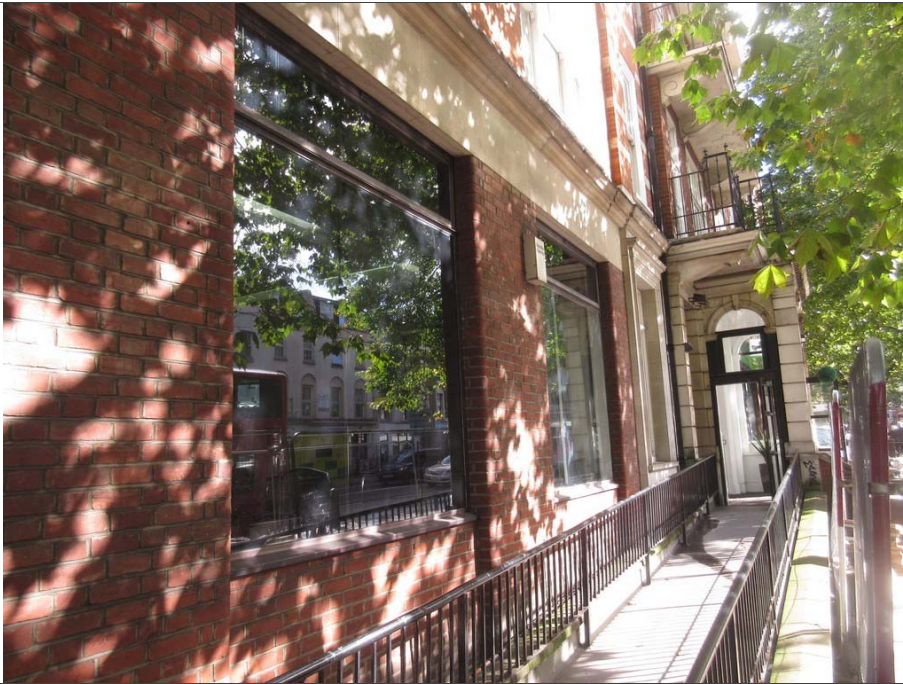
05: Front elevation – powder coated aluminium windows to ground floor

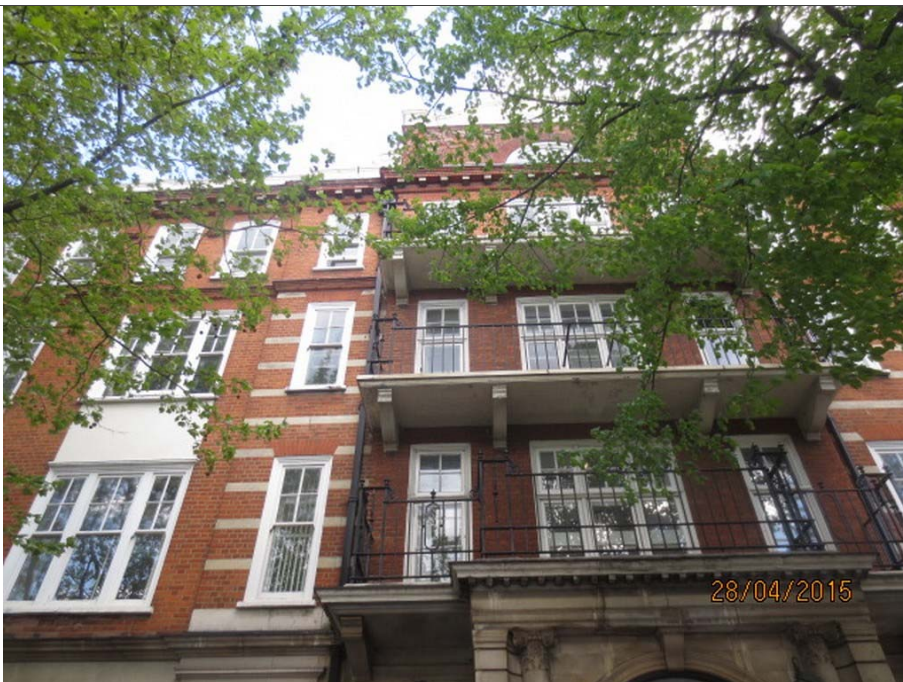
06: Front elevation – timber sliding sash windows to 1st, 2nd and 3rd floors

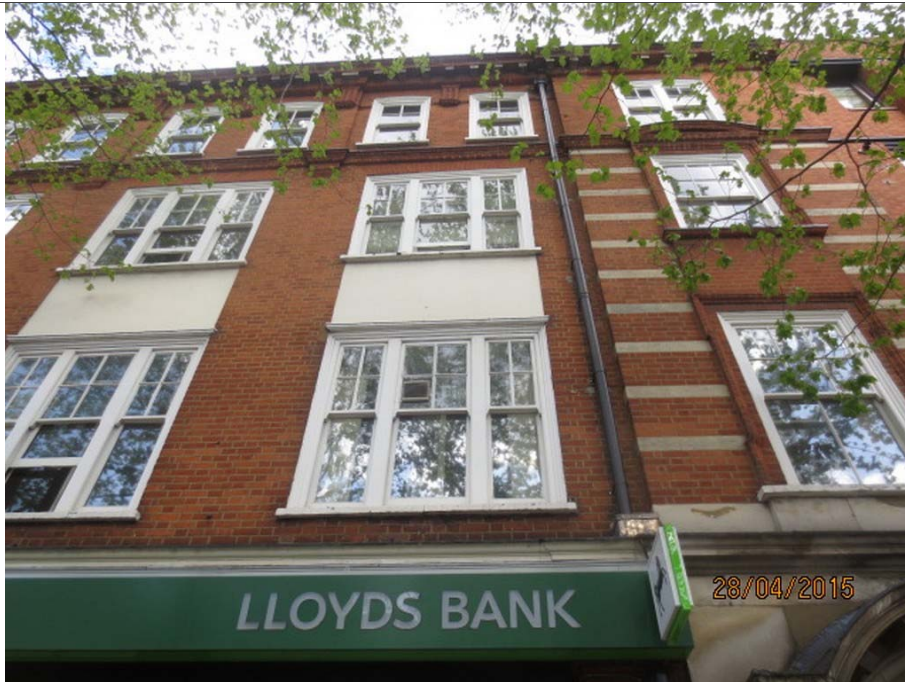
07: Front elevation – timber sliding sash windows to 1st, 2nd and 3rd floors

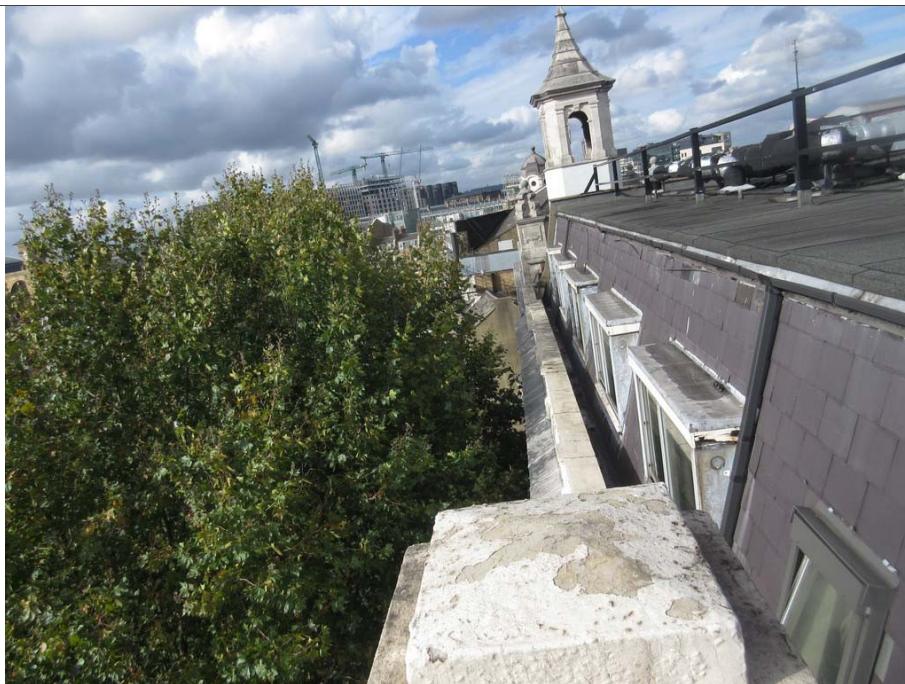
08: Front elevation – existing aluminium sliding windows to 4th floor mansard situated behind parapet wall

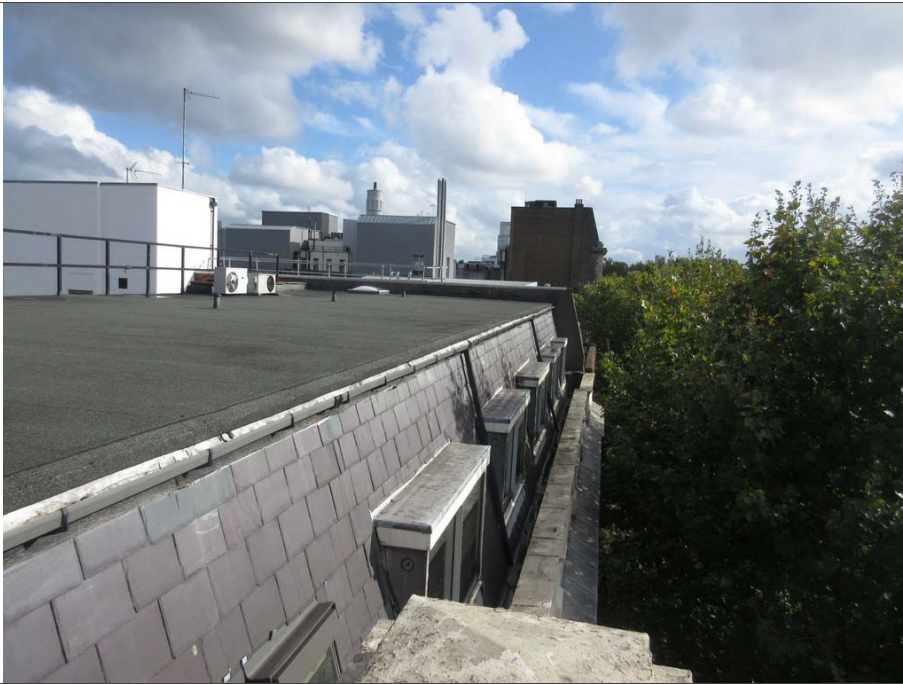
09: Front elevation – existing aluminium sliding windows to 4th floor situated behind parapet wall

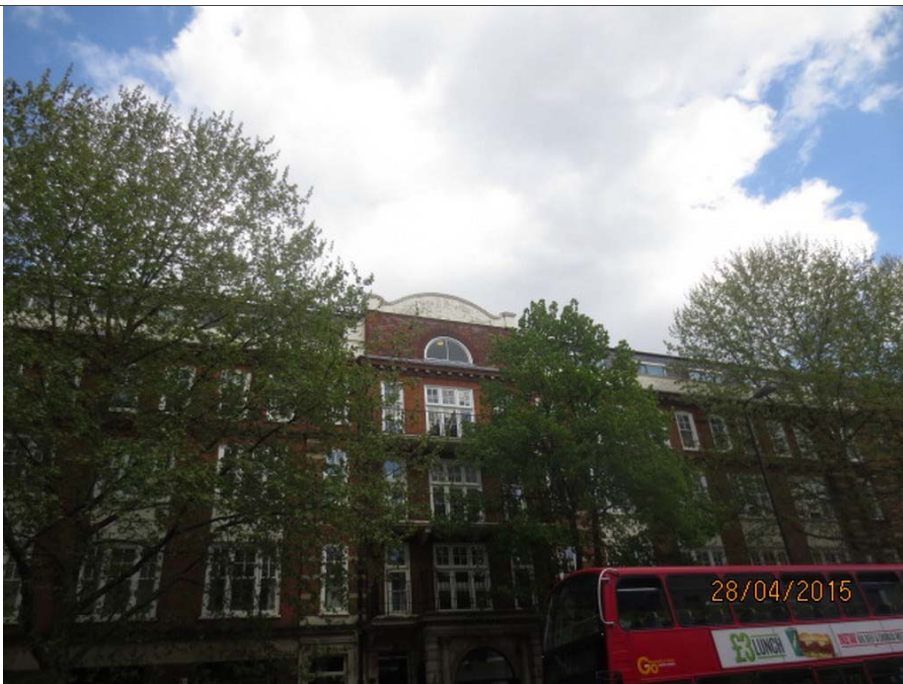
10: Front elevation – showing semi circular window at high level and render above

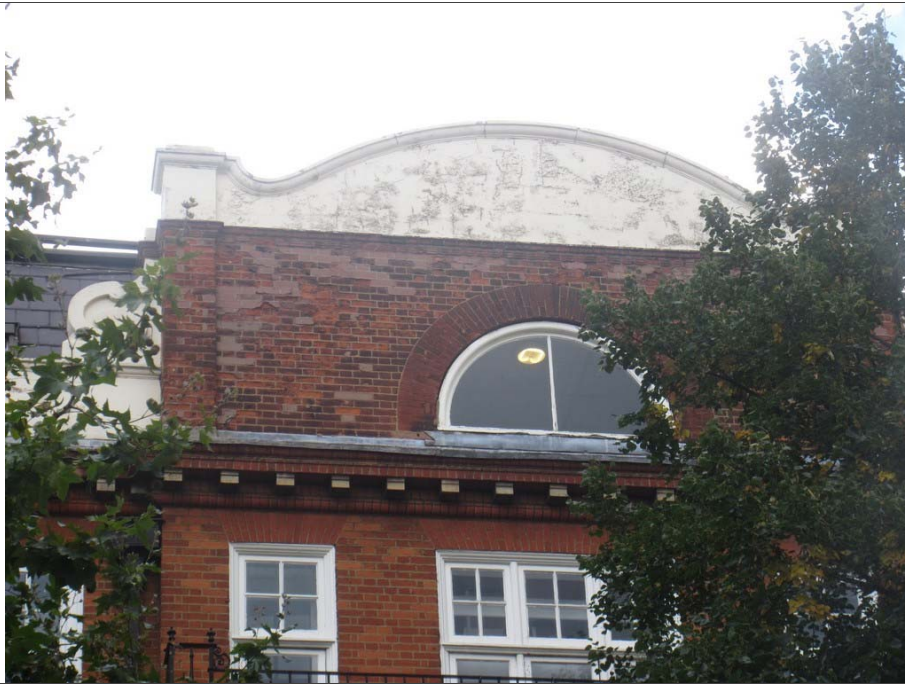
11: Front elevation – frost shattered brickwork below rendering and around semi circular window

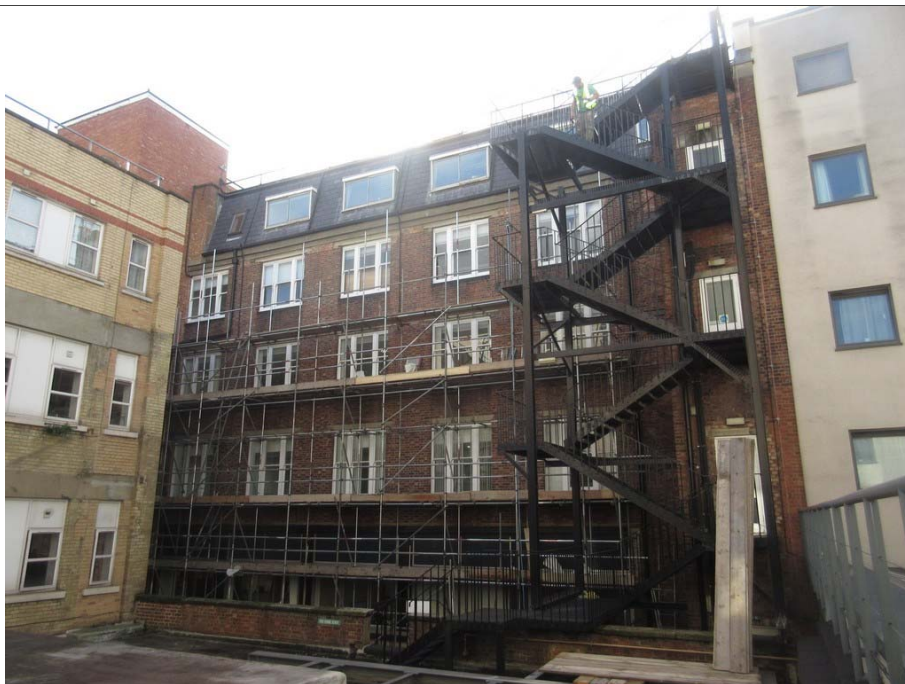
12: Rear elevation – general view

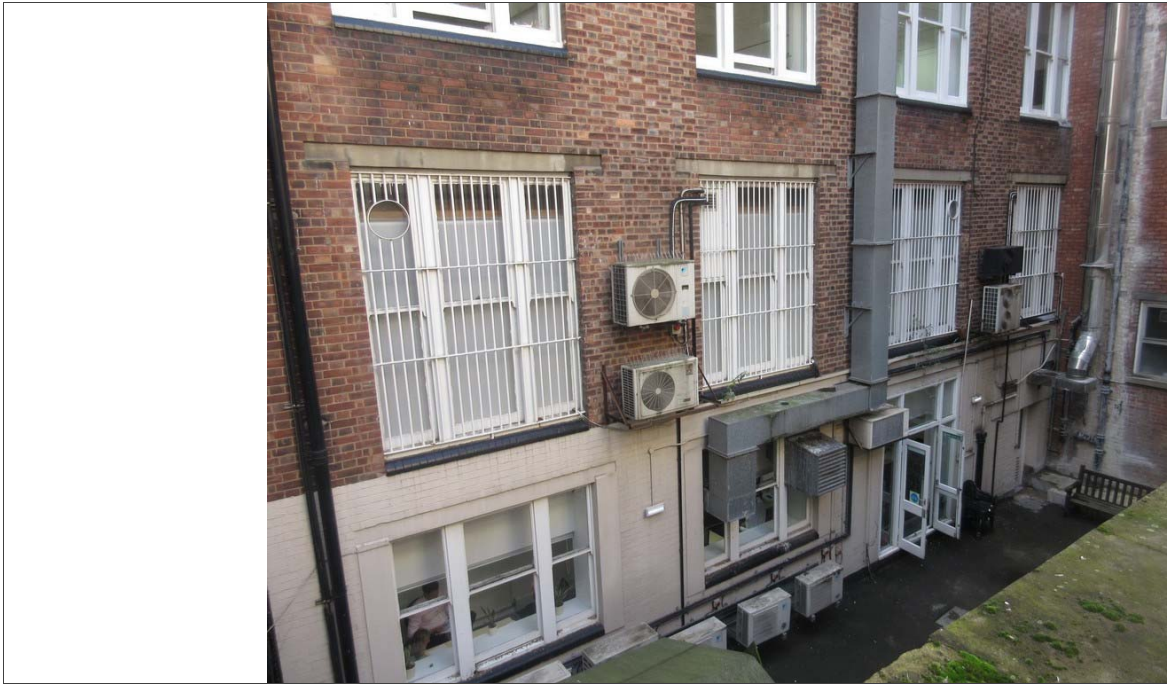
13: Rear elevation - timber sliding sash windows to lower ground and ground floors

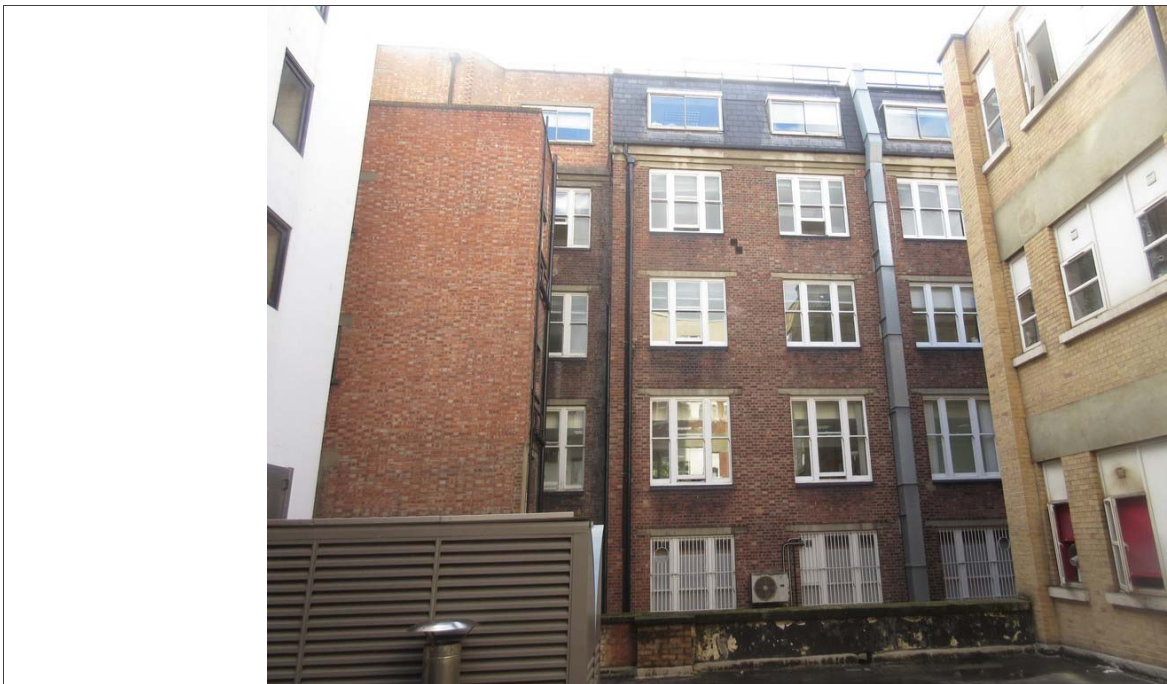
14: Rear elevation – general view

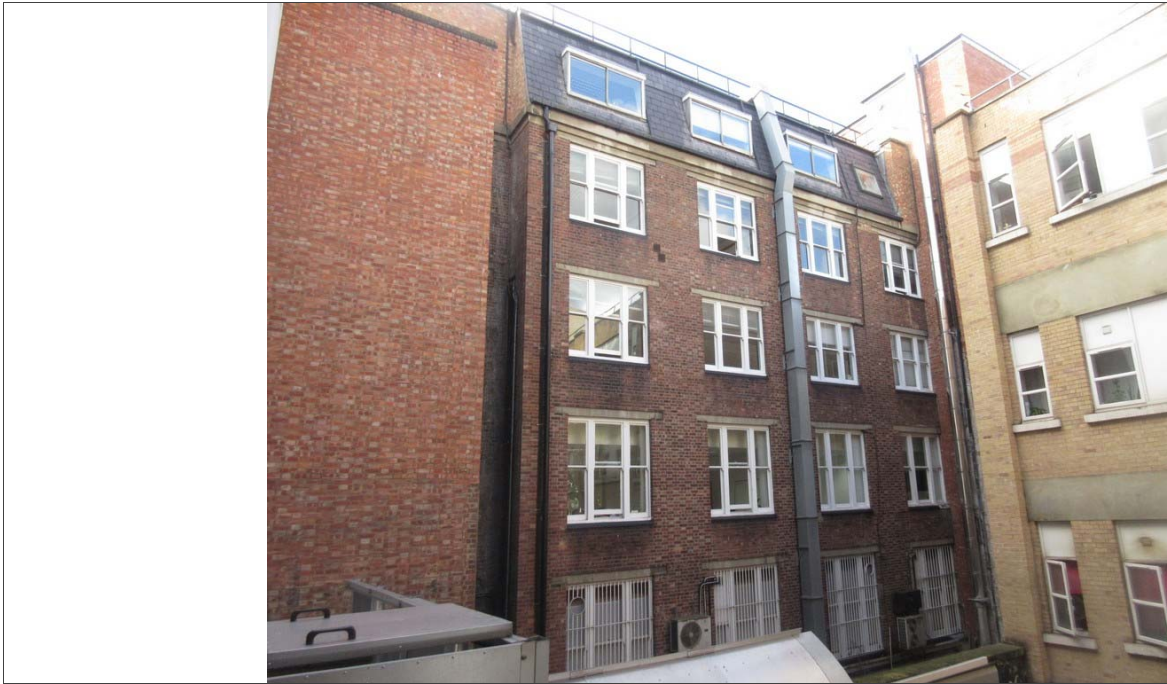
15: Rear elevation - timber sliding sash windows to ground, 1st, 2nd and 3rd floors

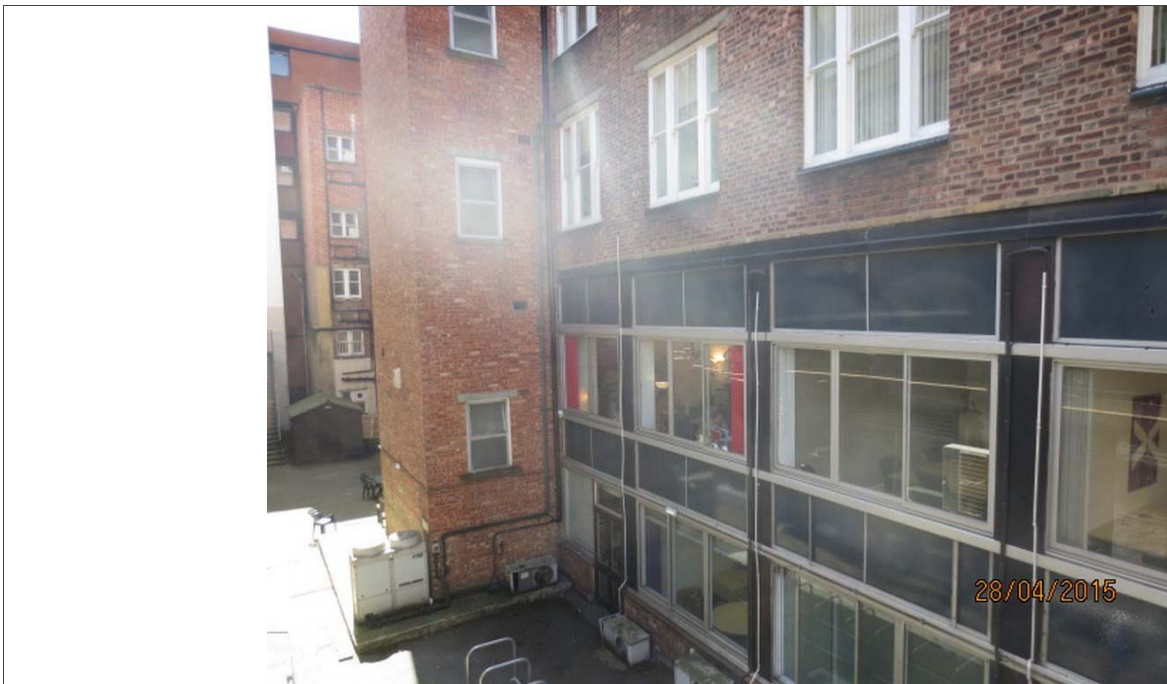
16: Rear elevation - metal framed windows to lower ground and ground floors

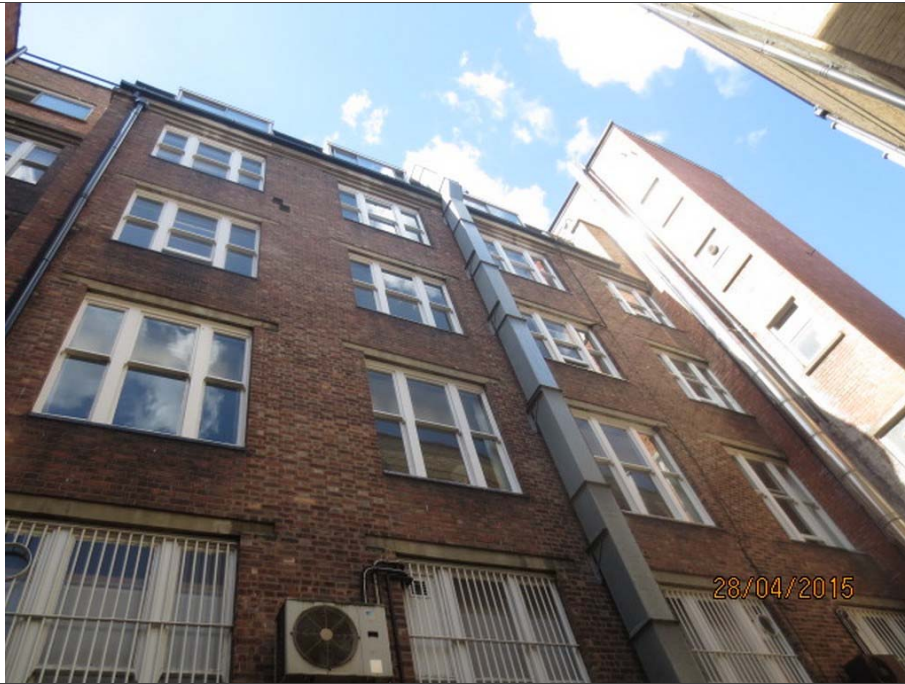
17: Rear elevation - timber sliding sash windows to ground, 1st, 2nd and 3rd floors

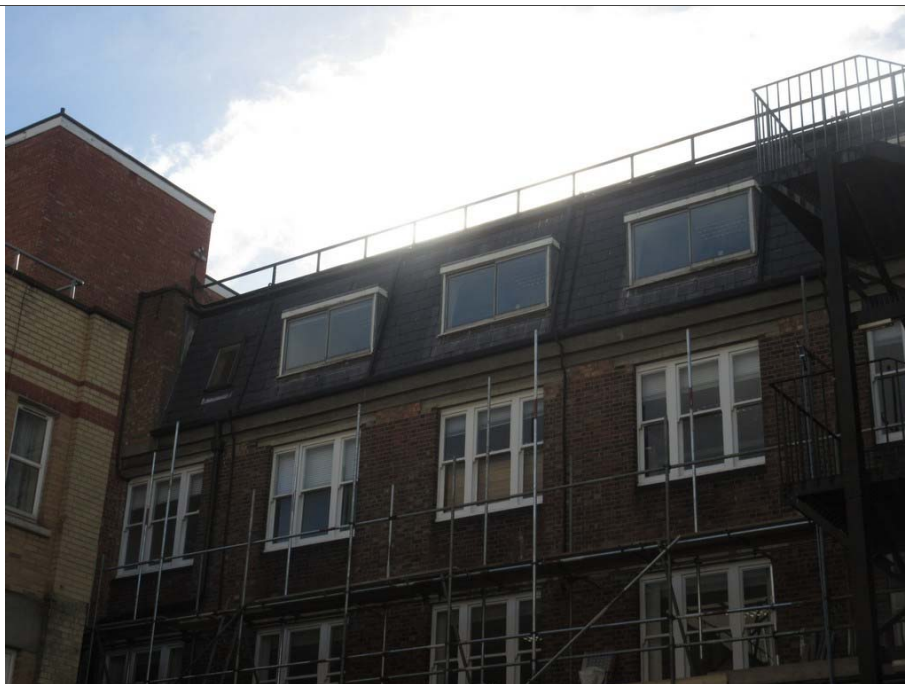
18: Rear elevation - existing aluminium sliding windows to 4th floor mansard roof

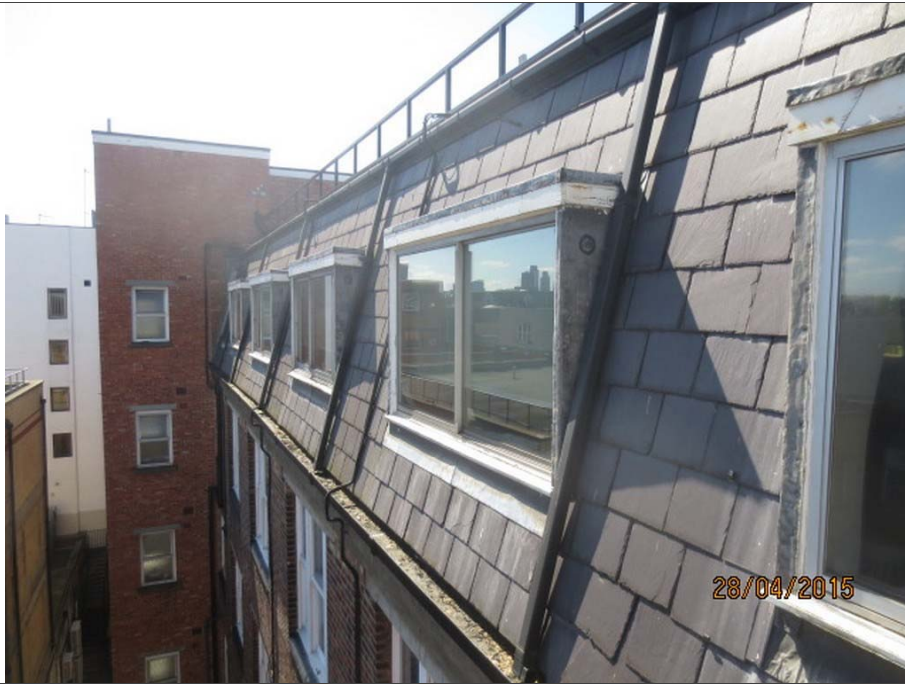
19: Rear elevation - existing aluminium sliding windows to 4th floor mansard roof

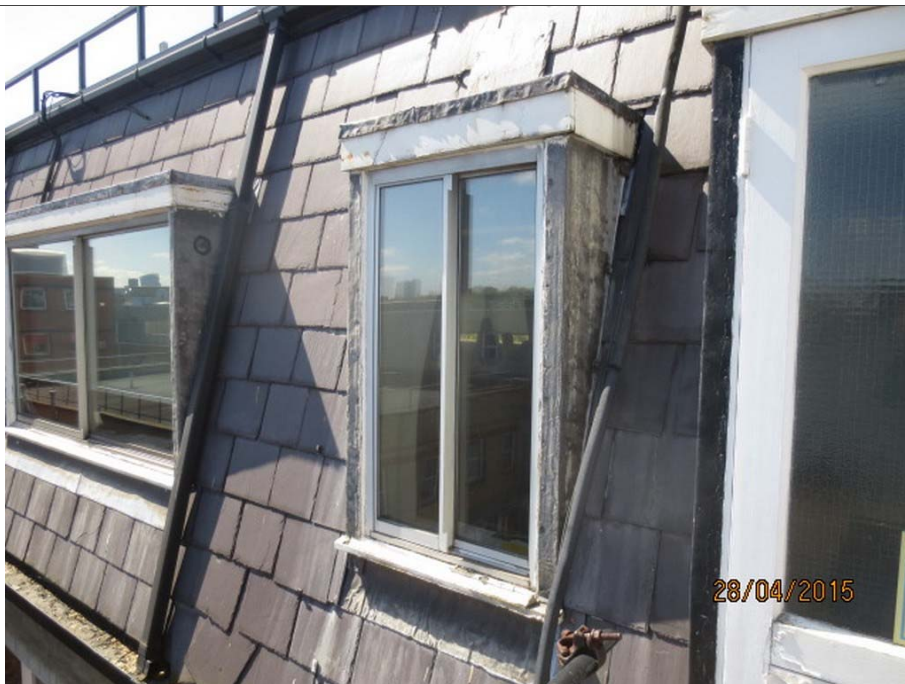
20: Rear elevation - existing aluminium sliding windows to 4th floor mansard roof

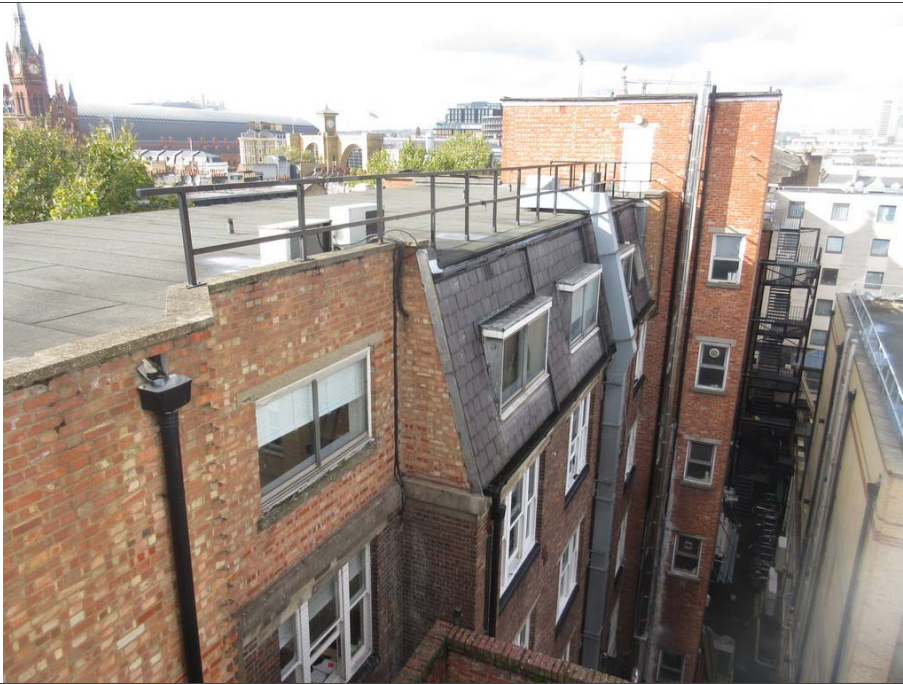
21: Rear elevation - existing aluminium sliding windows to 4th floor mansard roof

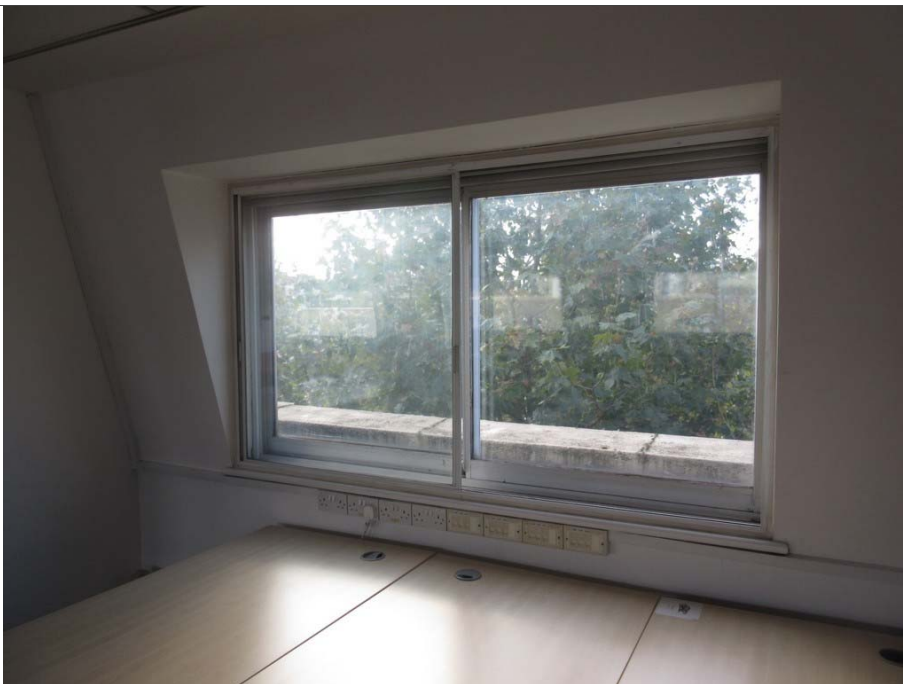
22: Front elevation – internal view of existing sliding windows to 4th floor with secondary glazing

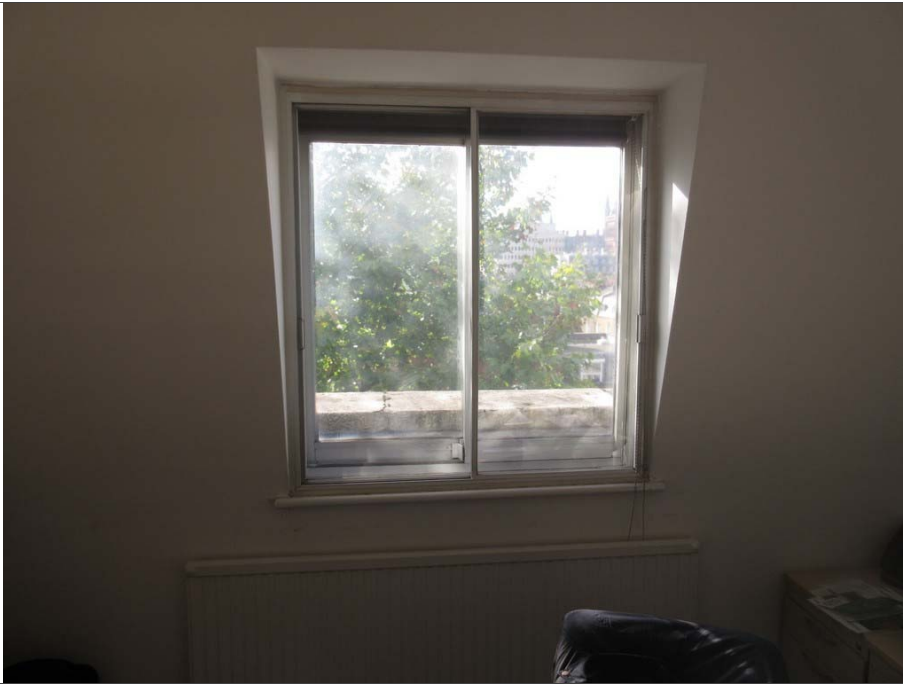
23: Front elevation – internal view of existing sliding windows to 4th floor with secondary glazing

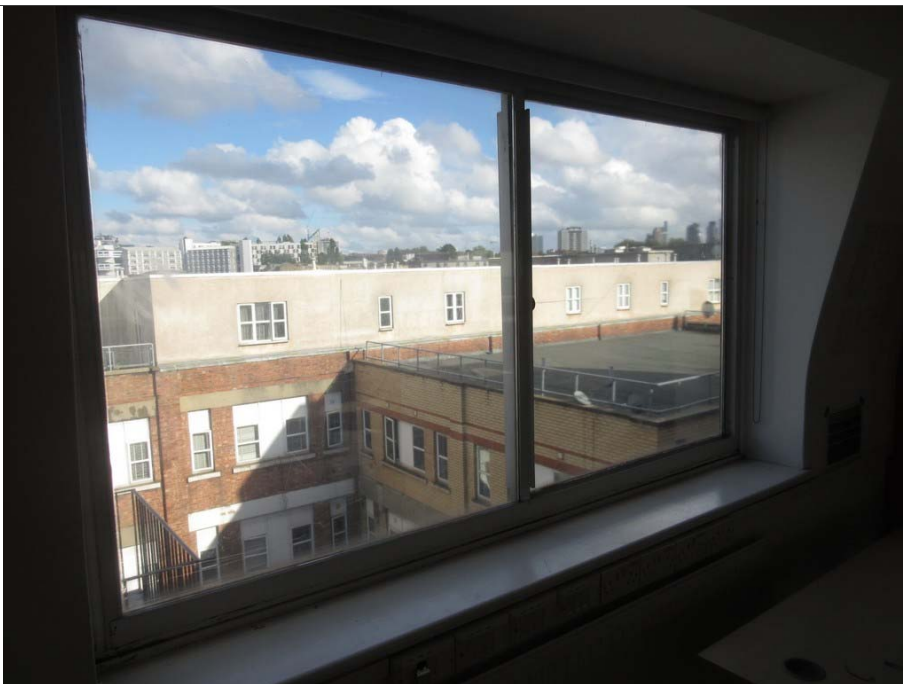
24: Rear elevation – internal view of existing sliding windows to 4th floor

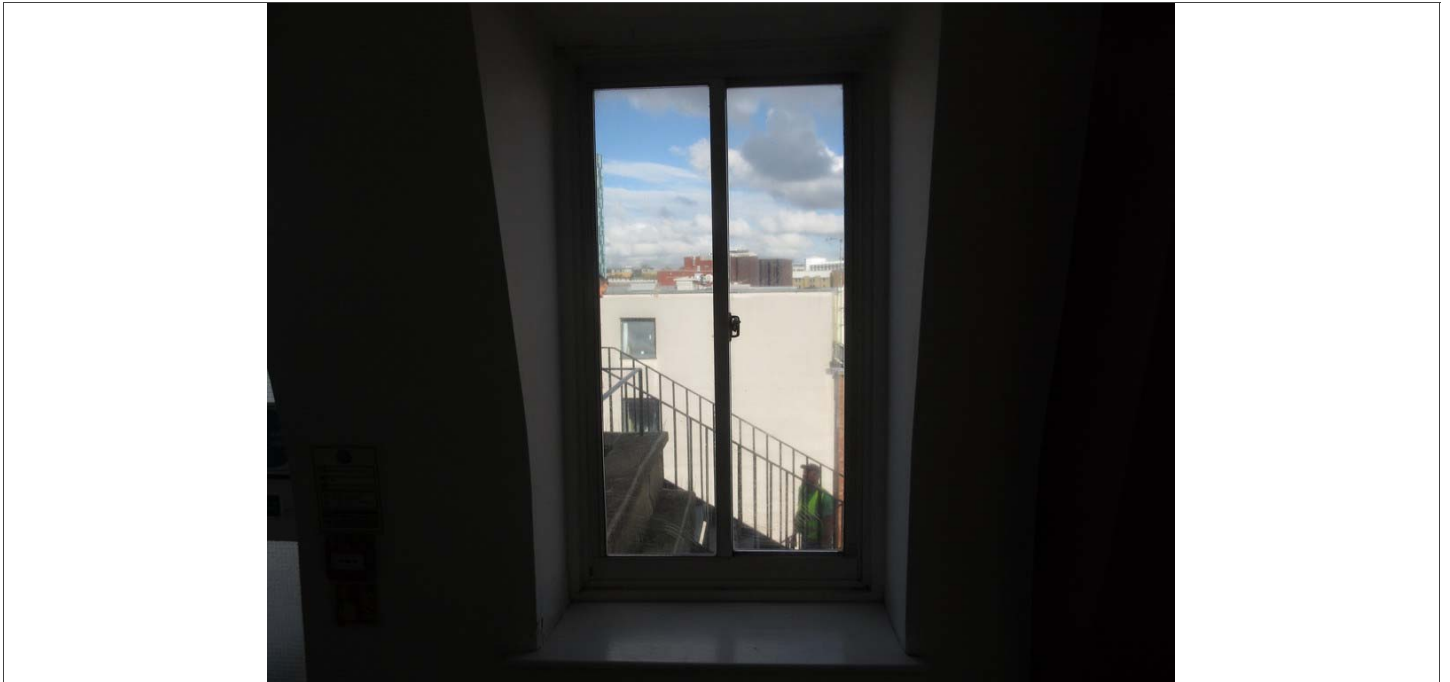
25: Rear elevation – internal view of existing sliding windows to 4th floor
