**BUILDING SURVEY
REPORT**

**45 NEW OXFORD STREET AND
15-16 WEST CENTRAL STREET,
LONDON W1**

**BotleyByrne
Chartered Surveyors
20 Hanover Square
London W1S 1JY**

**JUNE 2012
MDB/BBCS**

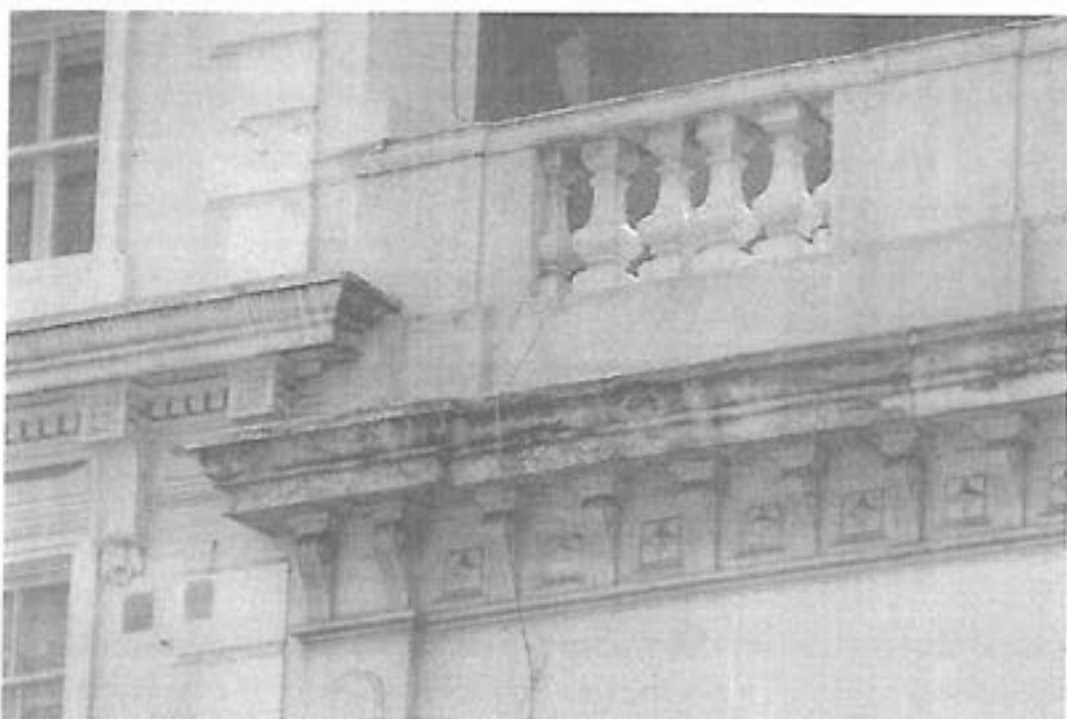
The cornices are not discharging water adequately and this has resulted in their deterioration together with staining and foliage growth.

1. Front of building.
2. Damp staining and defects- at cornice level

Repair and redecoration works are required to the external elevations to prevent their further deterioration.

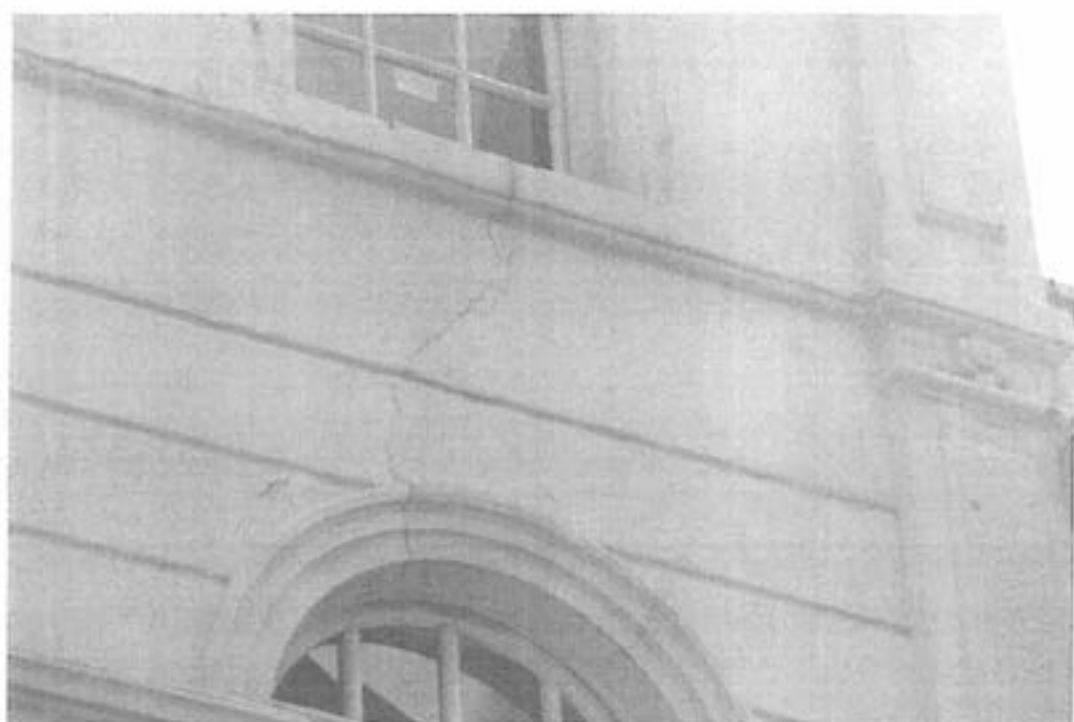
Although the walls appear to be structurally sound, there has been some structural movement and this has largely manifested itself between window sills and heads where settlement of timber lintels has occurred over time, allowing brickwork to be disturbed slightly, resulting in consequential cracking to the stucco render. We do not consider this structural movement to be of undue concern but see comments below regarding walls.

3. Typical cracking between window heads and eills-
4. Defective decorations

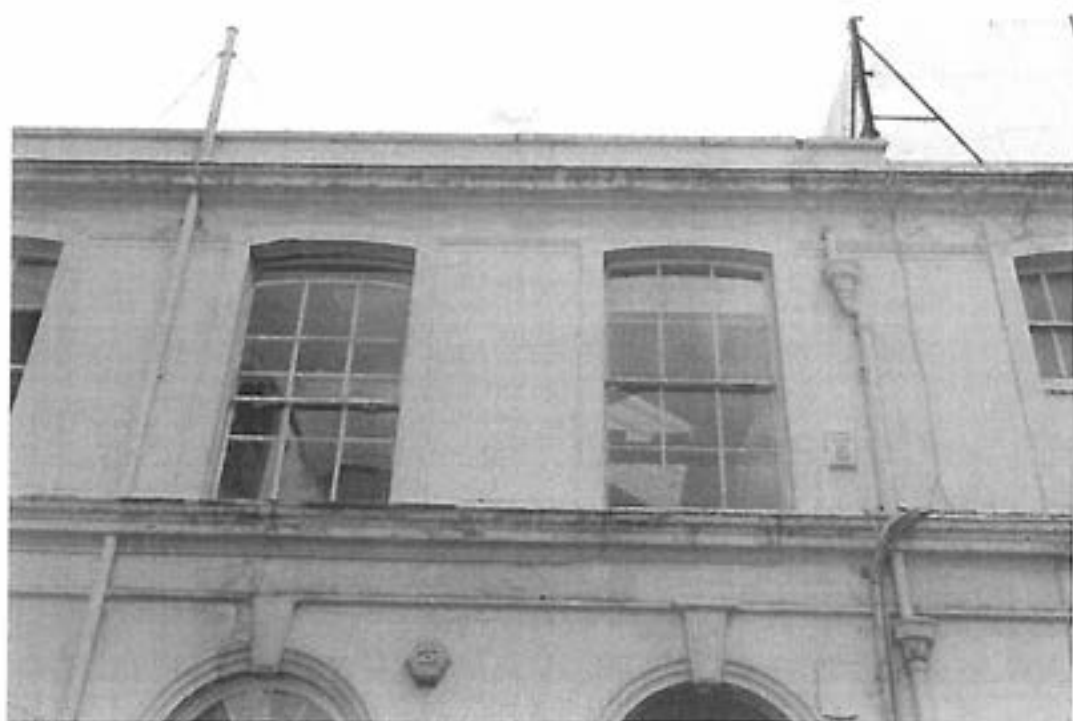
Windows to the property comprise timber framed and single glazed sliding sash windows with a paint finish. The windows at ground floor along West Central Street are metal framed but of the same design. Decorations to all elevation windows have failed and are in poor condition exposing timber beneath. Sash windows were inspected where ill-fitting and difficult to operate. Repair, refurbishment and redecoration of windows is required.

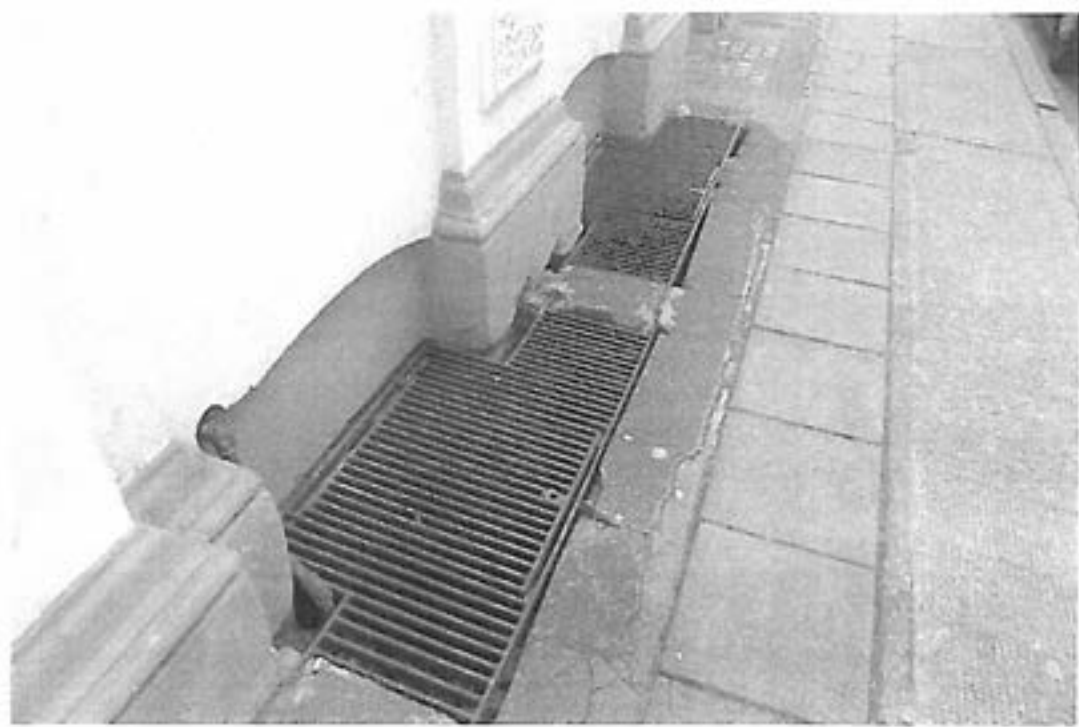
Along the New Oxford Street elevation are further pavement lights but with metal grilles over. These areas serve as ventilation, air extract/intake for this particular tenant's air-conditioning kit, which is located within the basement area. The grilles are buckled and the surrounding areas are in disrepair.

5. Defective pavement grille
6. Defective pavement lights

Pavement lights and adjacent pavement areas require replacement and refurbishment.

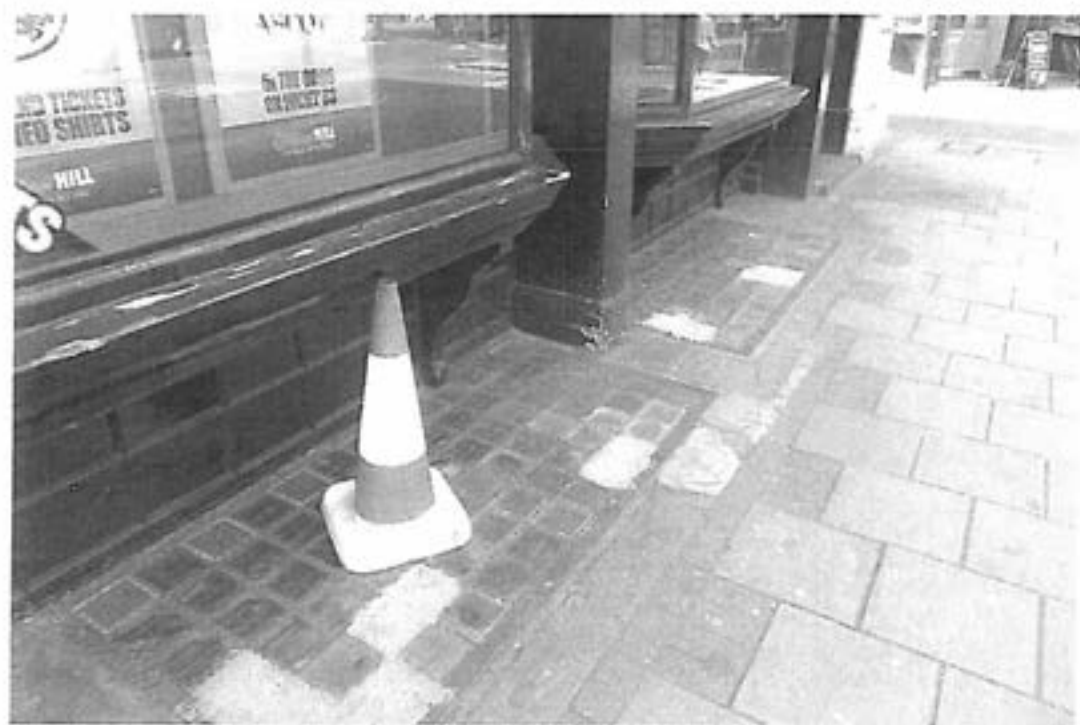
To the New Oxford Street elevation these comprise cast-iron framed and glazed pavement lights. These are all in very poor condition, many of which have been repaired or replaced and on the whole, are supported by timber props internally. This situation is untenable. We understand from the tenant that historically there had been a fire due to cigarette smokers dropping cigarettes down between the pavement lights and into debris accumulated in the basement.

There are defects to the pavement lights which are detrimental to the property but also present a health and safety risk to the general public. These pavement lights should be comprehensively repaired at your earliest convenience.

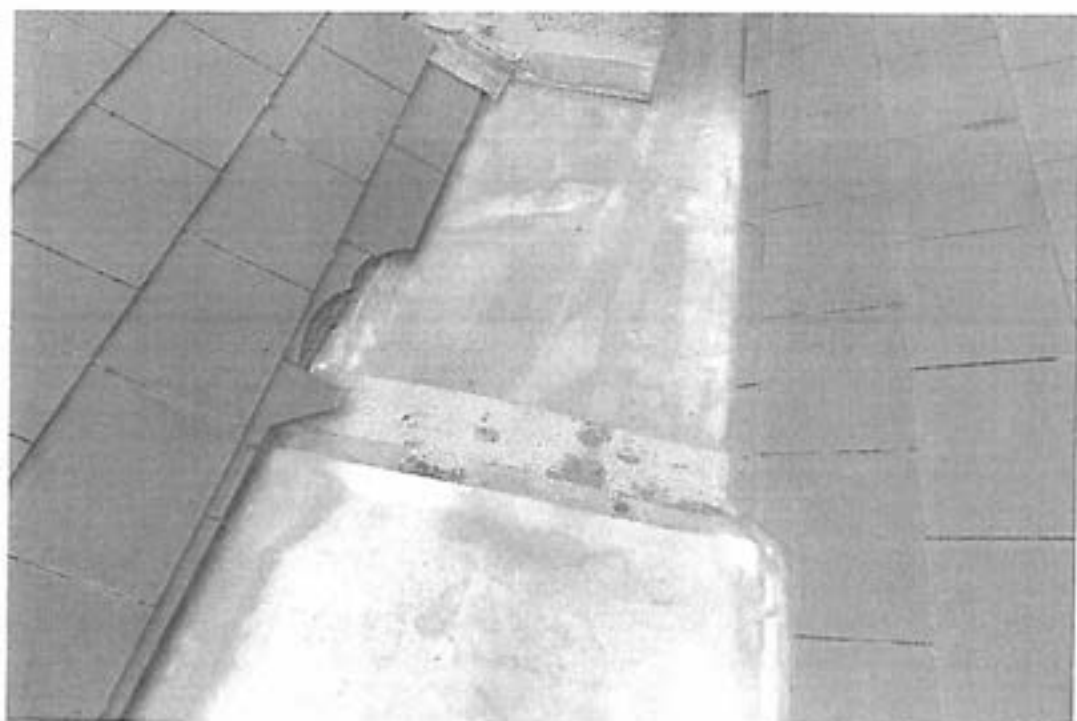
These pitched roofs are not covered with their original finishing, which would have been natural slate and have been replaced with manmade tiles. Manmade tiles are a cost effective solution but your Solicitors should confirm that this work is in compliance with Local Authority and listed building guidelines. There are a number of tiles which are broken and these should be replaced.

Pitched roofs drain to lead valley gutters and these have been patch repaired over the years as evidenced by various flashband, mineral felt and other such temporary repair solutions. We would suggest, therefore, that although the tiled roof seems to have been replaced in the relatively recent past, say 10 years, the opportunity to replace the gutter was not taken at the same time and consequently is now becoming time sensitive.

8. Cracked tiles and defective gutter

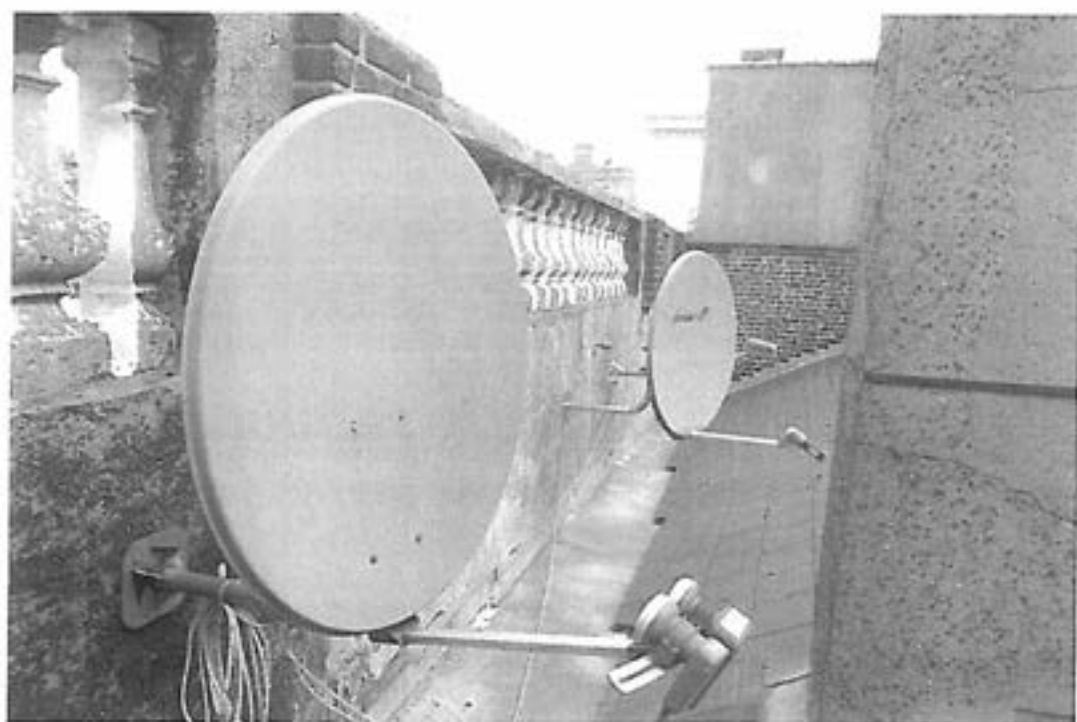
Satellite dishes were noted on the roof of No43. We do not know whose these belong to or how they are serviced. You should query this with the vendor.

9. Satellite dishes at roof level

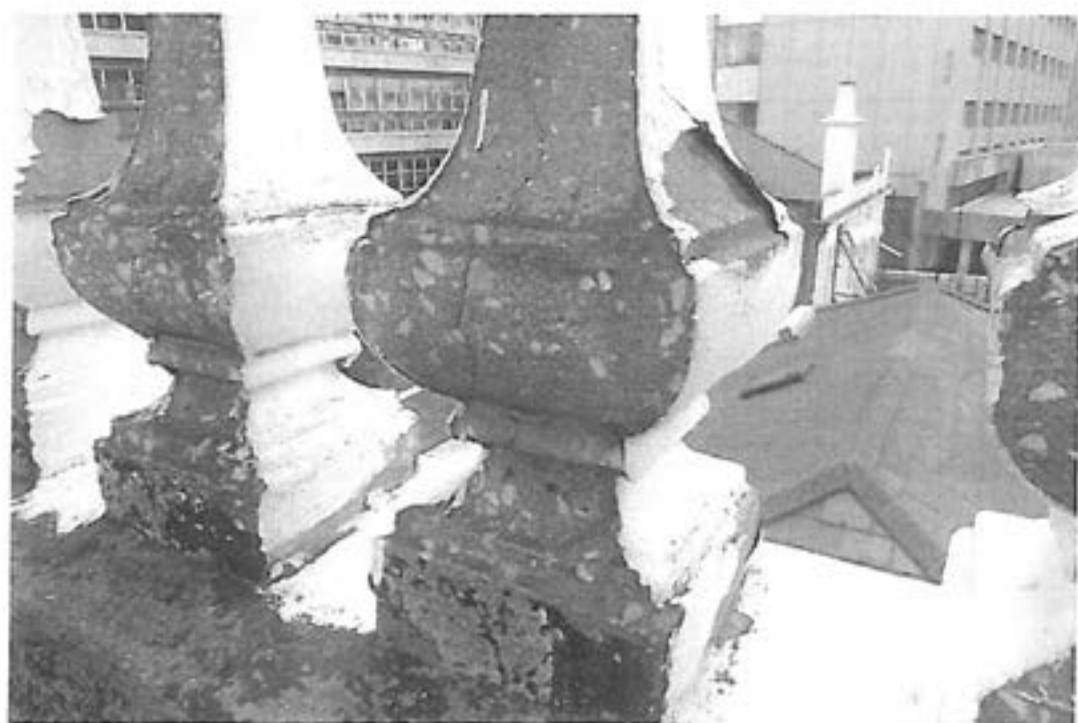
There is a feature parapet, including bottle balustrades the New Oxford Street portion of the property. These are formed in concrete and with a painted stucco render finish. Again, due to a lack of maintenance, the stucco render is cracked and delaminated, allowing water ingress to the substrate beneath. Maintenance works are required as soon as possible.

10. Defective render to balustrade

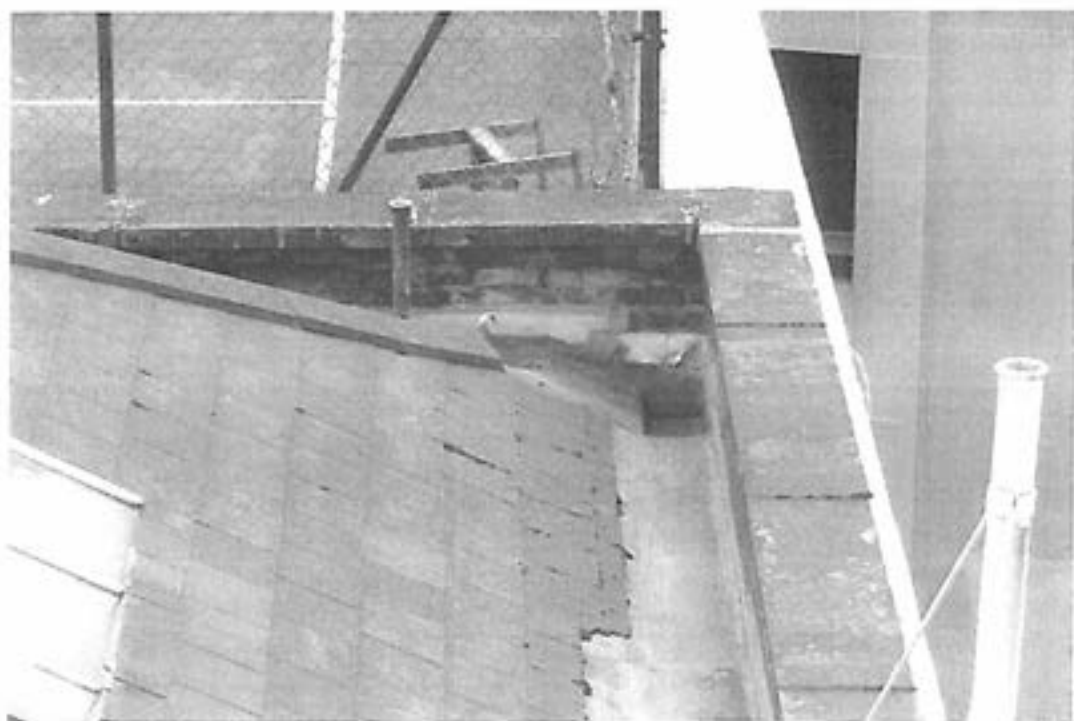
- 11. View to roofs over West Central Street
- 12. Historic gutter repairs

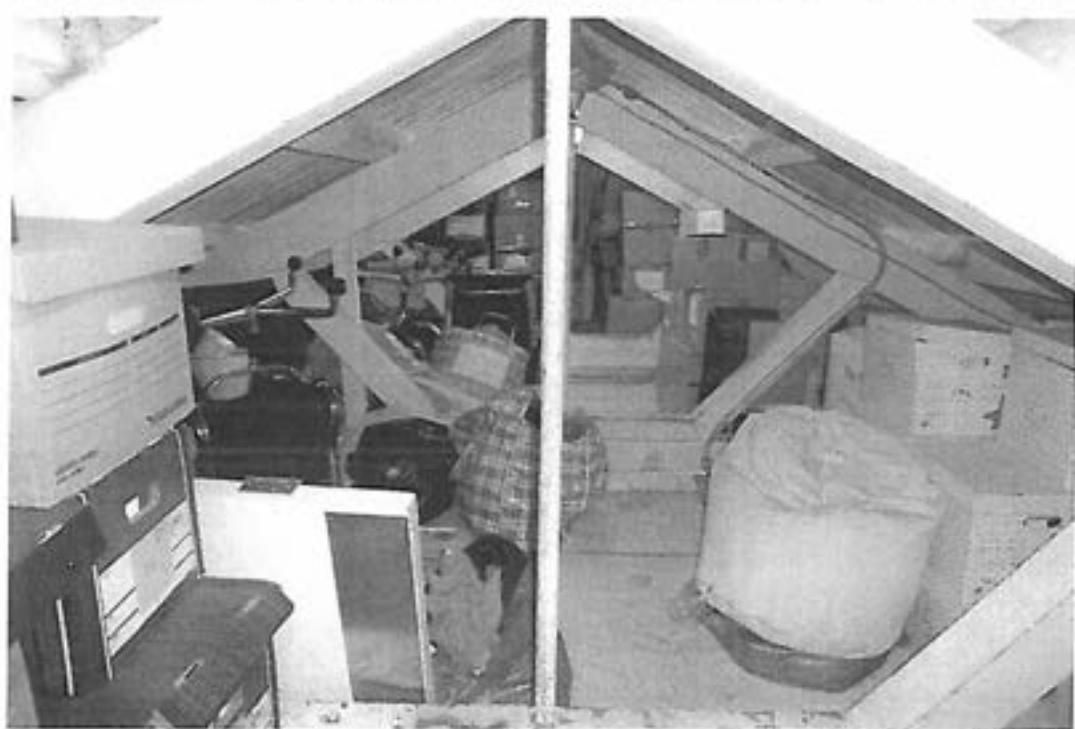
Internally the roof space of No43 is close boarded and the walls are unfinished. This space is used for storage. There are signs of historic water ingress but not of current leaks.

13. Roof space

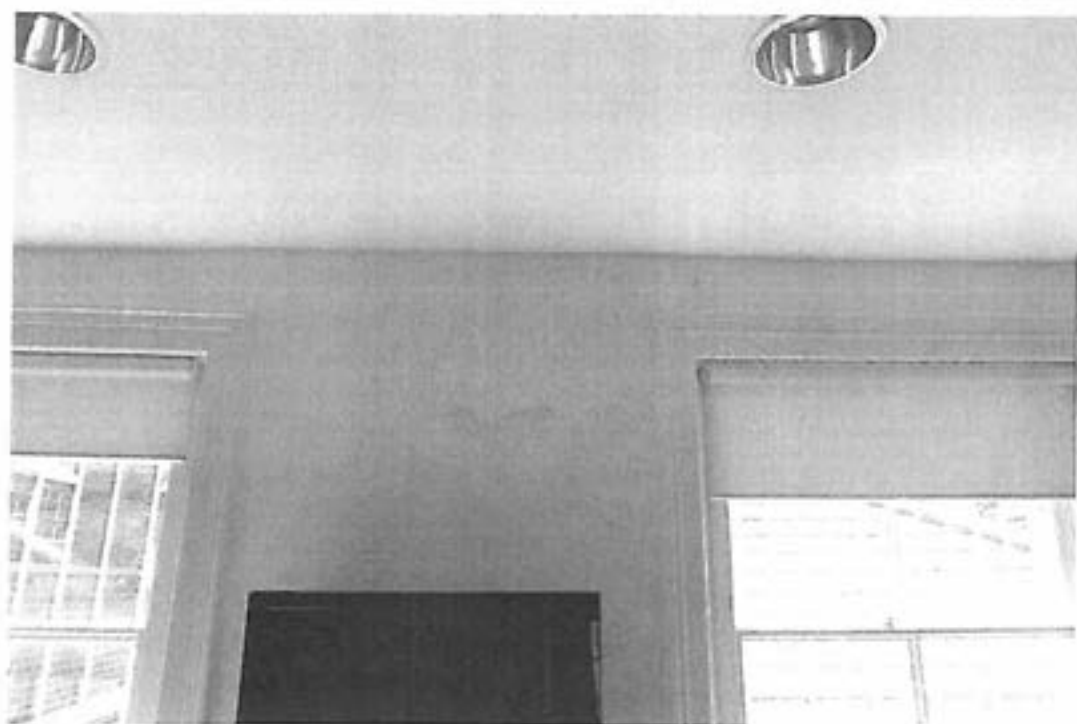
Damp staining was noted in a number of areas to the second floor and also the first floor ceiling areas. This is as a result of external defects to the roof and walls and which should be addressed as part of an imminent external repair and redecoration project.

17. Damp staining at 2nd floor level

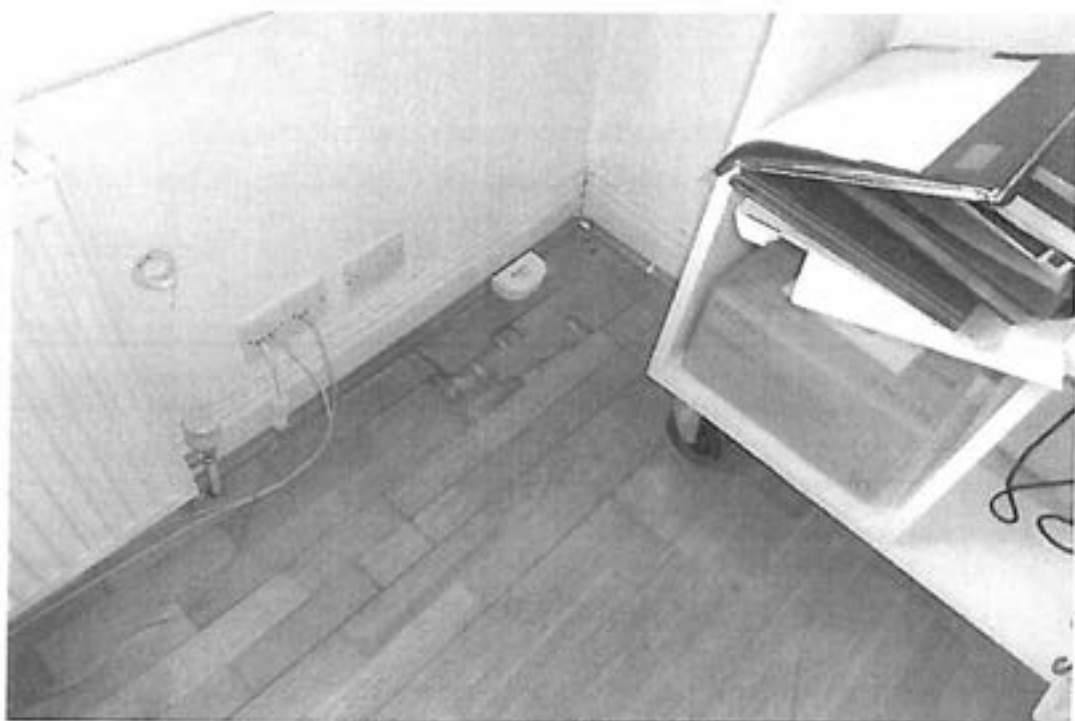
18. Damp staining to front elevation

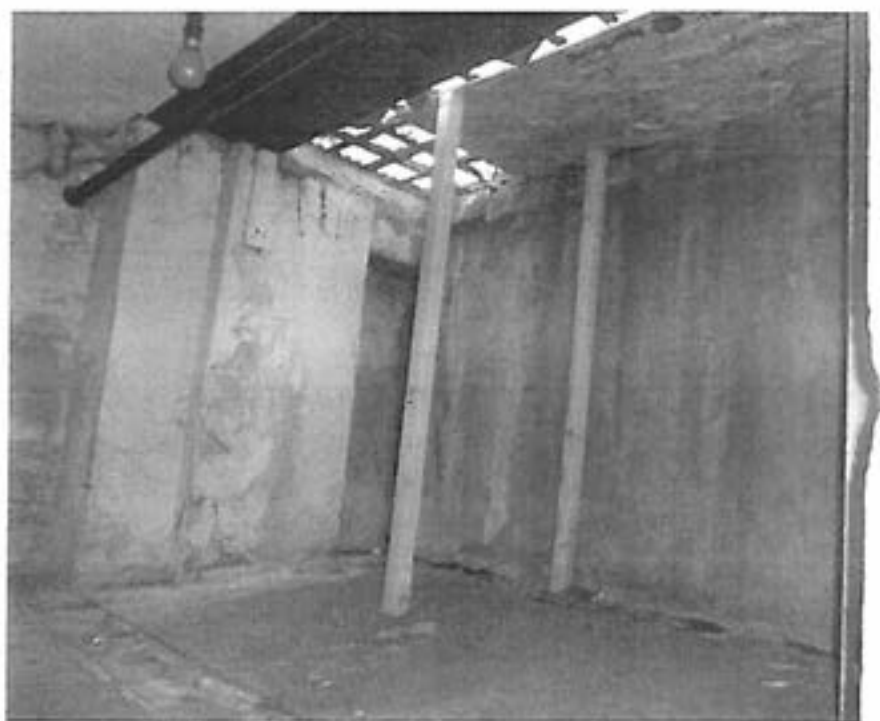
At basement level, there are various rooms which appear to be unused. The floor is concrete, the walls are plastered and painted and the ceilings are suspended. To the perimeter of the basement areas are pavement lights. Pavement lights are defective as mentioned above. Some dampness was detected to the walls at low level but on the whole the basement areas are dry.

22. Defective front elevation (reverse) light

Overall, William Hill's demise is in good condition, although the basement areas require to be tidied up and perimeter pavement lights and vents require immediate attention.
