Photographic Record for External & Internal Refurbishment Works

45 New Oxford Street & 15-16 West Central Street London WC1A

Fred Hill Properties Limited

Date: October 2015

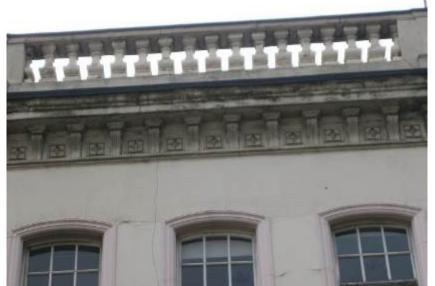
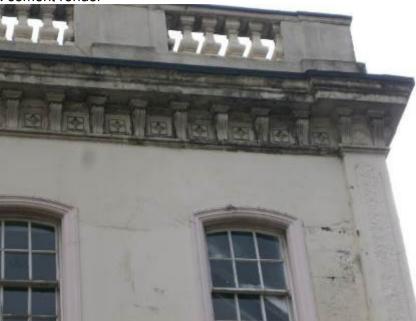
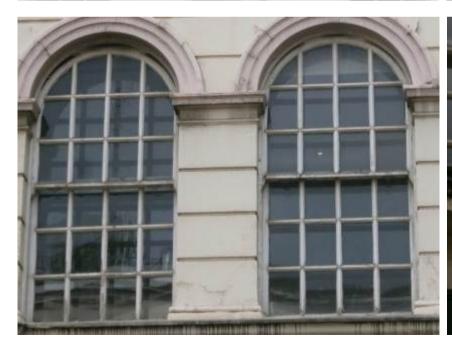
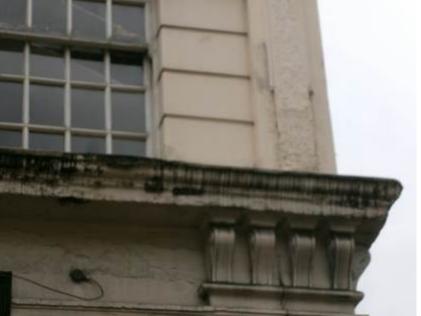
Front Elevation – Second Floor & First Floor – flaking decoration & cement render

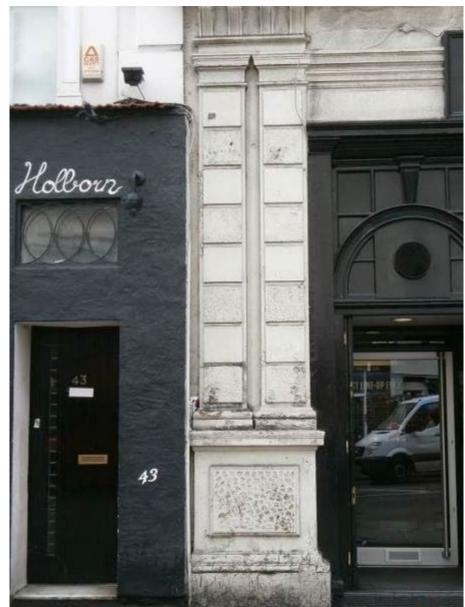
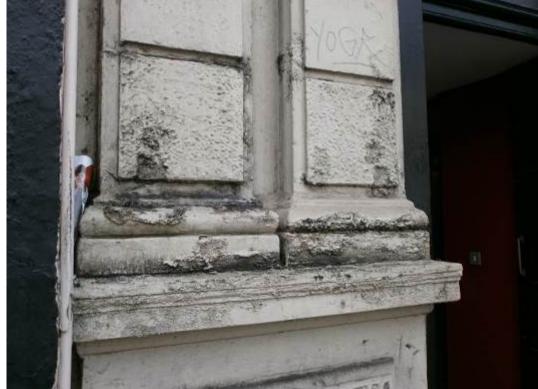
Front Elevation – Ground Floor – flaking decoration and sub-fluorescence to plinth. Paint-obscured vermiculated render panels.

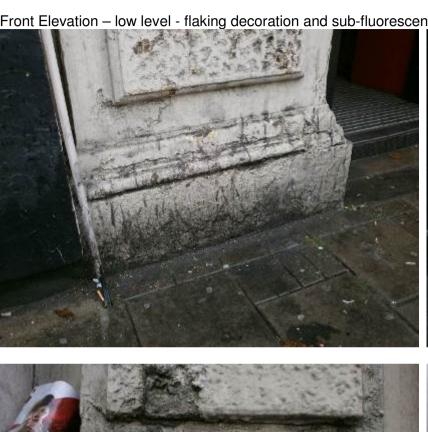
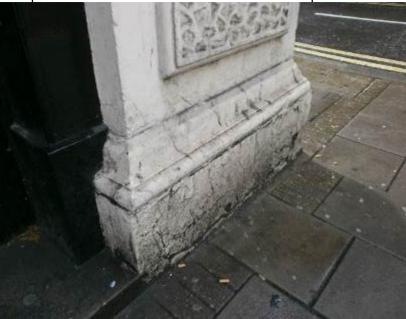
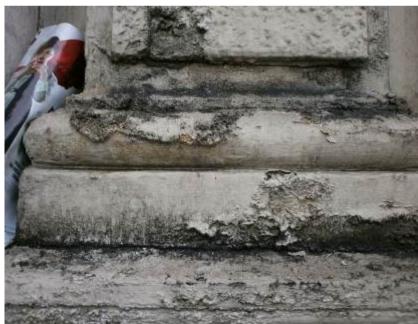
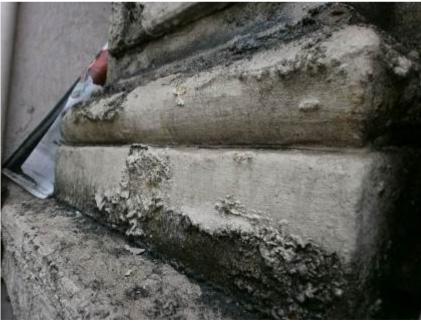
Front Elevation – low level - flaking decoration and sub-fluorescence to plinth. Paint-obscured vermiculated render panels.

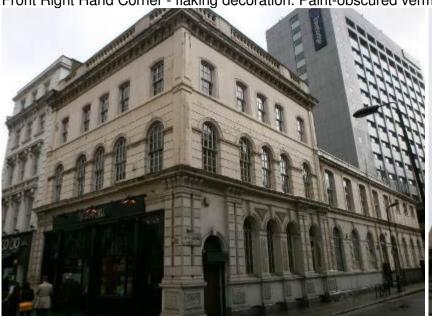
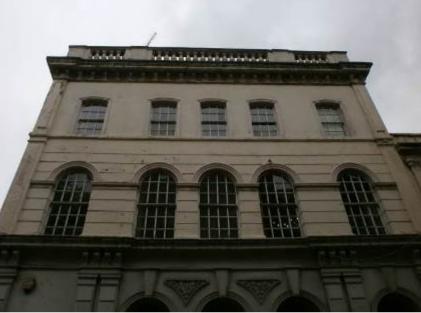
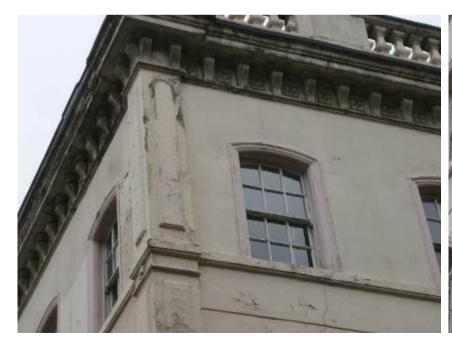
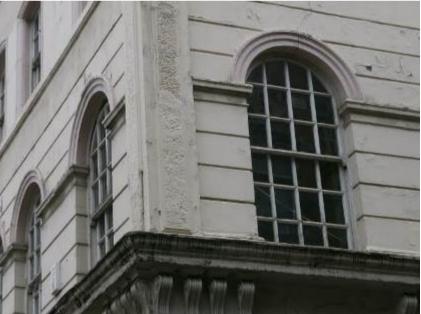
Front Right Hand Corner - flaking decoration. Paint-obscured vermiculated render panels.

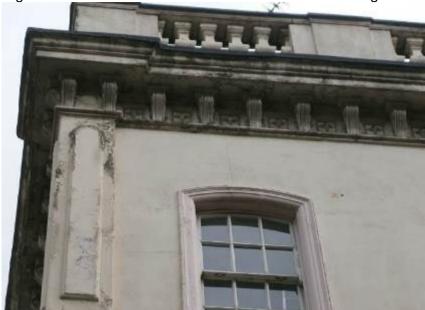
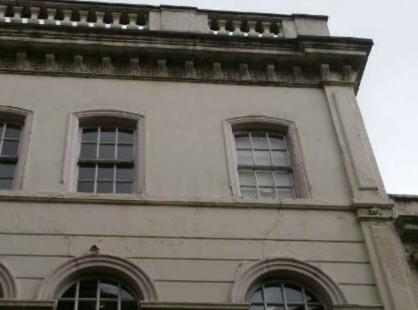
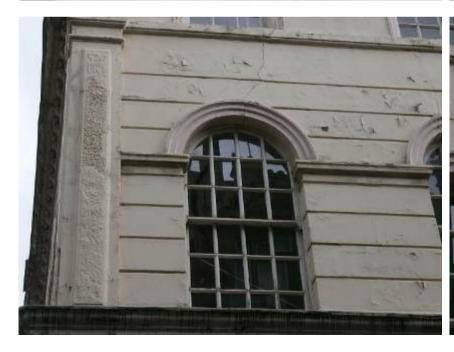
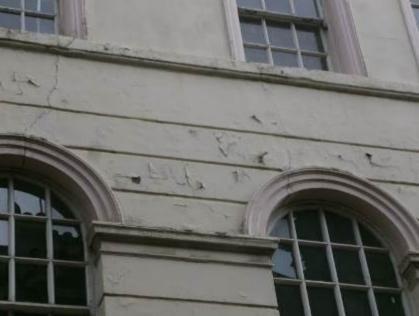
Right Hand Side Elevation – Second & First Floor - flaking decoration and cracking at window heads.

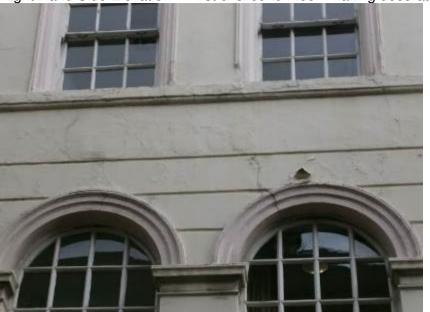
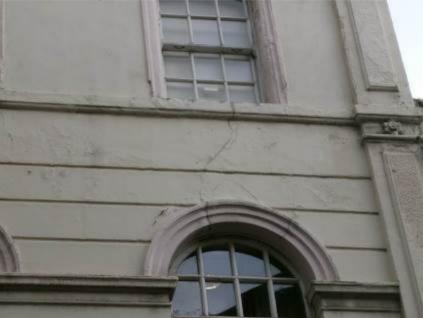
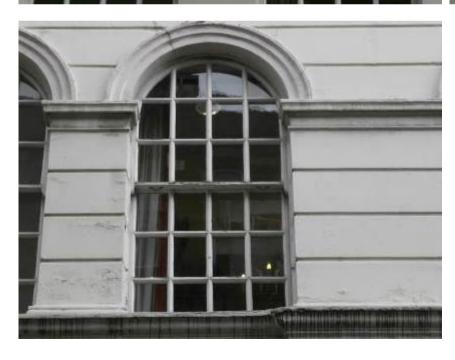
Right Hand Side Elevation – First & Ground Floor - flaking decoration and cracking at window heads.

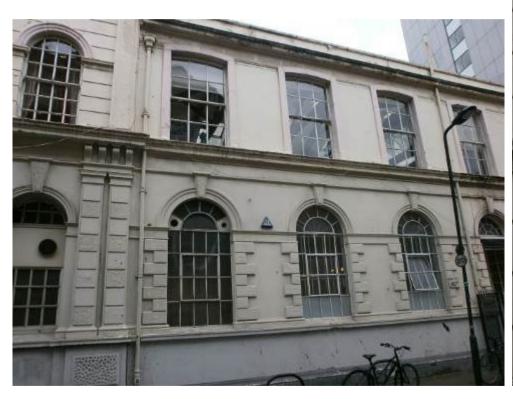
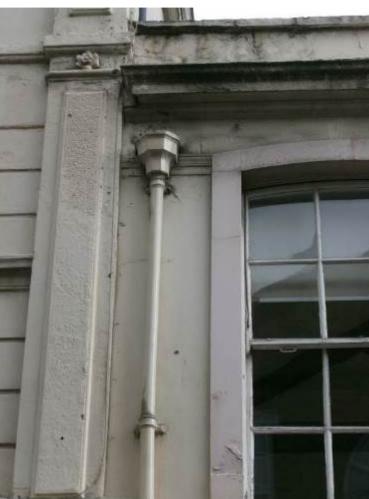
Right Hand Side Elevation – 2-Storey Section - flaking decoration and cracking at window heads. Paint-obscured vermiculated render panels.

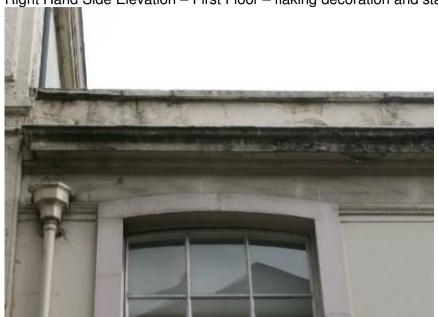
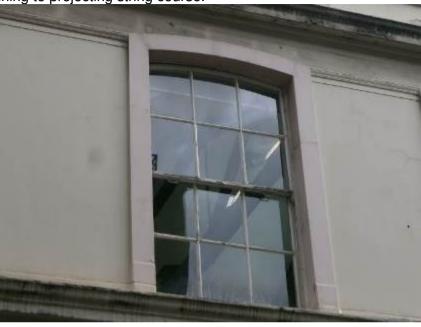
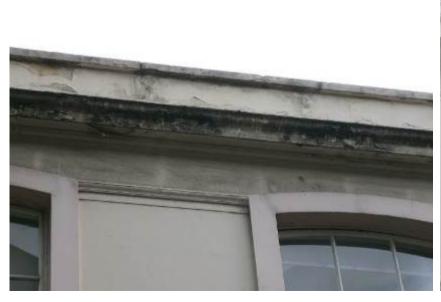
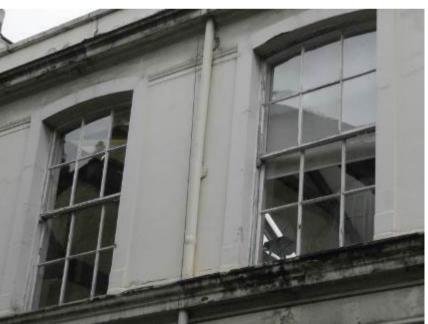
Right Hand Side Elevation – First Floor – flaking decoration and staining to projecting string course.

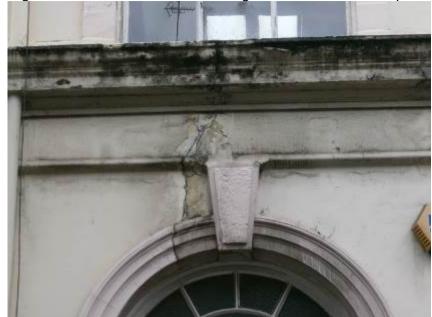
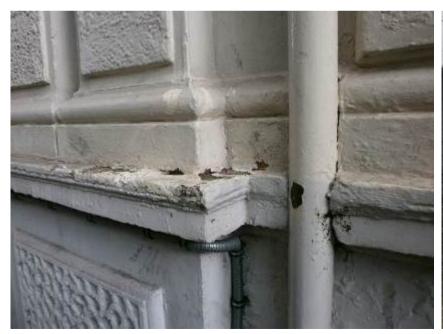
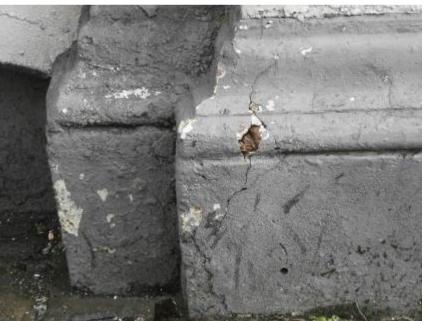
Right Hand Side Elevation – cracking to window heads and plinth. Flaking decorations.

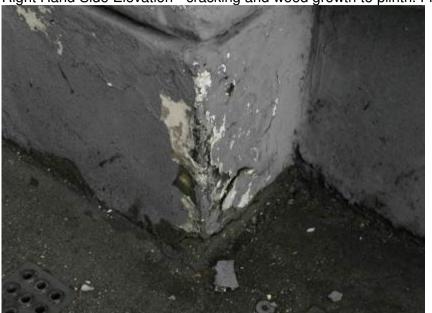
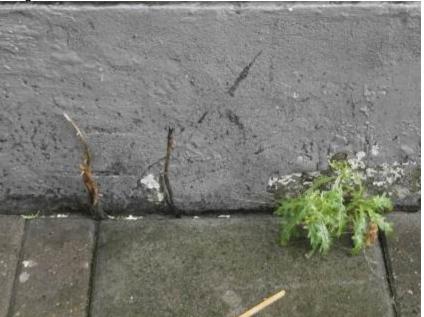
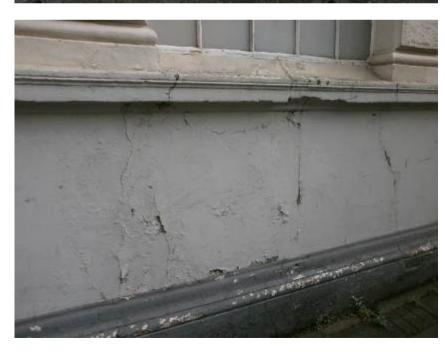
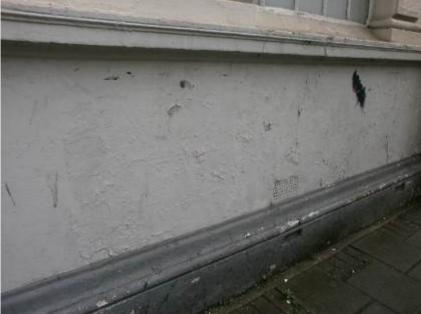
Right Hand Side Elevation - cracking and weed growth to plinth. Flaking decorations.

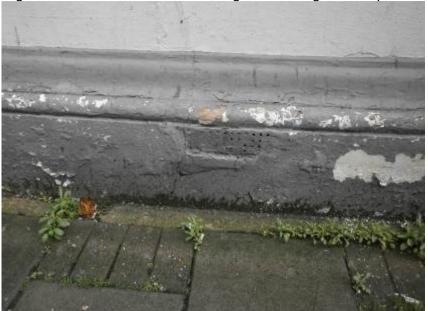
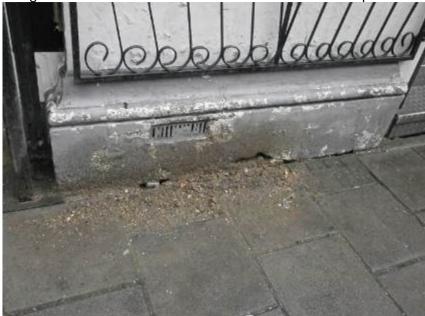
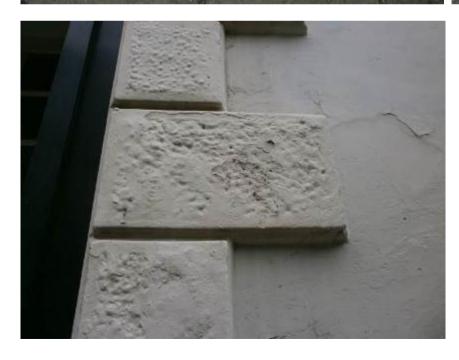
Right Hand Side Elevation - cracking and weed growth to plinth. Flaking decorations. Paint-obscured vermiculated render panels.

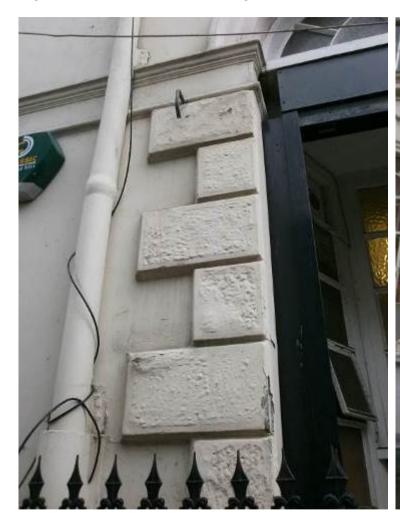
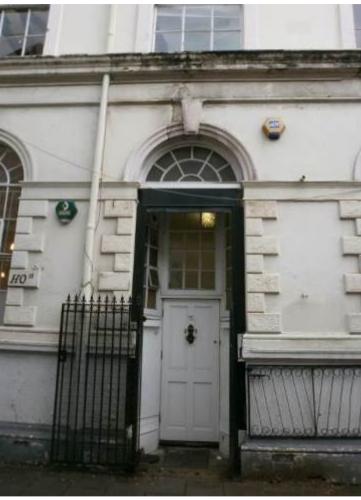
Right Hand Side Elevation - Flaking decorations. Paint-obscured vermiculated render panels.

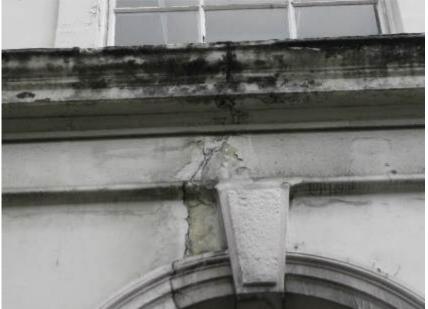
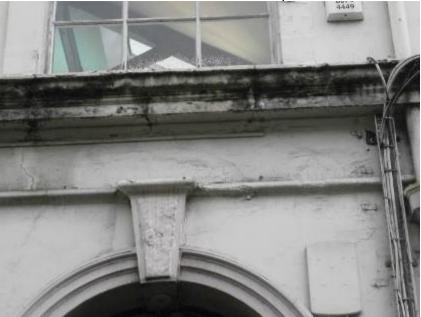
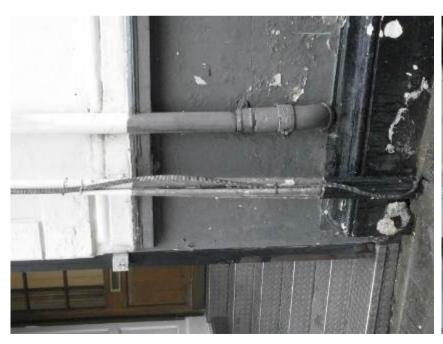
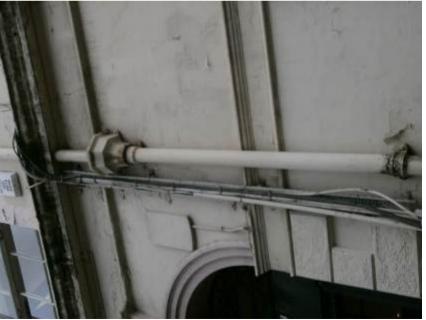
Right Hand Side Elevation - Flaking decorations. Cracking to door heads. Paint-obscured vermiculated render panels.

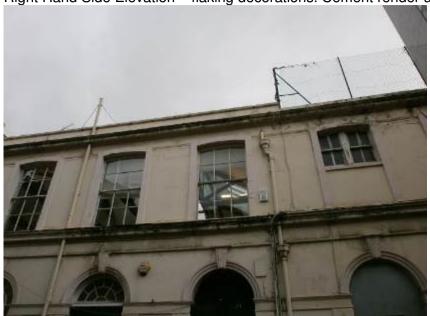
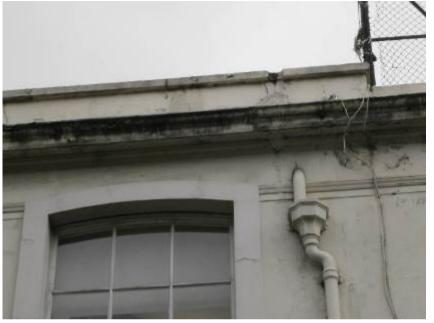
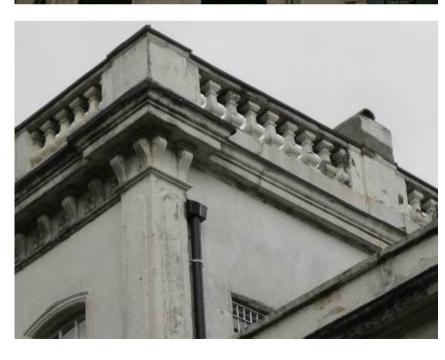
Right Hand Side Elevation – flaking decorations. Cement render at second floor level.
