90 South Hill Park, Record of Strip out and Demolitions

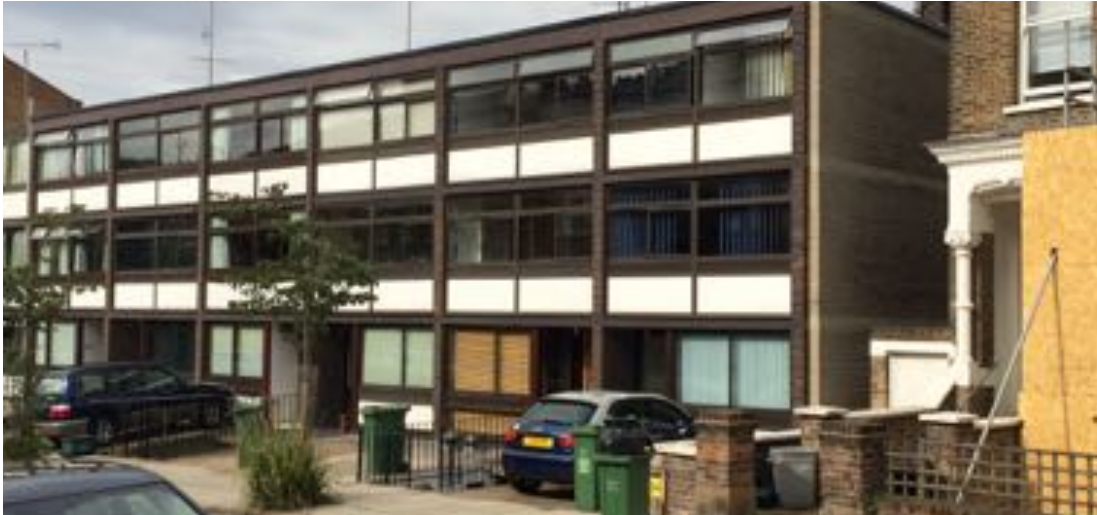
view from street

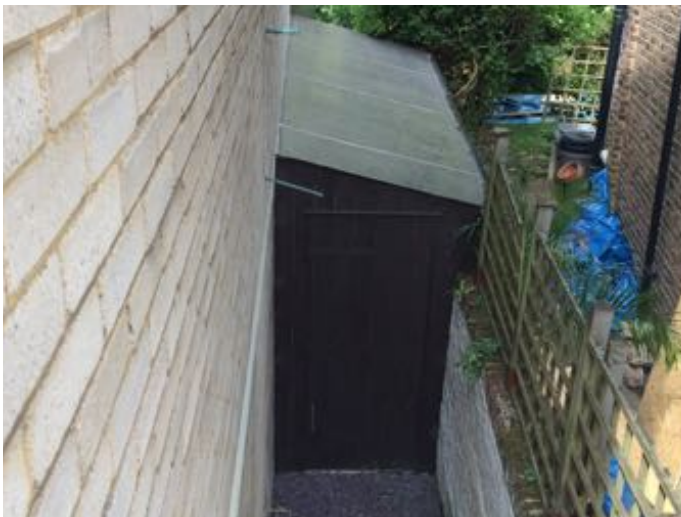
side lean-to extension

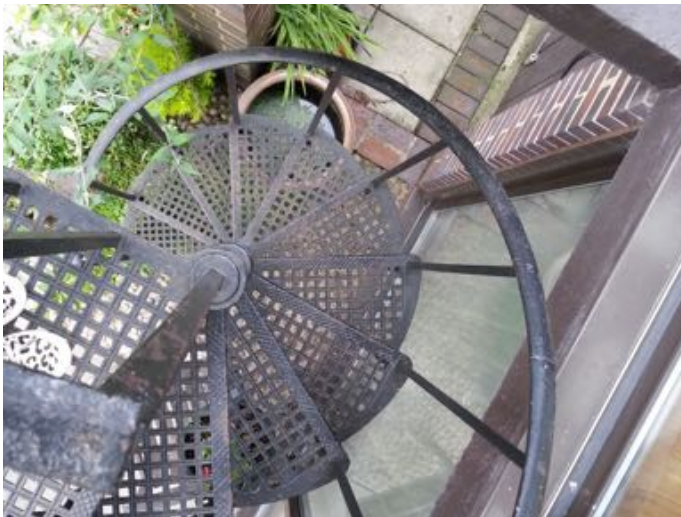
spiral stair to rear balcony

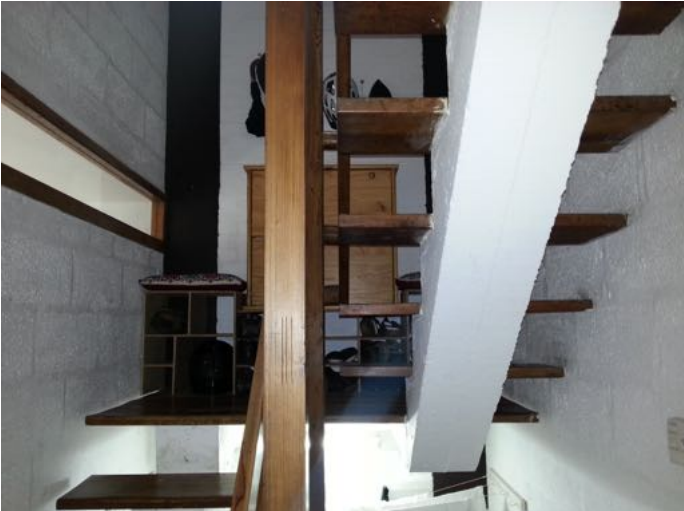
stairs with cinder block partitions

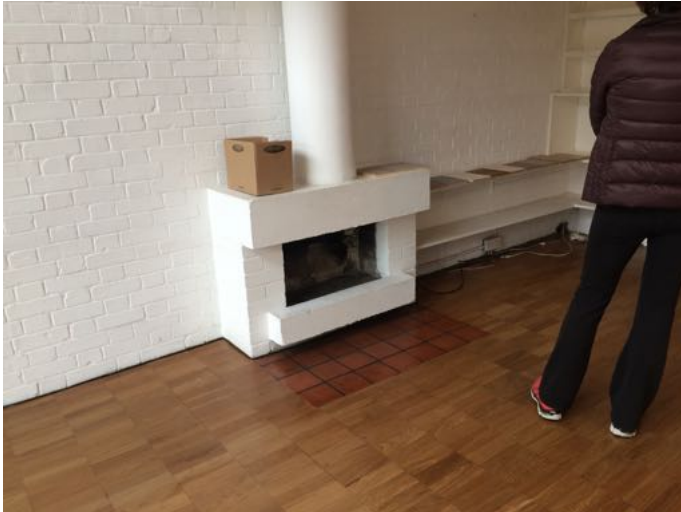
living room concrete fireplace with asbestos flue

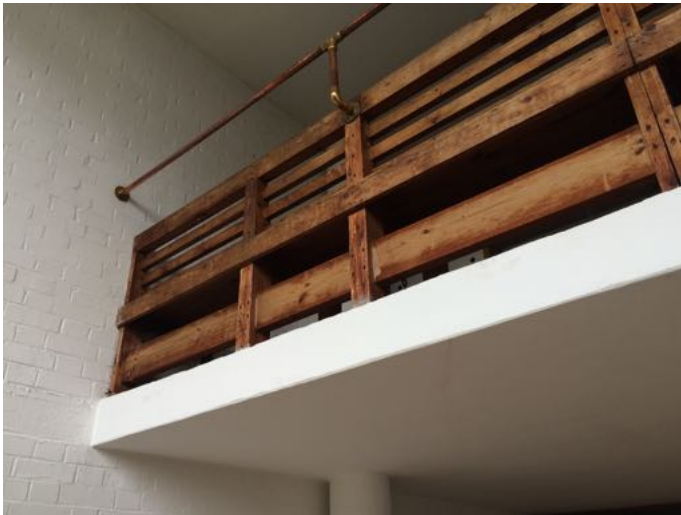
living room/mezzanine timber bench with copy handrail

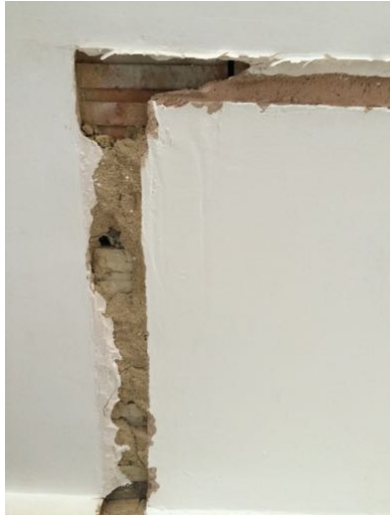
ceiling to first floor living room following removal of joinery

beam and block structure of second floor visible above skim plaster coat

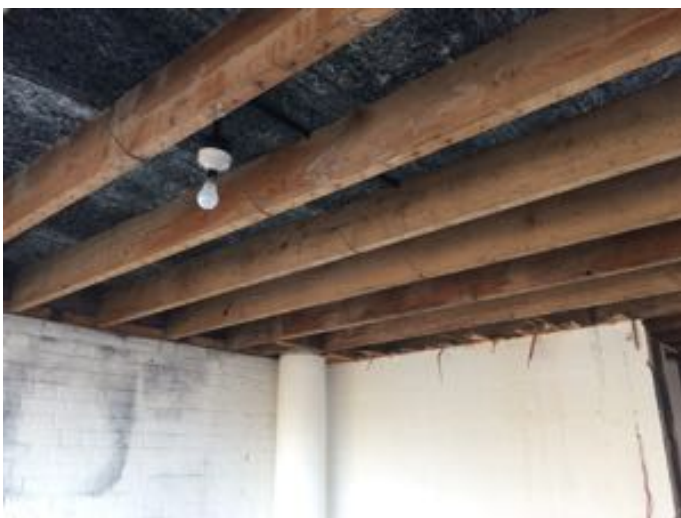
second floor roof structure from beneath

fibre panels over timber joists with wire bracing (all retained)

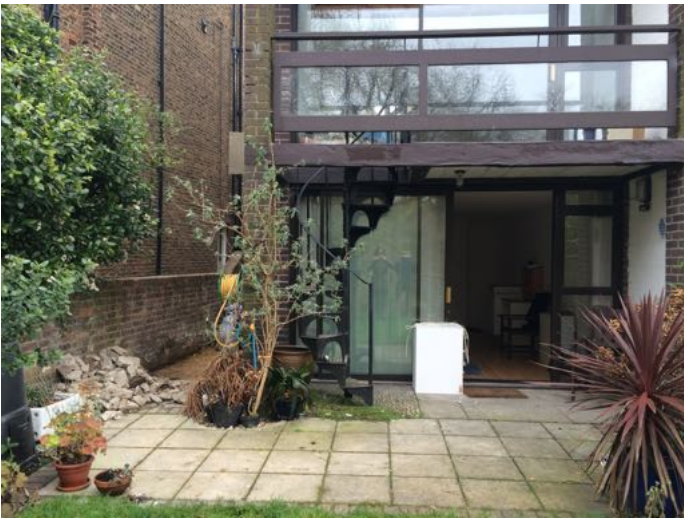
side extension demolished

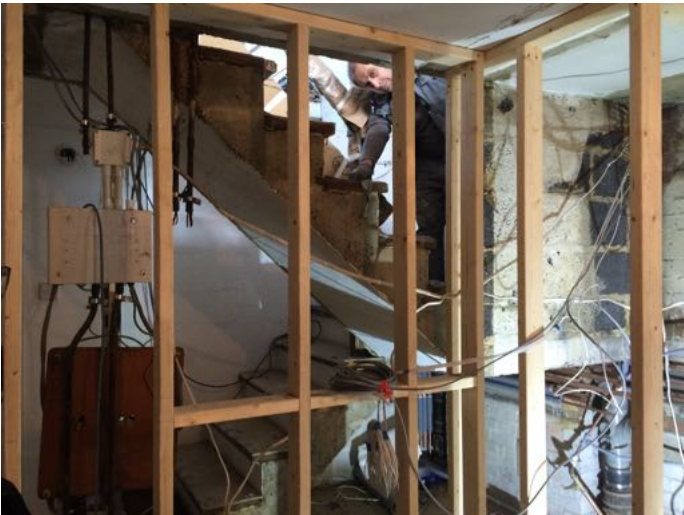
timber framing to new plant area

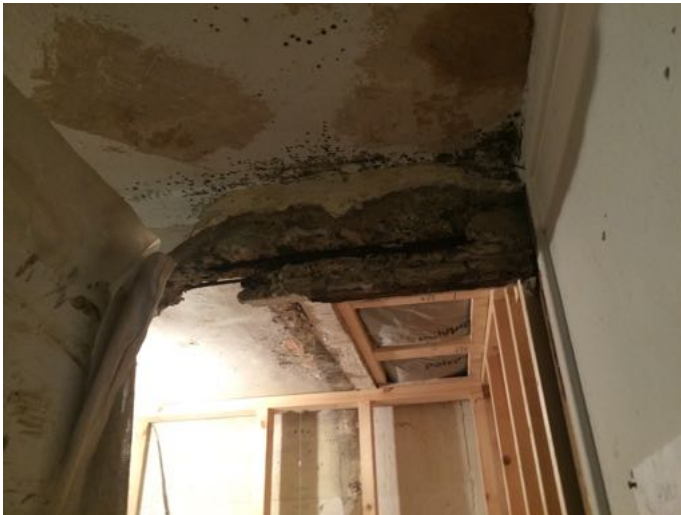
ceiling to new LG floor shower room

concrete repairs requires
