Fields Bar & Kitchen

Arboricultural Impact Assessment

Stage 1 & 2 Arboricultural Report

Lincoln's Inn Fields, London

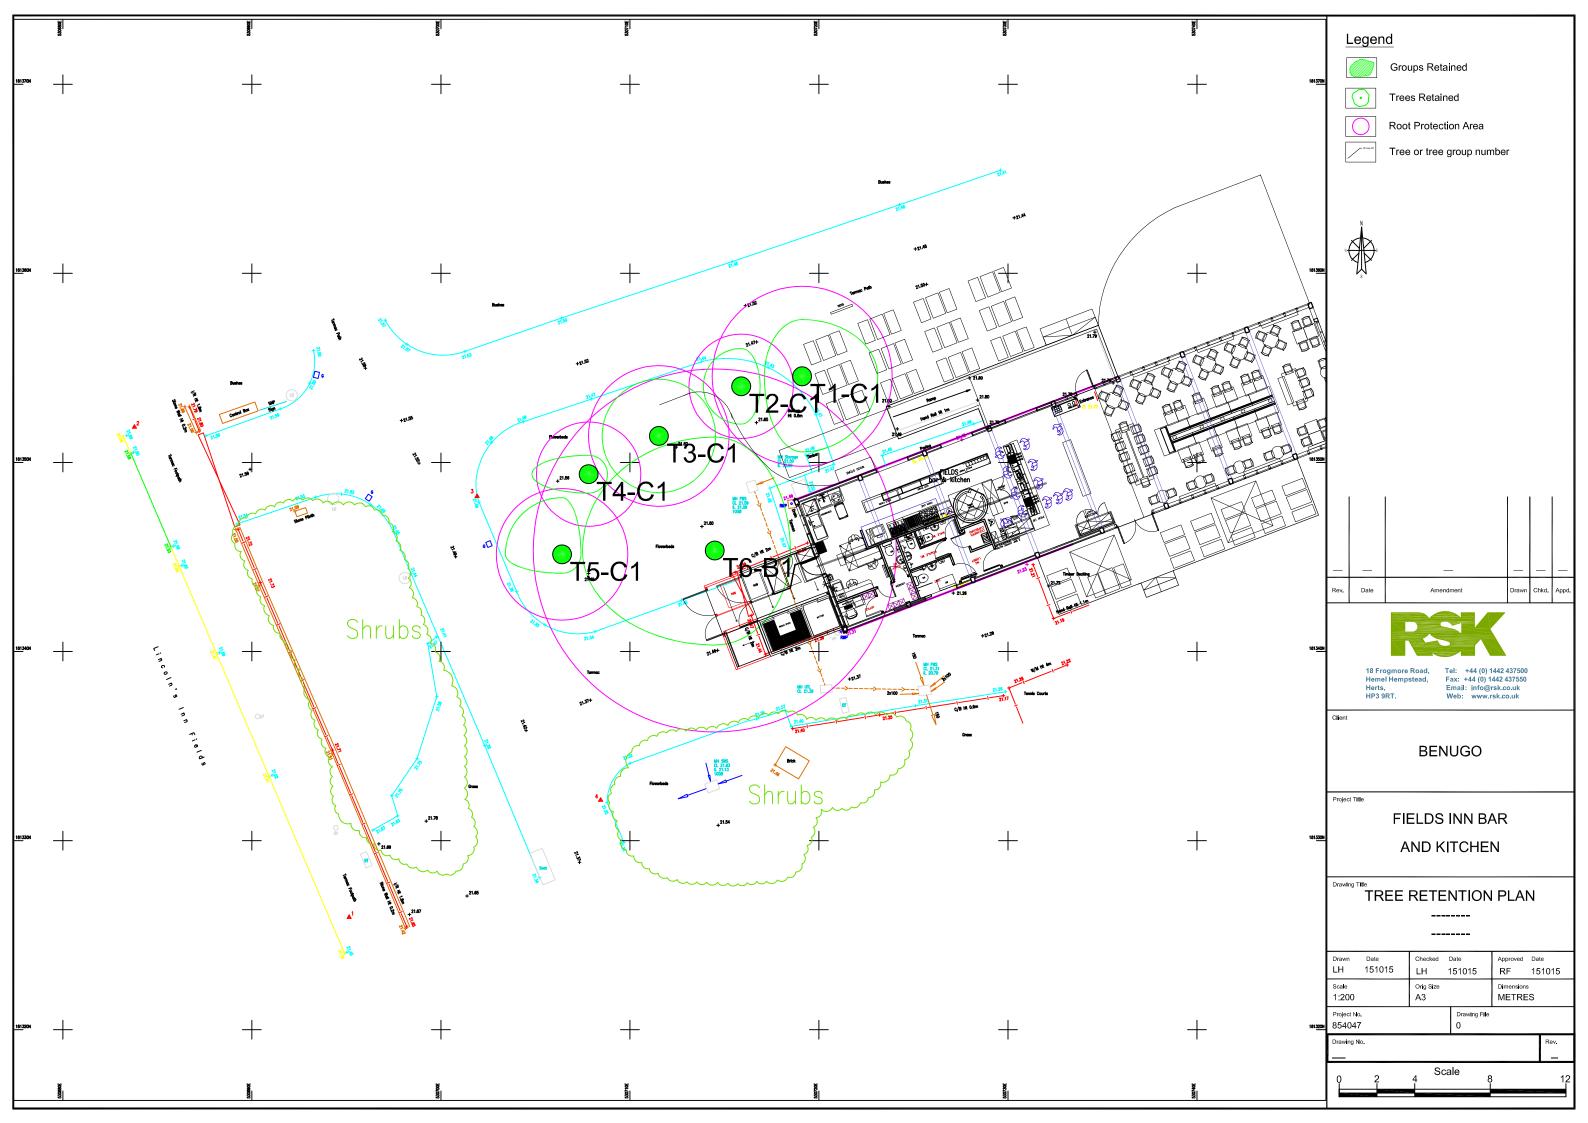
FIGURE 2 TREE RETENTION PLAN

All trees that were surveyed can be retained.

The extension will require an area of 9.26m^2 of the existing hard surface from within the RPA of T6 to be removed and replaced with a concrete slab 300mm deep. This area equates to 3.1% of the trees total RPA.

In order for this encroachment to be acceptable an appropriate sub-base option would have to be incorporated that would cause the least impact to tree roots. This would involve hand digging the area without the use of plant or machinery. All major roots (over 25mm diameter) must be avoided during its installation; minor roots can be pruned neatly under arboricultural supervision. This should form part of an Arboricultural Method Statement (AMS) and be completed under an arboricultural consultants supervision.
