TECHNICAL REPORT ON A SUBSIDENCE CLAIM

Crawford Reference: SU1500403

**Ms Annabelle Apsion
88 Savernake Road
London
NW3 2JR**

DATE 30 April 2015

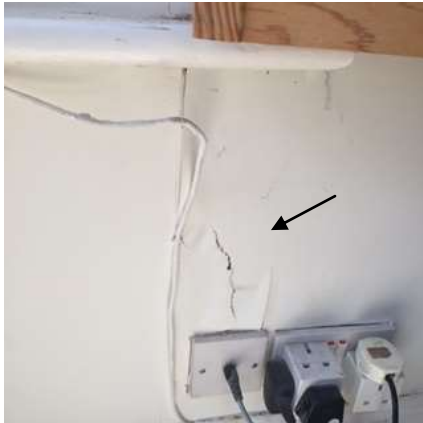
Diagonal cracking to first floor bay.

First Floor Flat 2 Front Lounge

3mm diagonal Cracking under window to left hand side of bay.

2mm vertical/diagonal cracking under window to right hand side of bay.

In structural terms the damage falls into Category 2 of Table 1, Building Research Establishment⁸ Digest 251, which describes it as "slight".

The pattern and nature of the cracks is indicative of an episode of subsidence. The cause of movement appears to be clay shrinkage.

The timing of the event, the presence of shrinkable clay beneath the foundations and the proximity of vegetation where there is damage indicates the shrinkage to be root induced. This is a commonly encountered problem and probably accounts for around 70% of subsidence claims notified to insurers.

Although the cause of the movement needs to be dealt with, we note the vegetation is subject to a Preservation Order. Unfortunately, current legislation requires certain investigations to be carried out to support an application for the tree works.

Typically, these investigations would involve trial pit(s) to determine the depth and type of footings, boreholes to determine the nature of the subsoil/influence of any roots and monitoring to establish the rate and pattern of movement. The monitoring data provided must be sufficient to show a pattern of movement consistent with the influence of the vegetation and therefore it may be necessary to carry out the monitoring for up to a 12 month period.

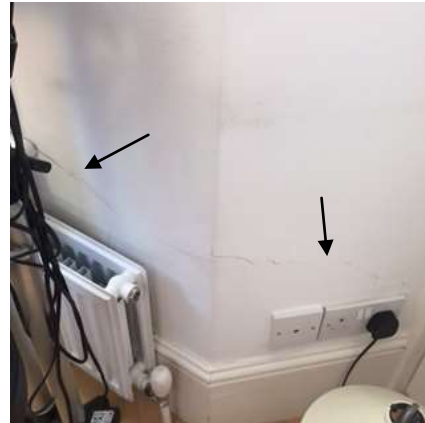
Diagonal cracking to ground floor bay.

Ground Floor Flat Front Study

2mm diagonal cracking under window to left hand side of bay.

2mm diagonal cracking under window to right hand side of bay.

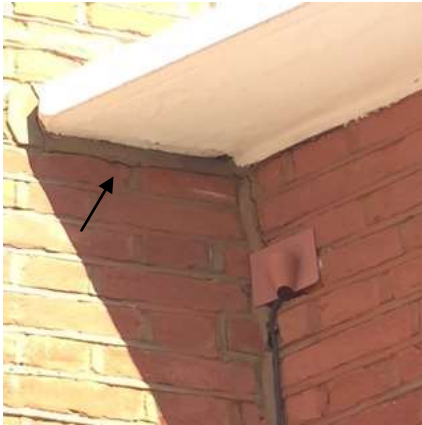
Separation to abutment of bay.

2mm diagonal stepped cracking under window to left side of bay.
 2mm separation to abutment of left side of bay with main house.

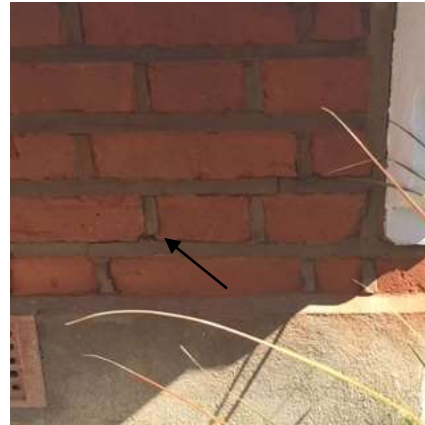
Diagonal stepped cracking to ground floor bay.

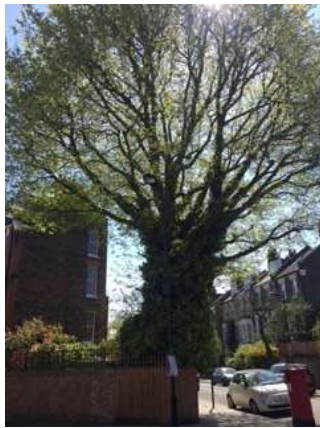
Type	Height	Distance	Ownership
Oak	16 m	16 m	Neighbour 1

Oaks are, in my experience, worthy of considerable respect when dealing with subsidence claims. Their root system extends for surprising distances and can be associated with particularly high soil suctions.

Vegetation to front

It will also be necessary to obtain a specialist Arboricultural Report.

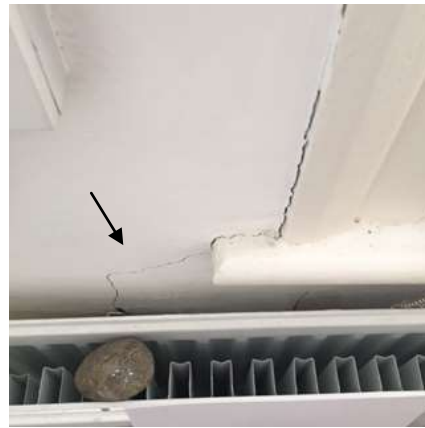
Diagonal cracking below bay window to ground floor flat.

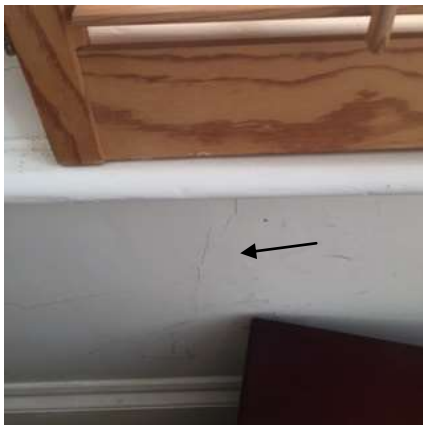
Diagonal cracking below bay window to first floor flat.
