ADDENDUM TECHNICAL REPORT

Crawford Reference: SU1500403

**88 Savernake Road
London
NW3 2JR**

SUBSIDENCE CLAIM

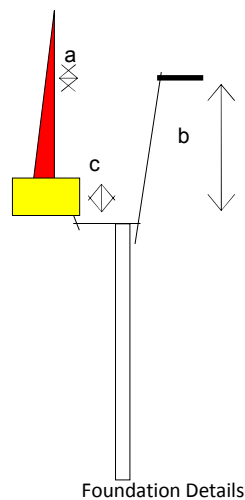
A trial hole was excavated to expose the foundations - see site plan for location and the diagram below for details. Trial Hole 1 revealed brick corbel on a crushed brick footing founded at a depth of 0.98m below ground level which bears onto stiff, mid brown, mottled orange, grey veined, silty CLAY with partings of orange silt and fine sand.

Root activity of live appearance was noted to the underside of the foundations.

No.	Borehole Depth	Footing (a)	Underside (b)	Thickness (c)
TH1	3.00 m.	180 mm.	975 mm.	825 mm.
