Arboricultural Appraisal Report

Subsidence Damage Investigation at:

88 Savernake Road
London
NW3 2JR

CLIENT:	Crawford & Company
CLIENT REF:	SU1500403
MWA REF:	SUB150813-175
MWA CONSULTANT:	Giles Mercer BSc (Hons) M.Arbor.A.
REPORT DATE:	26-08-2015

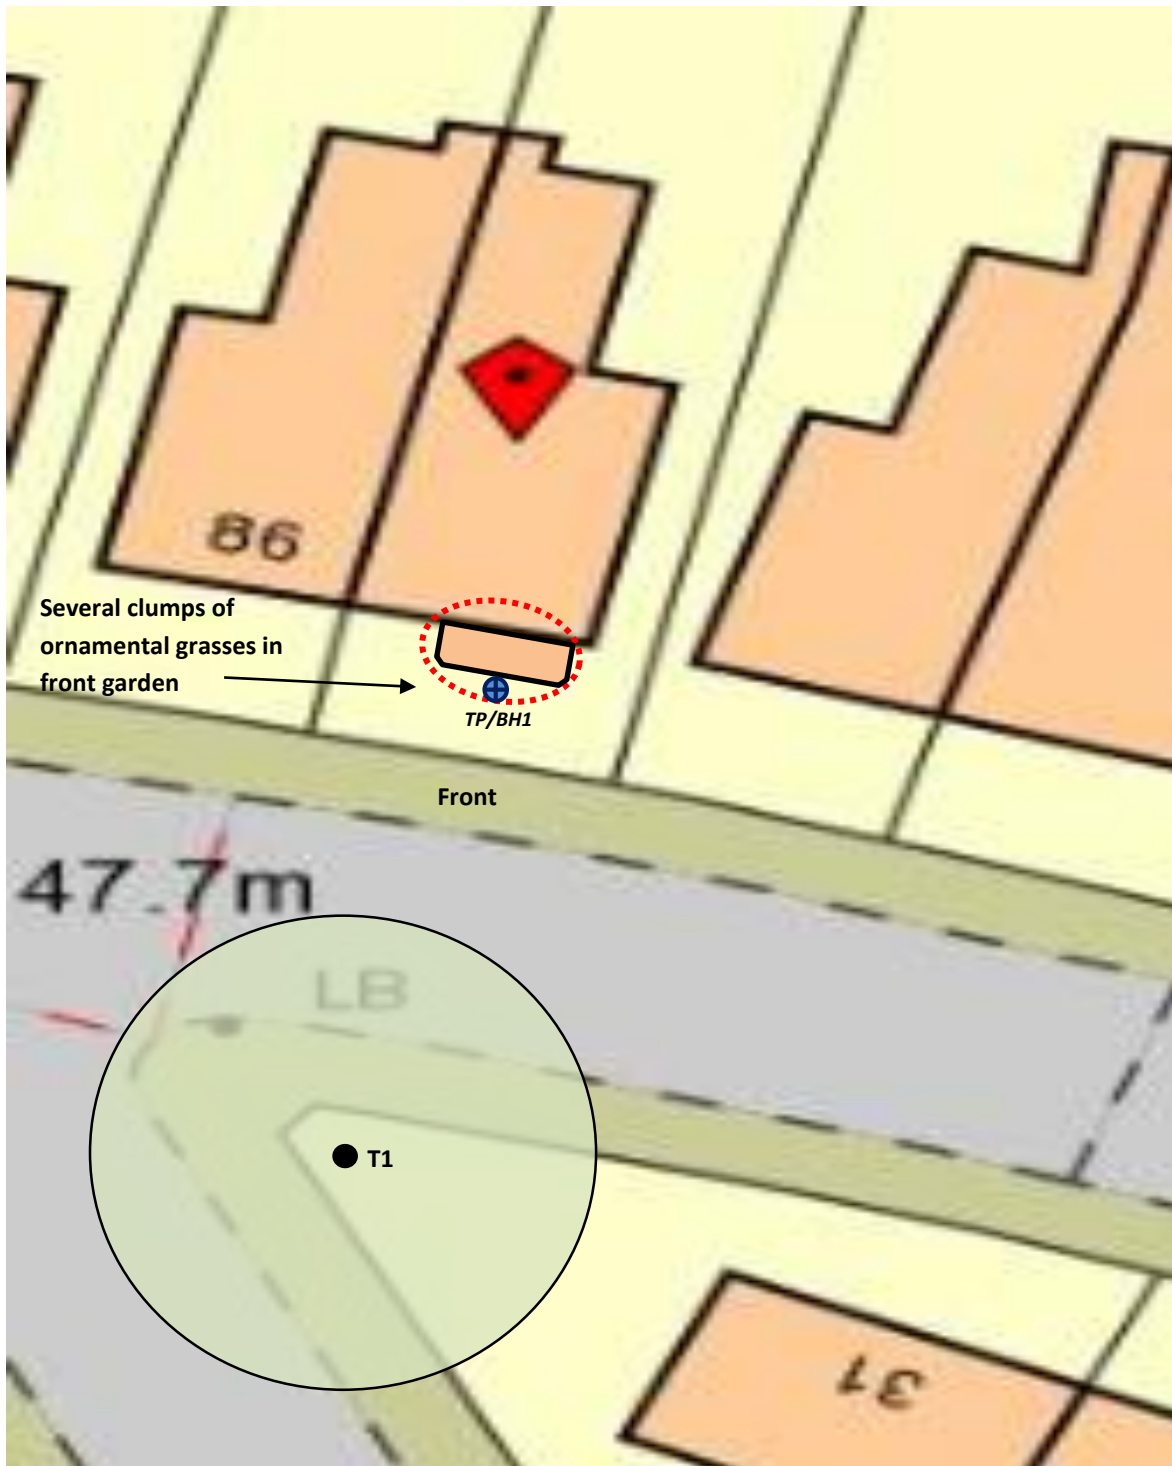
SITE PLAN

Approximate areas of damage

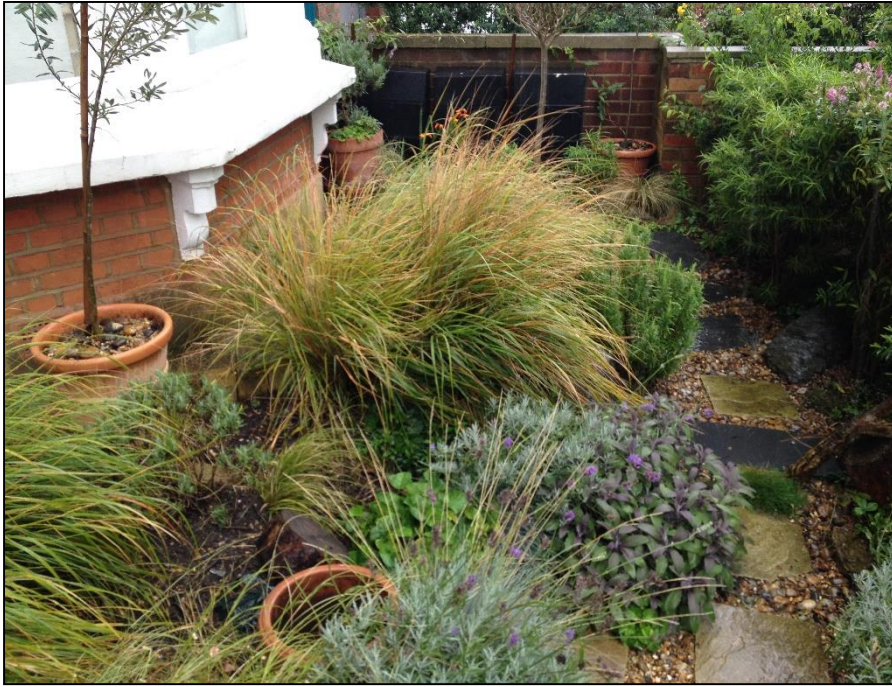
Our survey of the site identified several clumps of ornamental grasses in the front garden of 88 Savernake Road, these will be the source of the recovered Monocotyledon roots and are not considered to be a material influence in the current subsidence event.

View of ornamental grasses

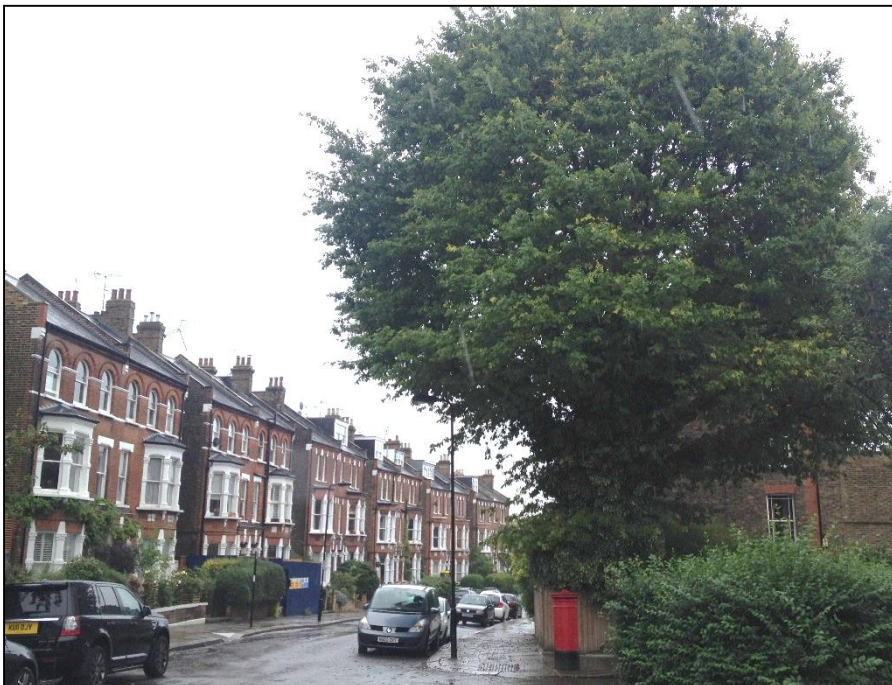
Our survey did not identify any potential source of *Castanea* spp. roots and accordingly we are confident that the recovered root is *Quercus* spp. and that it emanated from the Oak tree (T1).

Having considered the available information, it is our opinion that the Oak (T1) is the material cause of the current subsidence damage.

View of T1

If an arboricultural solution is to be implemented to mitigate the current damage and allow the soils beneath the property to recover to a position such that an effective repair solution can be implemented we recommend that the Oak (T1) is removed.

Tree No.	Species	Ht (m)	Dia (mm)	Crown Spread (m)	Dist. to building (m)	Age Classification	Ownership
T1	Oak	20	1000*	16	17	Older than property	Third Party 31 Savernake Road
Management history		No evidence of recent management.					
Recommendation		Remove and treat stump to inhibit regrowth
