Arboricultural Consultancy for Aviva

Insured	Haverstock Hill Limited	Address	96 Haverstock Hill, London, NW3 2BD		
Client	Subsidence Management Services	Contact	Emily Bogie	Claim No.	IFS-AVI-SUB-14-0052426
ES Ref	NL/0110140922/TP-REV1	Consultant	Thomas Peppiatt	Contact No.	0330 380 1036
Report Date	02/10/2015 Revised: 16/10/2015

5. Technical Synopsis (Revised)

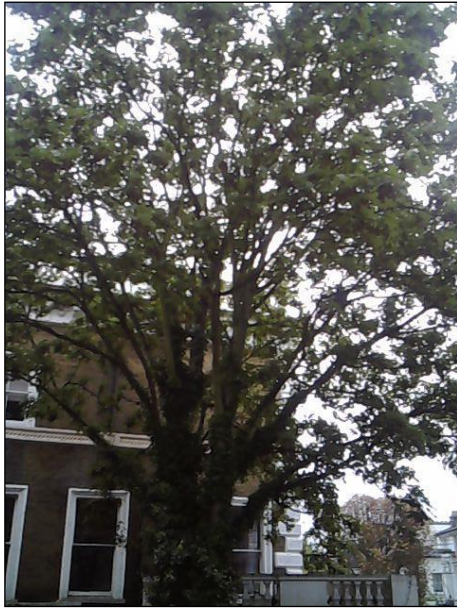
T2 - Acer

Our survey of the site identified T2 (Acer) and T3 (Elm), which, given their position relative to the damage it is our opinion that the roots identified emanate from these trees.

In assessing the extent of damage and the potential drying influence of the vegetation on site, T2 (Acer) and T3 (Elm) are judged to be the dominant features and accordingly we have identified them as the principal cause of the subsidence.

Tree No.	Species	Age Cat	Approx. Height (m)	Distance to Building (m)	Ownership	Action	Requirement
T2	Acer	1	17	8	F - Commercial Third Party	Remove	Remove and treat stump to inhibit regrowth.
T3	Elm	1	15	10.5	C - Insured	Remove	Remove and treat stump to inhibit regrowth.
T5	Pear	1	9	1	F - Commercial Third Party	Remove	Remove and treat stump to inhibit regrowth.

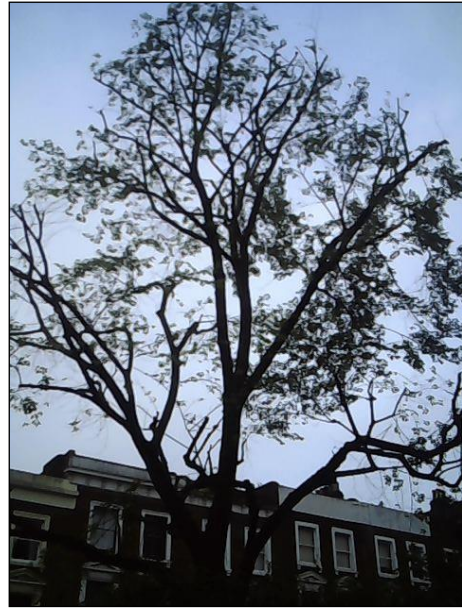
T3 - Elm

Site Investigations from 2014 revealed the presence of functionally active *Ulmus* roots in TP/BH1 to a depth of 1500mm and 1900mm in TP/BH2; this depth is in excess of foundations which extend to a depth of 500mm in TP/BH1 and 1200mm in TP/BH2.

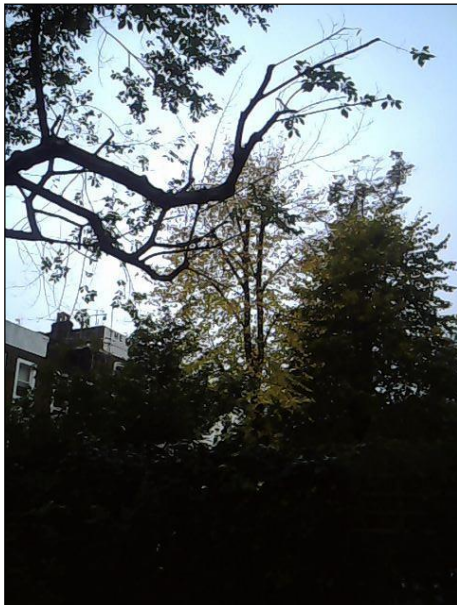
T4 - Lime

Please note that the footing of the subject property fall within the likely rooting zone of a further tree identified as T1 (Lime); this tree is noted to present a theoretical future risk.

Tree No.	Species	Age Cat	Approx. Height (m)	Distance to Building (m)	Ownership	Action	Requirement
SG1	Mixed species group including Cordyline and Fern.	1	1	1	C - Insured	Action to avoid future risk	Do not allow to exceed current dimensions by way of regular pruning.
T1	Lime	1	16	10	A - Third Party 98 Haverstock Hill London NW3 2BD	Action to avoid future risk	Remove and treat stump to inhibit regrowth.
T4	Lime	1	11.5	16	A - Third Party 98 Haverstock Hill London NW3 2BD	Action to avoid future risk	Do not allow to exceed current dimensions by way of regular pruning.
TG1	Mixed species group	1	17	15	A - Third Party 100 Haverstock Hill London NW3 2BD	Action to avoid future risk	Reduce Beech to 14m in height and maintain at reduced dimensions. Do not allow Lime to exceed 12m max height current dimensions by way of regular pruning.
