Application for tree works: works to trees subject to a tree preservation order (TPO)
and/or notification of proposed works to trees in a conservation area.

Date: 05 November 2015

My ref 15/083

Horse chestnut in the rear garden

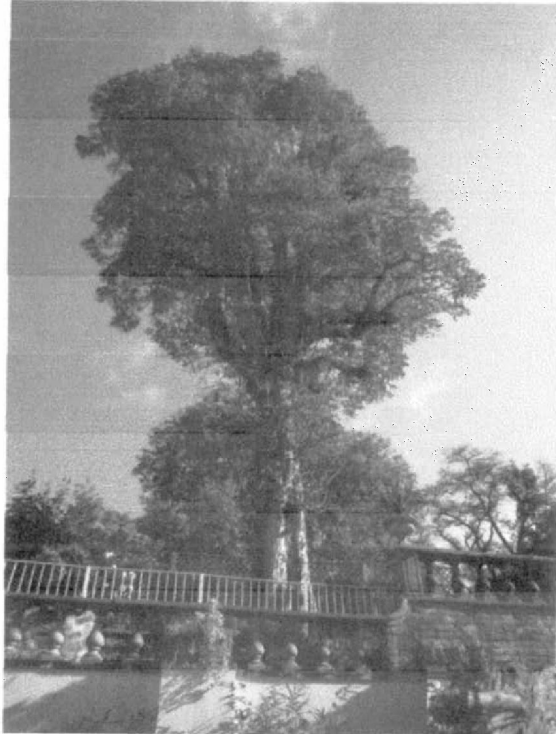
4. The tree is a mature horse chestnut about 13m high from ground level at the base and has a single vertical trunk about 1m in diameter. The first main branches start about 5m above ground and it has a dense, compact crown with a radial spread about 4m, mainly due to being pollarded when younger and reduced successively in recent years (photo 1). Available records of recent work are summarised below.
5. There is no major dead wood in the crown, nor any signs of die back, possibly due to the regular pruning. The leaves were starting to change colour when I was there, but there is evidence of infestation by chestnut leaf miner.
6. There is some dark brown fluid bleeding from the trunk between about 1 and 2m on the south side, (right as seen from the house). (photo 2) This is a sign of bleeding canker, a disease formerly thought to be caused by fungi, but now considered to be bacterial.

1) view up at the tree from the rear garden, showing the compact crown and branch structure resulting from regular reduction.

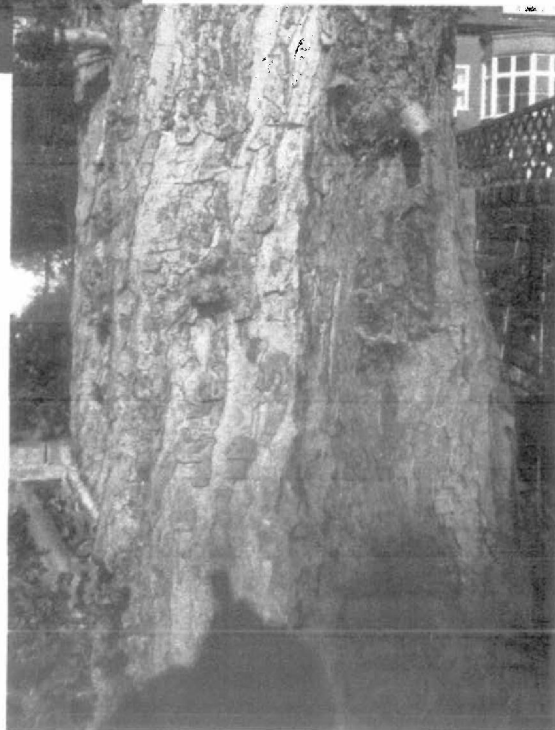
12. The bleeding from the trunk, also on the south side, could be a side effect of honey fungus, although that usually causes it lower down, round the base and main roots. In this case it is well above ground and the colour of the liquid is more consistent with horse chestnut bleeding canker. This was formerly thought to be due to *Phytophthora* fungi, which are widespread soil organisms and cause various plant diseases including potato blight. More recent work indicates that it is caused by a bacterium *Pseudomonas syringae*. Affected trees can survive for some time, but they decline steadily and it is ultimately fatal.

2) Bleeding on the south side of the trunk.

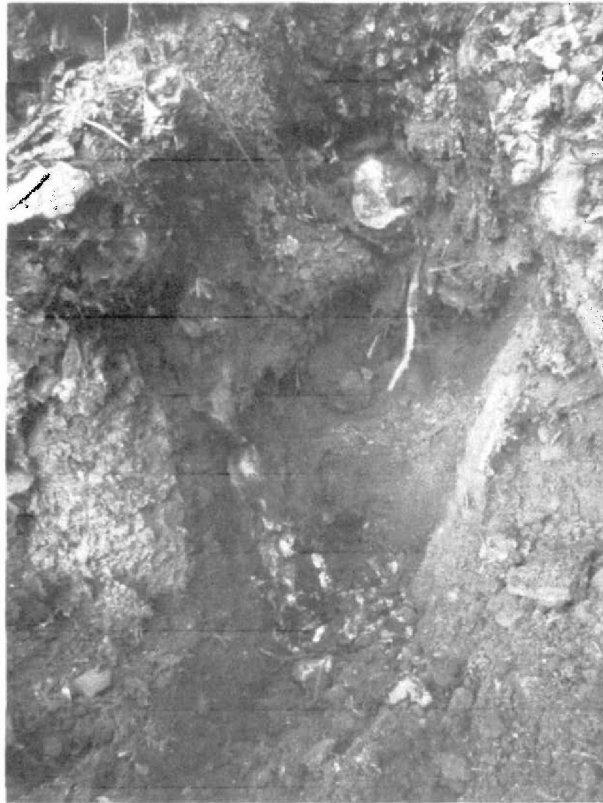
7. There are several dead roots at ground level on the west side between the base of the tree and the smaller retaining wall and several others on the south side, where there is also evidence of decay. Careful exploratory digging on that side also revealed dead and decaying roots, which appear to be up to about 100mm diameter. There were no signs of any fungal fruiting bodies on the tree's base, but the appearance of the decayed wood, with patches of white fungal tissue, is consistent with honey fungus, *Armillaria* species. (photo 3)

10. Honey fungus is a group of closely related species that affect a wide range of plants and vary in their effects. Some tree species are killed rapidly but in others, including horse chestnut, it can decay the main structural roots without initially affecting the smaller absorbing ones, so the trees become unstable whilst looking outwardly healthy and vigorous. Another feature is that it does not always produce fruiting bodies or does so intermittently, which can make it difficult to diagnose conclusively, but the appearance of the affected roots here is consistent with, particularly the white fungal tissue. The dead, broken roots on the west side must have been damaged some years ago when the low wall was built or possibly repaired, but the decay found in the deeper root below that is of more concern. The root itself was dead looking and the damage occurred some time ago, indicating that the decay is well established and is likely to be weakening the tree significantly.

3) Dead roots at ground level and decaying root exposed by shallow exploratory digging.

15. In view of these points the most appropriate course of action at this stage would be to remove the tree. The problems with it are due to its age and condition, so there is no reason why a suitable replacement could not be planted, ideally one that did not need regular maintenance.
