### Arboricultural Survey (BS5837:2012) & Impact Assessment Report

26 Dartmouth Park Avenue  
London  
NW5 1JN

16th November 2015

Marcus Foster  
*BA (Hons) NDArb. TechCert (ArborA) EGS.Dip*

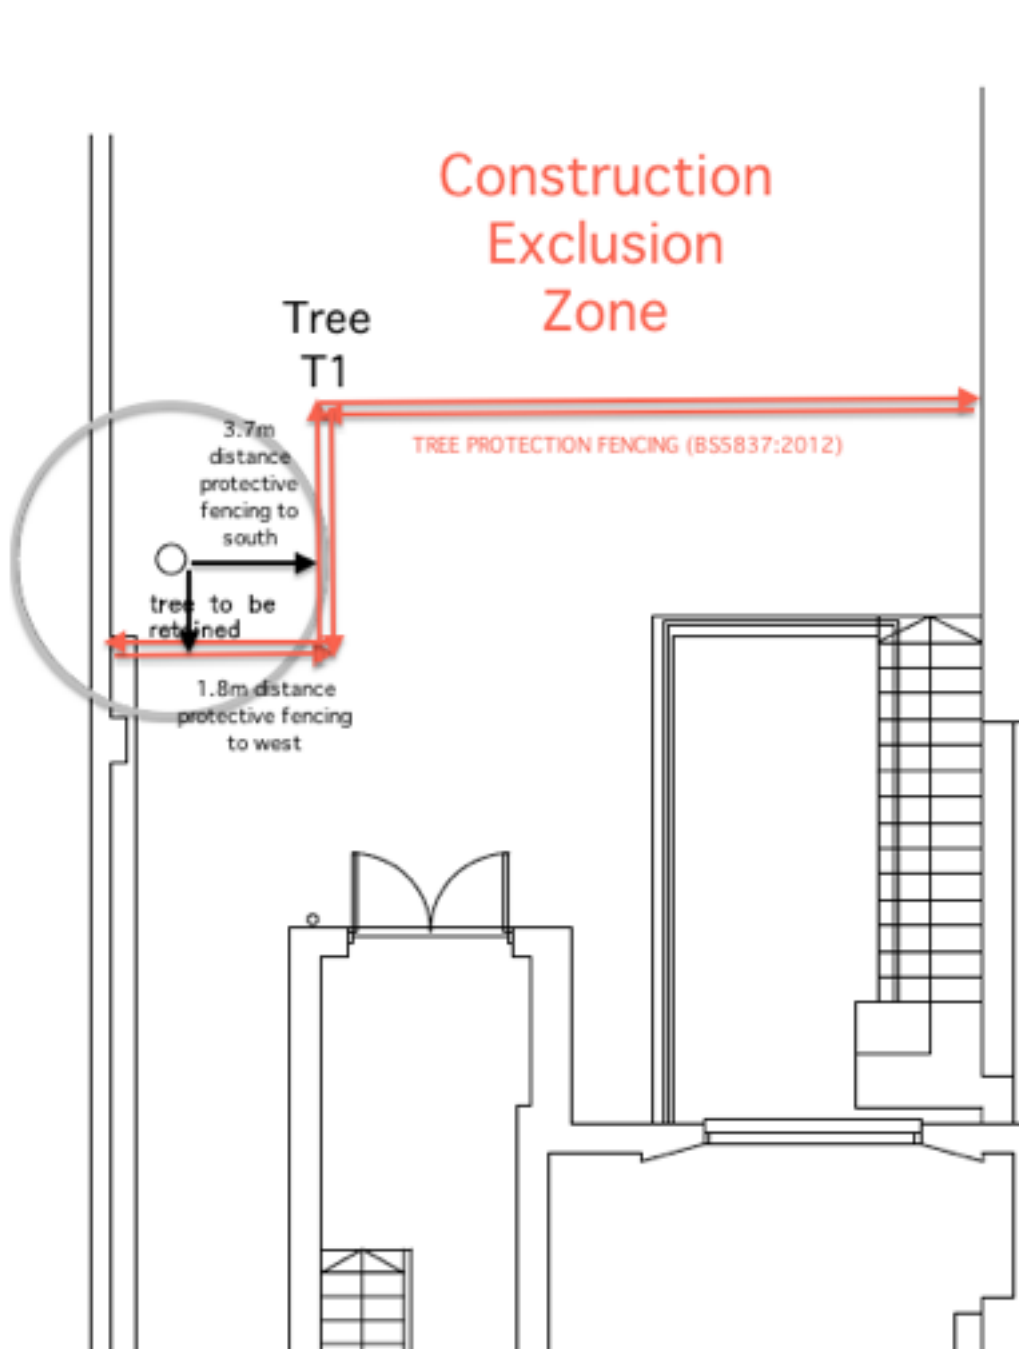
Appendix B.4: Site Plan of Tree Protection:  
26 Dartmouth Park Avenue, London, NW5 1JN

1. **Red line** denotes Tree Protection Fencing to offer protection to T1, soft landscaped areas and also incorporating full protection for trees T2 and T3

- **The tree protection fencing / root protection area to be constructed as outlined with *Appendix B.3* of this report and to the specifications provided within *Appendix E* and *Appendix F***
- **All construction activities must adhere to the tree protection guidelines as explained throughout the report and as outlined below – these should remain for the entire construction process in order to provide comprehensive protection from the trees.**
- **No building materials or chemicals are stored within the Root Protection Areas - the boundaries of which will be clearly marked with the TREE PROTECTION NOTICES.**
- **There should be no mixing of concrete or chemicals within the tree protection areas during the construction process.**
- **There should be no fires within the site**

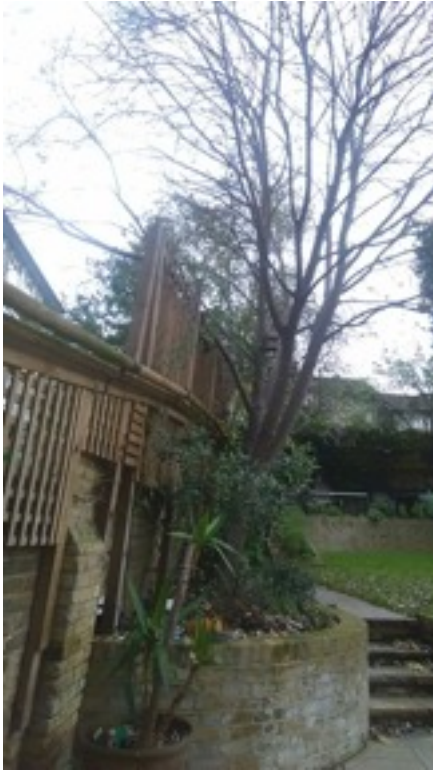
4.10 Tree T1 is a mature Whitebeam (*Sorbus aria*) tree located within a raised border on the northern boundary which has good form and is showing good vigour. The tree is generally structurally sound with good root flare compensating for a slight lean to the south and a sound main union at 1.5m. With a relatively light pruning history the tree has a balanced mid and upper canopy lightly encroaching towards the property and neighbouring building to the south. The tree is rated as a 'C.1' category tree (BS5837: 2012) offering some amenity value and is therefore proposed for retention.

4.11 The tree's location within very close proximity of the proposed extended basement area means that the tree will require protection during the construction process. Whilst the rootplate to the north, east and west will be afforded the full 3.7 metre protection distance as recommended within BS5837:2012, some encroachment within the the western root plate will be required to implement the proposed development. However the existing site topography and hard landscape features mean that this will be achievable as the root system will already likely be retained within the raised border area where the tree is sited.

C.1 Photograph of tree T1 proposed for retention within rear raised border 26 Dartmouth Park Avenue, London, NW5 1JN as viewed in an easterly direction

4.13 The tree protection specified will ensure that the tree is protected with the initial root plate to the west and south receiving protection to a point 1.8m from the main stem - for the remainder of the root plate the full protection distances will be adhered to with the fencing extending across the full width of the garden therefore providing a full Construction Exclusion Zone (CEZ). When implementing this protection fencing the area surrounding tree T1 specifically should be to a standard as illustrated in *Appendix F* - basal shuttering to provide comprehensive protection. This can be extended for the remainder of the garden or a reversion to that specified within *Appendix E* (BS5837:2012).

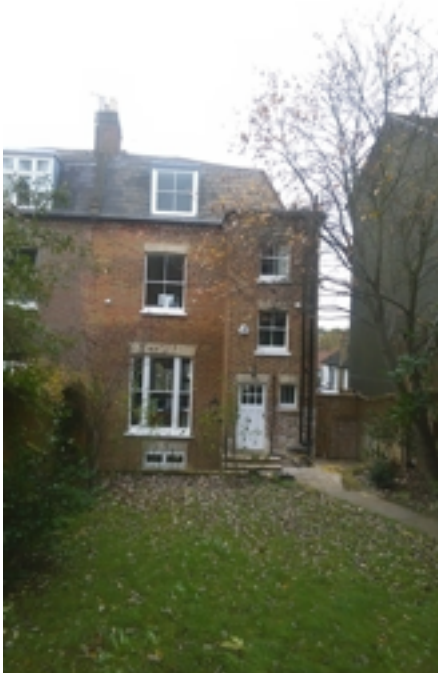
C.2 Photograph of tree T1 proposed for retention within rear raised border 26 Dartmouth Park Avenue, London, NW5 1JN as viewed in a westerly direction showing the property as exists also

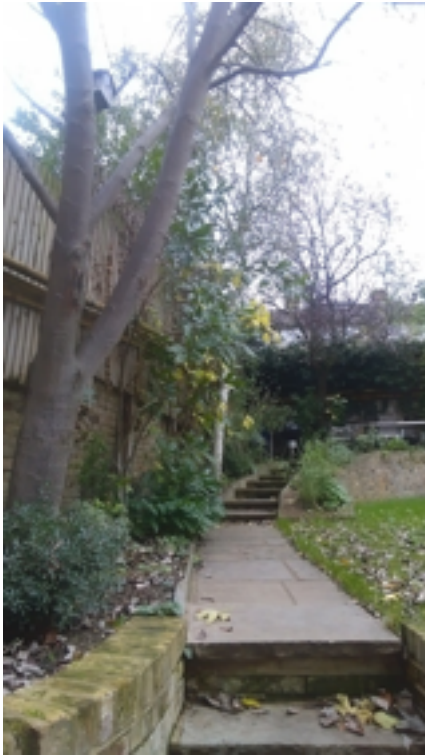
C.3 Photograph of trees T1 -T3 within rear garden - 26 Dartmouth Park Avenue, London, NW5 1JN as viewed in an easterly direction

4.18 The protection fencing that is specified for trees T2 and T3 is therefore recommended to extend across the width of the garden (see *Appendix B.3*) ensuring that full protection is provided for the entire rear garden area for this development site.
