BUILDING SURVEY

Mr and Mrs J Oliver

**4 The Grove
Highgate
London
N6 6JU**

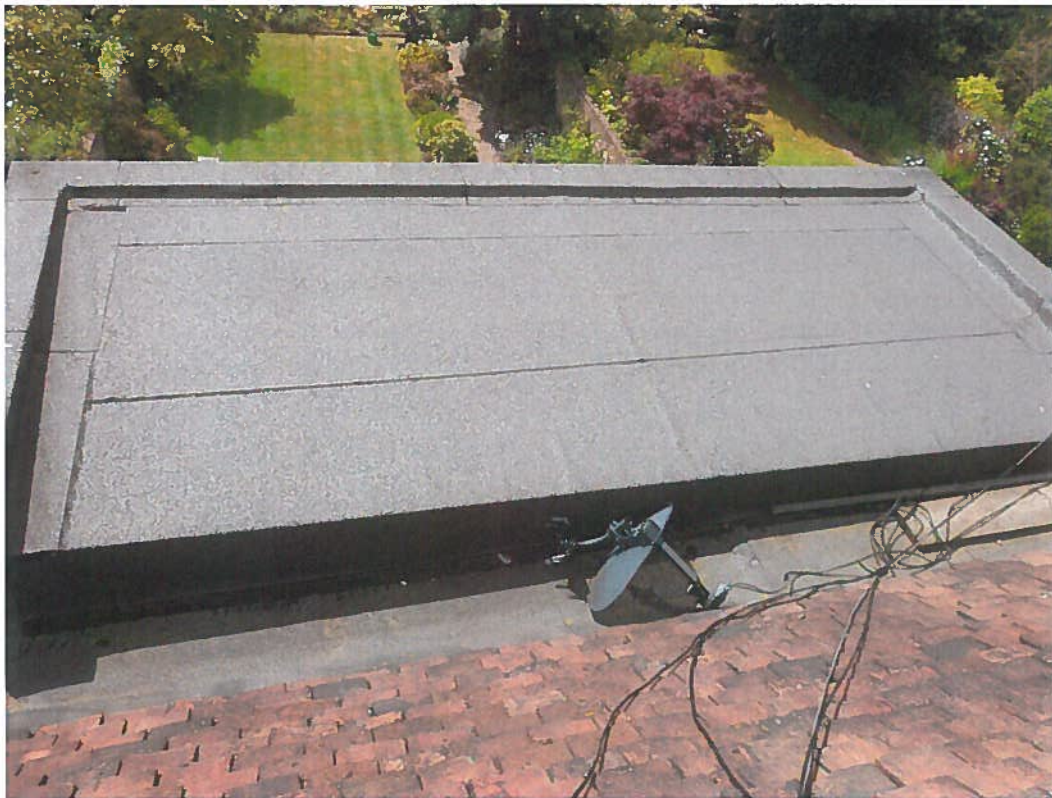
At the rear, a large dormer construction has been added in recent times with hung clay tiles to the sides and bitumen felt to the flat roof (photo 6). Bitumen felt is a relatively short life material and is showing signs of deterioration. The edge detailing is poor with no drip to throw the water clear of the fascia boards. In the near future a new covering to this dormer will be required and the decayed fascia boards will have to be replaced at the same time. Thermal insulation to this roof is likely to be minimal and, when the covering is replaced, the opportunity should be taken to upgrade the installation to current standards.

Photo 6 – Flat roof over rear dormer

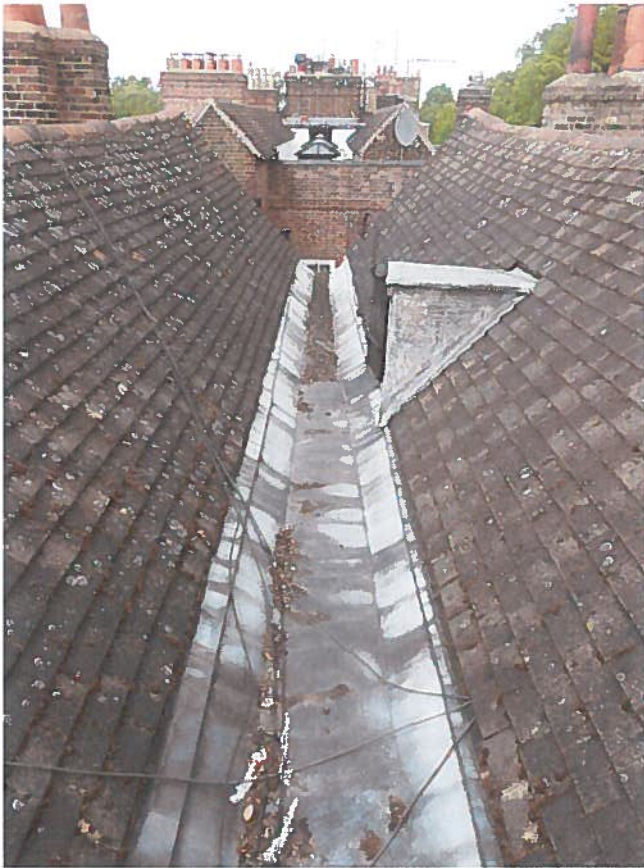
The central valley has been relined with zinc which would have replaced the original lead (photo 7). The zinc has been laid in a continuous sheet with welded joints and is now quite badly buckled from thermal movement and also beginning to develop pin holes near the access door from the front loft. Although the zinc could be repaired and remain weathertight for a few more years, we would recommend that it is replaced in the near future, preferably using lead. However, if lead is used, the valley boarding will need to be relaid to allow for the stepped joints at intervals which are required in leadwork to allow for thermal movement. If properly detailed, lead has an almost indefinite service life.

Photo 7 – Central valley to main roof

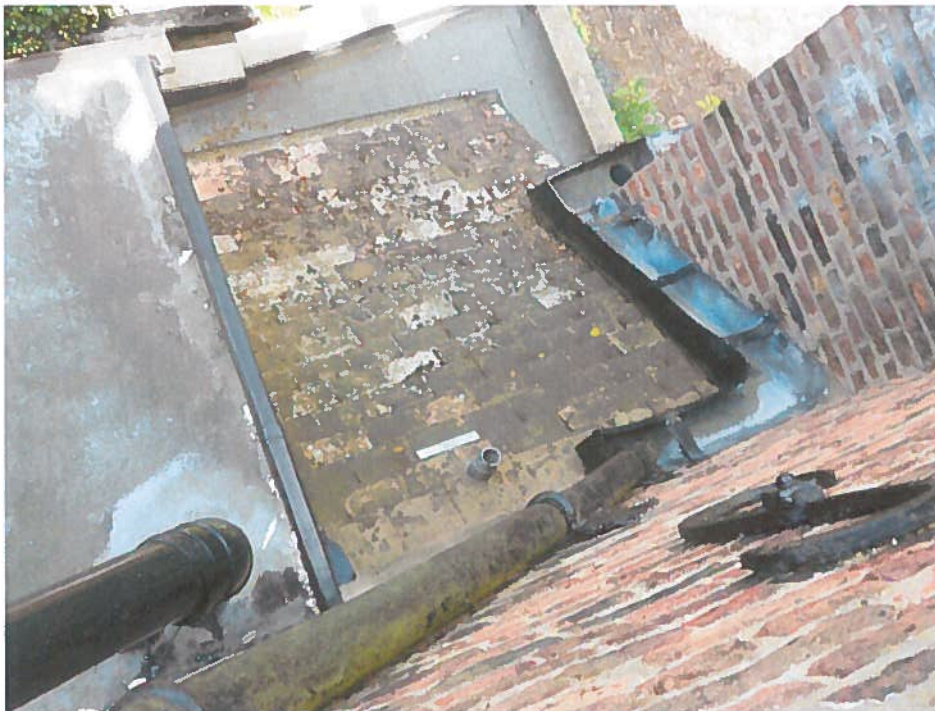
There are two, separate roofs over the small timber framed extension on the north side of the main house, comprising a lean-to, clay tiled area and a flat roof at a higher level covered with zinc (photo 8). From the roof valley above, a limited inspection of these roofs could be undertaken and the zinc appears to be in fair condition. However, there are a number of broken tiles to be replaced on the lean-to roof.

Photo 8 – Zinc flat and tiled lean-to roofs over north extension

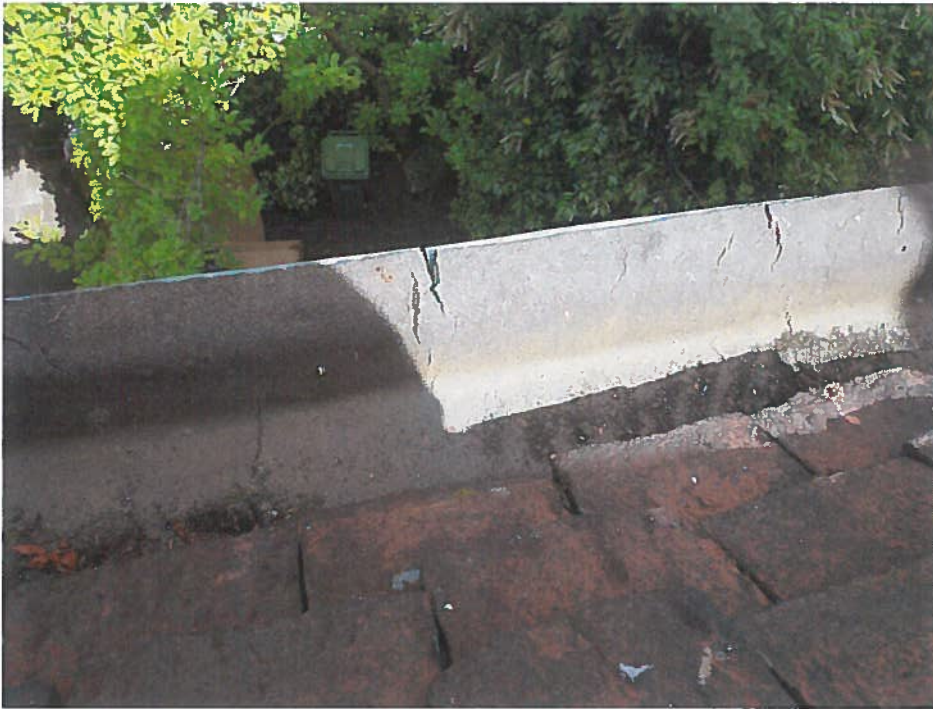
Photo 9 – Front gutter – splits in asphalt lining

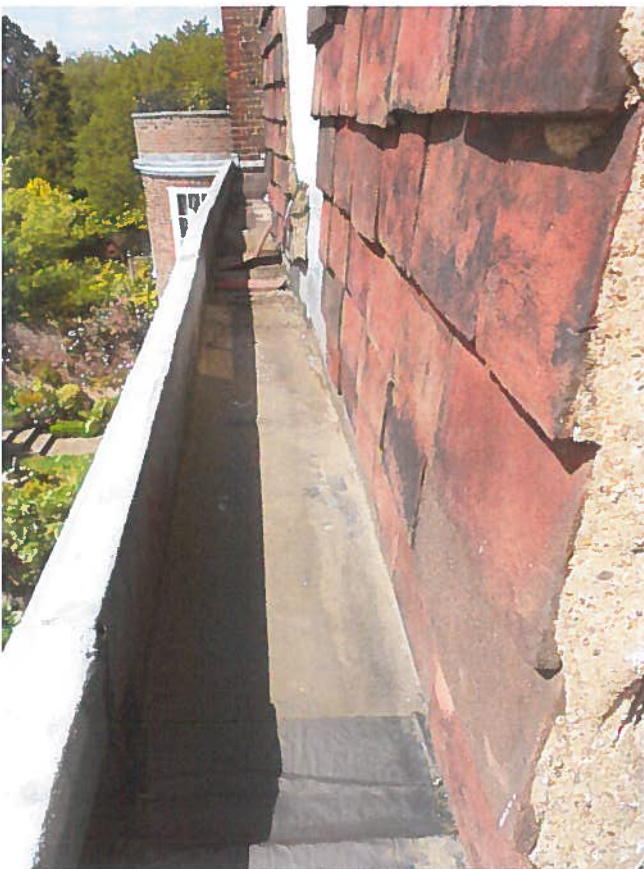
Photo 10 – Rear gutter – patched lead lining

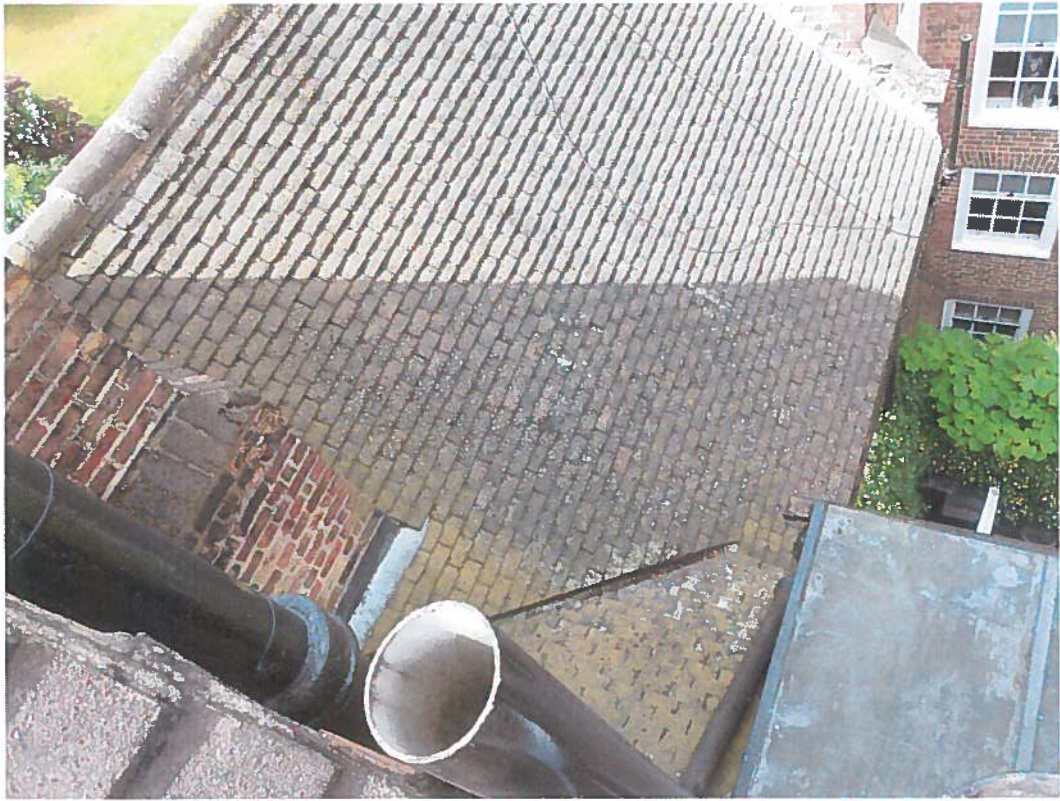
The lower roof over the annexe is also clad with plain clay tiles and these are in good condition with only one broken tile currently needing to be replaced on the front slope (photo 11). The lead flashings at abutments also appear to be sound. At the south end, some of the ridge tiles have recently been relaid or repointed and the finish is poor although no immediate attention appears to be required. There is no access to the roof space above the annexe except for a small space at the front, accessed via a hatch above the staircase. The roof here is clearly later than the main roof with sawn softwood rafters below close softwood boarding. Again, the tiles have been relaid in the past over a layer of bitumen felt. From the exterior, there is nothing to suggest that the roof structure is in any way defective but we could not check the amount of thermal insulation provided, if any, above the bedroom on the second floor.

Photo 11 – Roof over annexe

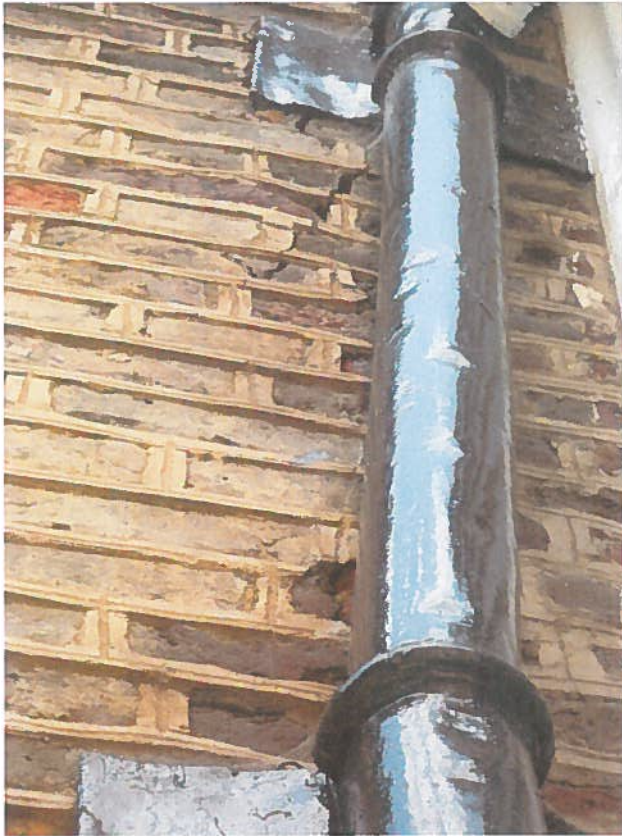
We were not able to determine the size and depth of the foundations to the house but some uneven settlement has clearly occurred in the past and, by modern standards, the foundations would no doubt be considered undersized. The worst of the settlement has occurred at the north east corner of the main house where a large buttress has been constructed against the chimney stack and the adjacent brick coursing is very uneven where it has been rebuilt. Although the movement here was quite severe, it is clearly historic and there is little evidence to suggest that any movement has occurred since the walls were repointed, probably 50 years ago and long after the buttress was constructed. An old fracture is visible behind the lead rainwater pipe and this should be repaired in due course, but not as a matter of urgency (photo 17).

The front elevation of the main house was repointed many years ago using what appears to be a cement based mix finished well proud of the brickwork and scored along the centre of each joint (photo 17). Although the pointing is sound, it very much detracts from the appearance of the brickwork and the use of a relatively impervious pointing mix increases the likelihood of frost damage to the brickwork. At present, this does not appear to be a problem but, ideally, the existing pointing would be very carefully raked out and replaced in a lime based mix finished flush with the faces of the bricks. If repointing is to be considered, the details of the mix and finish will need to be agreed with the local Conservation Officer and Listed Building Consent would be required. Elsewhere, the pointing to the brickwork is old but not badly weathered and no immediate attention is required.

Photo 17 – Close up of repointing on front elevation (old fracture also visible by lead rainwater pipe)

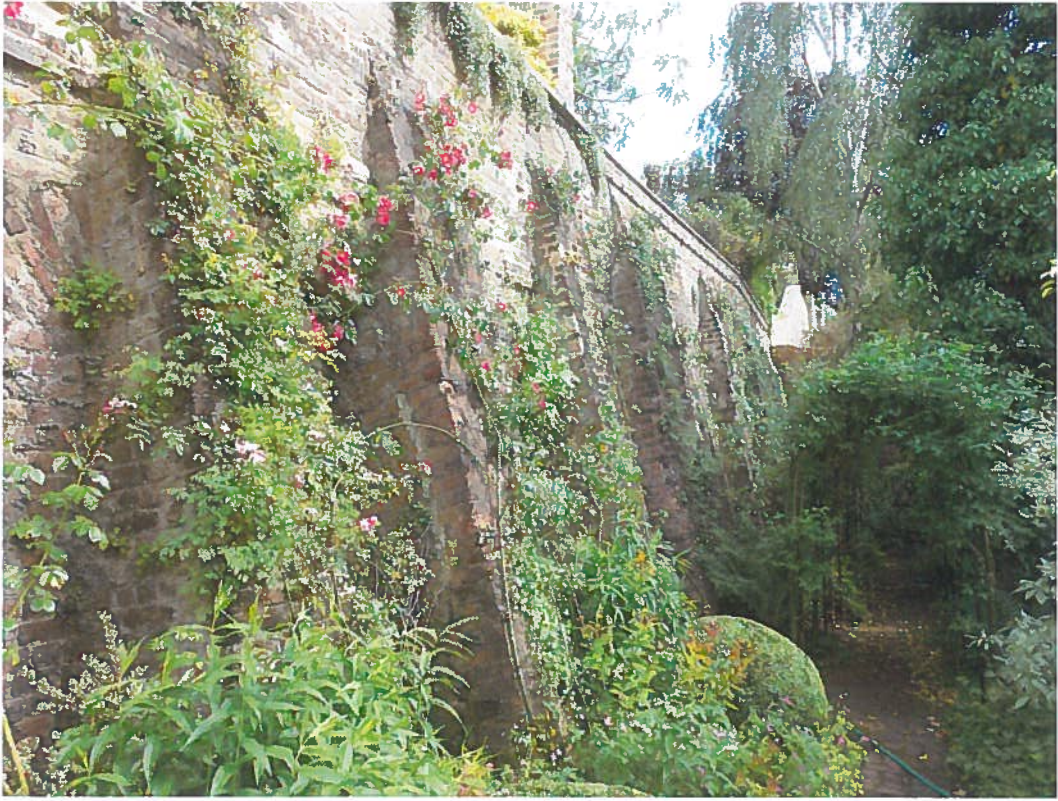
Photo 34 – Steel beams and brick piers in garden vault

- In the longer term, the corroded steel beams at the entrances to the three garden vaults will need to be replaced, preferably using reinforced concrete or galvanised steel lintels to provide a longer service life.
