RUSSELL HOTEL
EXTERNAL FAÇADE
CONDITION SURVEY
COVERING;

RUSSELL SQUARE
BERNARD STREET
GUILFORD STREET

Report prepared by
Mark Goldman
Harrison Goldman

Report Number C5181-01
10th February 2015

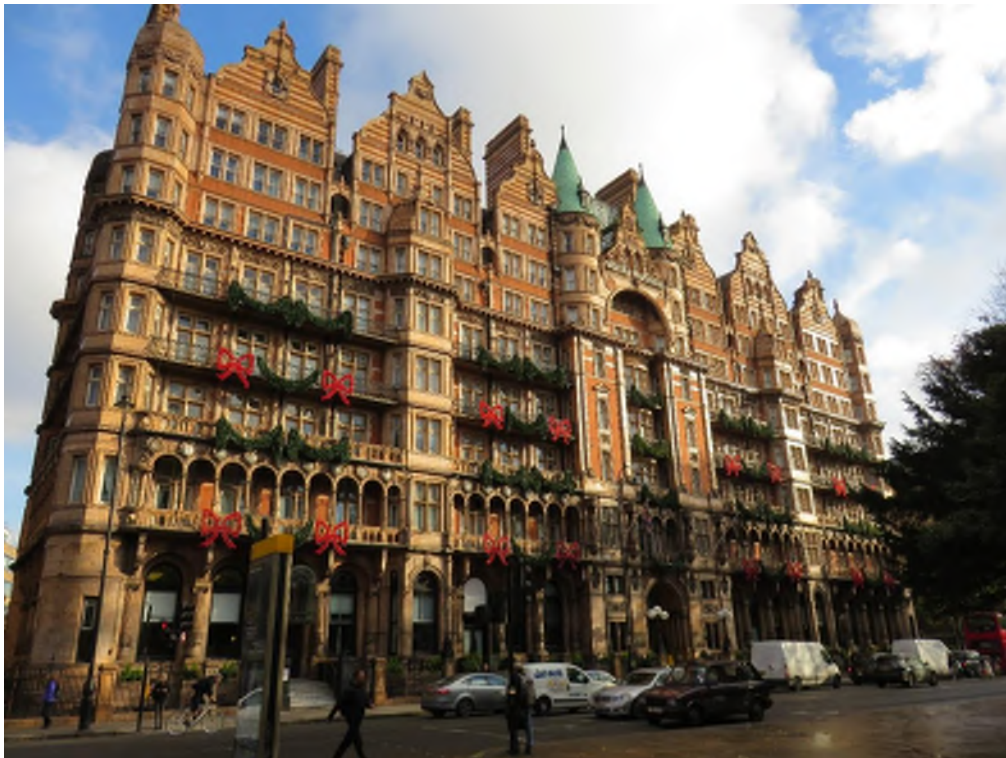
Russell Square Elevation

- 3.3 We understand that the building underwent significant renovation in the 1980's. There are many old "stitch" repairs to the terracotta façade. It is noticeable that the Russell Square elevation has been cleaned in isolation to the other three elevations. It is a little lighter and the finish surface has altered in many areas. This clean to the front elevation has caused some surface damage to the terracotta. The protective surface *Fire Skin* in many areas has been removed (probably by unsuitable abrasion cleaning). Overall however the front façade is in a good condition given the age of the building.
- 3.4 No obvious structural issues were identified.

3.6 The elevation would benefit from a sympathetic clean.

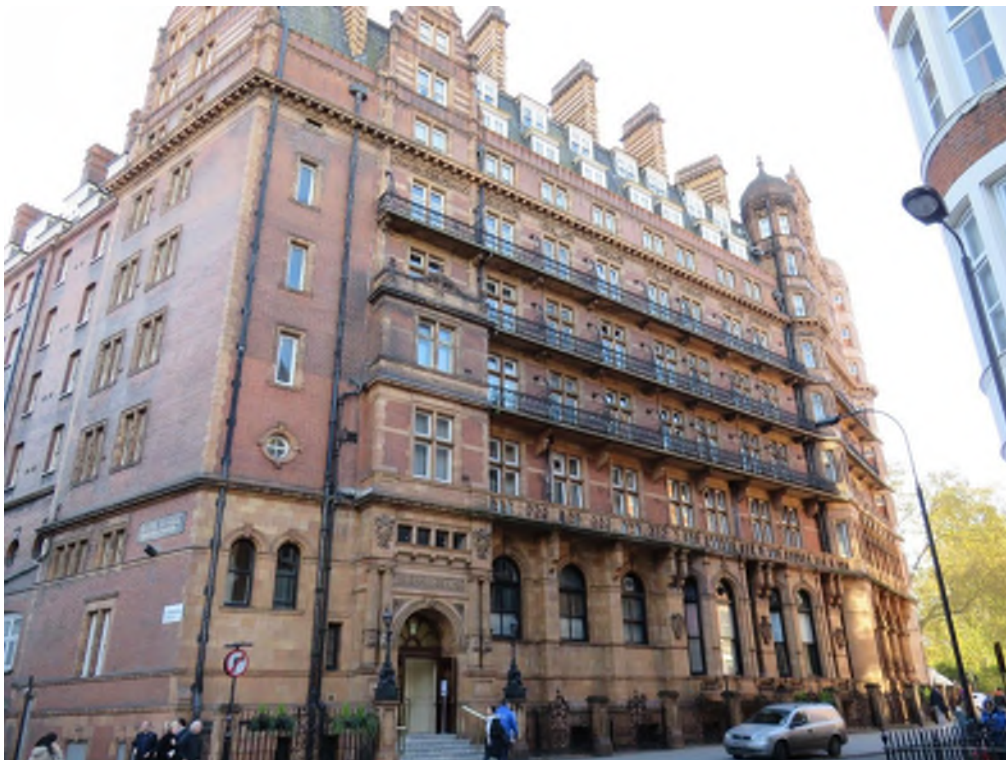
Bernard Street Elevation

3.8 Unlike the Russell Square elevation this façade has not been cleaned for some time or had been cleaned using a different method or non-abrasion cleaned. Whilst the elevation is dirty, marked, stained and has some facade issues, generally it is in a good condition for the age of the building.

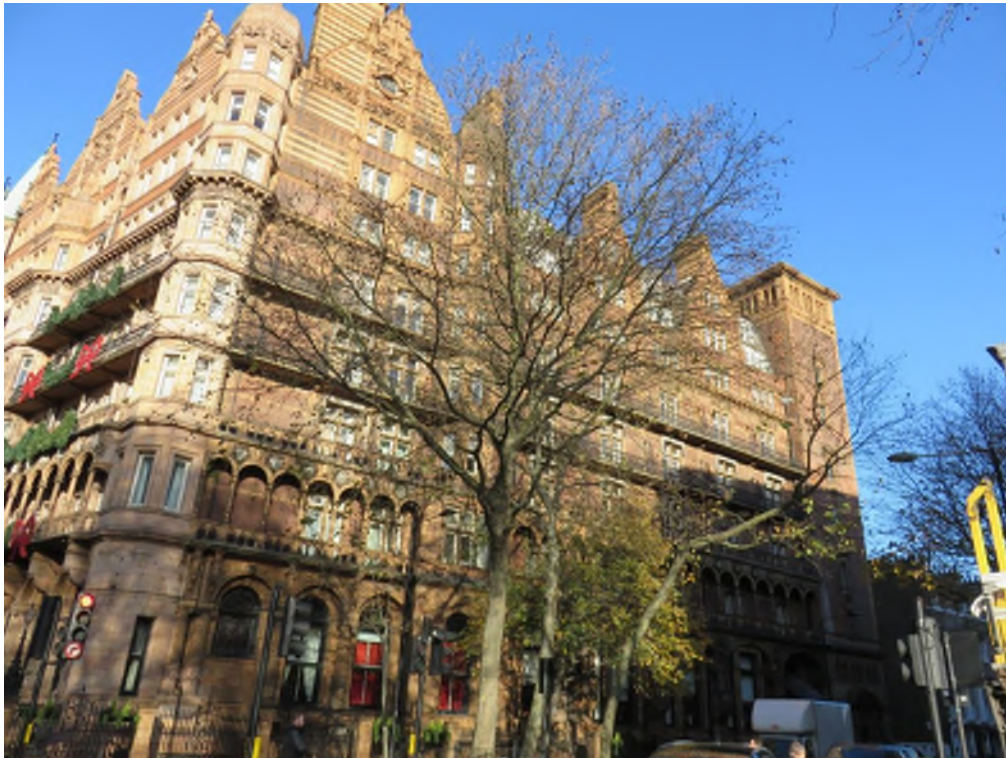
Guildford Street Elevation

Generally the issues are the same as Bernard Street elevation

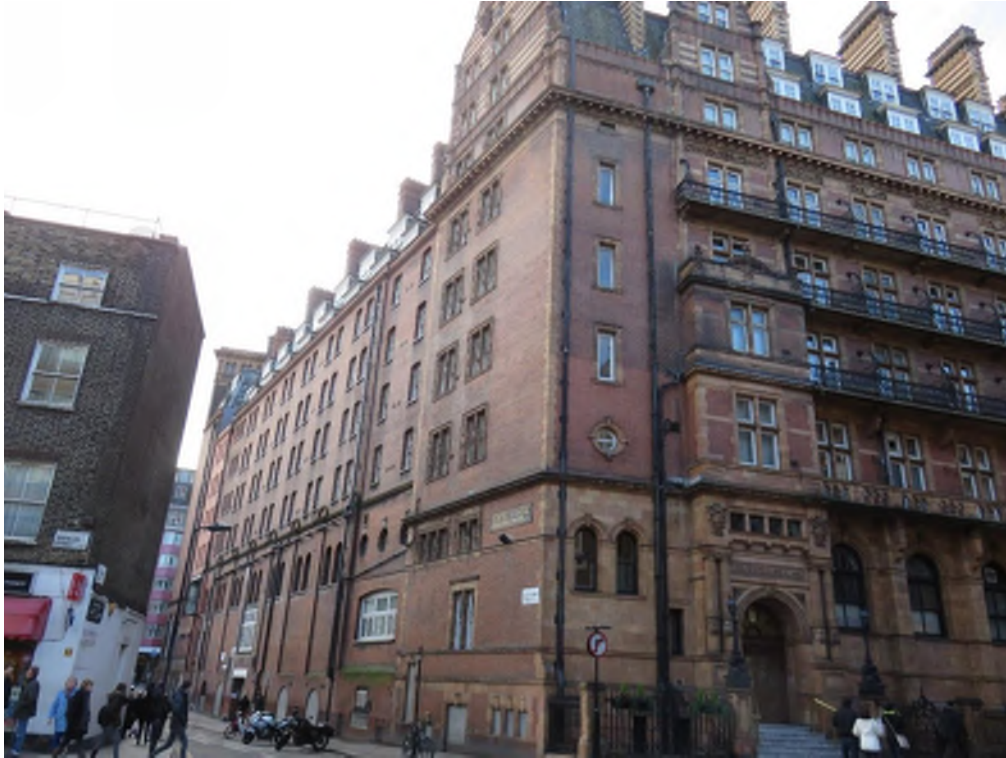
Herbrand Elevation

- 3.13 There are a few movement cracks around three windows, many holes and water stain marks from leaking pipework.

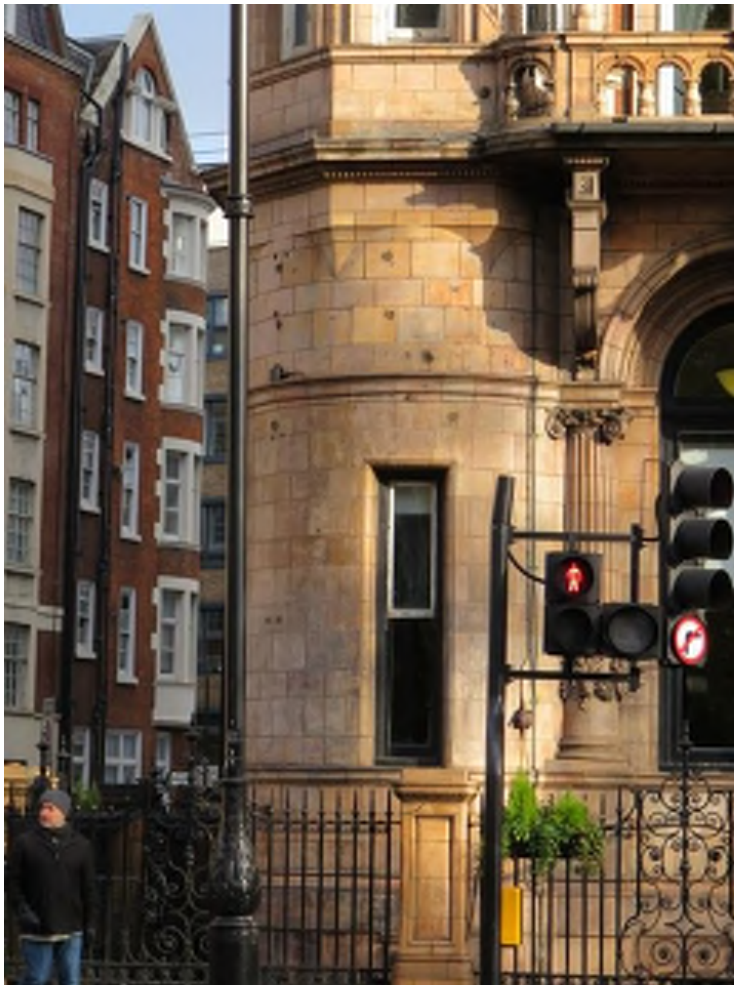
P1

Cement spots or poor previous repairs, holes & scaffold sockets and scaffold socket holes, all occur to this corner area. All holes should be filled to prevent the ingress of water. Aesthetically this area could be improved.

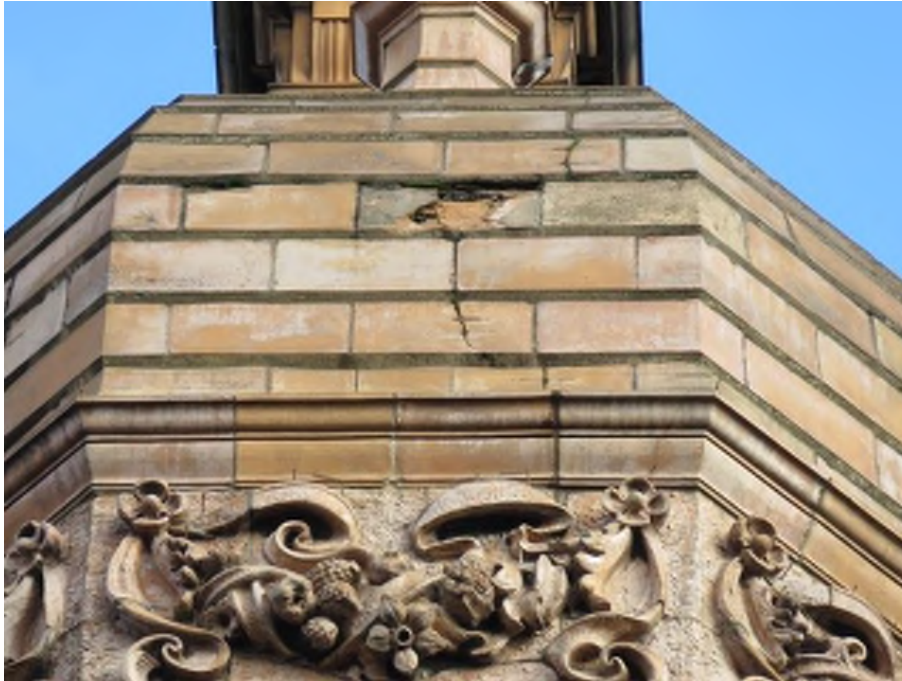
4.3 **P2**

There has been some previous stitch repairs to the terracotta roof. The surface of an area has broken down and is failing. This will allow water into the building. It is possible that small pieces of terracotta could fall from this damaged area creating a risk to health and safety. It is recommended that this terracotta is repaired.

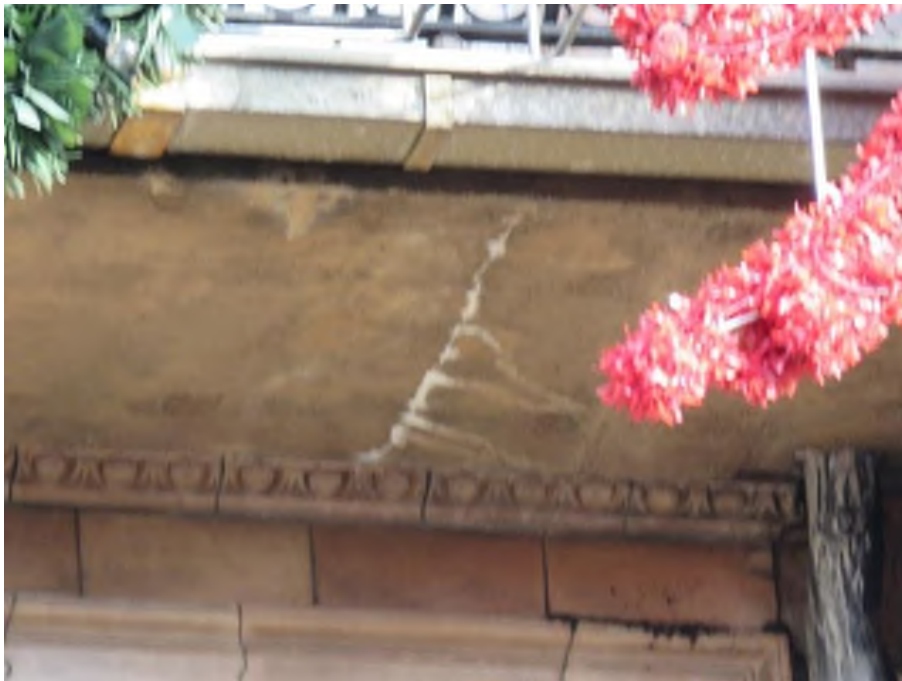
4.4 **P3**

Water from above seeping through to stain the soffit. The clean should remove the

water stain mark but investigation should be carried out to determine the condition of the water protection on the balcony.

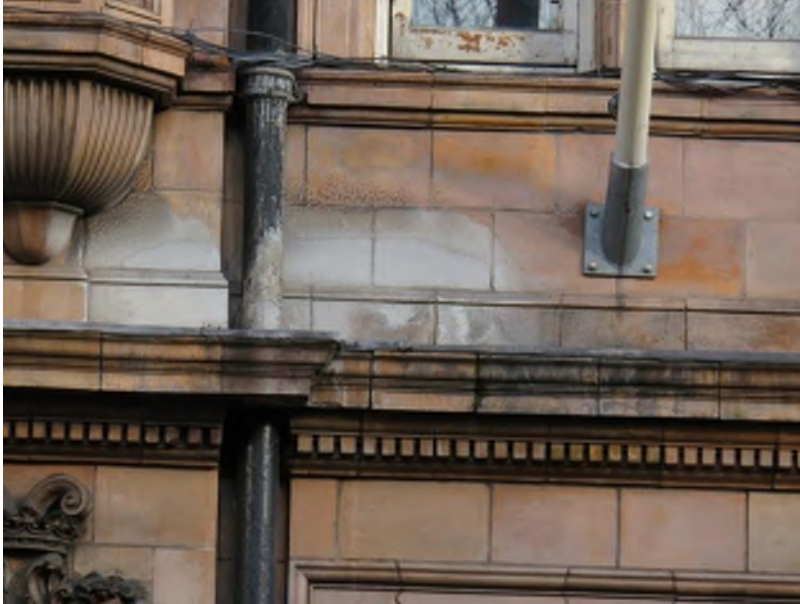
4.5 **P4**

This light cement stain is probably an attempt to repair surface damage to the terracotta. This will need to be removed. A more aggressive cleaning regime is likely to be applied and the surface of the terracotta more sympathetically repaired to match the surrounding colour.

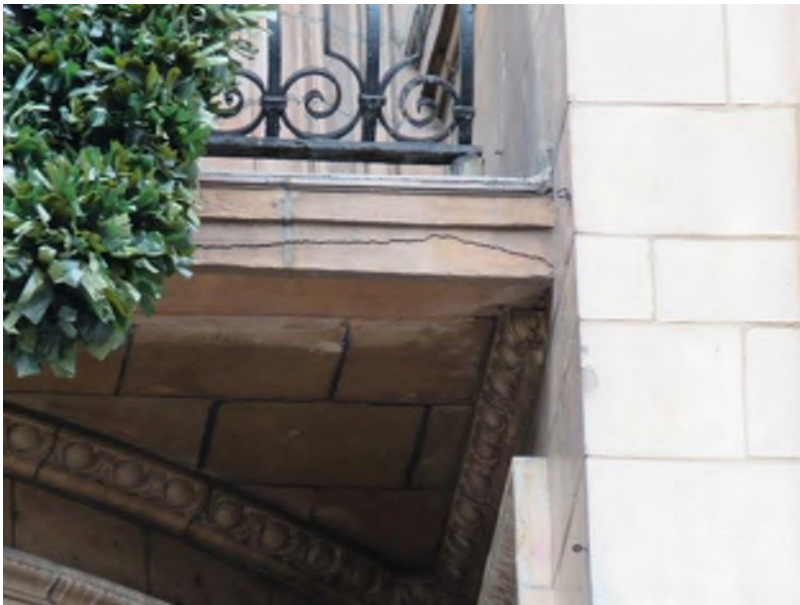
4.6 **P5**

The crack to the balcony edge is significant and should be repaired.

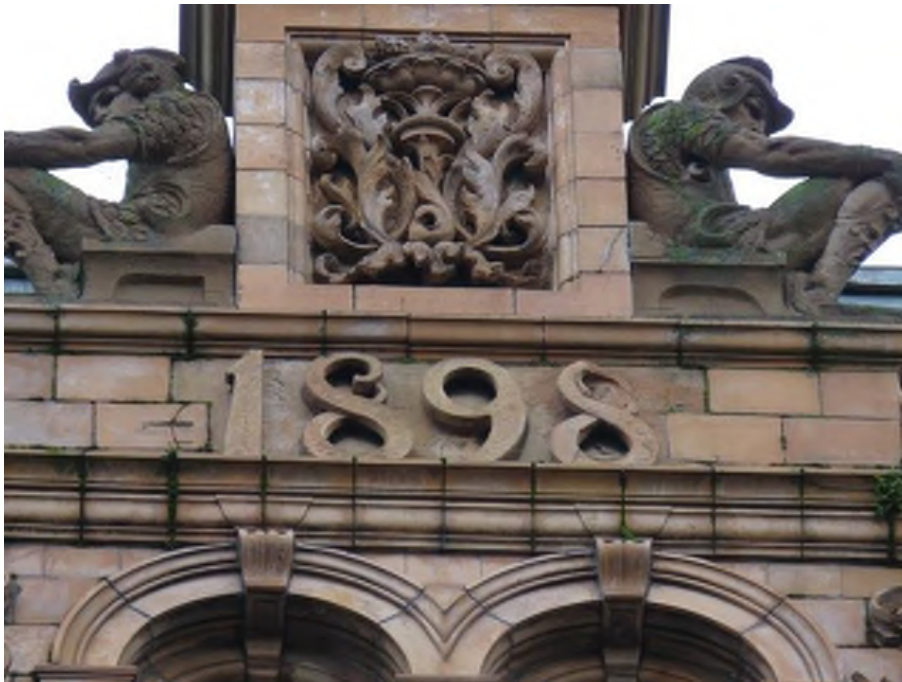
4.7 **P6**

The “8” of the 1898 is damaged. This can be repaired if required by the client, although its location is category “B”.

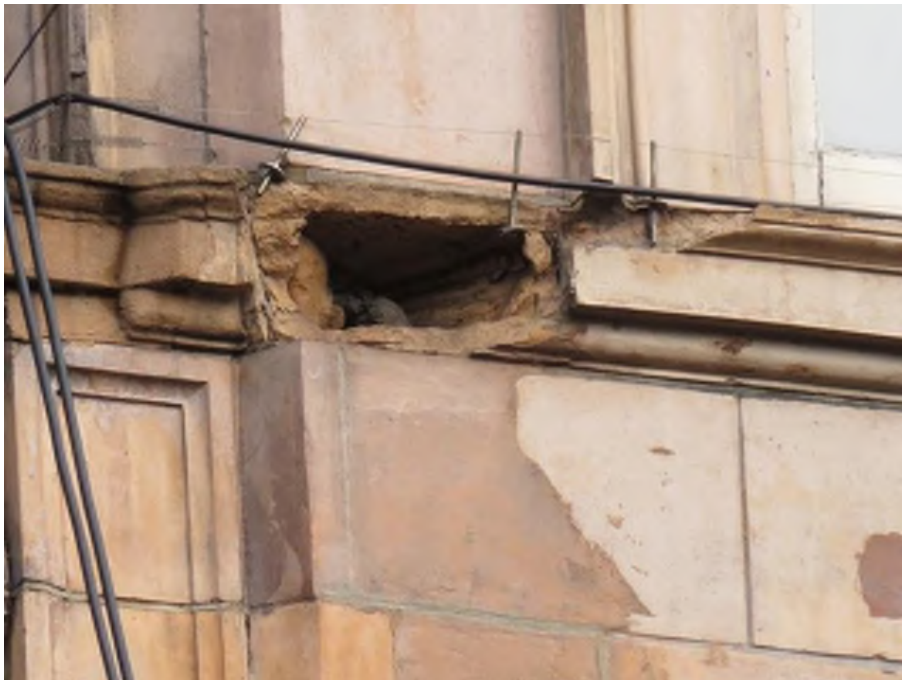
4.8 **P7**

This area of the terracotta has failed and must be replaced.

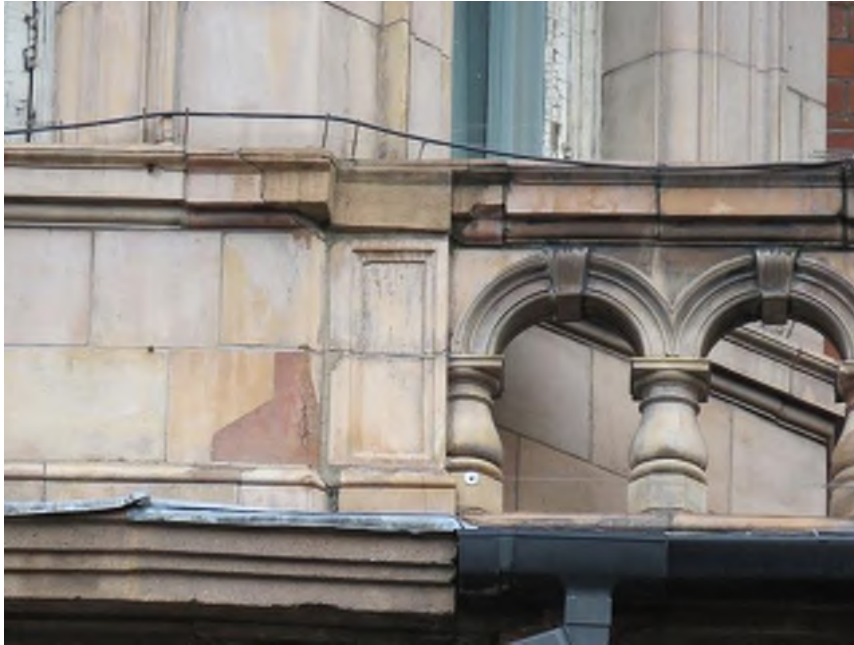
4.9 **P8**

This is a poor repair which is starting to fail. This should be cut out and repaired.

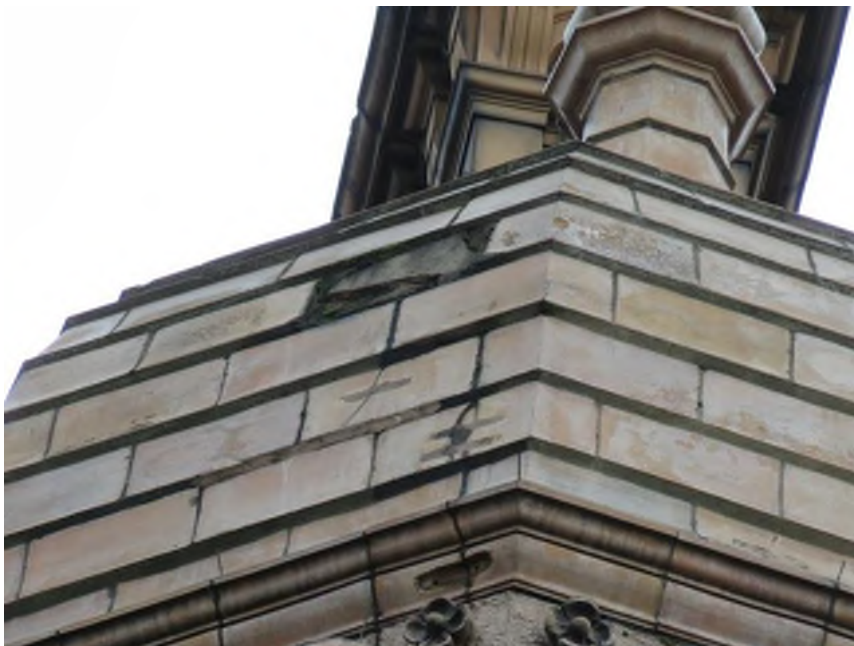
4.10 **P9**

There has been some previous stitch repairs to the terracotta roof. The surface of an area has broken down and is failing. This will allow water into the building. It is possible that small pieces of terracotta could fall from this damaged area creating a risk to health and safety. It is recommended that this terracotta is repaired.

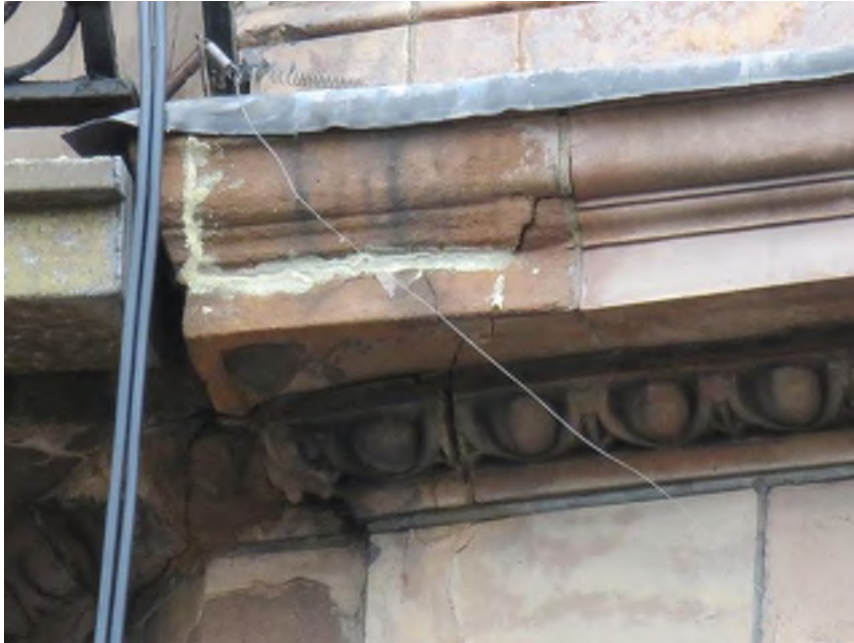
4.11 **P10**

A very poor previous repair. The terracotta is clearly showing signs of damage and is cracking. It is recommended that this terracotta piece is repaired or replaced.

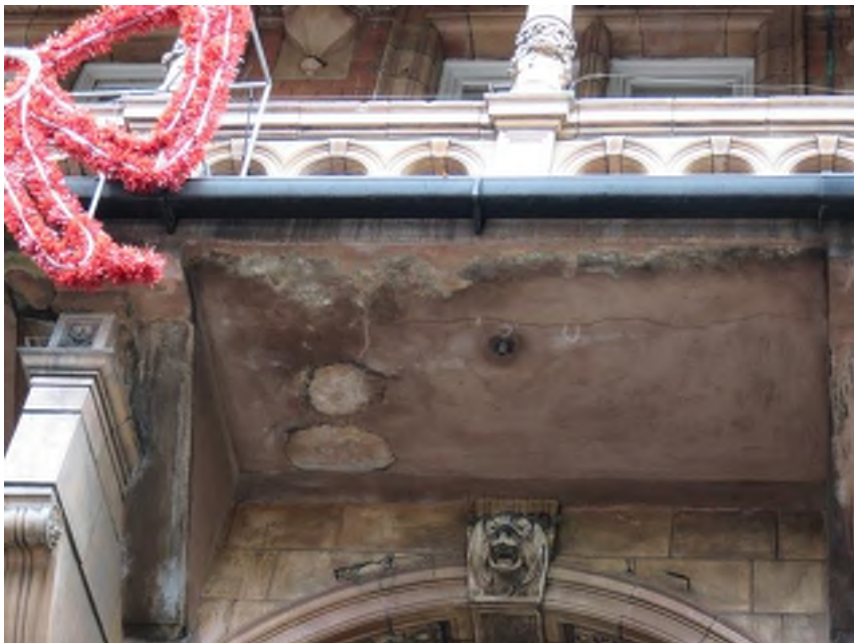
4.12 **P11**

The soffit render is failing and is badly stained and cracked. This will need to be removed and replaced. It is very likely that all of the soffit balcony areas are damaged and all should be closely inspected.

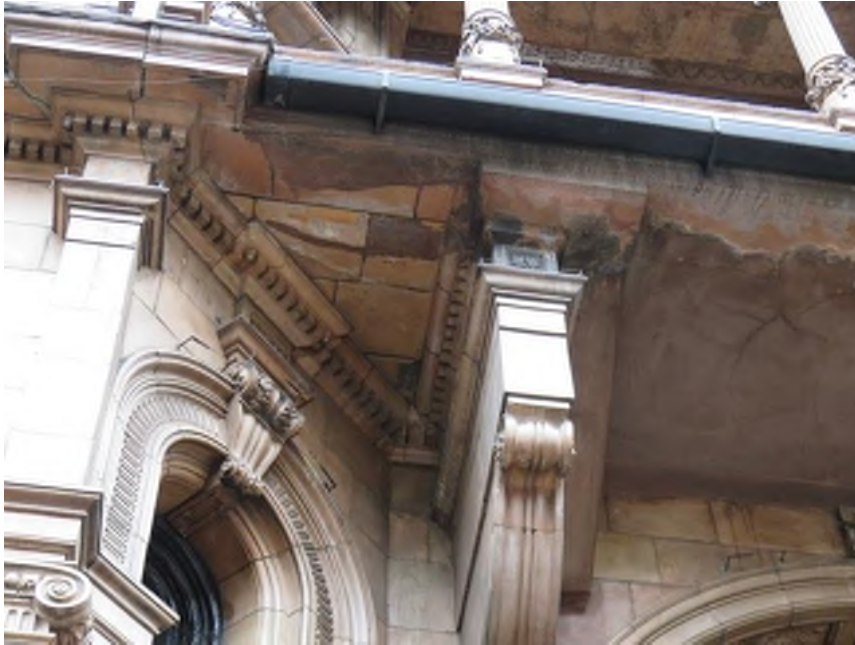
4.13 **P12**

The soffit has been extensively repaired. A close inspection of all of the soffit areas should be carried out.

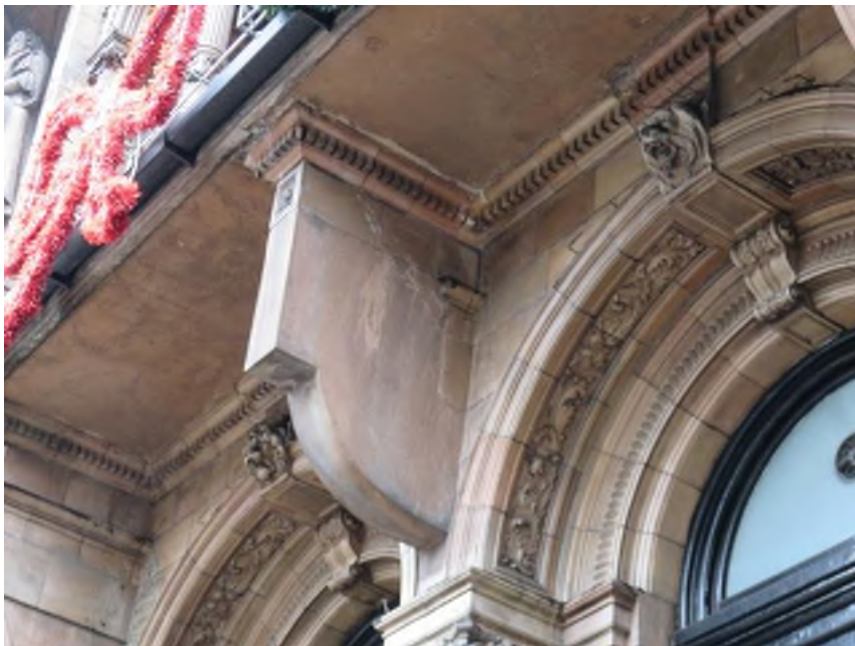
4.14 **P13**

This terracotta support feature has been replaced with a poor imitation of the original support. Aesthetically it is out of place with the façade. This could be carefully removed and a new support installed to match the original detail.

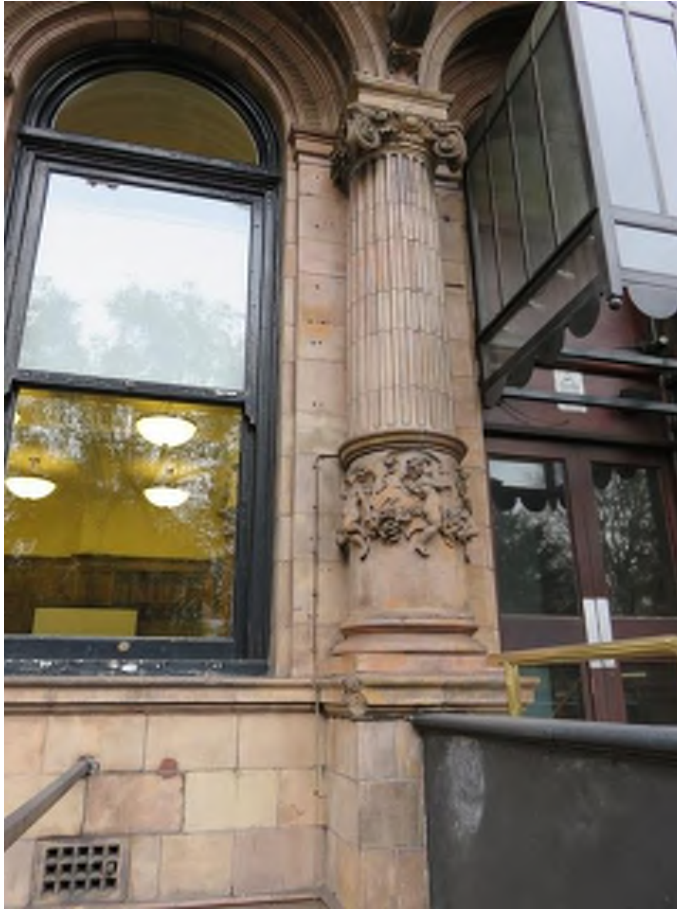
4.15 **P14**

Several hole and nylon plugs in the façade. As they are new an exist they can be repaired.

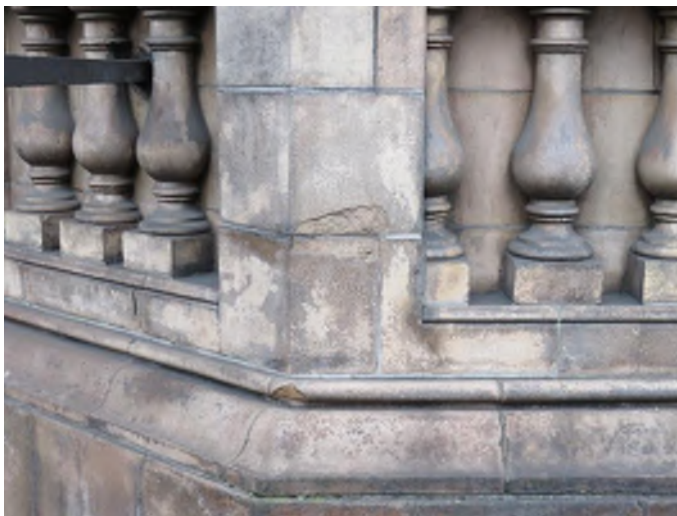
4.16 **P15**

Surface damage. Can be repaired or left as character of the building.

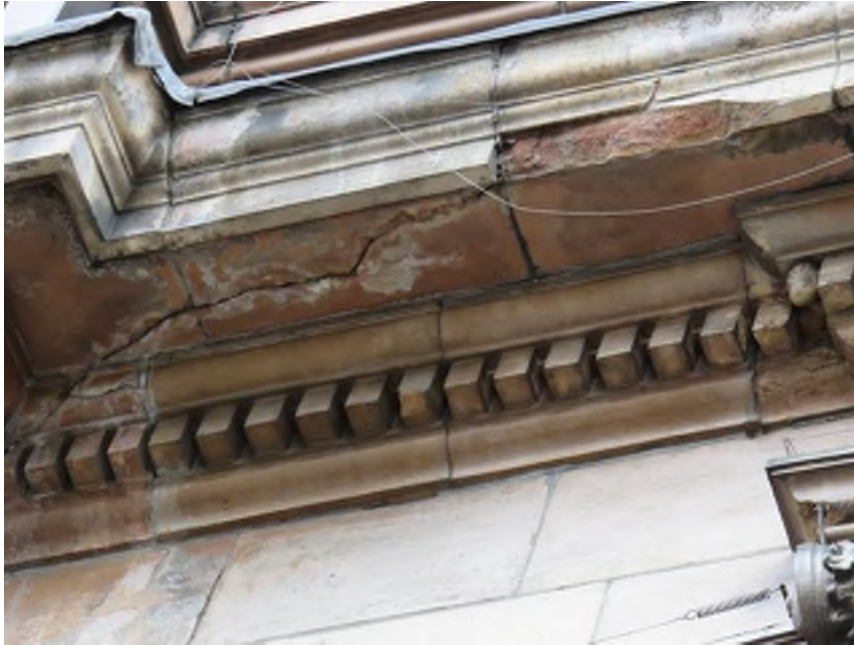
4.17 P16

Significant cracks and failure of the terracotta here. Further failure is likely to occur. We recommend that the terracotta is cut out and replaced.

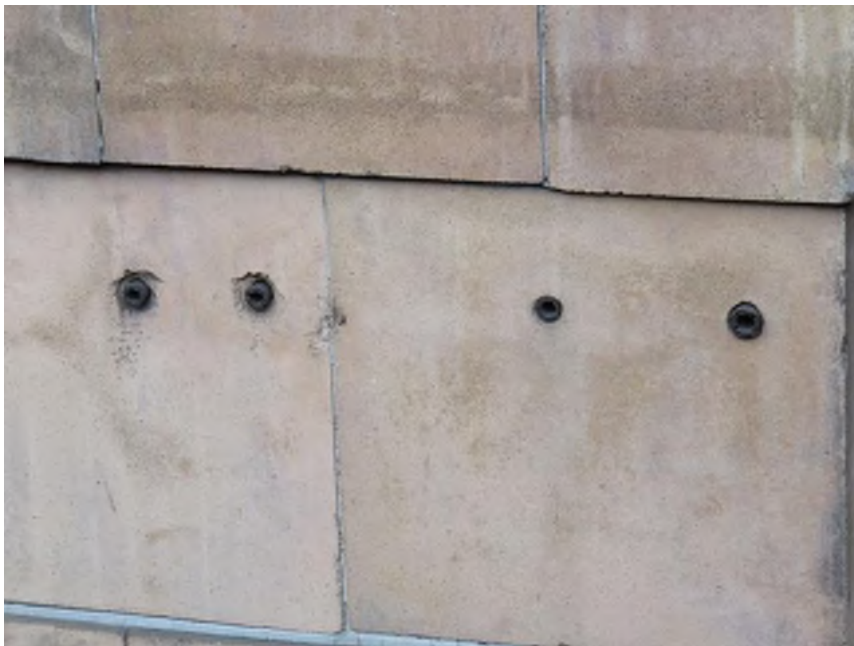
4.18 P17

Old and corroding scaffold sockets. These are at ground level. They can be removed and the holes repaired. These are typical of the 39No. identified on this elevation (some of this number includes holes left by previously removed sockets).

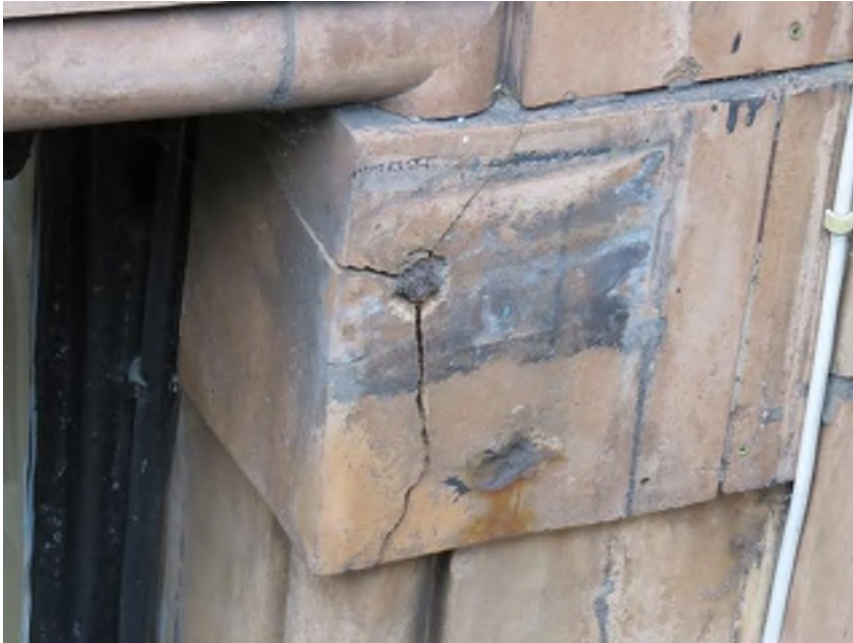
4.19 **P18**

An old corroded socket has badly cracked the terracotta. Water ingress will further damage the façade. This piece should be cut out and replaced.

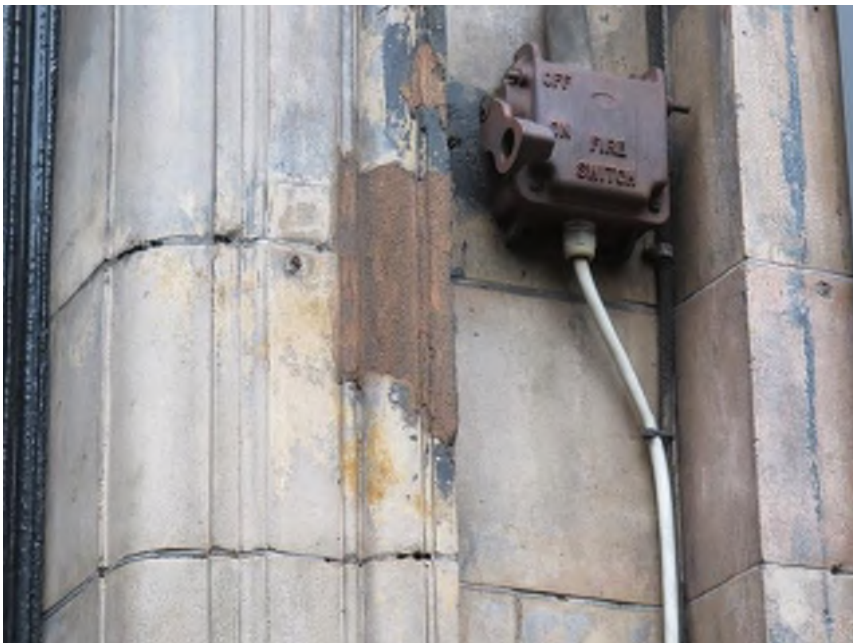
4.20 **P19**

A previous very poor repair. This should be cut out and a new sympathetic repair made.

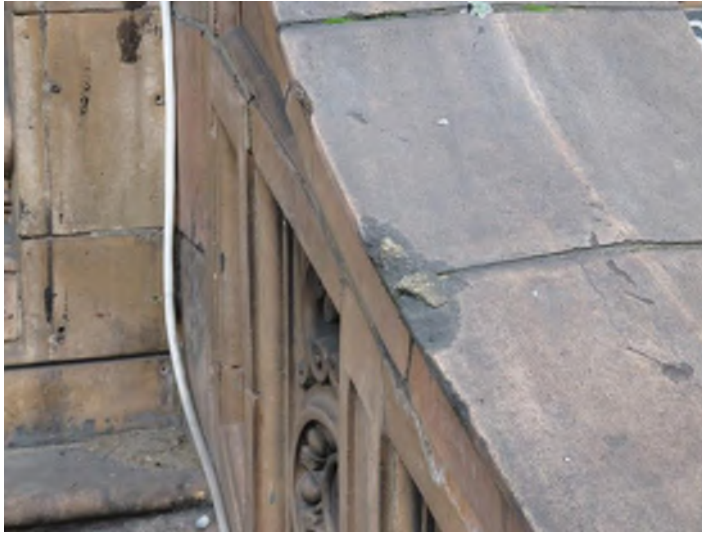
4.21 P20

This chip is to the main entrance balustrade and part of an old repair still remains. The old repair can be cut out and a new repair made.

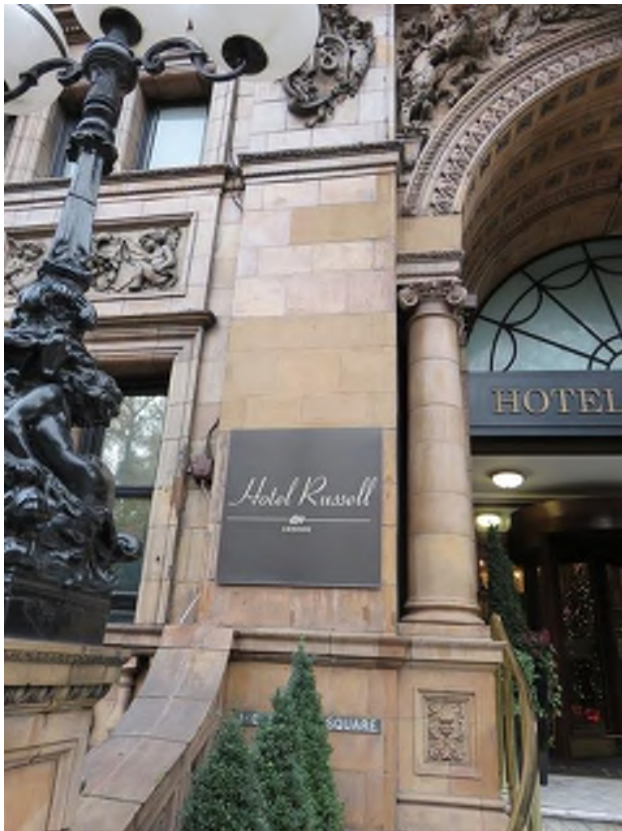
4.22 P21

The left front façade to the main entrance has been extensively repaired. These can be improved by installing new terracotta or left as an historic feature of the building.

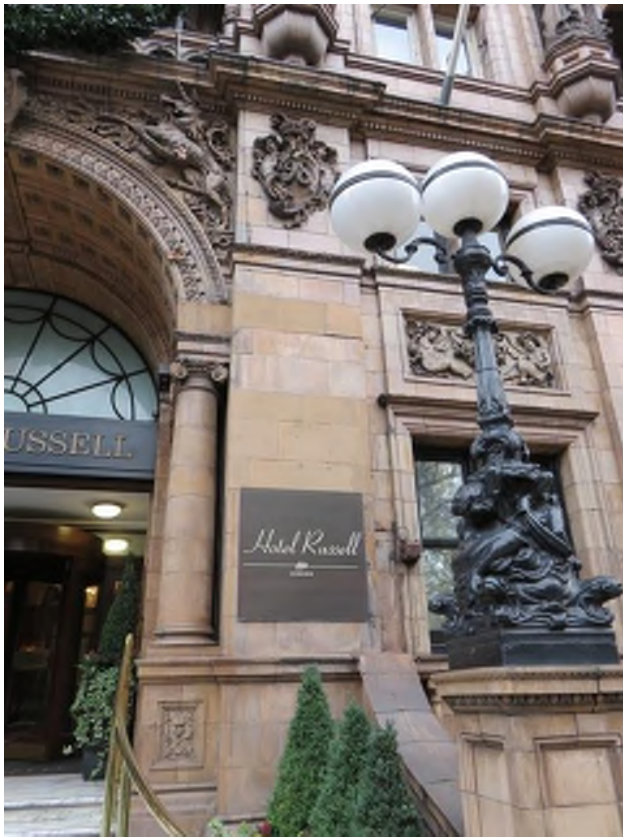
4.23 **P22**

The right front façade to the main entrance has been extensively repaired. These can be improved by installing new terracotta or left as an historic feature of the building.

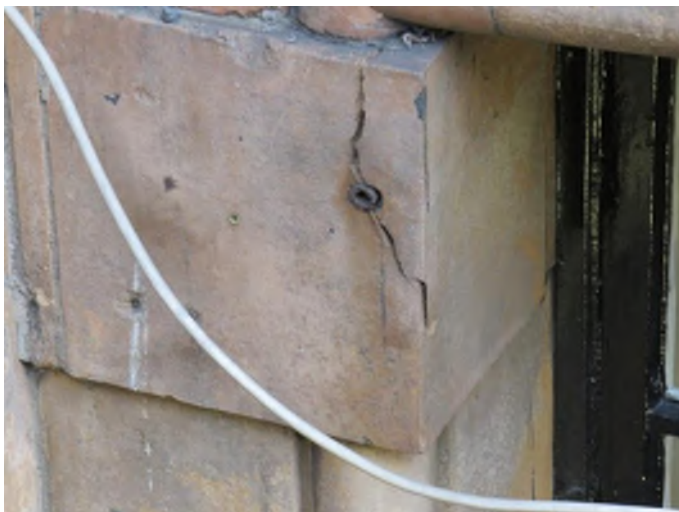
4.24 **P23**

An old corroded scaffold socket has badly cracked the terracotta. Water ingress will further damage the façade. This piece could be cut out and replaced or the socket removed and the terracotta repaired.

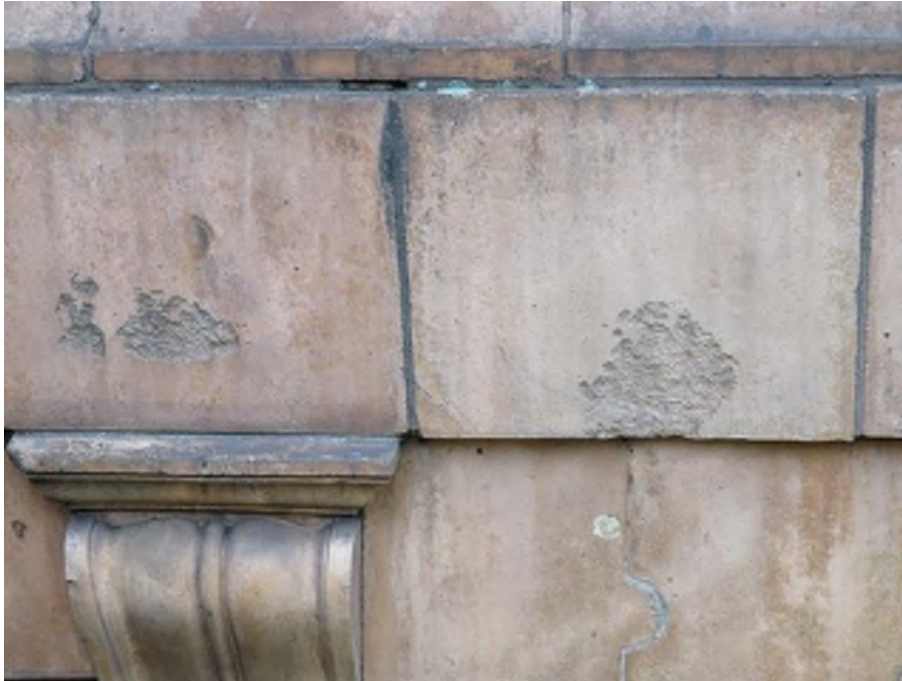
4.25 **P24**

Typical of surface damage to the terracotta façade. Generally this can remain as the historic character of the building. However it is also evidence of the lack of the protective *fire skin* (removed during previous aggressive cleaning and erosion over time). All surface damage should be monitored to ensure full surface decay is not occurring. Once cracked or decayed, the ingress of water will quickly exacerbate the failure and pieces of terracotta may fall causing a risk to health and safety.

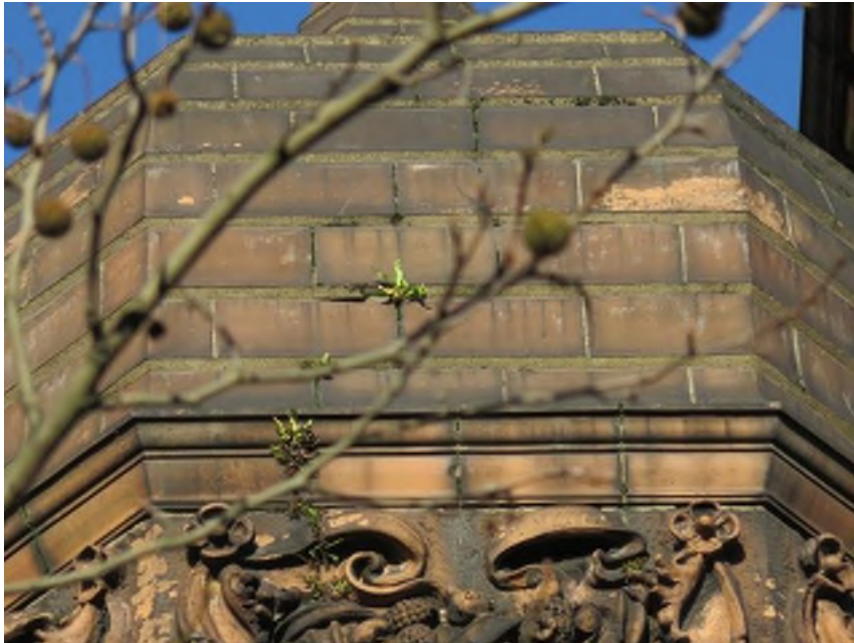
4.31 **P25**

Some surface decay, although not server. This could be monitored. Foliage is growing out of some damaged joints. This will attract and hold water, which will cause further damage. All foliage should be removed and the joints cleaned or repaired.

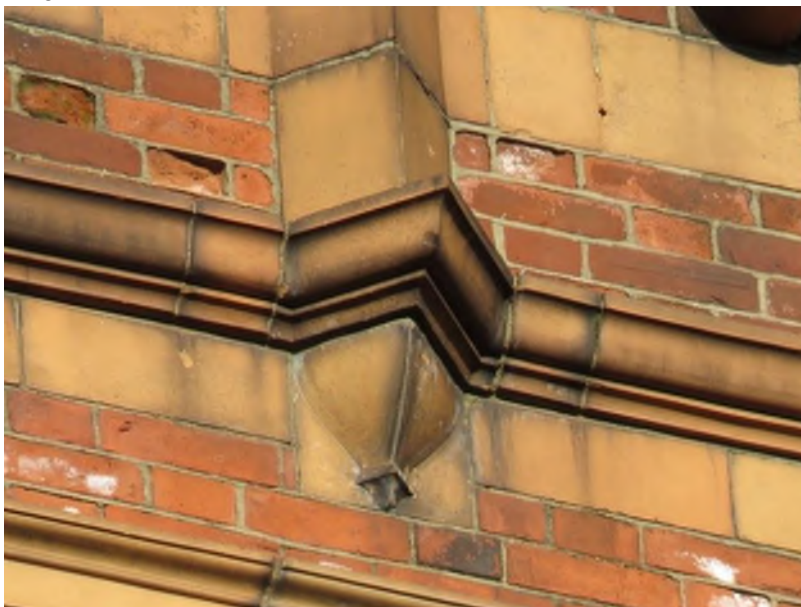
4.32 **P26**

Surface damage to the brickwork. These three bricks should be repaired.

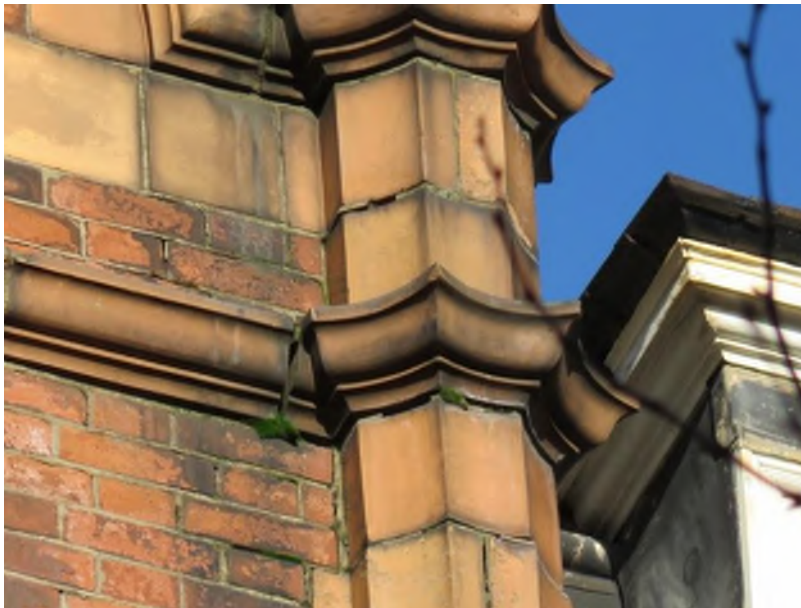
4.33 **P27**

After cleaning it is likely that some of the joints will be open and in need of repair. All moss and other growth should be removed.

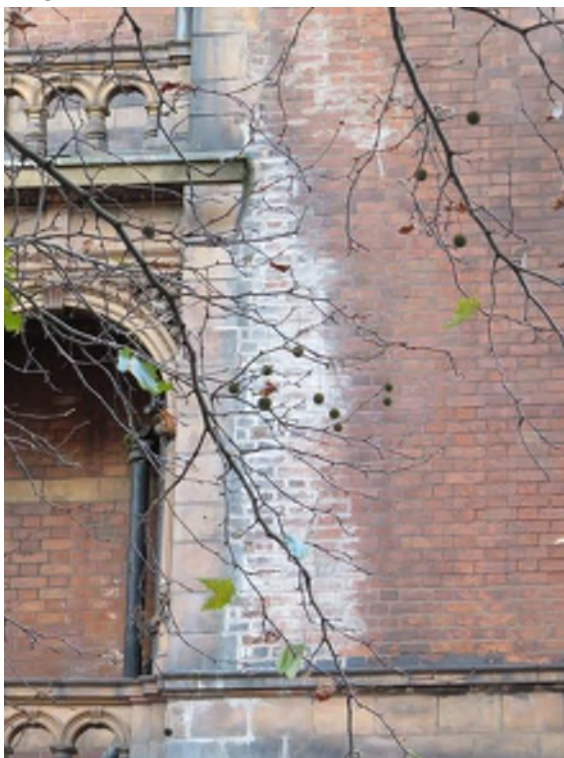
4.34 **P28**

There is significant water staining to the brickwork and terracotta in this area and both are being damaged.

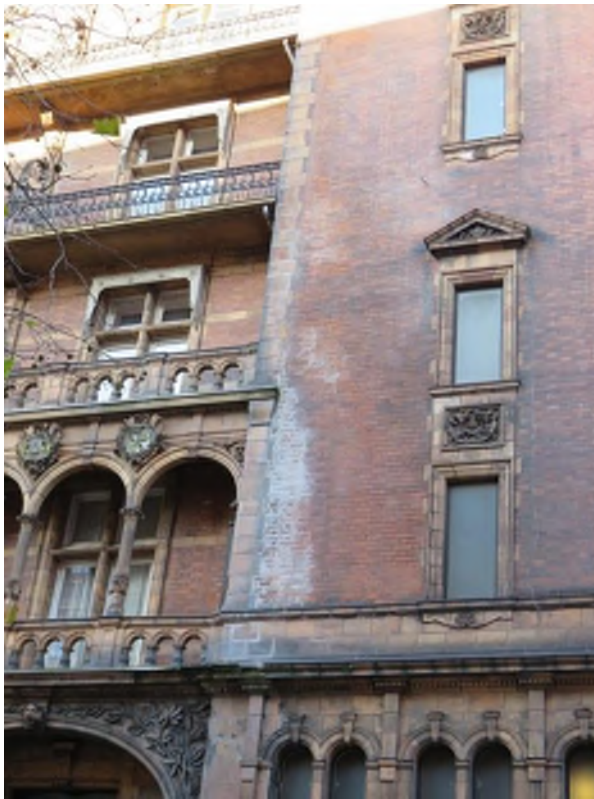
P29

The water is still continuing to leak from a broken pipe or gutter at a higher level. This water leak should be stopped at the earliest opportunity. The area will require concentrated cleaning and may require special attention. Repairs to joints and surface are likely and should be reviewed after cleaning.

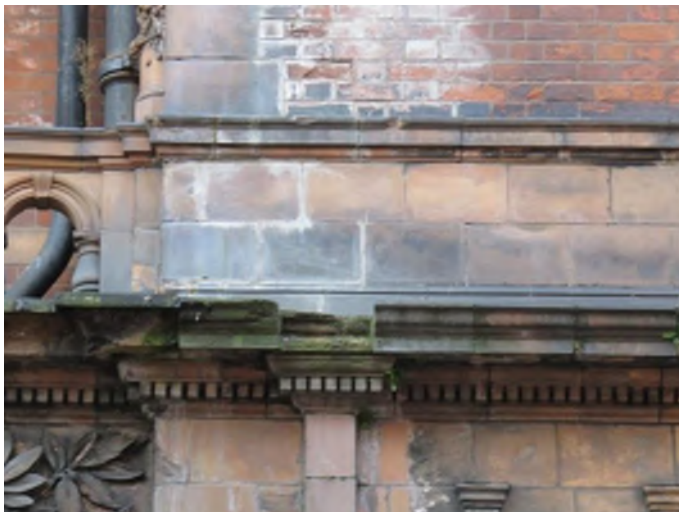
P30

Terracotta corroded & missing, joints open and damaged, white stains and algae all due to water leakage.

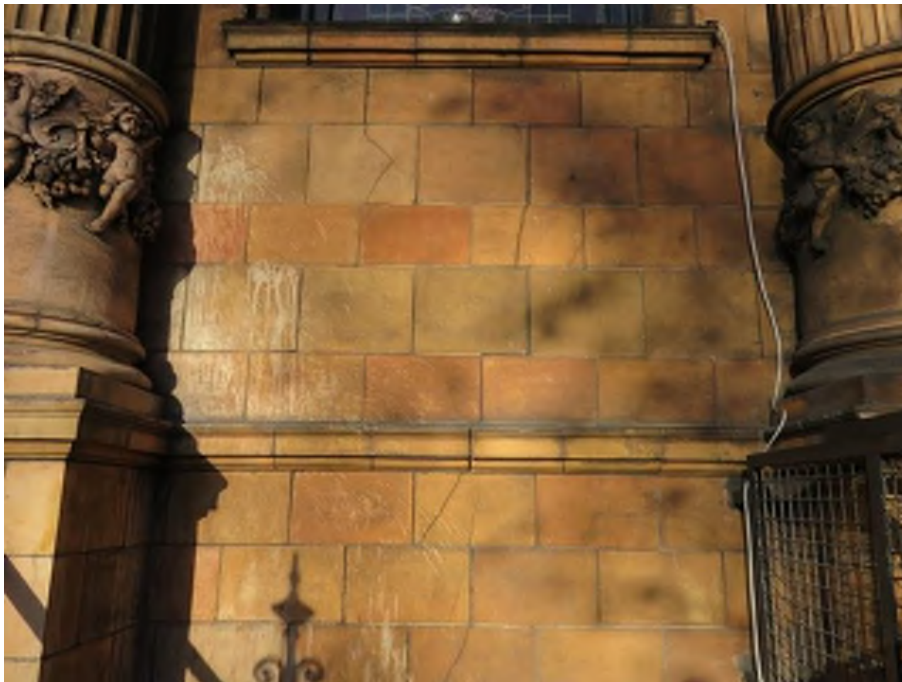
4.36 **P31**

Cracks in the terracotta faience. These could be repaired.

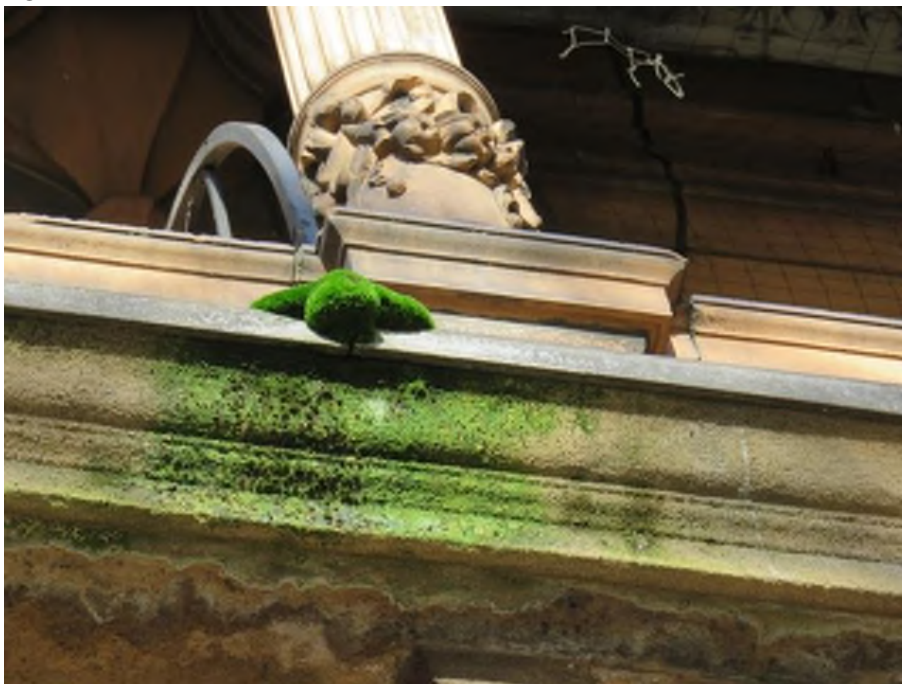
4.37 **P32**

Concentrated algae growth, where water has been directed and contained by obstructions on the cornice. This should be cleaned and any obstruction removed.

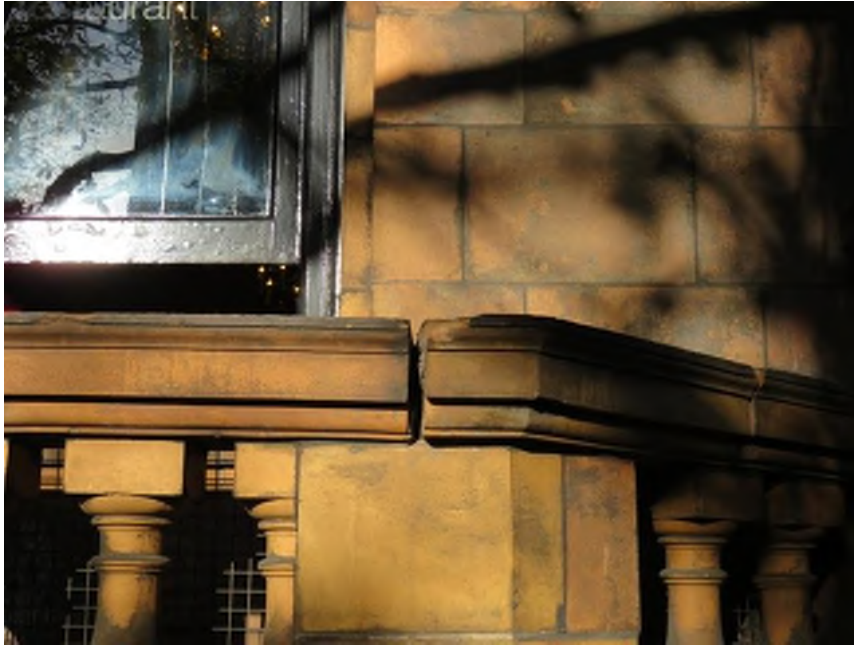
4.38 **P33**

There is a very large space between two balustrade copings. Some movement or displacement has occurred. The coping should be reset and the joint repaired.
