RUSSELL HOTEL
EXTERNAL FAÇADE
CONDITION SURVEY
COVERING;

RUSSELL SQUARE
BERNARD STREET
GUILFORD STREET

Report prepared by
Mark Goldman
Harrison Goldman

Report Number C5181-01
10th February 2015

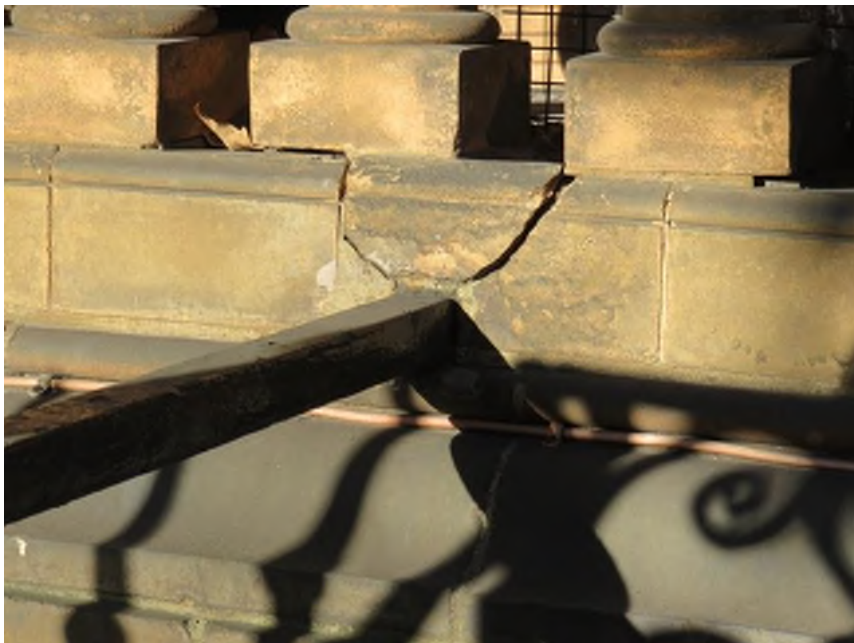
4.39 **P34**

This is a typical detail of damage (albeit the worst case) caused by the metal railing retaining steel tie. The terracotta should be repaired.

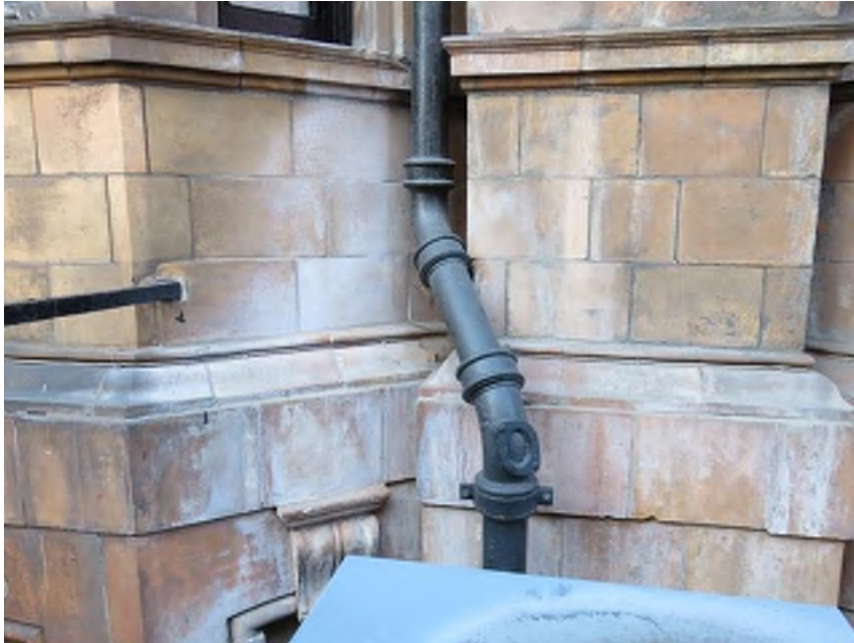
4.40 **P35**

Historic water stain marks. No obvious damage appears on the terracotta. Clean the areas and review the condition. There may be the need for concentrated cleaning in this area.

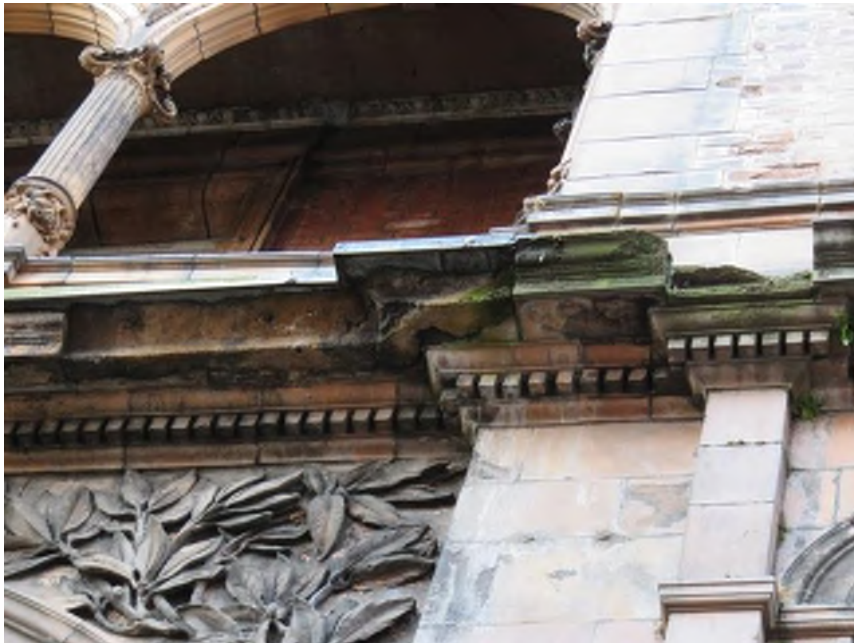
4.41 **P36**

Sever damage to the terracotta cornice caused by water leakage over a long period of time. Once cleaned it is suggested that this whole area is replaced and restored.

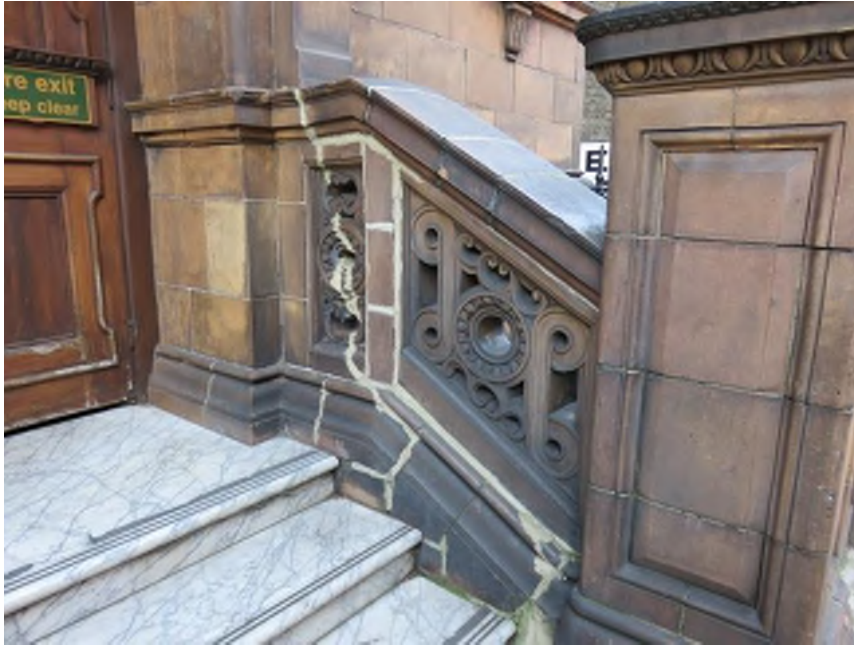
4.42 **P37**

Really poor repair to the side entrance balustrade. This can be significantly improved by cutting out the unsightly mortar and repairing using suitably coloured mortar.

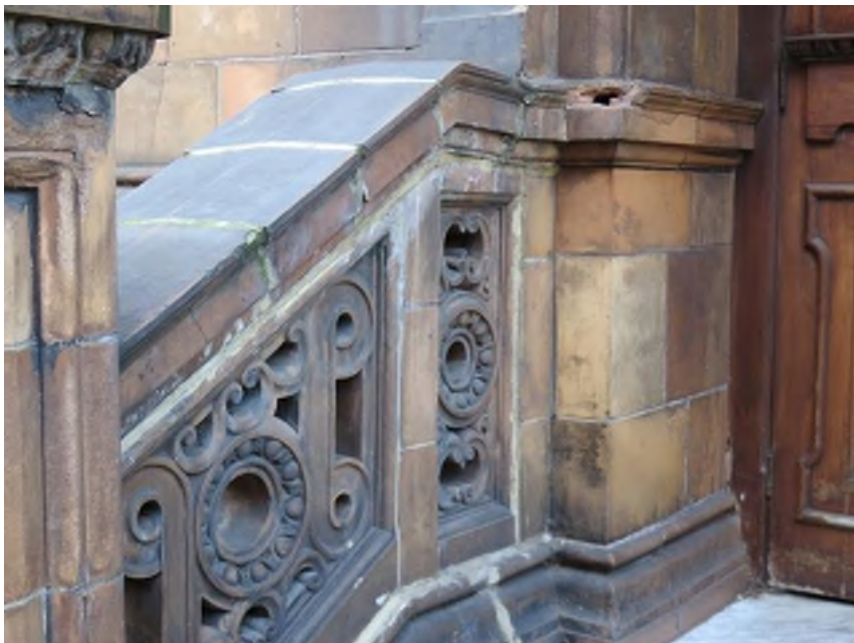
4.43 **P38**

Poorly repaired balustrade and broken cap. Replace poor mortar and repair broken terracotta corner cap.

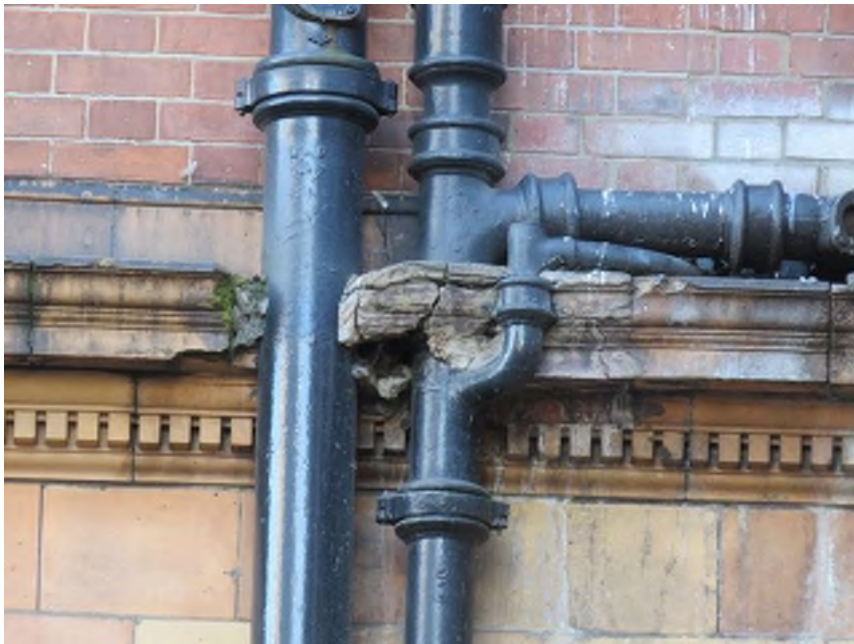
There is a lot of damage to the terracotta which appears unstable. This area should be dismantled and new terracotta installed. It may be prudent to stop the new terracotta short of the pipes as this will smarten the detail plus will be far simpler to install.

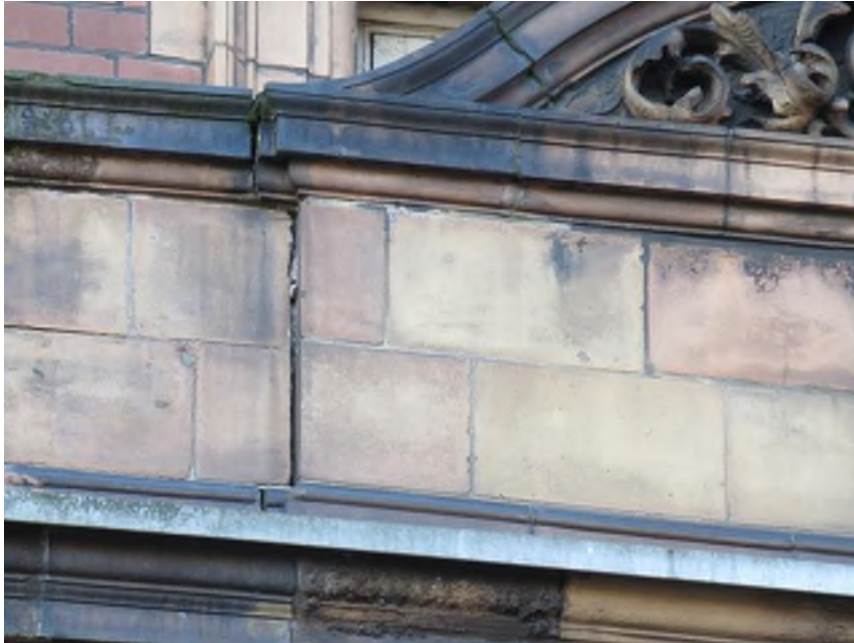
4.51 **P40**

There has been some movement here in the past. The joints should be repaired and we may need to pin the terracotta. A close inspection is recommended.

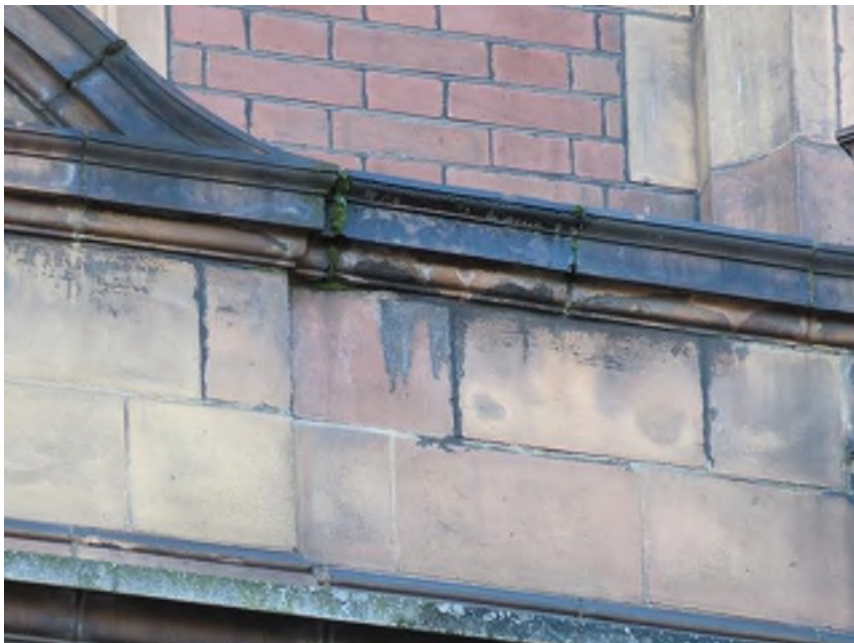
4.52 **P41**

These joints are damaged and in need of repair. The black markings may need some special attention in order to remove them.

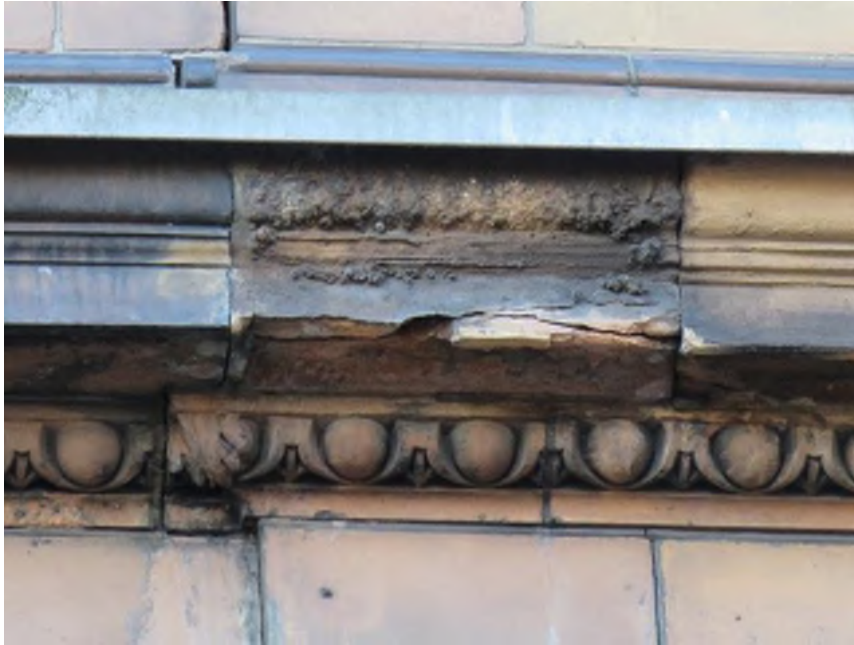
4.53 **P42 & P43**

This terracotta piece is terminally damaged and should be replaced as it represents a risk to health and safety.

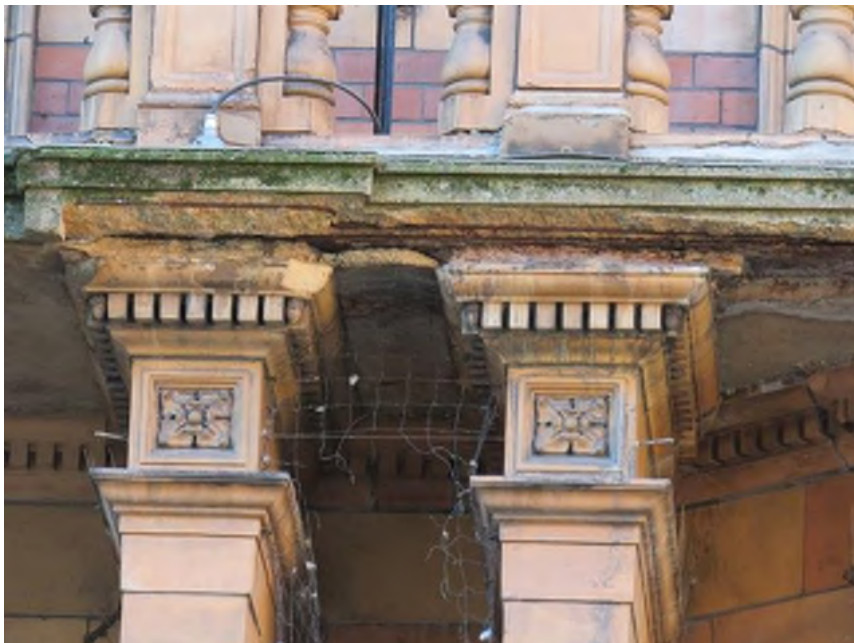
4.54 **P44**

There is a lot of damage to the terracotta all along the edge of the 1st floor balcony on this elevation. After cleaning a close inspection of the areas is recommended. All loose and damaged terracotta should be replaced, repaired or restored.

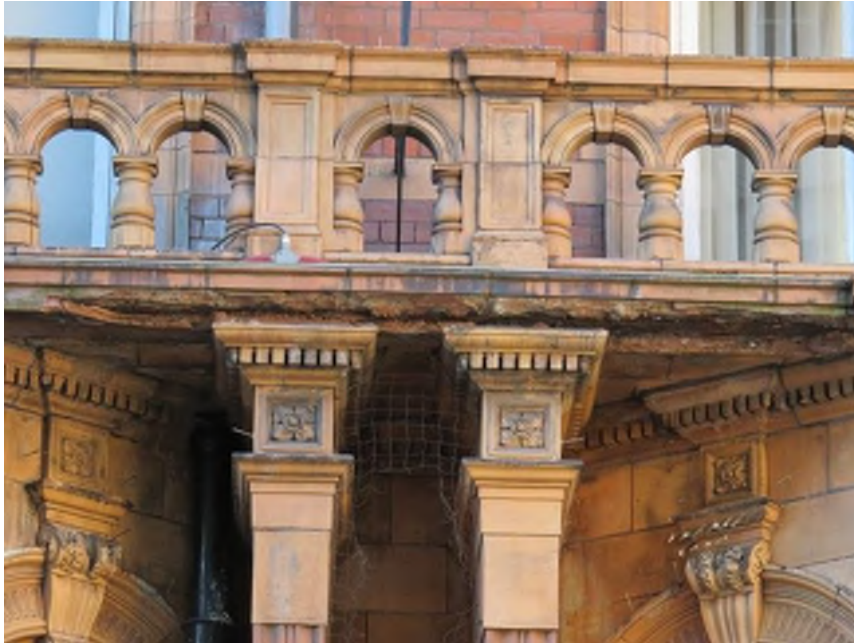
4.55 **P45**

More damage along the 1st floor balcony. There is a potential for the terracotta to fall which is a risk to health and safety. After cleaning a close inspection of the areas is recommended. All loose and damaged terracotta should be replaced, repaired or restored.

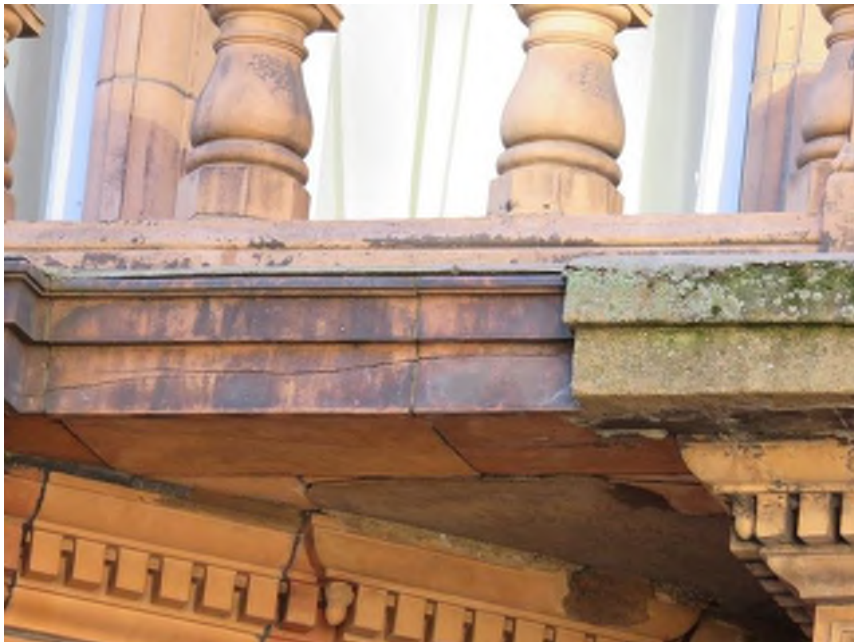
4.56 **P46**

The front edge is cracked along the 1st floor balcony. This must be repaired

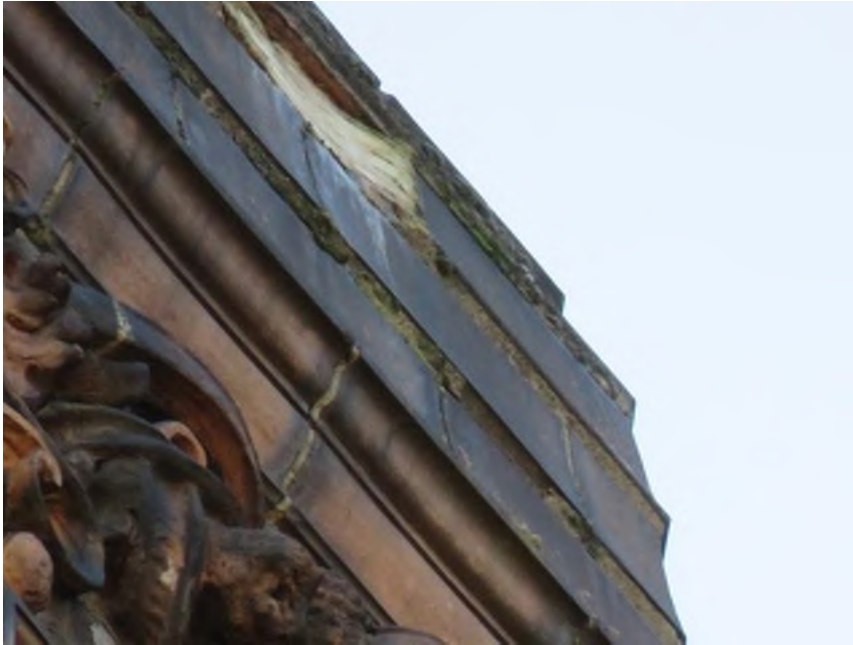
4.57 **P47**

There is damage to the terracotta roof piece which is likely to allow the ingress of water. This should be repaired or replaced.

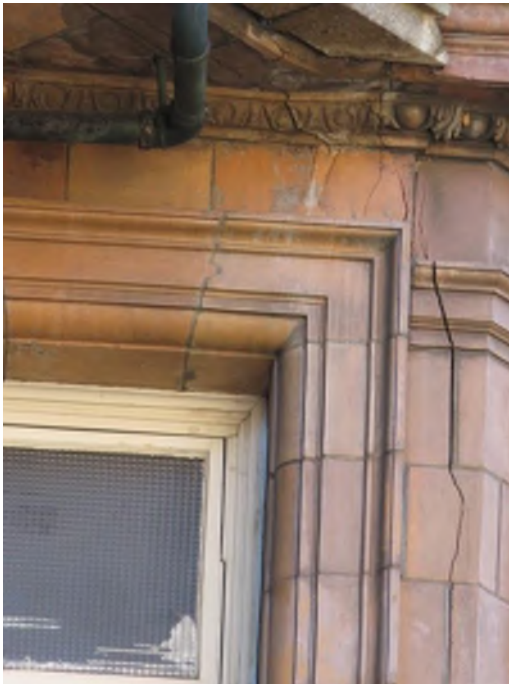
4.58 **P48**

There is a significant crack in the terracotta. This should be repaired to prevent the ingress of water. The cracks above the top corner head area should be further investigated. Repairs are likely here.

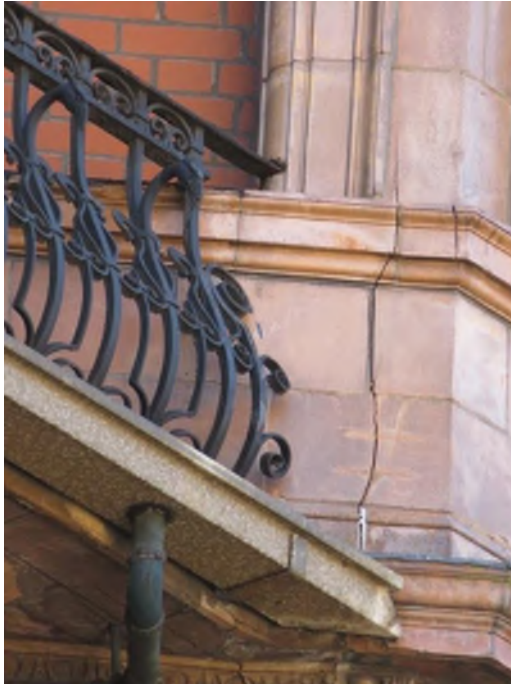
4.59 **P49**

There is a significant crack in the terracotta. This should be repaired to prevent the ingress of water

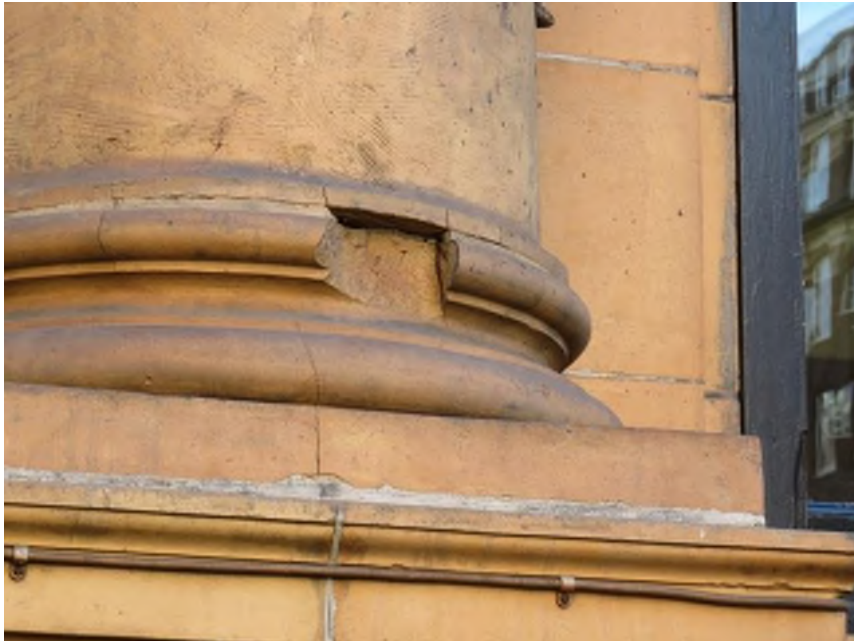
4.60 **P50**

A large chip missing from the base of the column. Piece-in a new repair.

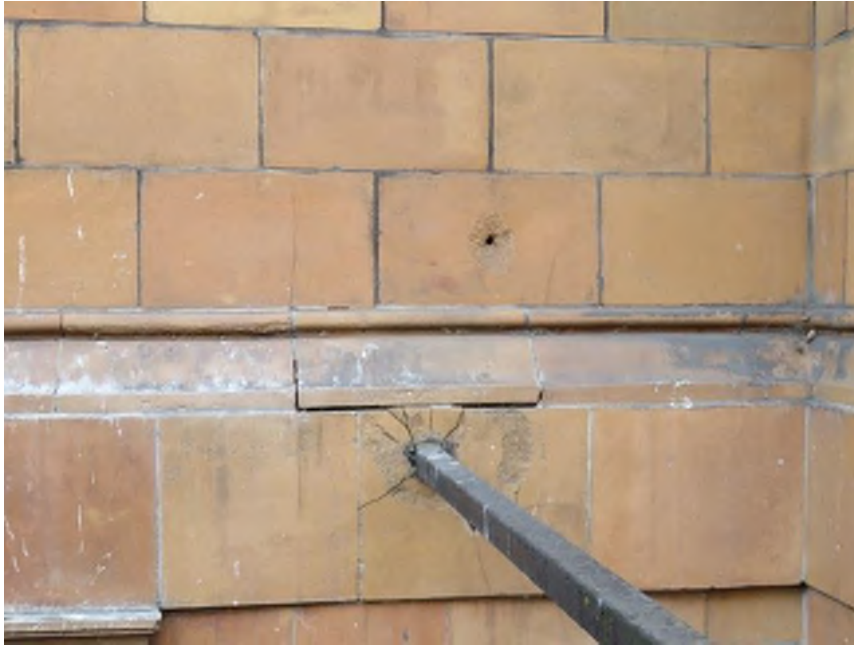
4.61 **P51**

This is a typical detail of damage caused by the metal railing retaining steel tie. The terracotta should be repaired.
