HISTORIC ENGLAND CIVIL & STRUCTURAL ENGINEERING TEAM SITE VISIT RECORD

KENWOOD HOUSE LADY MANSFIELD'S BEDROOM

Date of Visit 05 /11/2015
Time on Site 3.0pm to 4.30pm
Visit by Stephen Parris, Stuart Ellis, Kate Marchant, Jerzy Kierkuc-Bielinski

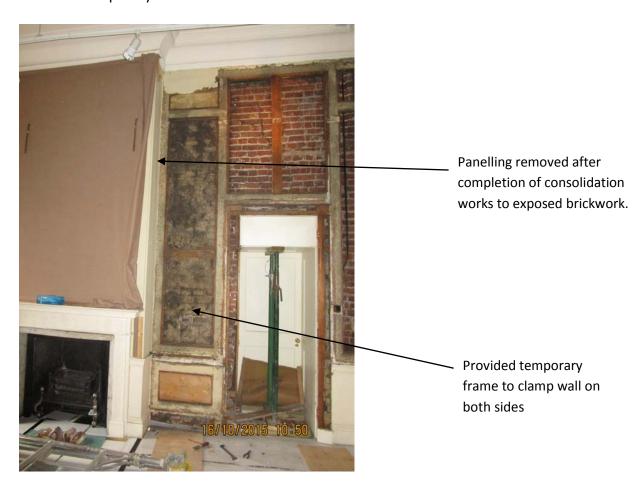
- 2) The wall finish adjacent to the opening is to be investigated in order to identify the material and to record its historical significance. It noted that there are areas of loose and fractured brickwork behind the finish and it is anticipated that it will need to be removed in order to consolidate the brickwork.

1) The existing timber panelling frame is not to be removed until additional temporary support to the facing brickwork is provided. The facing brickwork located in both Lady Mansfield's bedroom and the curators store room are to be held in place. See SK/ 02-03 which indicate the basic principles. The contractor will be required to submit more detailed temporary works information.
