CONTRACT NO. 5367
REPORT ON STRUCTURAL DEFECTS AT
22 NEAL STREET

Further to your instructions we visited the above premises on 10 September 2015 in order to carry out a visual inspection of the external walls.

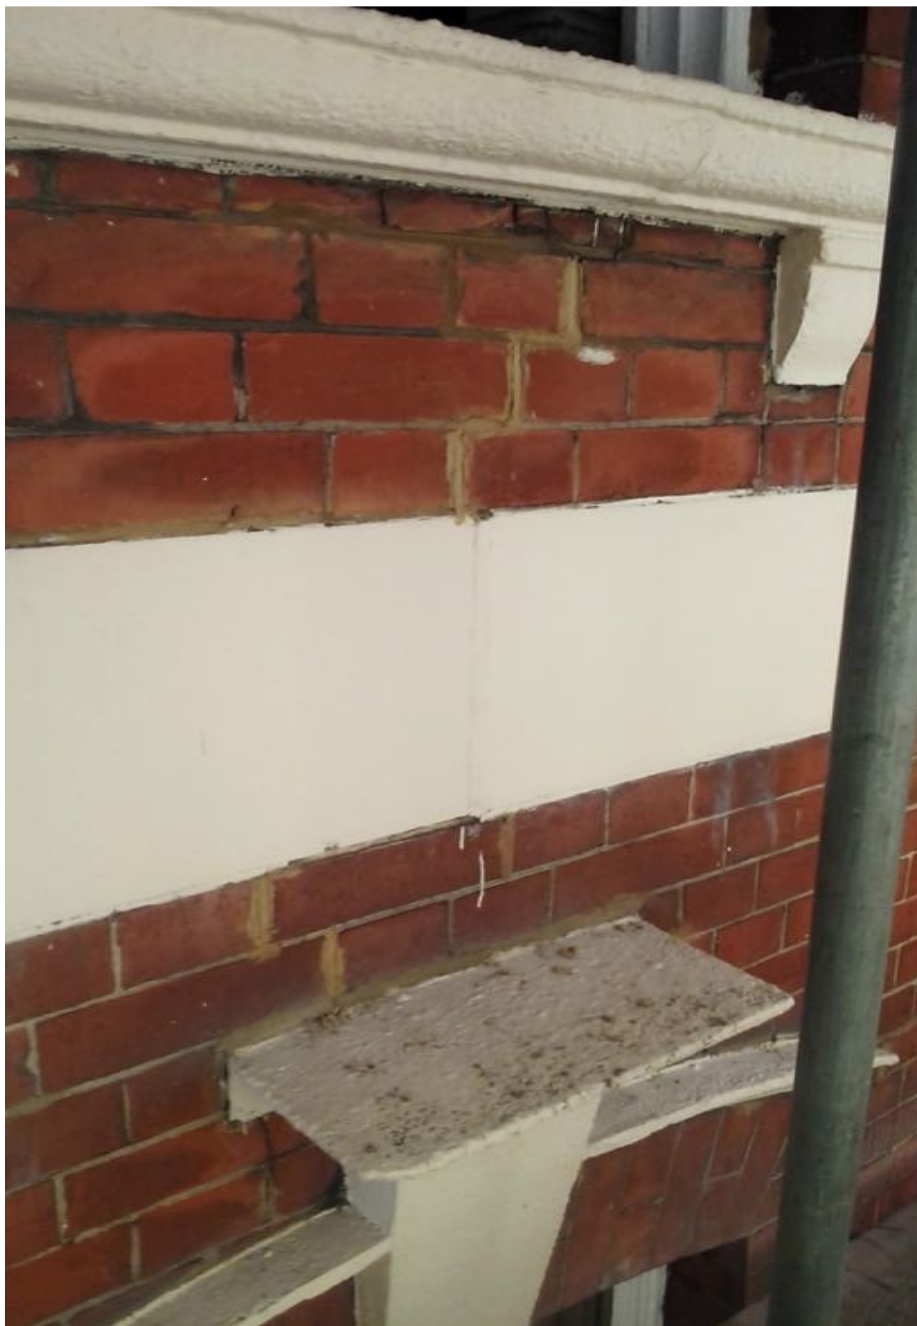
PHOTO 1

1. Recent repairs to cracks above ground floor windows. See photo 1

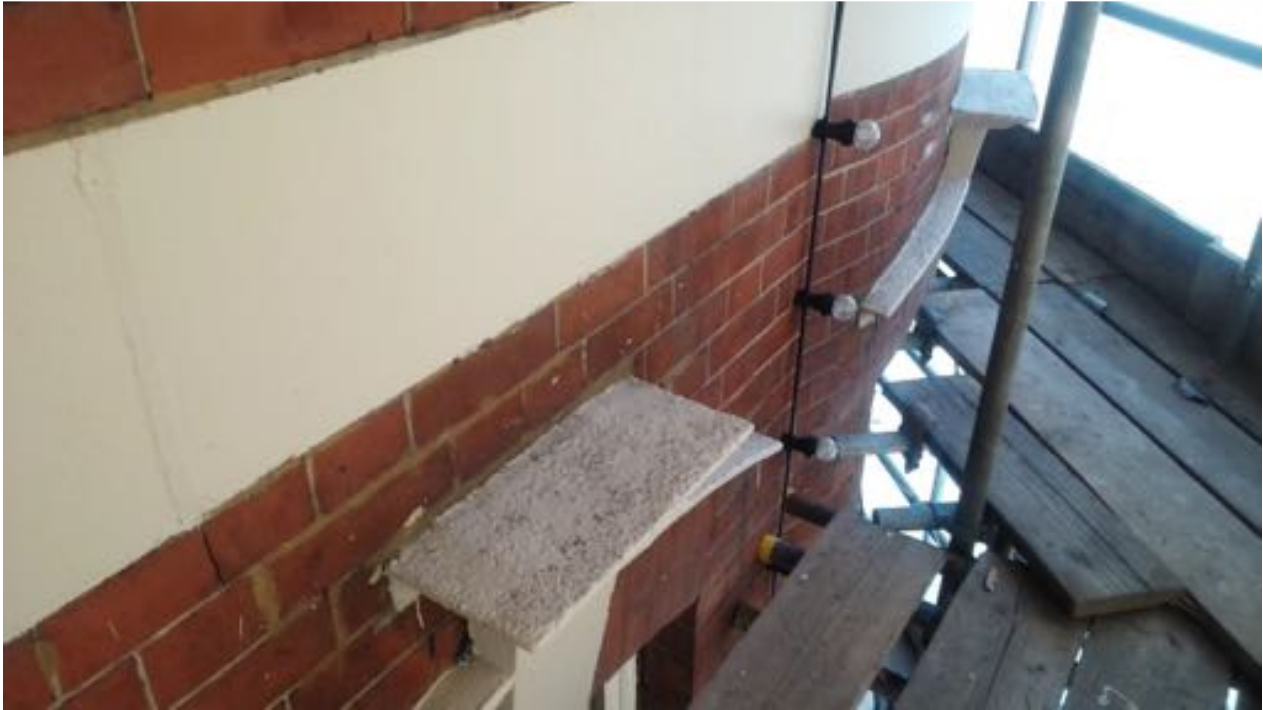
PHOTO 2

2. As item 1 but with open perpend. See photo 2
3. Vertical crack at the base of mullion. The crack continues through the stone margin down to the brickwork above the lintel. See photo 3

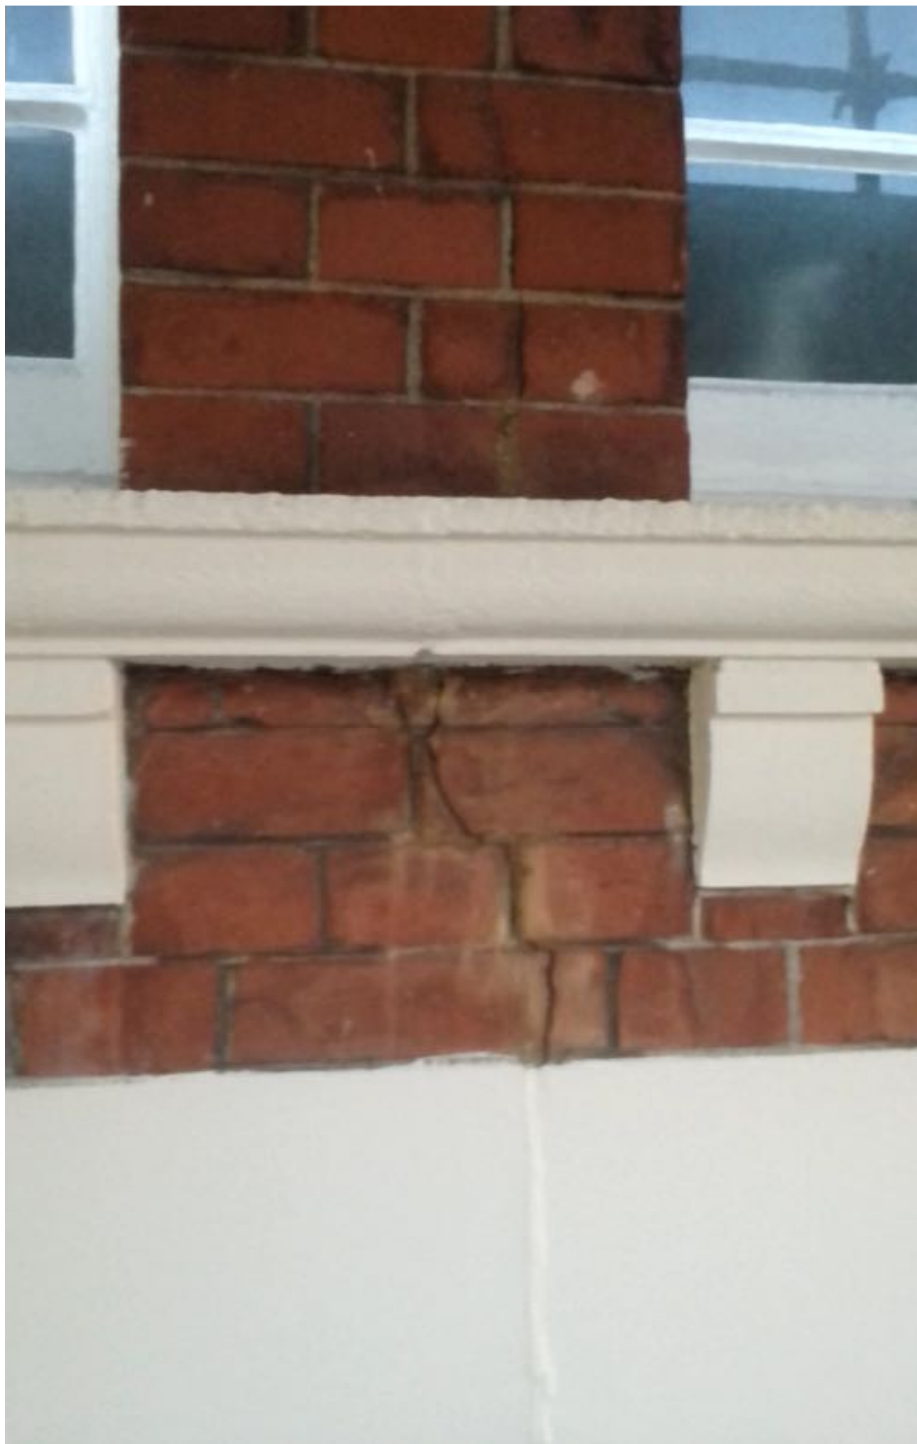
PHOTO 3

There is evidence of overloading to the masonry mullions. The fact that this cracking also extends down into the spandrel panels which could also indicate corrosion of steel beams supported by the walls. Further intrusive investigations are necessary. Meanwhile, the lintels either side of the mullions should be temporarily propped.

101. Place acrow prop either side of mullion at 1st floor (elevation facing Shelton St.)
ensure props have timber spreaders /packers top and bottom. DO NOT OVER
TIGHTEN.
102. Carefully cut out brickwork beneath mullion to expose end of steel beam.

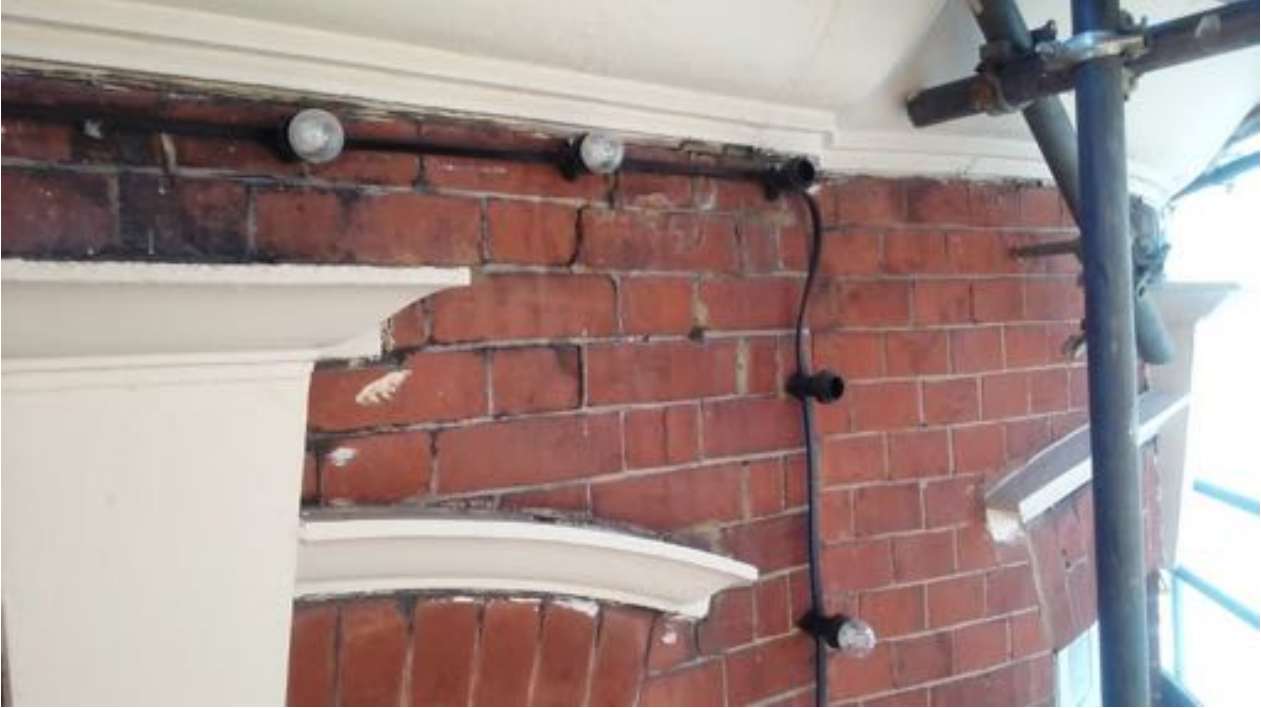
PHOTO 4

4. Diagonal and vertical cracking beneath parapet.
Lifting of parapet.
Displacement of arch
Water ingress beneath coping
See photo 4
5. Significant outward displacement of wall at end of parapet. See photo 5
6. Previous crack repairs to replace open perpend and bed joints. One perpend still left open. See photo 6
7. As item 5, but end cut brick has fallen off. See photo 7

The coping to the parapet has moved due to thermal expansion. There are no expansion joints in the coping, thus the outward thermal movement is maximum at the ends of the parapets. The movement at this property has been sufficient to displace bricks at the ends. This is potentially dangerous. Furthermore the lifting of the coping due to the thermal movements has caused gaps to appear, allowing water ingress. This water is damaging the brickwork and may be causing damage to the internal elements of structure also.

1. Carefully remove and set-aside for re-use full length of coping stones on both parapets.
2. Carefully remove mortar on top of parapet.
3. Lay mortar bed.
4. Lay 1st course of DPC. (Type to be suitable to resist tension, e.g. 2 courses slate or creasing tiles)
5. Lay mortar bed.
6. Replace coping stones. Leave 30mm gap every 3m.
7. In location of gap carefully remove top mortar bed.
8. Inset suitable silicone mastic into gap to form expansion joint.
