ARBORICULTURAL IMPACT ASSESSMENT REPORT:

9 Harley Road
London
NW3 3BX

Ref: SHH/9HRR/AIA/01

Date: 23rd November 2015

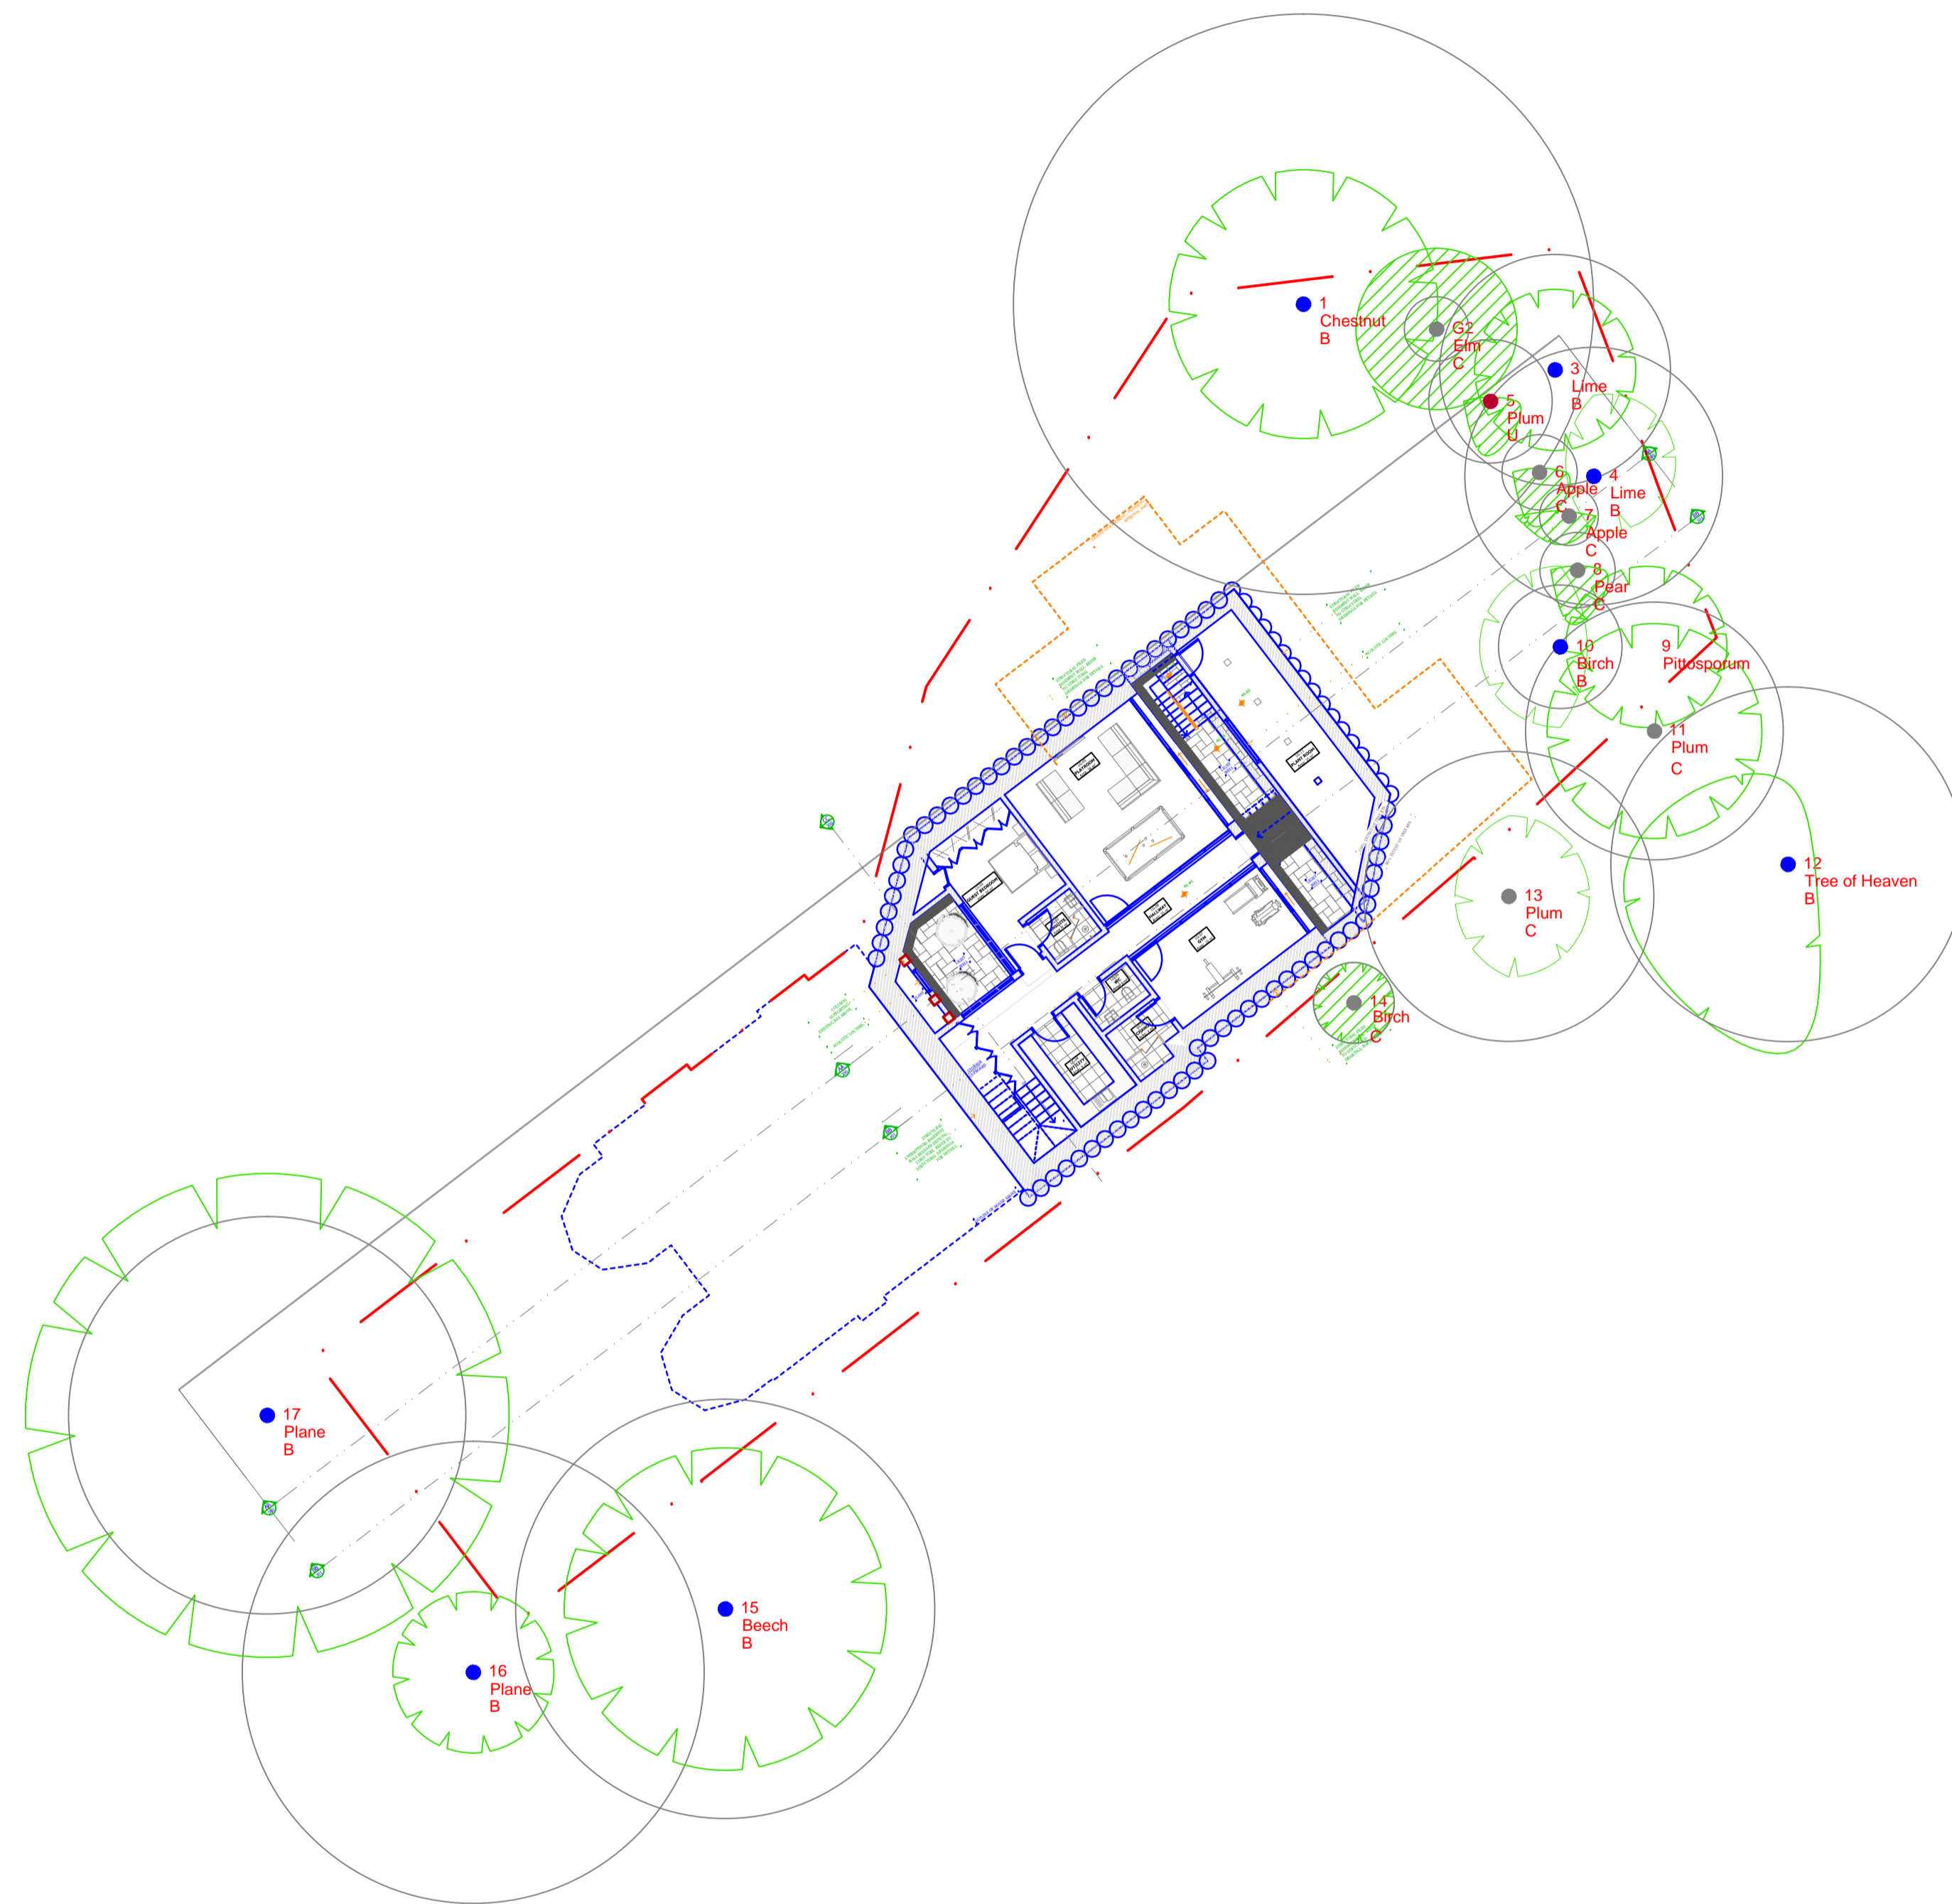
Proposed Lower Ground Floor Plan

6.1.2 There are theoretically low impacts from basement proposals to the off-site, category C tree, T13, which are likely to be very low in practice, due to the foundations of the summerhouse in its current location. As a precautionary measure, it is recommended that the basement line is manually excavated to 750mm, with pre-emptive root pruning if required. Manual excavation is also proposed for the minor encroachment of additional hard landscaping within the RPA of the category B tree T1. In addition, there is a small area of additional hard landscaping proposed within the RPA of the category B tree T1, which should be manually excavated and any roots lying beneath the surface pre-emptively pruned.

- 6.3.2 The path of foundations through RPAs will be manually excavated to 750mm depth under arboricultural supervision; any roots encountered within the trenches / pits will be cleanly pruned back to an appropriate junction with a sharp pruning saw or secateurs back to a junction. Roots larger than 25mm diameter may only be cut in consultation with an arboriculturalist.

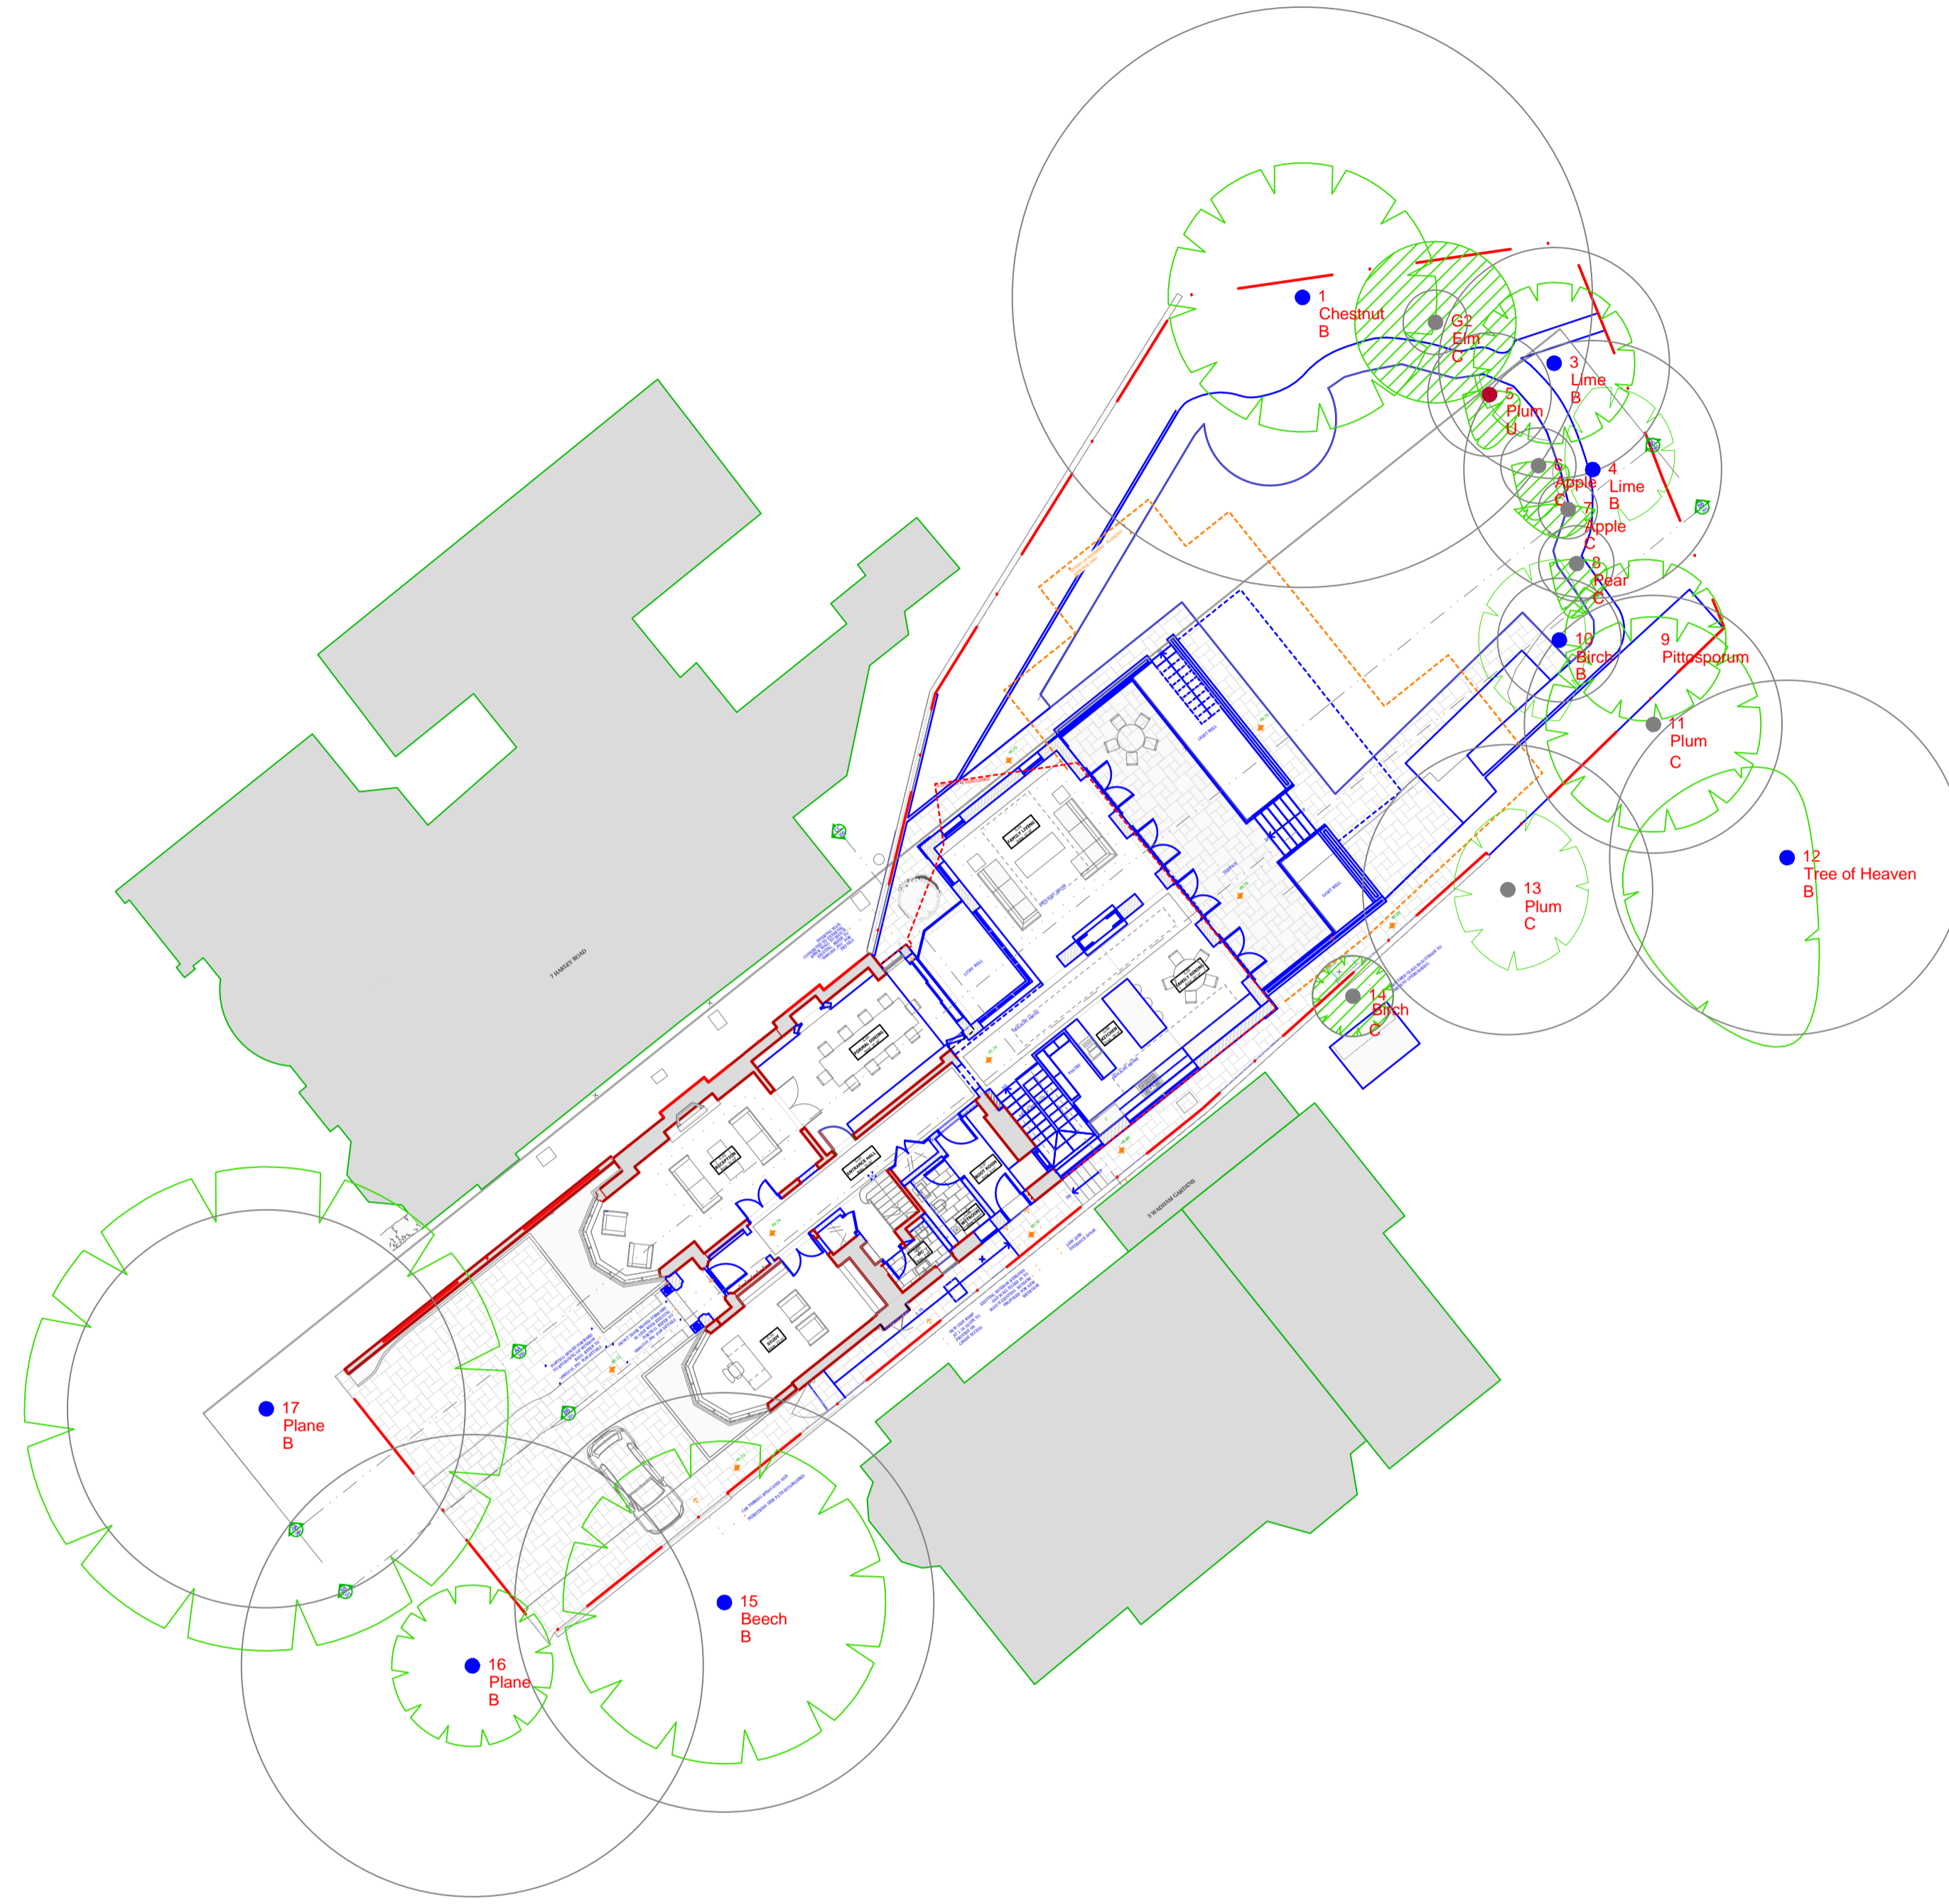
Proposed Ground Floor Plan

- 1.3 The principal primary impacts of the scheme involve the relocation of the summerhouse beneath the canopy of the semi-mature, category B birch tree, T10: the proposals indicate a new path adjacent to the stem of this tree, additional hard standing and the summer house structure within 27% of the theoretical RPA; the tree currently has a 2m ground clearance, therefore minor tree works would also be required to crown lift the tree to provide sufficient clearance for construction. These proposals could have potentially significant impacts upon a birch tree, but it is a relatively young specimen (rated B for future merit, rather than current stature), capable of sustaining this level of site disturbance with suitable mitigation. The indicative path should be relocated to allow a minimum area of 1m² around the stem of the tree to be kept clear; the summerhouse should be built on low-invasive foundations, with any additional hard-standings constructed on a no-dig basis with porous surfaces. Subject to the proposed mitigation, and minor tree works to raise the canopy, the impacts can be rated as low for a semi-mature birch tree.

6.1.3 There are further primary impacts to the category B street trees T16, T17 and off-site T15 from the proposed new access, resurfacing and street fencing to the front of the property. These can be mitigated with low invasive foundations for the street fence and no-dig replacement surfaces. The street tree, T16, will benefit from relocation of the access, as the existing one lies adjacent to the stem.

- 6.3.3 The replacement paving/hard landscaping will require a no-dig construction technique, either using a cellular confinement system with no fines aggregate for the sub-base or simply building upon the existing sub-base without disturbing the ground below. Choice of construction method will initially depend upon root penetration within the existing sub-grade. The key principle is not to excavate in the presence of roots and to provide a porous surface to promote healthy soil water relations for future root growth. A further consideration in the use of a more expensive cellular confinement system or similar, may be the claimed reduction in risk of possible future slab / surface displacement by roots of trees growing in paved areas.

- 6.3.4 The immediate canopy encroachment can be avoided with a crown lift of lower limbs of T10, affecting a 3m ground clearance.
- 6.3.5 Nuisance deposition can be further mitigated with routine maintenance, light pruning / deadwooding and the fitting of filtration traps on guttering (see Figure 5 below).
