Addendum Arboricultural Note (BS5837:2012)

59 Redington Road
London
NW3 7RP

14th December 2015

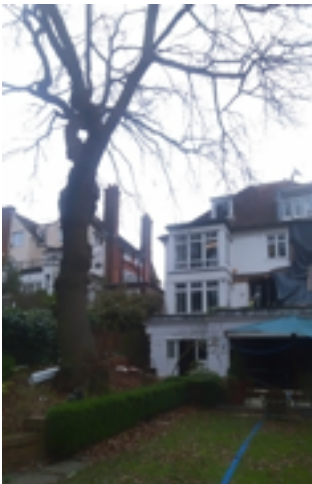
4.5.1 Tree T1 shows very similar attributes with continued occluding growth of the main cavity at the base of the tree. No works have likely been carried out since the tree survey was carried out in 2009.

B.1 Photograph of tree T1 within the rear garden of 59 Redington Road, London, NW3 - as viewed from south west to north east

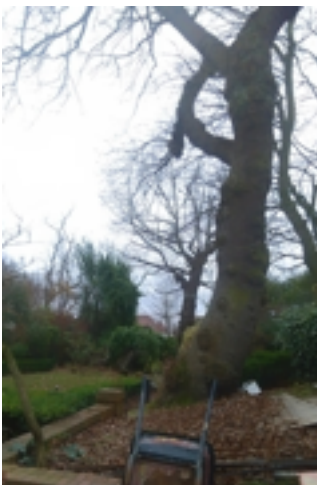
B.2 Photograph of tree T1 within the rear garden of 59 Redington Road, London, NW3 - as viewed in a southerly direction

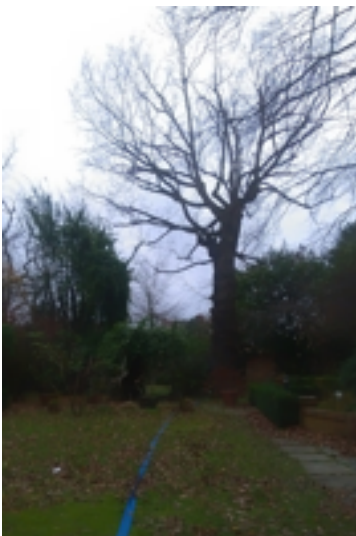
4.5.3 Tree T3 is a mature ornamental Cherry tree which has not likely changed within the past 6 years since the report in 2009 in relation to the form and structural integrity of the tree.

B.3 Photograph of tree T3 within the rear garden of 59 Redington Road, London, NW3 - as viewed in a southerly direction

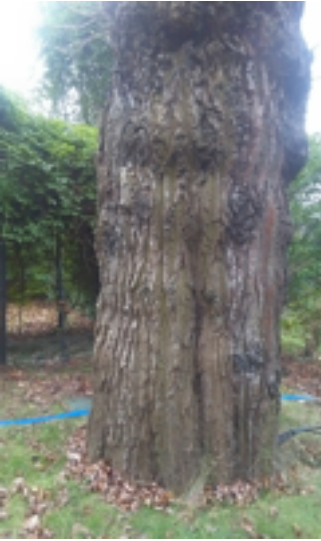
4.5.2 Tree T2 shows declining health with significant deadwood and a sparse upper crown. The limited root flare and abrupt stem to ground level connection suggests a possible level change which is historic / not recent with a possible excess of soil on the root plate. The tree retains fair form but the condition does limit overall lifespan.

B.4 Photograph of northern base of tree T2 within the rear garden of 59 Redington Road, London, NW3

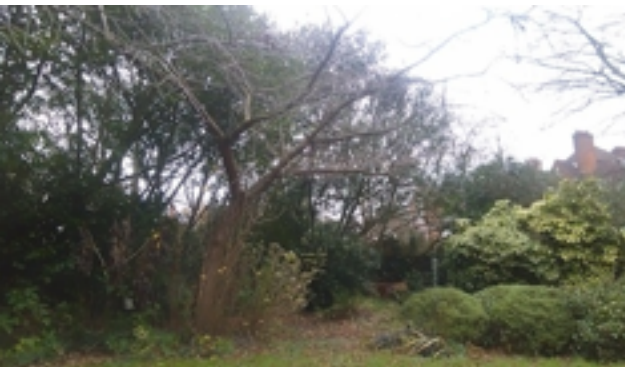
B.5 Photograph of tree T3 within the rear garden of 59 Redington Road, London, NW3 - as viewed in a northerly direction

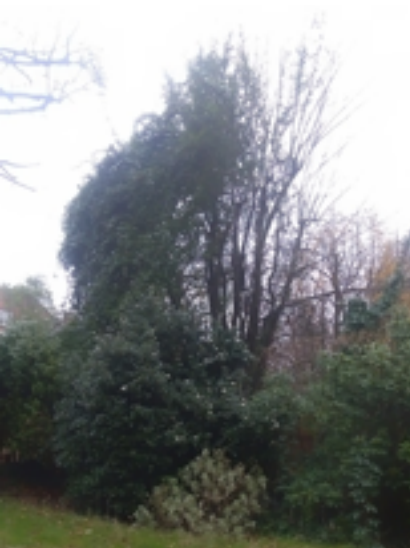
4.5.4 Tree T4 had been recently crown reduced in 2009 when the original survey was carried out. 5 years of maturing epicormic growth since have led to an re-established main crown which is also ivy / climber clad to 10 metres height.

B.6 Photograph of tree T4 within the rear garden of 59 Redington Road, London, NW3 - as viewed in a south easterly direction
