Engineer's Report

Our Reference **IFS-AVI-SUB-14-0052426**
Claim Reference **14C600459**
Prepared for **Aviva**

Report Date **15 August 2014**
Policyholder **Hill Limited**
Address **96 Haverstock Hill, London, NW3 2BD**

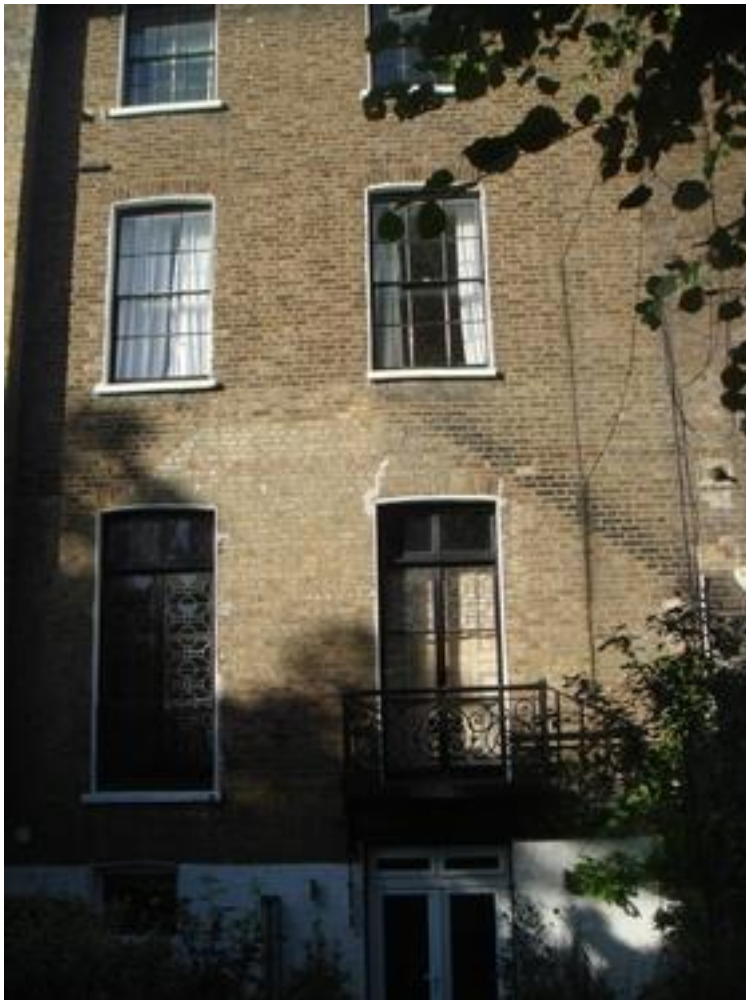
FIGURE 03 Rear Elevation.

No crack damage was recorded.
