Arboricultural Consultancy for Aviva

1. Case Details

Insured	Haverstock Hill Limited	Address	96 Haverstock Hill, London, NW3 2BD		
Client	Subsidence Management Services	Contact	Emily Bogie	Claim No.	IFS-AVI-SUB-14-0052426
ES Ref	NL/0110140922/TP-REV1	Consultant	Thomas Peppiatt	Contact No.	0330 380 1036
Report Date	02/10/2015 Revised: 16/10/2015

Scope of Report: To survey the property and determine significant vegetation contributing to subsidence damage, make recommendation for remedial action and assess initial mitigation and recovery prospects. The survey does not make an assessment for decay or hazard evaluation.

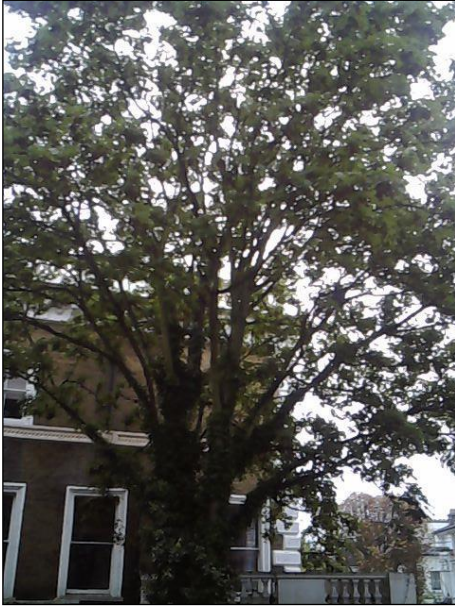
T2 - Acer

Site Investigations from 2014 revealed the presence of functionally active *Ulmus* roots in TP/BH1 to a depth of 1500mm and 1900mm in TP/BH2; this depth is in excess of foundations which extend to a depth of 500mm in TP/BH1 and 1200mm in TP/BH2.

Functionally active *Acer spp* and *Ulmus spp* roots were also found in BH3 (2015) down to a depth of 3000mm below ground level.

Our survey of the site identified T2 (Acer) and T3 (Elm), which, given their position relative to the damage it is our opinion that the roots identified emanate from these trees.

In assessing the extent of damage and the potential drying influence of the vegetation on site, T2 (Acer) and T3 (Elm) are judged to be the dominant features and accordingly we have identified them as the principal cause of the subsidence.

Tree No.	Species	Age Cat	Approx. Height (m)	Distance to Building (m)	Ownership	Action	Requirement
T2	Acer	1	17	8	F - Commercial Third Party	Remove	Remove and treat stump to inhibit regrowth.
T3	Elm	1	15	10.5	C - Insured	Remove	Remove and treat stump to inhibit regrowth.
T5	Pear	1	9	1	F - Commercial Third Party	Remove	Remove and treat stump to inhibit regrowth.

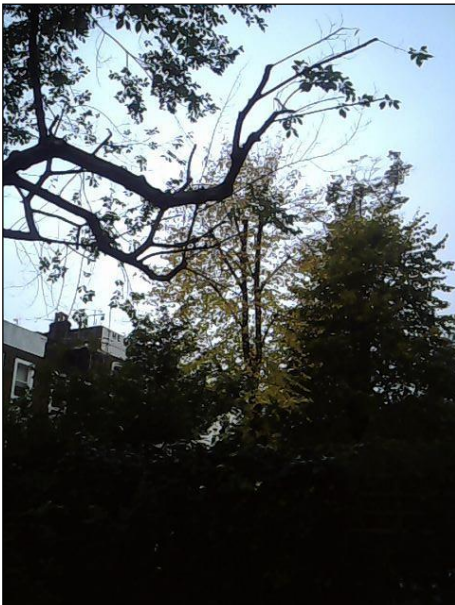
T4 - Lime

Please note that the footing of the subject property fall within the likely rooting zone of a further tree identified as T1 (Lime); this tree is noted to present a theoretical future risk.

Tree No.	Species	Age Cat	Approx. Height (m)	Distance to Building (m)	Ownership	Action	Requirement
SG1	Mixed species group including Cordyline and Fern.	1	1	1	C - Insured	Action to avoid future risk	Do not allow to exceed current dimensions by way of regular pruning.
T1	Lime	1	16	10	A - Third Party 98 Haverstock Hill London NW3 2BD	Action to avoid future risk	Remove and treat stump to inhibit regrowth.
T4	Lime	1	11.5	16	A - Third Party 98 Haverstock Hill London NW3 2BD	Action to avoid future risk	Do not allow to exceed current dimensions by way of regular pruning.
TG1	Mixed species group	1	17	15	A - Third Party 100 Haverstock Hill London NW3 2BD	Action to avoid future risk	Reduce Beech to 14m in height and maintain at reduced dimensions. Do not allow Lime to exceed 12m max height current dimensions by way of regular pruning.

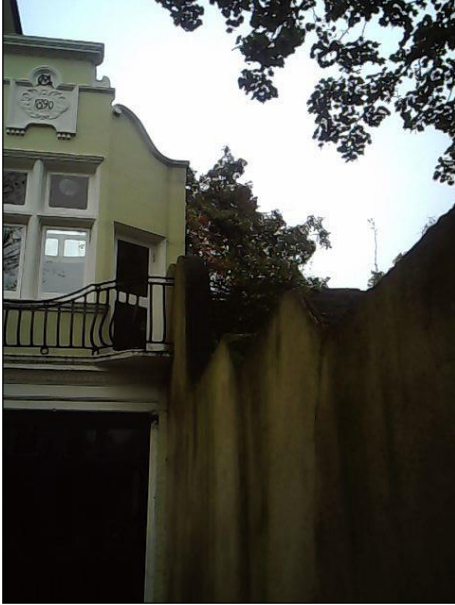
T5 - Pear

There is currently no positive root identification to implicate the causal elements of T5 (Pear), however, based on our assessment on site we consider that the footings of the subject property fall within the anticipated rooting zone of this vegetation.

T5 (Pear), cannot be discounted as contributing to the overall level of soil drying proximate to the area of damage and is therefore also considered to retain a contributory influence, albeit in a limited / secondary capacity when compared to T2 (Acer) and T3 (Elm).
