## **Subsidence Claim Addendum Report**

Our Reference: IFS-AVI-SUB-14-0052426

Claim address: Haverstock Hill, London, NW3 2BD

This report has been prepared to support an application to remove statutory protection on implicated vegetation and removal of the same in order to stabilise the garden flat.

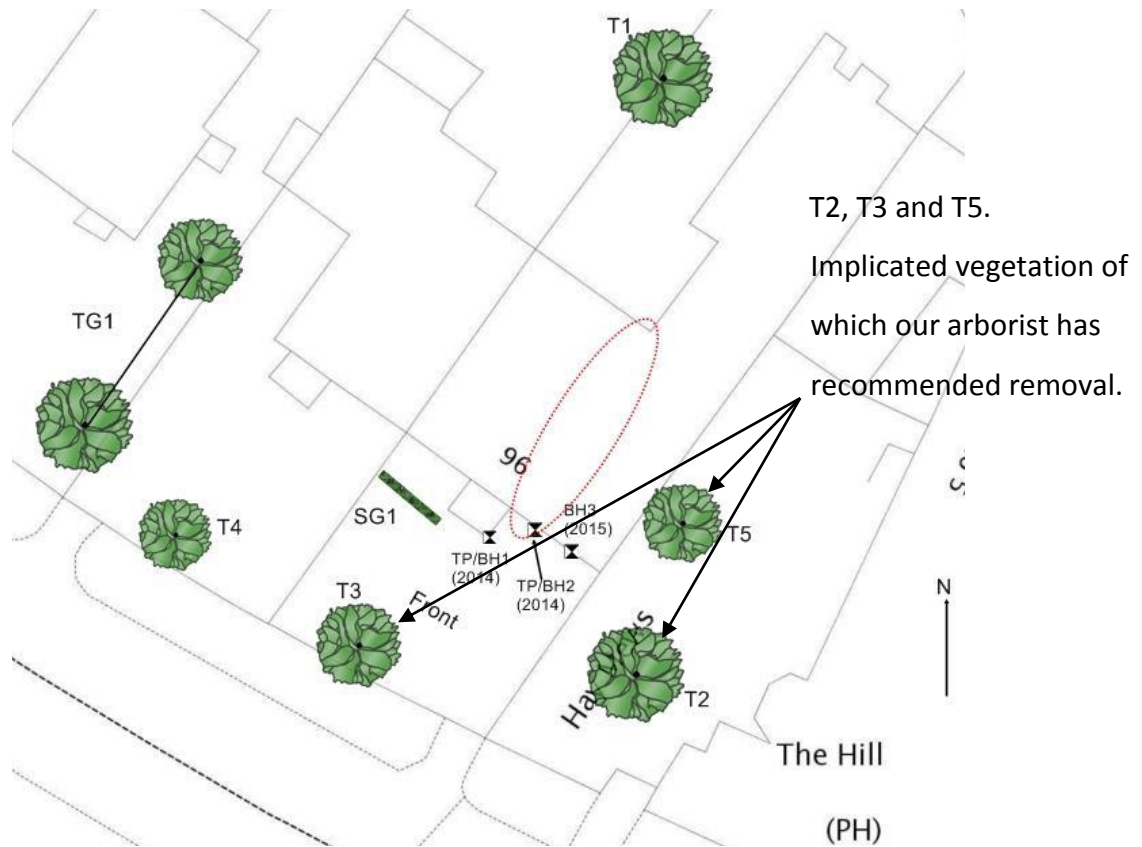
Figure 1 – site plan showing the location of the principal vegetation in relation to the property

The arboricultural consultant has advised that they have implicated T2 (Acer), T3 (Elm) and T5 (Pear), also based on their assessment, the footings of the subject property fall within the anticipated rooting zone of this vegetation.

The implicated vegetation is therefore deemed to retain the capacity to be causal to the current movement and building damage. In assessing the potential drying influence of the vegetation on site, T2 (Acer) and T3 (Elm) are considered the dominant features and accordingly the arboriculturist has identified them as the principal cause of subsidence.

T5 (Pear) cannot be discounted as contributing to the overall level of soil drying proximate to the area of damage and is therefore also considered to retain a contributory influence, albeit in a limited or secondary capacity .

The arboricultural consultant has recommended the removal of T2 (Acer), T3 (Elm) and T5 (Pear).

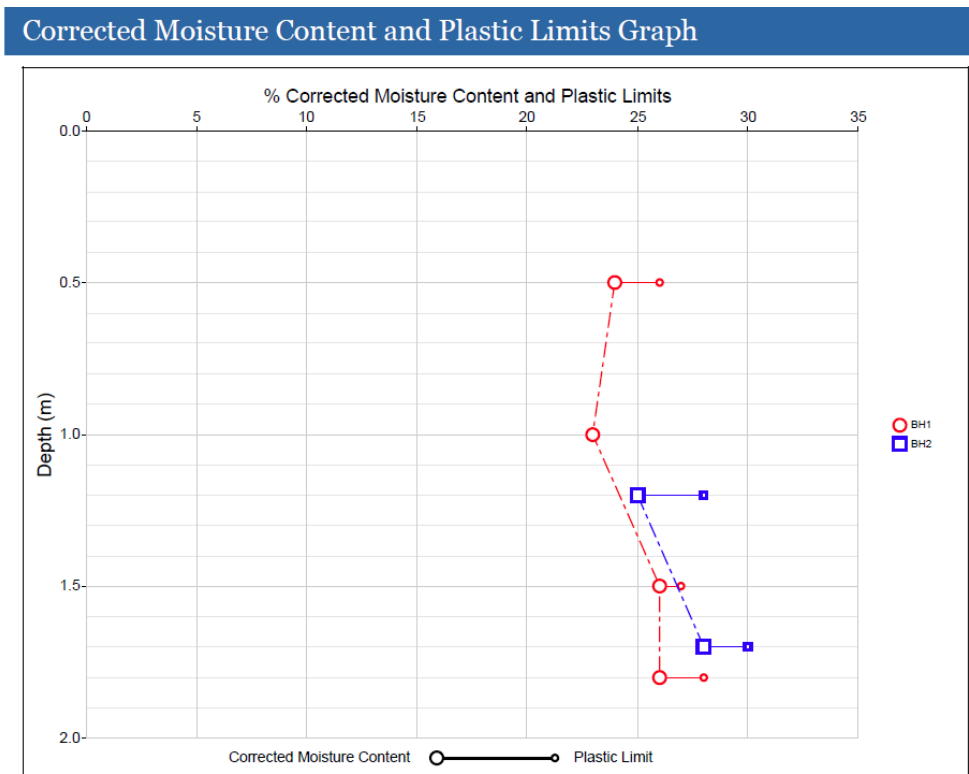
The results indicate that the clay at a shallower depth has a lower than expected moisture content, the moisture content increases with depth down to 1.80m in boreholes 1 and 2 but decreases with depth in borehole 3 after reaching 1.20m. The moisture contents of between 23% and 33% (across the 3 boreholes) are low for the time of the year that they were taken.

Figure 3 – moisture content and plastic limits graph

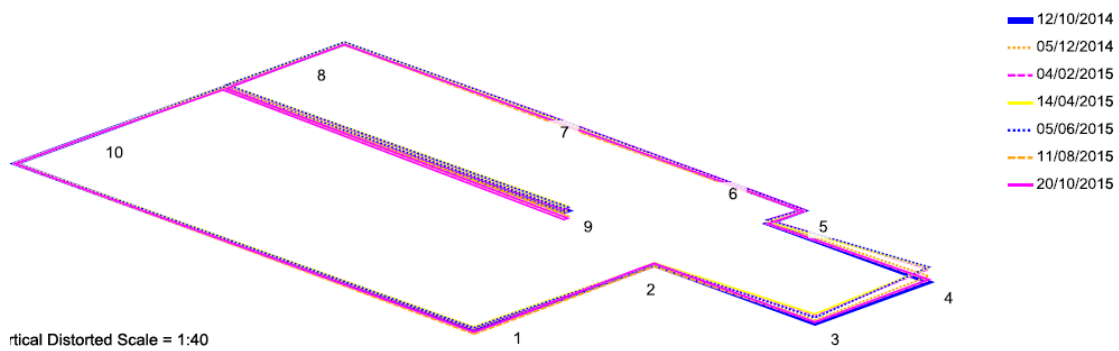
Figure 4 – areas of fixed pins.

The level monitoring has shown that the property is affected by seasonal downward movement to the front elevation/steps with the maximum degree of seasonal downward movement occurring to point 4 in the region of 10 mm overall.

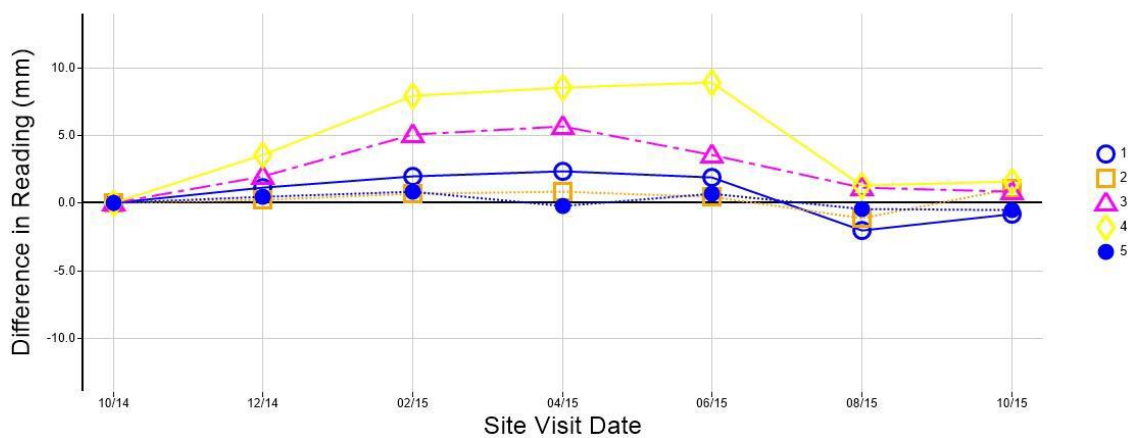
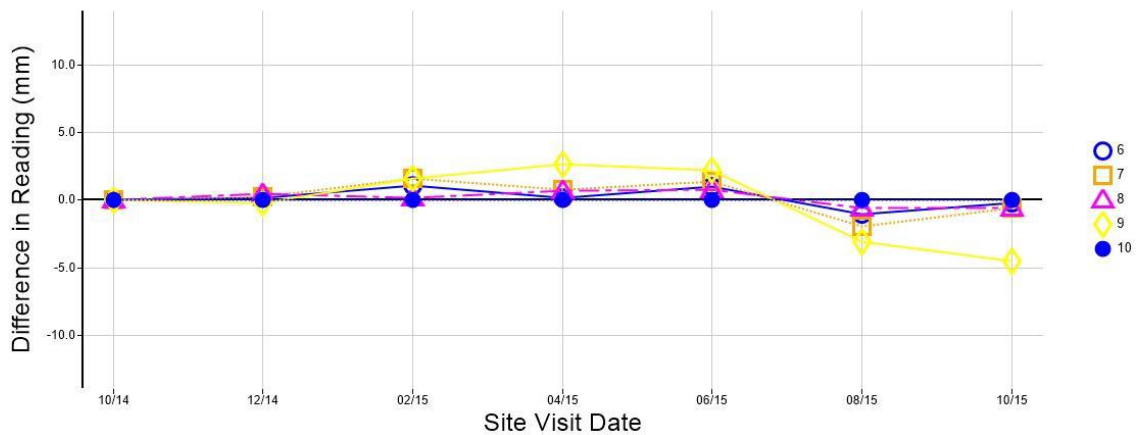
The monitoring shows the affected parts of the property moving downward during the summer months when the trees are in leaf demanding larger amounts of water, the rainfall is lower and the net moisture content within the clay soil below the property decreases.

Recovery or upward movement is then witnessed during the winter months when the tree loses leaf, demands less moisture and the rainfall events increase, allowing the soil to rehydrate to some degree and swell, causing upward movement and consequential closing of cracks within the property.

Figure 5 – level monitoring 10/14 – 10/15

The level monitoring program to date clearly indicates downward movement through summer 2014 with recovery becoming evident with the onset of the wetter winter months.

This demonstrates that the identified offending trees are the cause.
