# LEVEL MONITORING for Subsidence Management Services

### 96 Haverstock Hill, Lower Belsize Park, London, NW3 2BD

Client:	Subsidence Management Services
Client Contact:	Raymond Borrow
Claim Number:	14C600459
Client Reference:	IFS-AVI-SUB-14-0052426
Policy Holder:	Haverstock Hill Limited
Report Date:	23 October 2015
Our Ref:	M3868

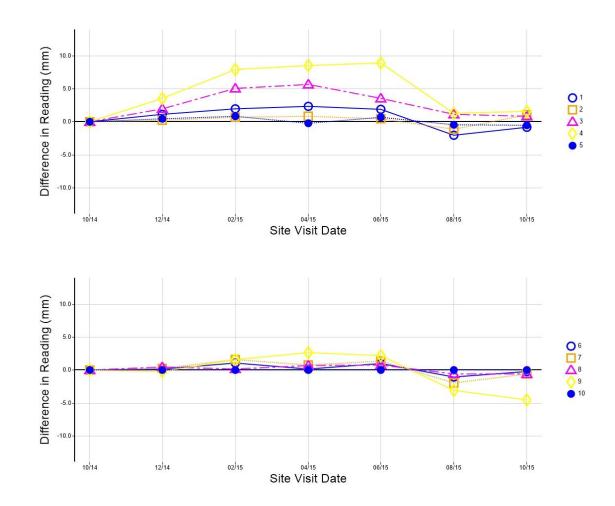
### Level Monitoring Difference Graphs

The following graphs display the progressive movement that each Level Monitoring Station recorded at each separate site visit date to give an overall look at how much the property is moving.

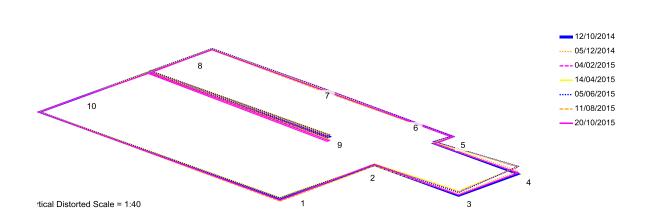
## Level Monitoring Displacement Map

The following image shows an isometric representation of the movement of the property, based on the Level Monitoring Stations that were installed.
