35-37 Fitzroy Street, London, W1T 6DX

Listed building Consent
ref: FitzroyStreet0011

EXISTING SITUATION

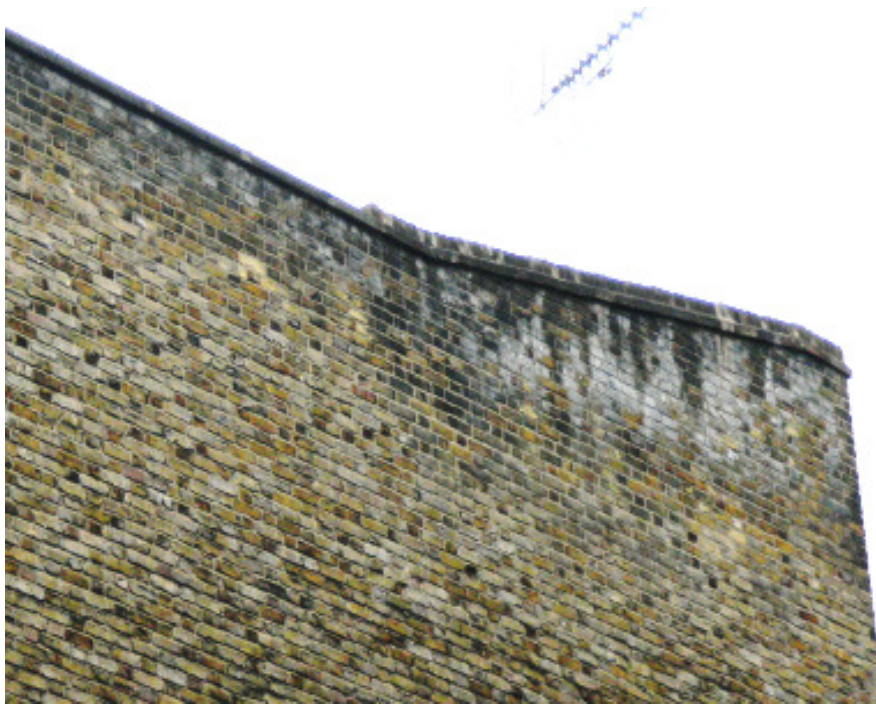
Photo #1

There is damp coming into the top floor. The dampness originally appeared in summer 2014 on the West wall. At the time we did repointing on the roof. See photo #1.

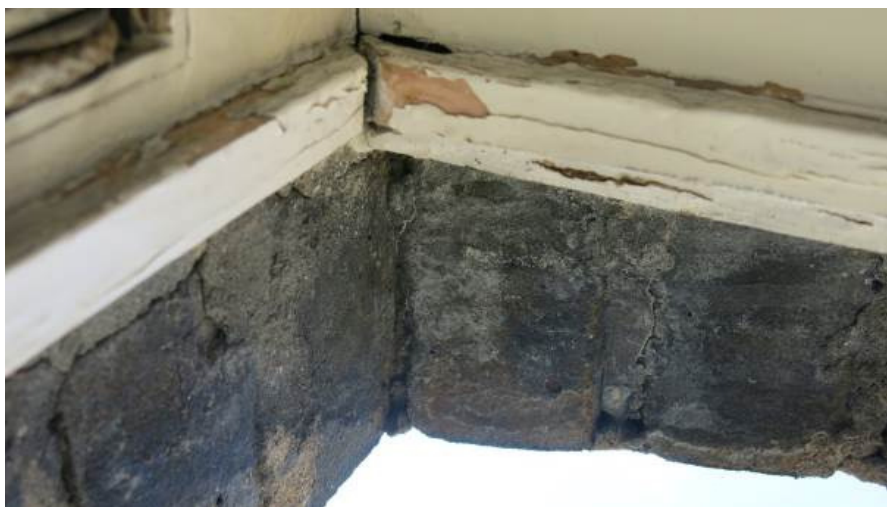
Photo #2

Recently at a closer inspection of the top corner of one of the windows we noticed that the wood has rotted due to dampness and the brick has also discoloured. See photo #2.

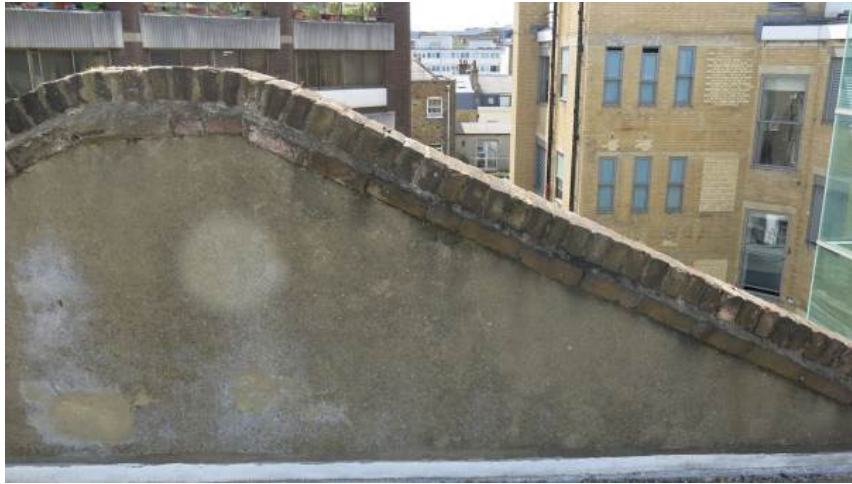
Photo #3

A number of roofing companies have come in and advised that the parapet wall in the roof needs a more rigorous approach. This is the cause of the discoloration of the top section part of the wall. See photo #3.
