## **SITE INVESTIGATION FACTUAL REPORT**

Report No: 287264  
Client: Cunningham Lindsey - Maidstone  
Site: 54 Compayne Gardens, London

Client Ref: 6095485-  
Date of Visit: 20/10/2015

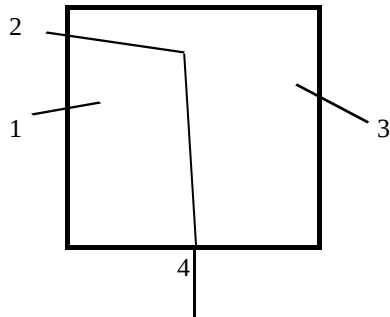
M/H: 1 Depth: 950mm

Manhole Condition

As built

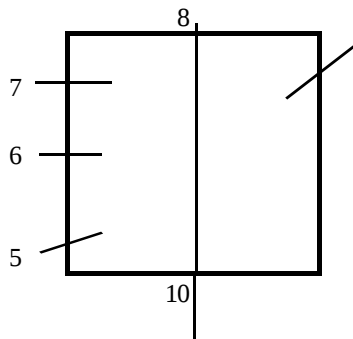
M/H: 4 Depth: 600mm

Chamber Dimension (mm): 650 X 450
