STRATEGIC PROPOSAL FOR TREATMENT OF EXTERNAL FINISHES AT ALEXANDRA ROAD AND AINSWORTH ESTATE

Prepared by Neave Brown

04.05.04

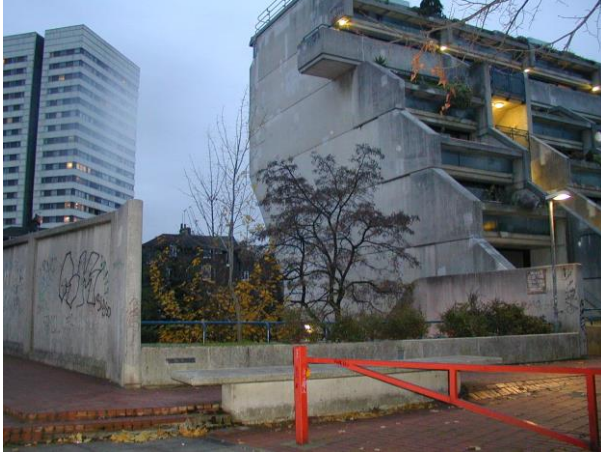
Current condition

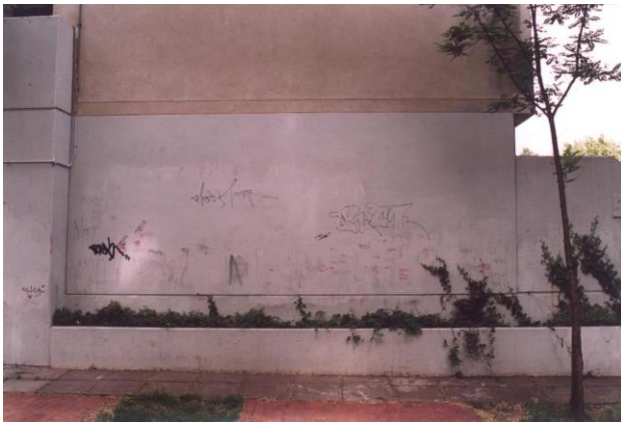
Bottom panel of render painted in with adjacent concrete – Architectural clarity lost.

Priority should be given to the rendered surfaces. Alexandra Road will never look good until they are treated. They should now be painted an 'off-white', carefully chosen and matched. This is as originally intended, will affect everything and will do more than anything to lift and brighten the buildings and create an optimistic environment. It is a genuinely renewable surface. It is understood that this work will require a major contract to cover all rendered surface of A, B, and C Blocks, and capital funding.

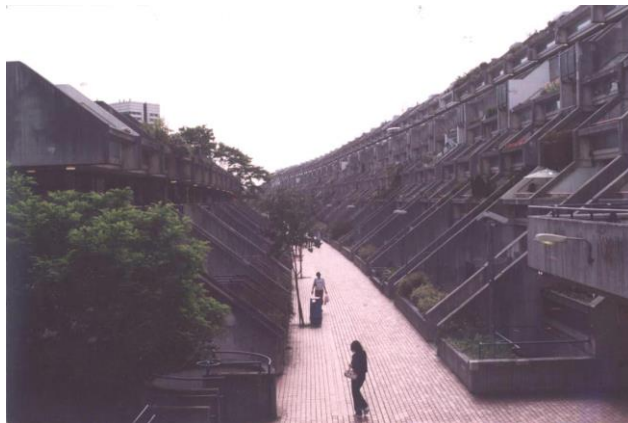
For this to succeed there must be a degree of uniformity and conformity in repetitive areas. Some local walls facing Rowley Way in A and B blocks, and C block south, have been painted (mainly white) by residents. I can see that this has been done to improve their immediate private environment and is likely to be a sensitive issue. However, they stand out in disruptive, jarring and conspicuous contrast, and destroy the form of the entire sweep of the building. They must be treated to return as far as possible to match adjoining concrete surfaces. This work, although local, is of primary importance.

Rowley Way: As existing – painted balconies

The treatment - painting an appropriate and matching grey to the adjoining concrete would be similar to recommendations for the painting of graffitied surfaces (see below). However, it should be 'once and for all' as opposed to the repetitive requirement for graffiti, and therefore might require a different specification.

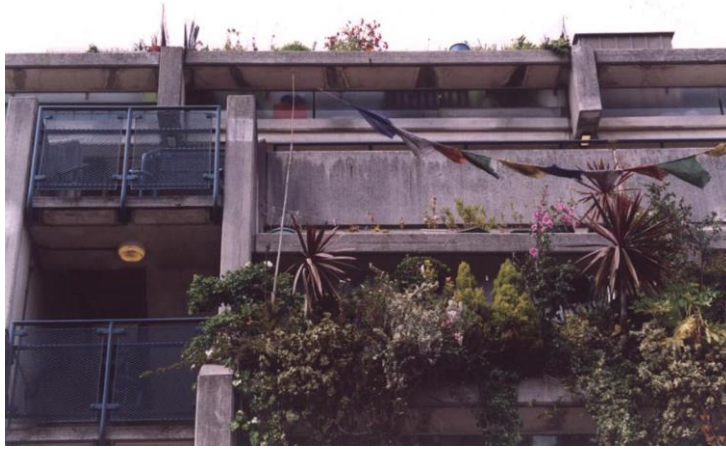
1. The underside of all precast planting bays at terrace fronts (A, B and C blocks) seen from below and forming one of the most conspicuous ranges of surfaces. The stains are due to an omitted drip detail to the drainage holes. The surface must be cleaned, perhaps painted, and a small drip element including a seal inserted.

Existing - Streaking under balconies

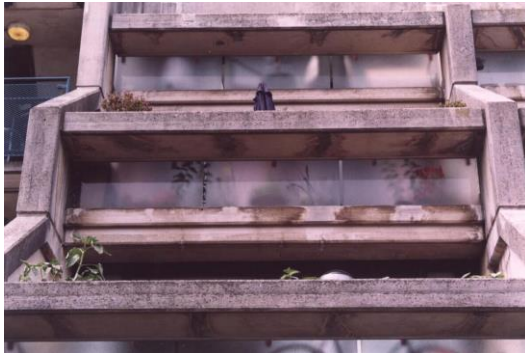
2. The narrow face of the profiled precast slab edges below the planting bays - A, B, and C Blocks which are streaked and need cleaning.
3. The face of the in situ planters between entrances, level 6 - B block north. These are very conspicuous and many badly stained with water both from above and from the planter itself, in strong contrast to the relatively clean bright concrete protected by the overhang above.
4. The surface of A Block staircase walls on the dwelling side at level 5,

Existing: Staining to planters

- 9.2 It was very effective across the entire surface of the B Block planters leaving only a ghost of the stain. All these surfaces should be cleaned and a study should be done to find a simple way of preventing the localised overspill of water which causes the stain. Since cleaning it appears that the ghost of the stain attracts further staining, and an experiment with silicone could be tried. Such an experiment could be useful for determining further work (see below). It was more difficult on the A Block stair wall.

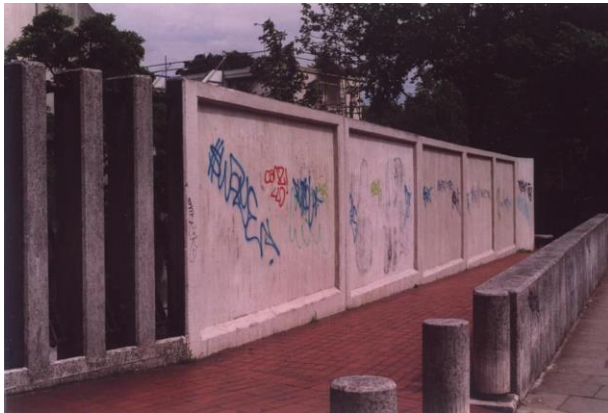
Existing: Graffiti on recently cleaned concrete.

- 11.1 It is my opinion that the painting out of the graffitied surfaces is the right method - the work of people on site doing this is already tireless and impressive. My suggestions are either in the context of, or in preparation for, the painting of rendering. In any case, it is important that the painting matches as far as possible the adjacent concrete, and intensifies rather than obscures the distinction between concrete and rendering. The two surfaces, even if adjacent, should not be painted the same colour.

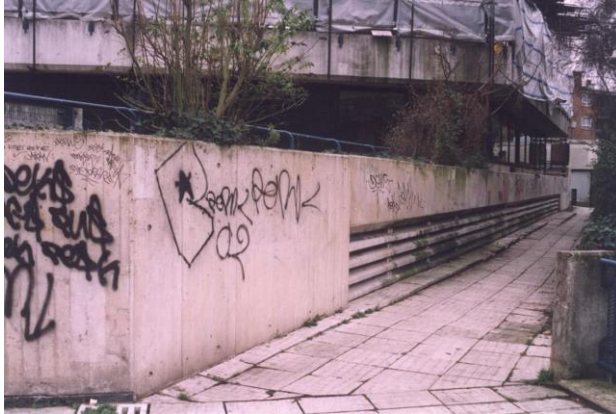
Existing: Graffitied wall near community Centre

- 11.3 A crucial question is the extent of painting on any uncoffered surface. All surfaces are outlined by chamfers and grooves and have the look of distinct elements. Painting to the edge of the chamfer may look right in some cases, but wrong in many (as it does already). I think that some walls will look better and retain their architectural role if the painting is like a panel, an area within an unpainted edge - either lighter or darker than the surround. It would also have some consistency with coffered walls. An example would be the graffitied walls above the louvres to the south of the Community Centre on the main walkway.

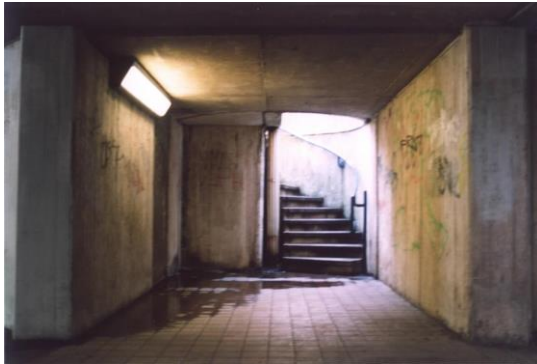
These areas have deteriorated badly and in some places are menacing and squalid. It is understandable that lower service areas get less (or look as if they get less) of the limited available care. However (as with the painting of rendering) the cleaning and decorating of these places could civilise and lift the quality of the environment for everyone and help to bring back into full use neglected facilities.

Existing: Poor quality service areas.
