Site Visit Date: 26.11.2015

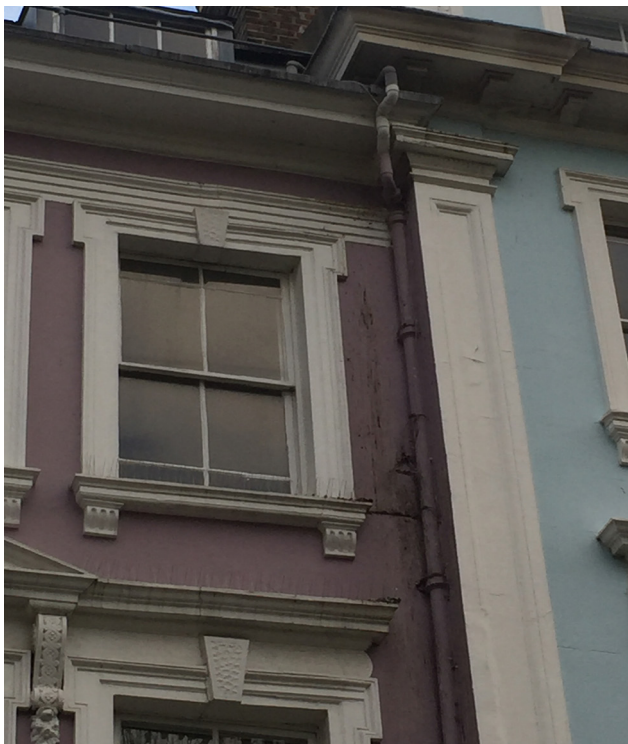
Close up of front elevation showing window header with historic settlement..

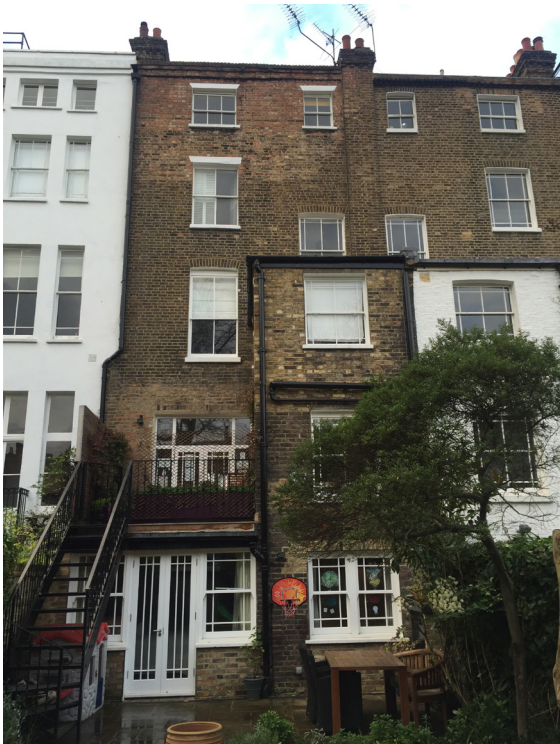
Rear elevation showing areas which have been repaired or rebuilt.

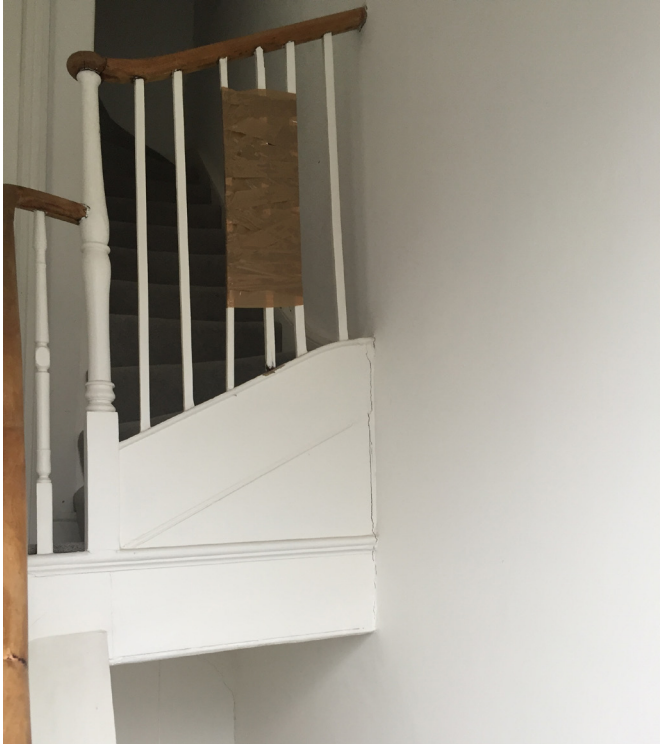
Landing at second floor with narrow crack.

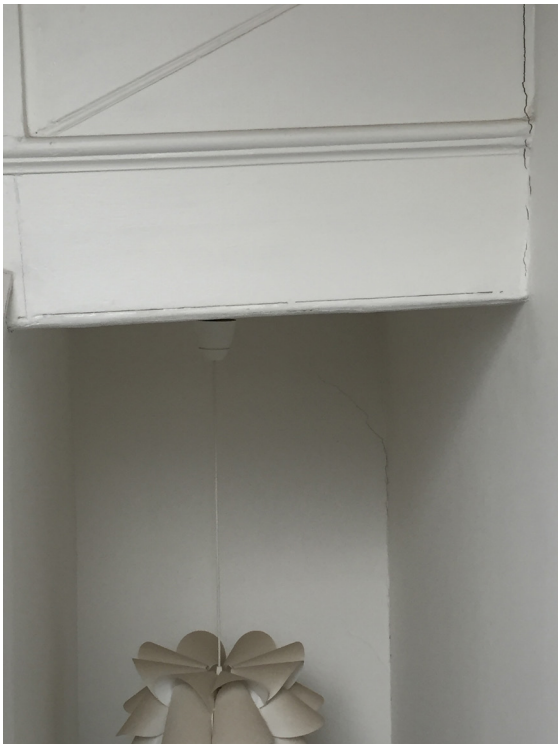
Landing at second floor showing settlement

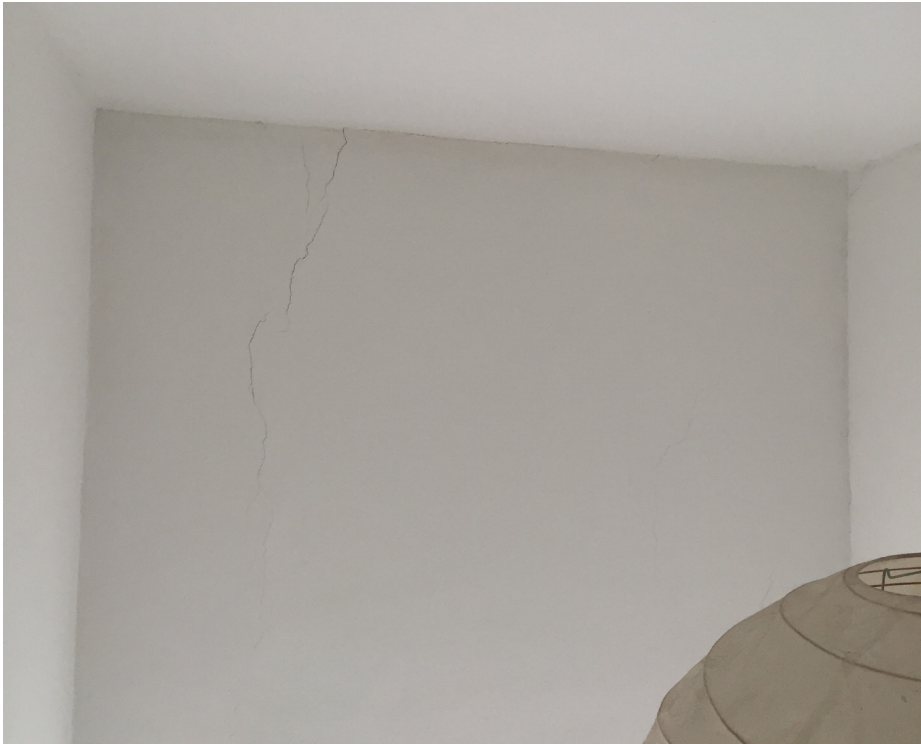
Minor crack in wall above staircase at second floor level

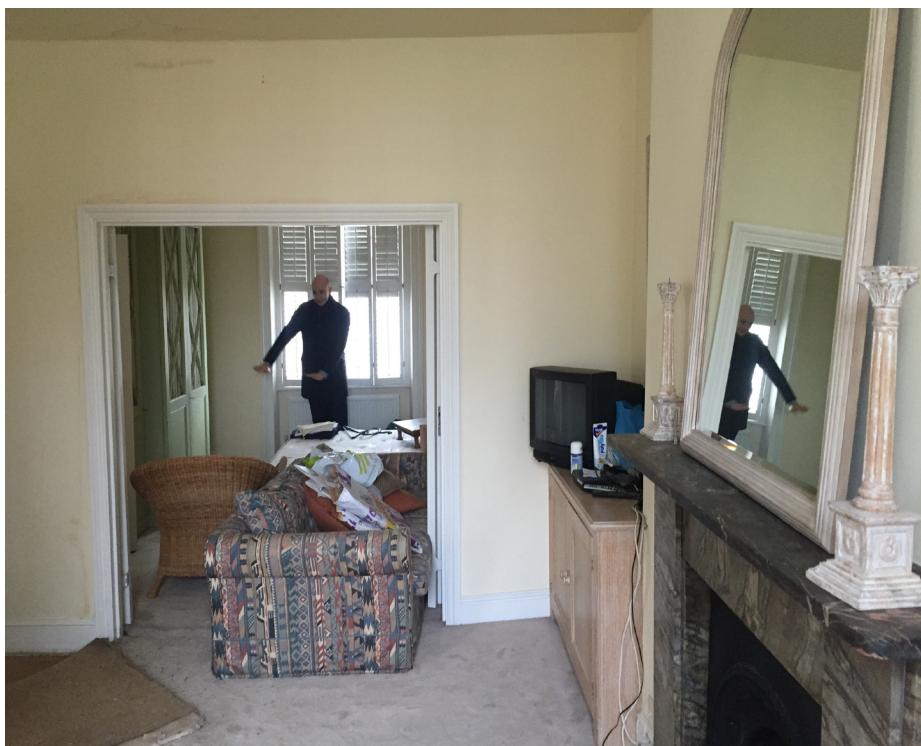
Spine wall at second floor showing direction of settlement towards left hand side

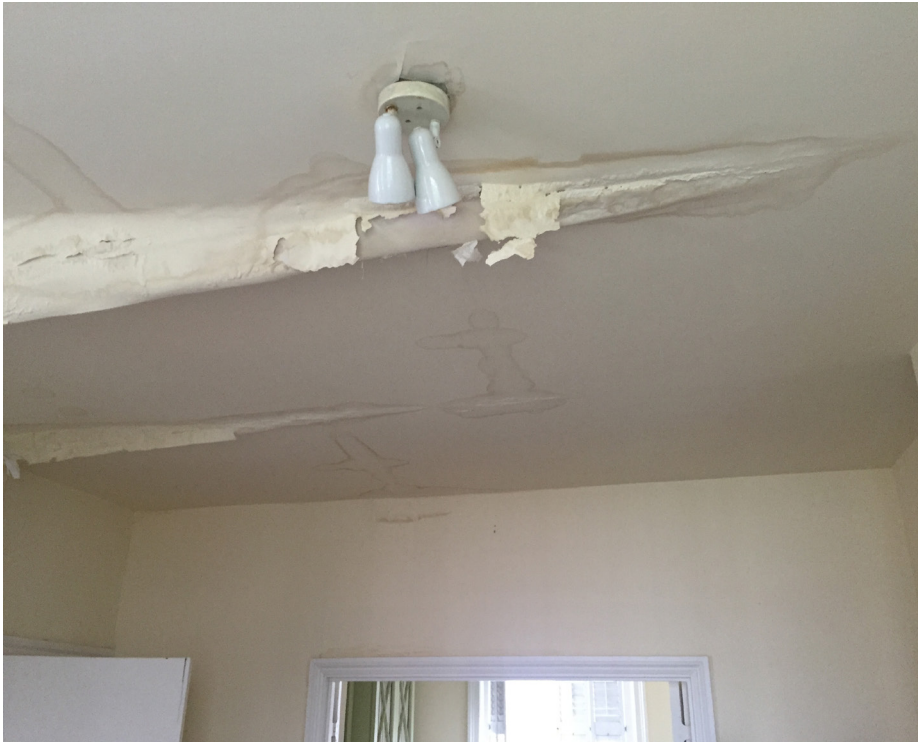
Second floor ceiling showing direction of slope of joists above

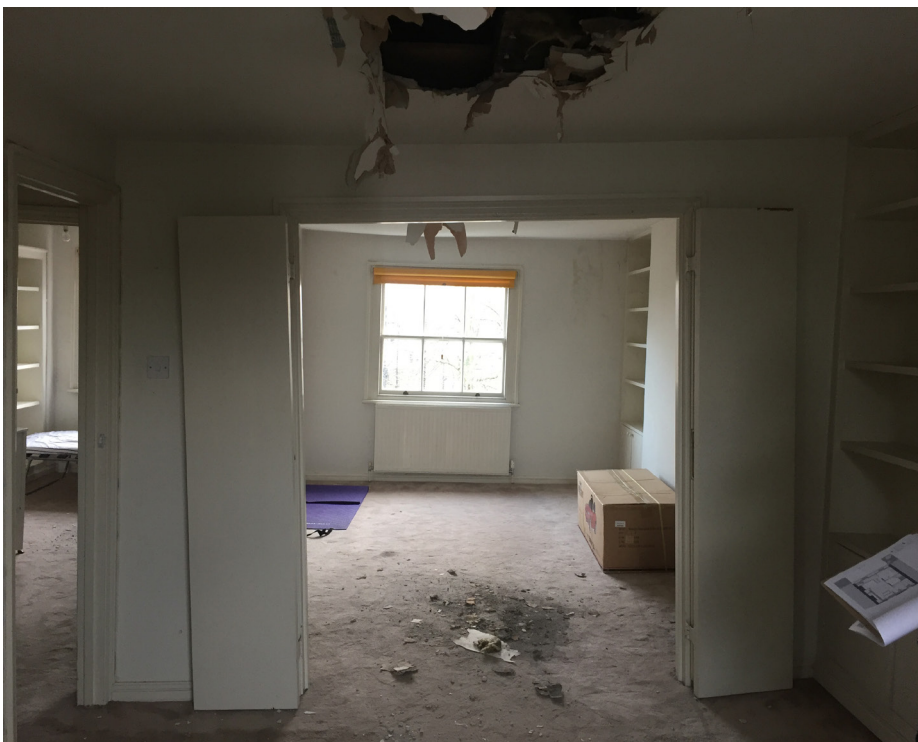
Elevation of third floor spine wall showing direction of floor slope
