ARG SURVEYS LTD

5 Holly Terrace, 88 Highgate West Hill, London, N6 6LX

Refurbishment/Demolition Survey

26 Nov 2015 to 28 Nov 2015

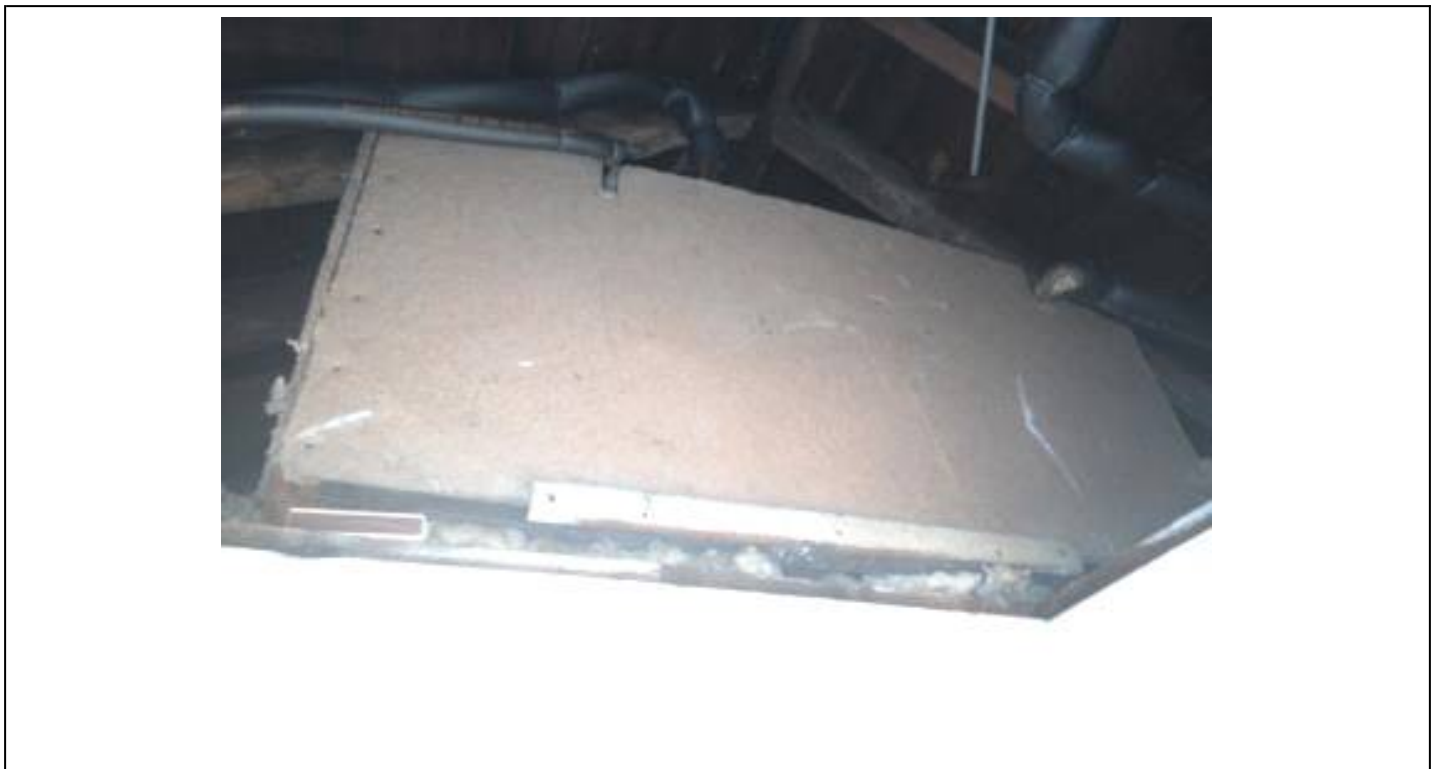
Item Number:	1 Ref Item: N/A	Sample Reference	AD000820
Item Description:	Board	Approx. Quantity:	N/A
Position:	lining to cold water storage	Identification:	Identified
Item Material:	N/A	Asbestos Present:	No Asbestos Detected

MATERIAL ASSESSMENT (MA)		PRIORITY ASSESSMENT (PA)	
Product Type:	N/A	Maintenance Activity:	N/A
Damage:	N/A	Occupant Activity:	N/A
Treatment:	N/A	Likelihood of Disturbance:	N/A
Asbestos Type:	No Asbestos Detected	Human Exposure Potential:	N/A
MA Score:	N/A	PA Score:	N/A

Total Assessment:	N/A	N/A	
Comments:			
Recommendation:	No further action required	Timescale	N/A

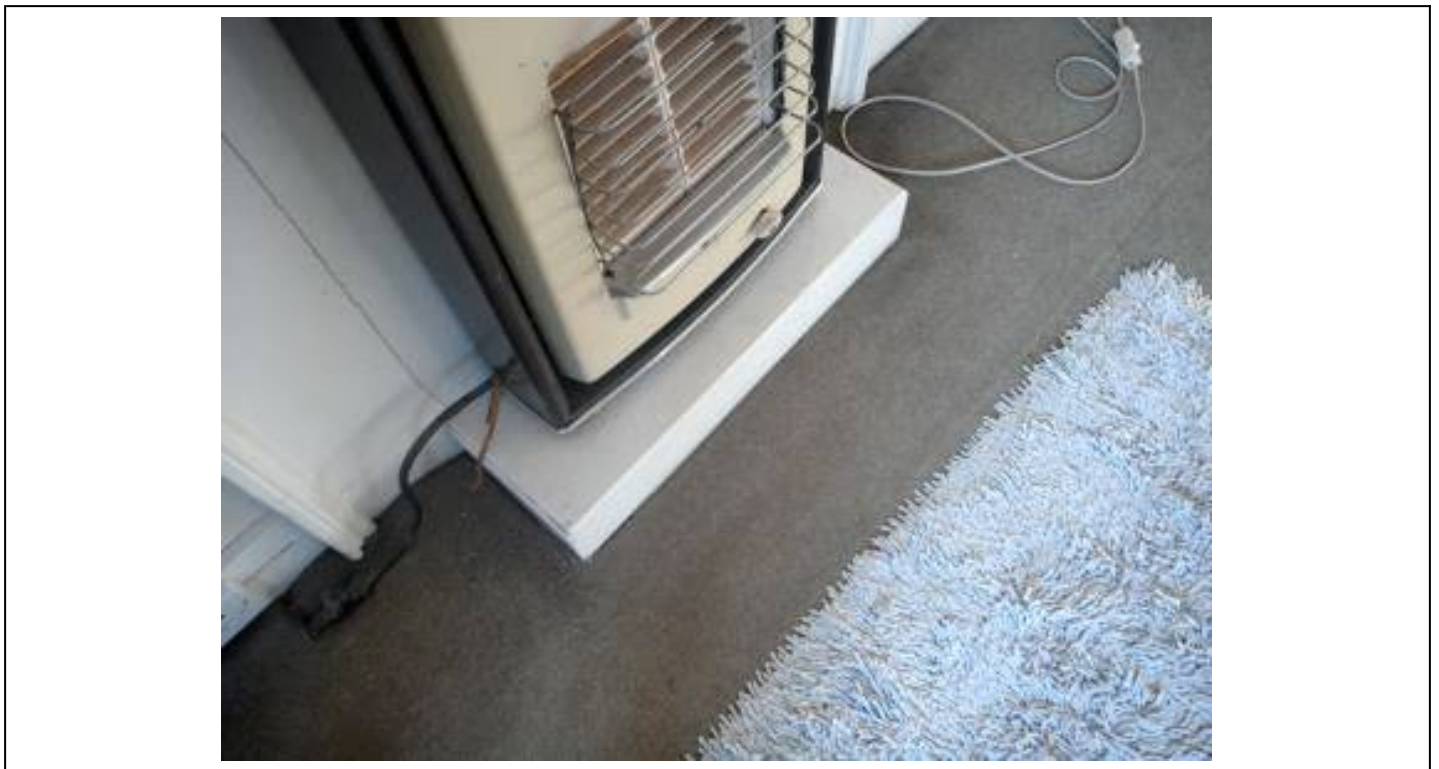
Item Number:	2 Ref Item: N/A	Sample Reference	AD000821
Item Description:	Panel	Approx. Quantity:	0.25m ²
Position:	beneath gas heater	Identification:	Identified
Item Material:	Asbestos Insulating Board	Asbestos Present:	Amosite

MATERIAL ASSESSMENT (MA)		PRIORITY ASSESSMENT (PA)	
Product Type:	2	Maintenance Activity:	0
Damage:	0	Occupant Activity:	1
Treatment:	1	Likelihood of Disturbance:	1
Asbestos Type:	2	Human Exposure Potential:	3
MA Score:	5	PA Score:	5

Total Assessment:	10	Low	
Comments:			
Recommendation:	Remove under Controlled Conditions	Timescale	12 Months

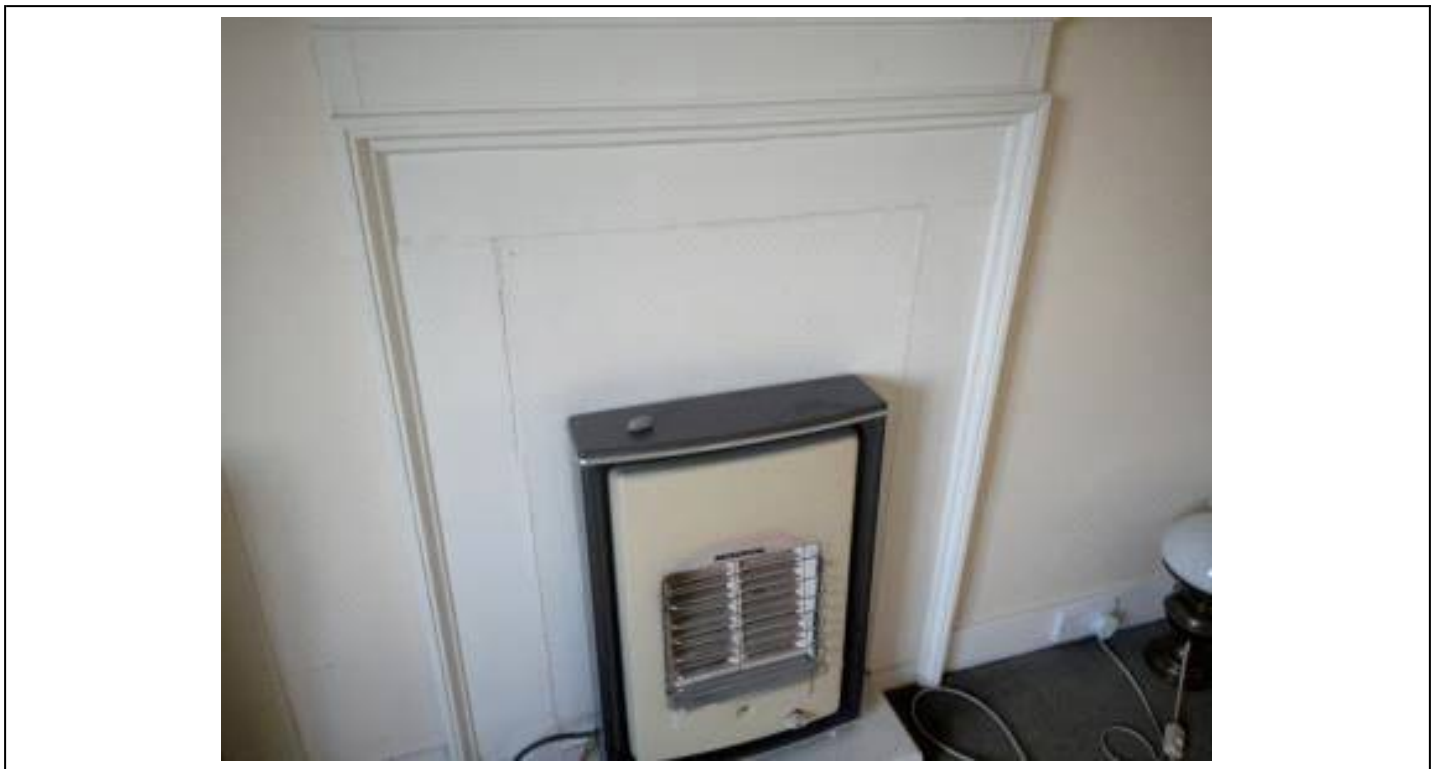
Item Number:	3 Ref Item: N/A	Sample Reference	AD000822
Item Description:	Panel	Approx. Quantity:	1m ²
Position:	behind gas heater	Identification:	Identified
Item Material:	Asbestos Cement	Asbestos Present:	Chrysotile

MATERIAL ASSESSMENT (MA)		PRIORITY ASSESSMENT (PA)	
Product Type:	1	Maintenance Activity:	0
Damage:	0	Occupant Activity:	1
Treatment:	1	Likelihood of Disturbance:	1
Asbestos Type:	1	Human Exposure Potential:	3
MA Score:	3	PA Score:	5

Total Assessment:	8	Low	
Comments:			
Recommendation:	Remove under Controlled Conditions	Timescale	12 Months

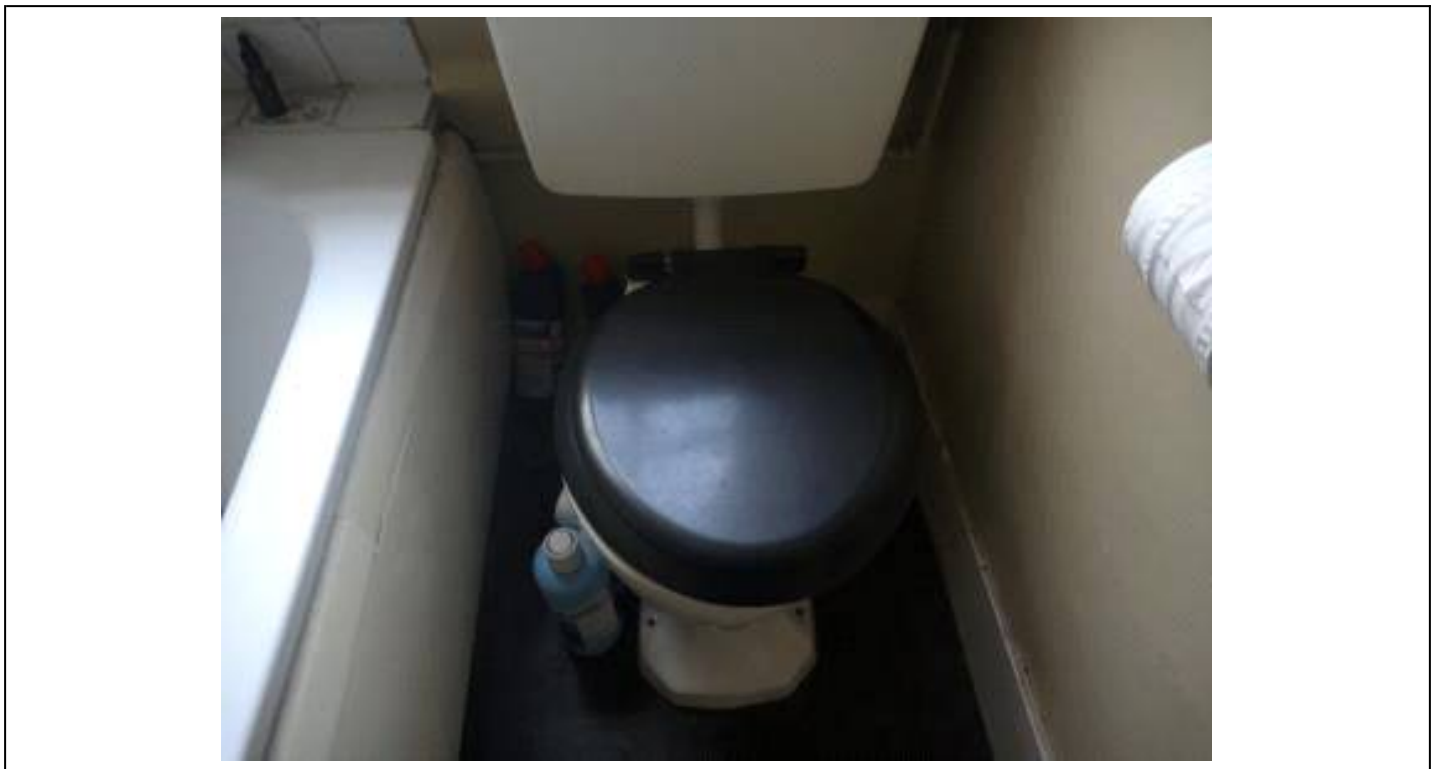
Item Number:	4 Ref Item: N/A	Sample Reference	AD000823
Item Description:	Toilet seat	Approx. Quantity:	N/A
Position:	toilet	Identification:	Identified
Item Material:	N/A	Asbestos Present:	No Asbestos Detected

MATERIAL ASSESSMENT (MA)		PRIORITY ASSESSMENT (PA)	
Product Type:	N/A	Maintenance Activity:	N/A
Damage:	N/A	Occupant Activity:	N/A
Treatment:	N/A	Likelihood of Disturbance:	N/A
Asbestos Type:	No Asbestos Detected	Human Exposure Potential:	N/A
MA Score:	N/A	PA Score:	N/A

Total Assessment:	N/A	N/A	
Comments:			
Recommendation:	No further action required	Timescale	N/A

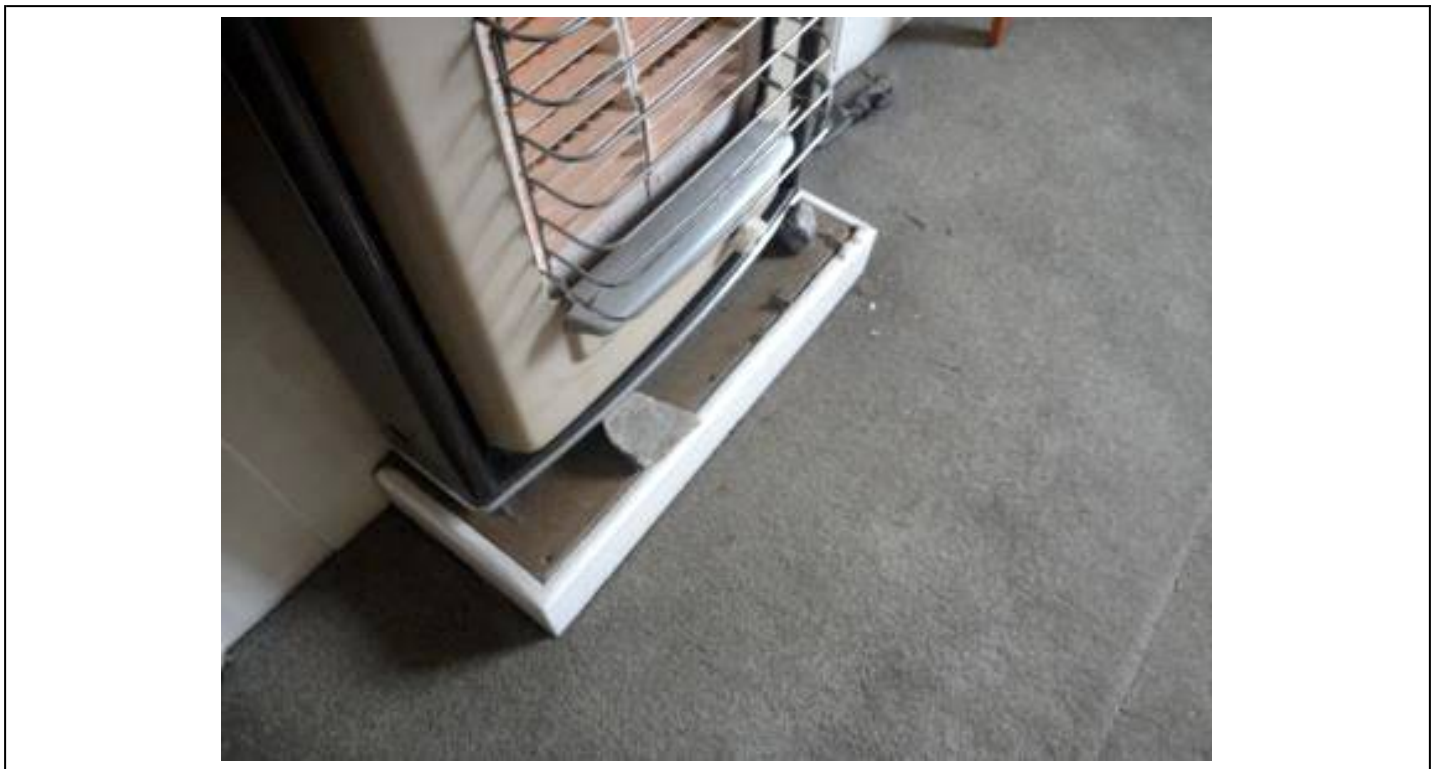
Item Number:	5 Ref Item: N/A	Sample Reference	AD000824
Item Description:	Panel	Approx. Quantity:	0.25m ²
Position:	beneath gas heater	Identification:	Identified
Item Material:	Asbestos Cement	Asbestos Present:	Chrysotile

MATERIAL ASSESSMENT (MA)		PRIORITY ASSESSMENT (PA)	
Product Type:	1	Maintenance Activity:	0
Damage:	0	Occupant Activity:	1
Treatment:	1	Likelihood of Disturbance:	1
Asbestos Type:	1	Human Exposure Potential:	3
MA Score:	3	PA Score:	5

Total Assessment:	8	Low	
Comments:			
Recommendation:	Remove under Controlled Conditions	Timescale	12 Months

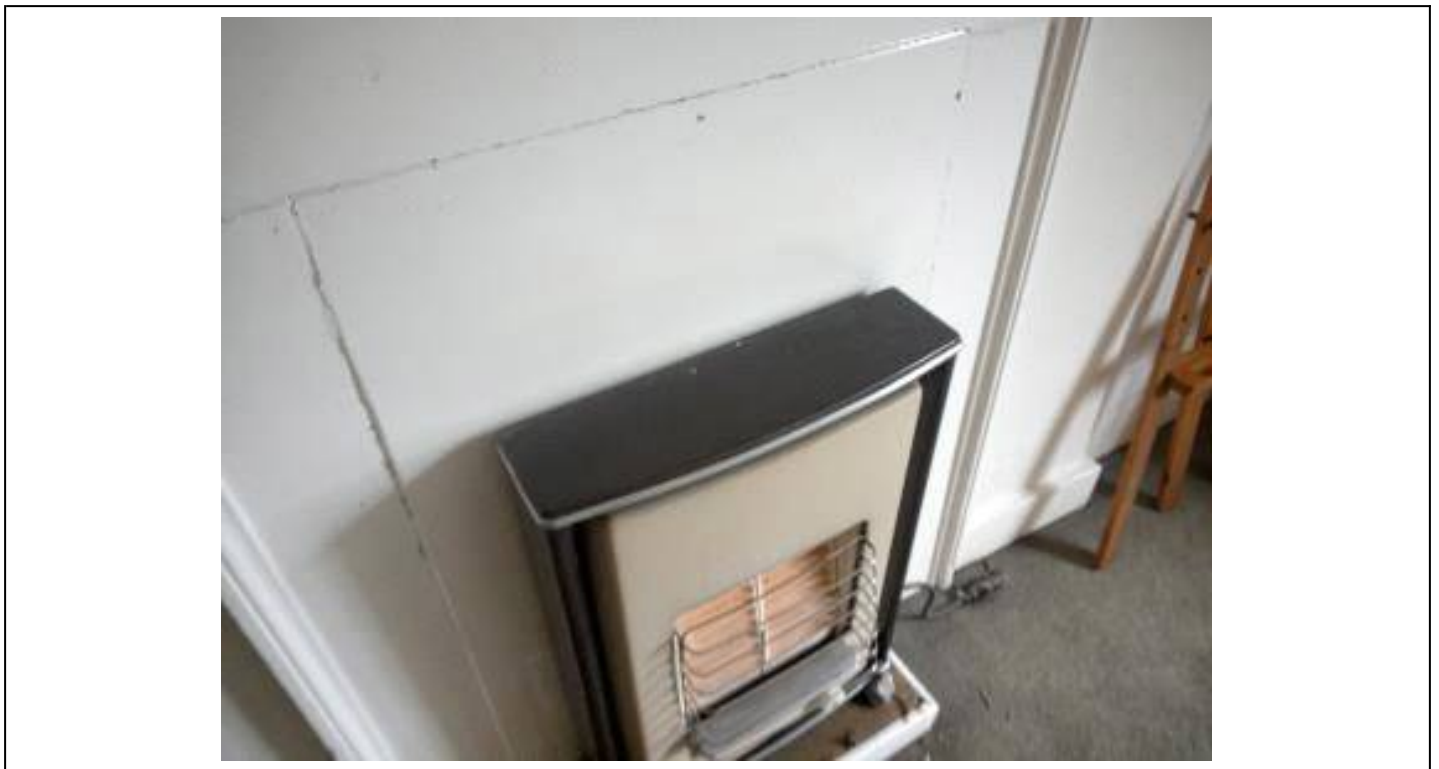
Item Number:	6 Ref Item: N/A	Sample Reference	AD000825
Item Description:	Panel	Approx. Quantity:	1m ²
Position:	behind gas heater	Identification:	Identified
Item Material:	Asbestos Cement	Asbestos Present:	Chrysotile

MATERIAL ASSESSMENT (MA)		PRIORITY ASSESSMENT (PA)	
Product Type:	1	Maintenance Activity:	0
Damage:	0	Occupant Activity:	1
Treatment:	1	Likelihood of Disturbance:	1
Asbestos Type:	1	Human Exposure Potential:	3
MA Score:	3	PA Score:	5

Total Assessment:	8	Low	
Comments:			
Recommendation:	Remove under Controlled Conditions	Timescale	12 Months

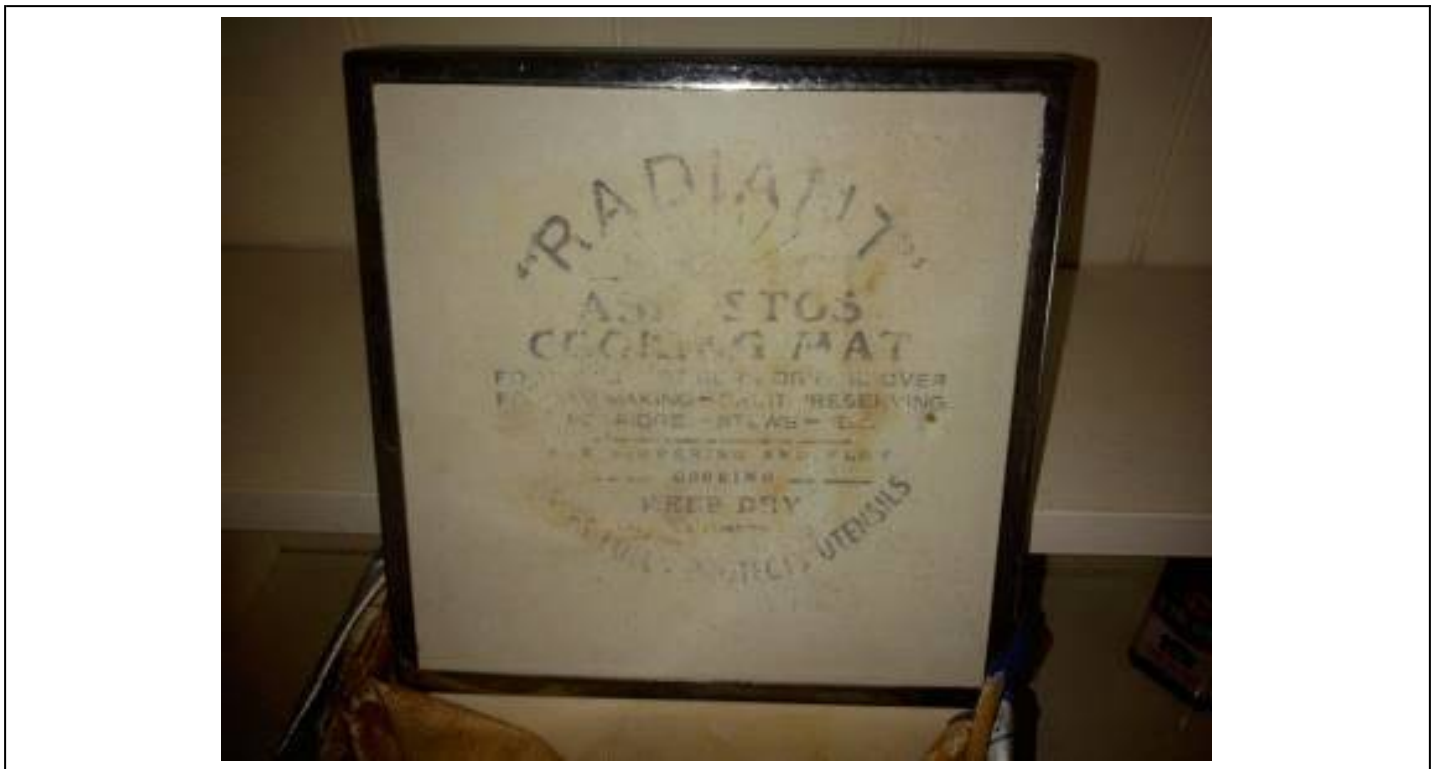
Item Number:	7 Ref Item: N/A	Sample Reference	AD000826
Item Description:	Heat mat	Approx. Quantity:	1no.
Position:	ironing board	Identification:	Identified
Item Material:	Asbestos Insulation/Coating	Asbestos Present:	Chrysotile

MATERIAL ASSESSMENT (MA)		PRIORITY ASSESSMENT (PA)	
Product Type:	3	Maintenance Activity:	0
Damage:	1	Occupant Activity:	2
Treatment:	1	Likelihood of Disturbance:	1
Asbestos Type:	1	Human Exposure Potential:	3
MA Score:	6	PA Score:	6

Total Assessment:	12	Low
Comments:		
Recommendation:	Remove under Fully Controlled Conditions	Timescale 12 Months

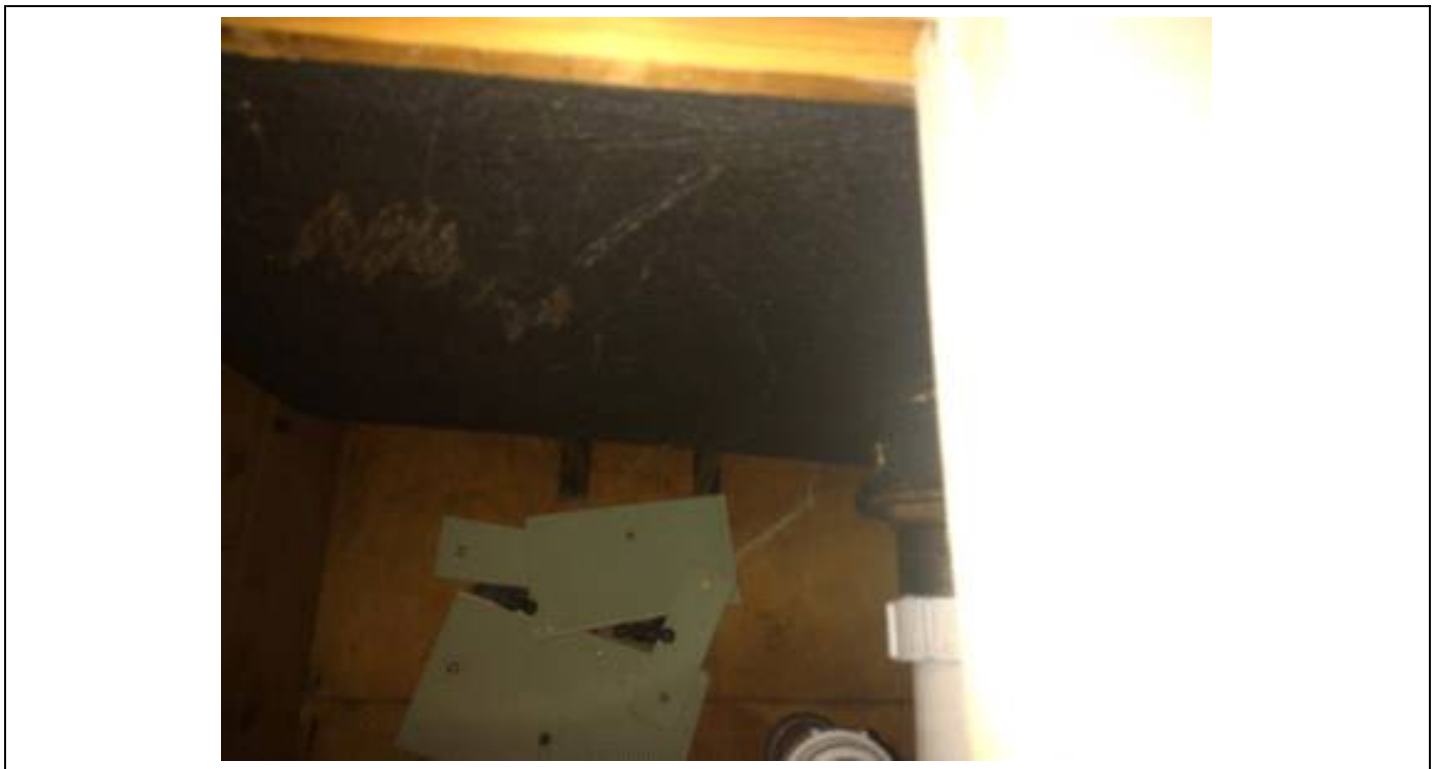
Item Number:	8 Ref Item: N/A	Sample Reference	AD000827
Item Description:	Bitumastic coating	Approx. Quantity:	N/A
Position:	beneath sink	Identification:	Identified
Item Material:	N/A	Asbestos Present:	No Asbestos Detected

MATERIAL ASSESSMENT (MA)		PRIORITY ASSESSMENT (PA)	
Product Type:	N/A	Maintenance Activity:	N/A
Damage:	N/A	Occupant Activity:	N/A
Treatment:	N/A	Likelihood of Disturbance:	N/A
Asbestos Type:	No Asbestos Detected	Human Exposure Potential:	N/A
MA Score:	N/A	PA Score:	N/A

Total Assessment:	N/A	N/A	
Comments:			
Recommendation:	No further action required	Timescale	N/A

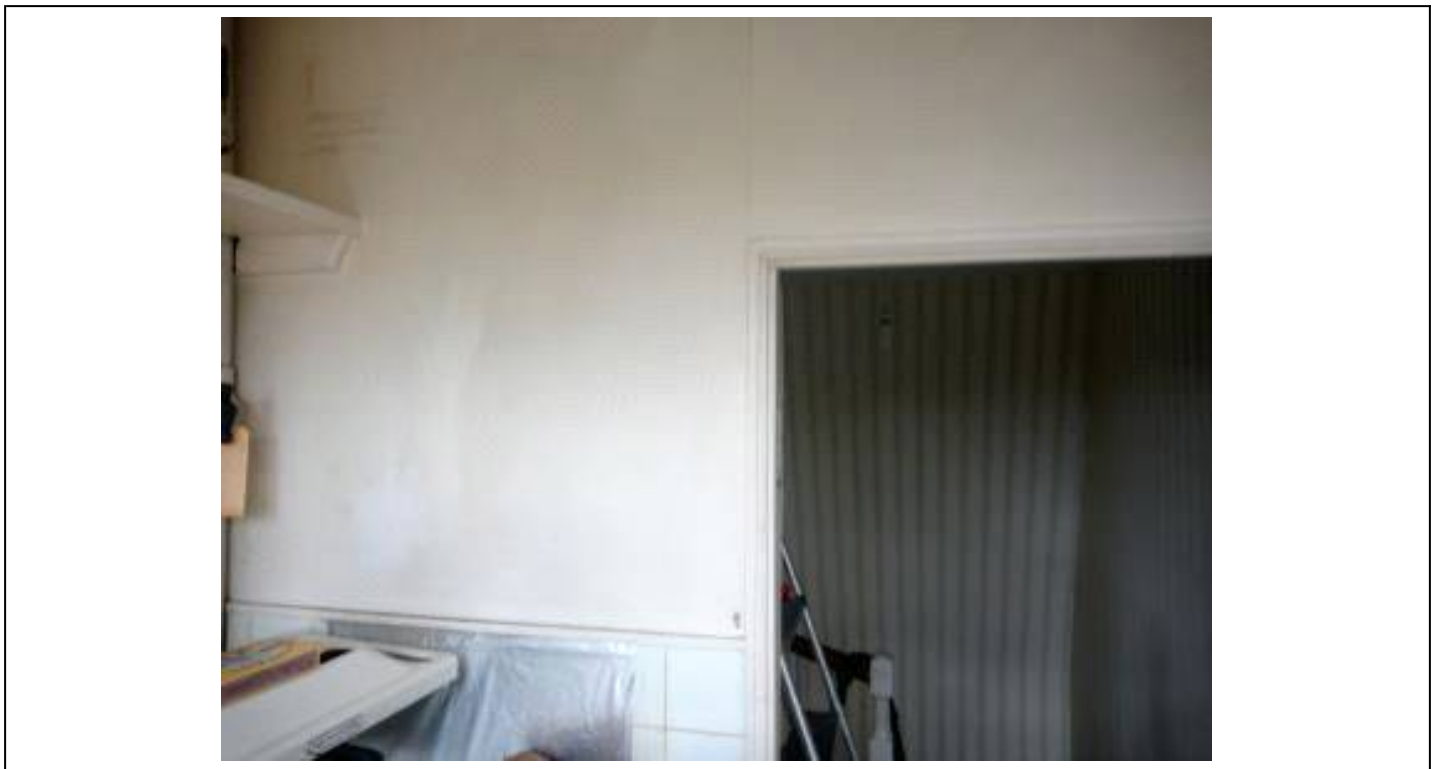
Item Number:	9 Ref Item: N/A	Sample Reference	AD000828
Item Description:	Wall board	Approx. Quantity:	4m ²
Position:	partition wall	Identification:	Identified
Item Material:	Asbestos Insulating Board	Asbestos Present:	Chrysotile

MATERIAL ASSESSMENT (MA)		PRIORITY ASSESSMENT (PA)	
Product Type:	2	Maintenance Activity:	0
Damage:	0	Occupant Activity:	1
Treatment:	1	Likelihood of Disturbance:	1
Asbestos Type:	1	Human Exposure Potential:	2
MA Score:	4	PA Score:	4

Total Assessment:	8	Low	
Comments:			
Recommendation:	Remove under Fully Controlled Conditions	Timescale	12 Months

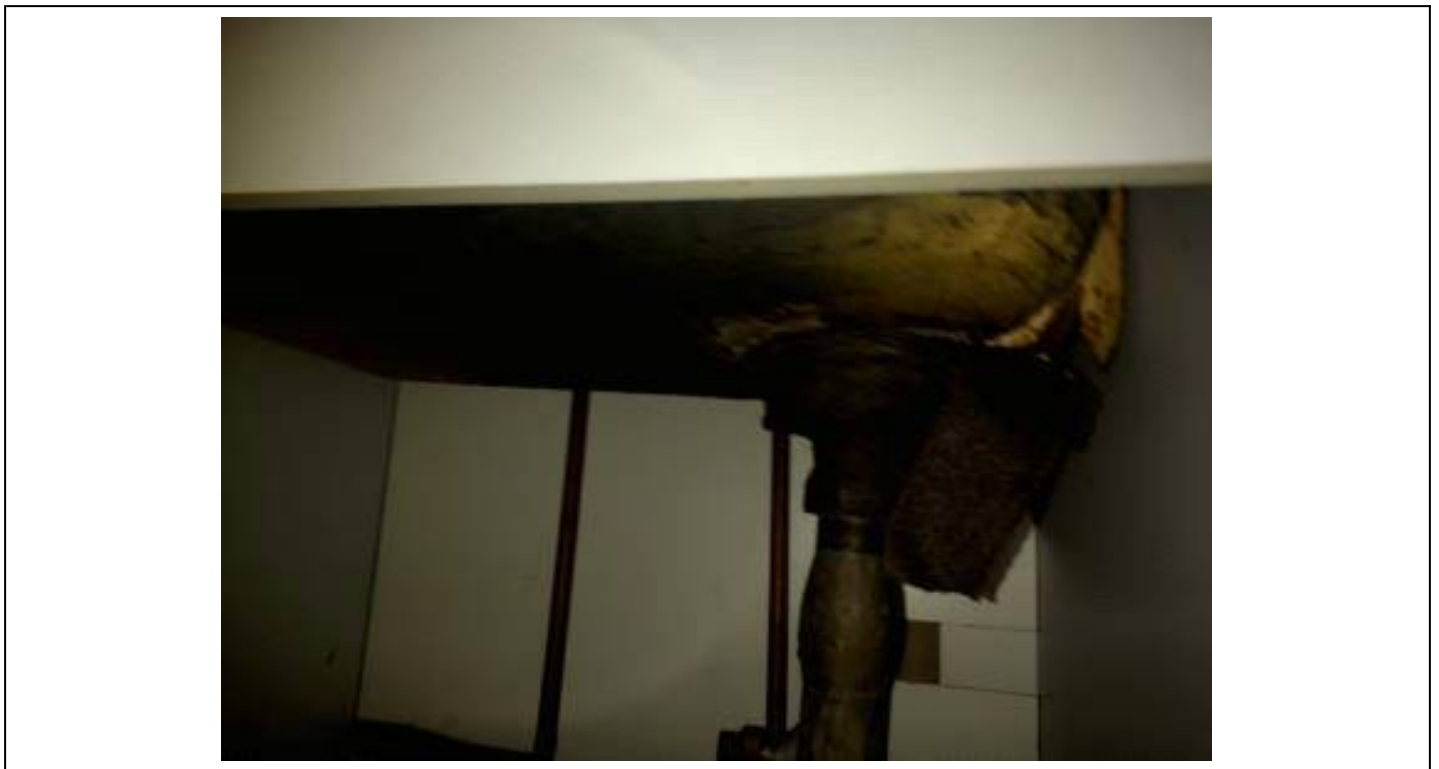
Item Number:	10 Ref Item: N/A	Sample Reference	AD000829
Item Description:	Bitumastic coating	Approx. Quantity:	N/A
Position:	beneath sink	Identification:	Identified
Item Material:	N/A	Asbestos Present:	No Asbestos Detected

MATERIAL ASSESSMENT (MA)		PRIORITY ASSESSMENT (PA)	
Product Type:	N/A	Maintenance Activity:	N/A
Damage:	N/A	Occupant Activity:	N/A
Treatment:	N/A	Likelihood of Disturbance:	N/A
Asbestos Type:	No Asbestos Detected	Human Exposure Potential:	N/A
MA Score:	N/A	PA Score:	N/A

Total Assessment:	N/A	N/A	
Comments:			
Recommendation:	No further action required	Timescale	N/A

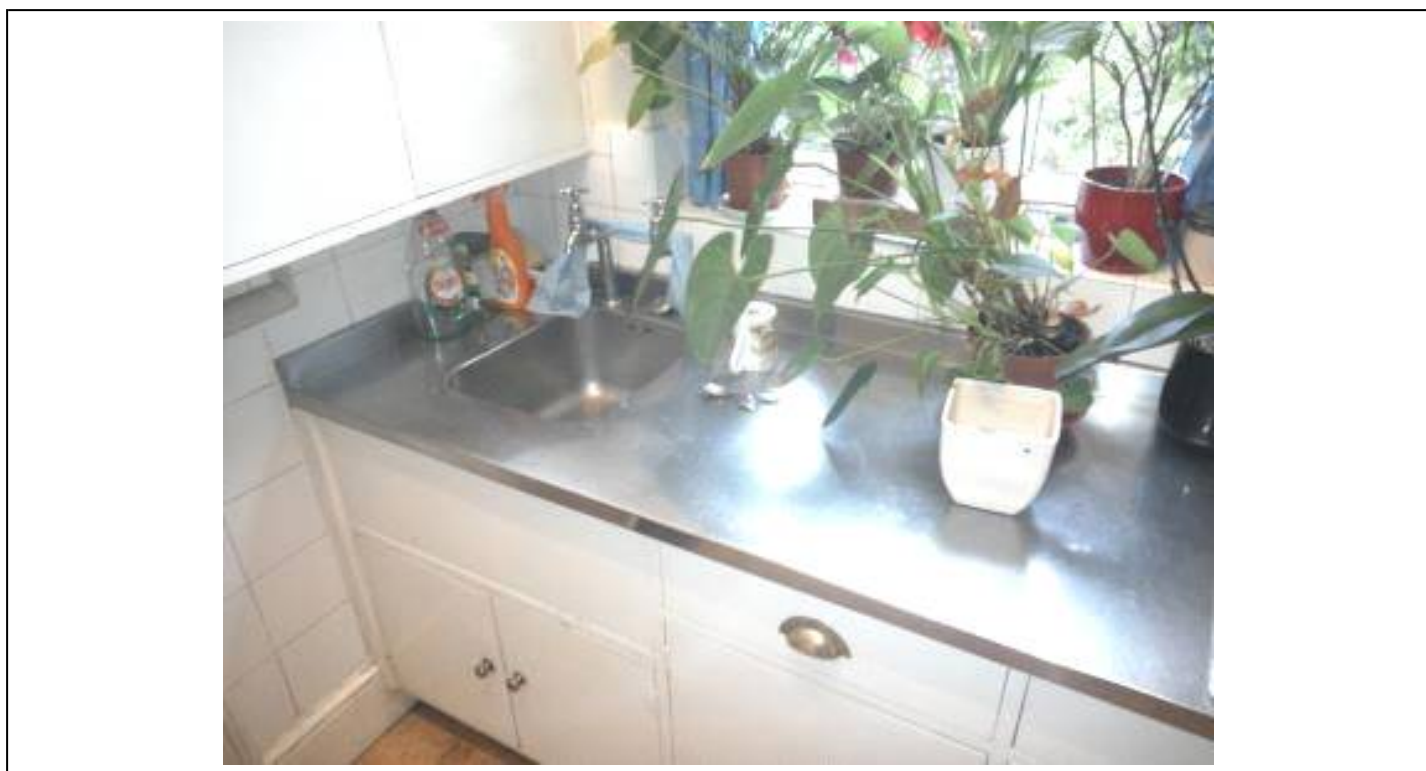
Item Number:	11 Ref Item: 10	Sample Reference	AS/ AD000829
Item Description:	Bitumastic coating	Approx. Quantity:	N/A
Position:	beneath sink 2	Identification:	Strongly Presumed
Item Material:	N/A	Asbestos Present:	No Asbestos Detected

MATERIAL ASSESSMENT (MA)		PRIORITY ASSESSMENT (PA)	
Product Type:	N/A	Maintenance Activity:	N/A
Damage:	N/A	Occupant Activity:	N/A
Treatment:	N/A	Likelihood of Disturbance:	N/A
Asbestos Type:	No Asbestos Detected	Human Exposure Potential:	N/A
MA Score:	N/A	PA Score:	N/A

Total Assessment:	N/A	N/A	
Comments:			
Recommendation:	No further action required	Timescale	N/A

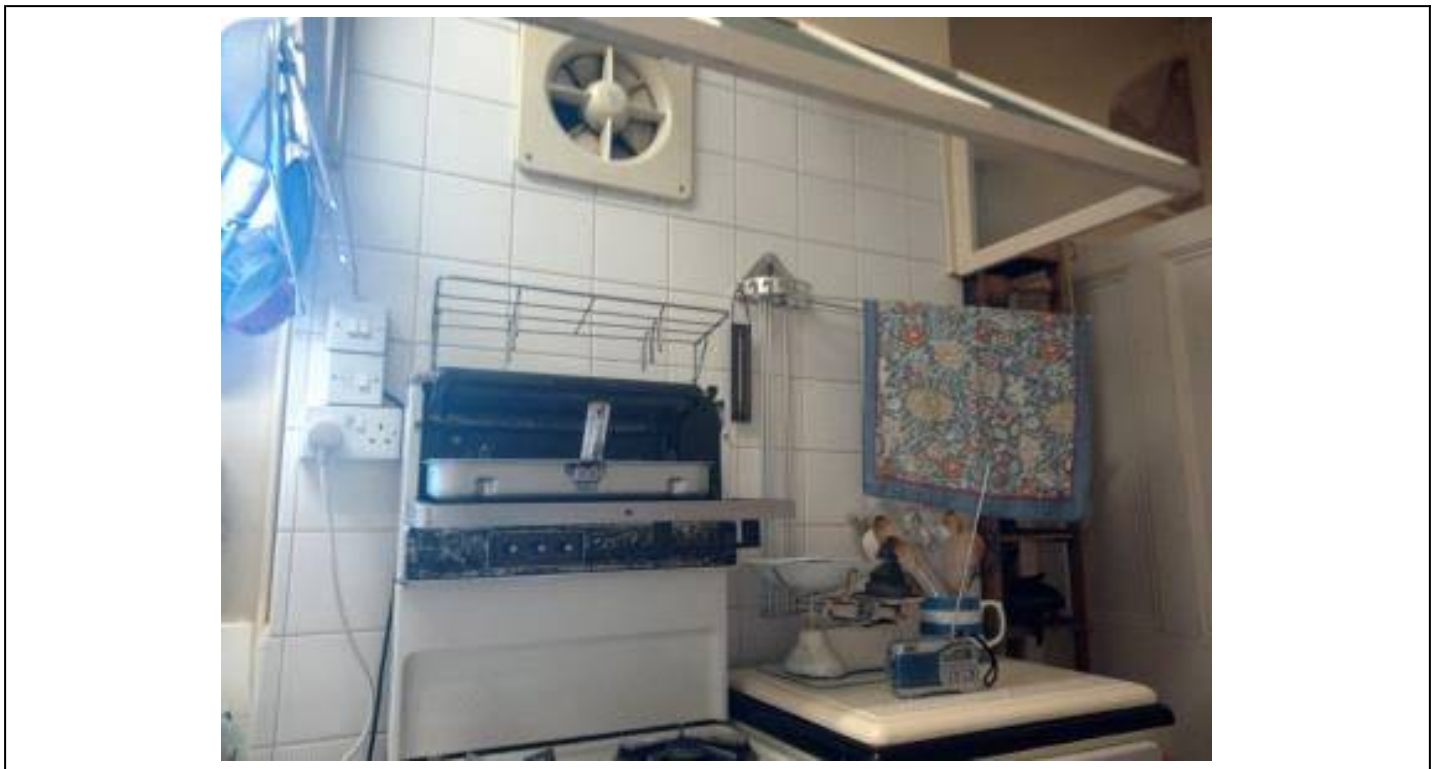
Item Number:	12 Ref Item: N/A	Sample Reference	Visual
Item Description:	Fan and duct	Approx. Quantity:	N/A
Position:	fitted to chimney breast	Identification:	Inaccessible (Presumed)
Item Material:	N/A	Asbestos Present:	N/A

MATERIAL ASSESSMENT (MA)		PRIORITY ASSESSMENT (PA)	
Product Type:	N/A	Maintenance Activity:	N/A
Damage:	N/A	Occupant Activity:	N/A
Treatment:	N/A	Likelihood of Disturbance:	N/A
Asbestos Type:	N/A	Human Exposure Potential:	N/A
MA Score:	N/A	PA Score:	N/A

Total Assessment:	N/A	N/A	
Comments:	Live electrical plant		
Recommendation:	Inspect prior to Maintenance	Timescale	N/A

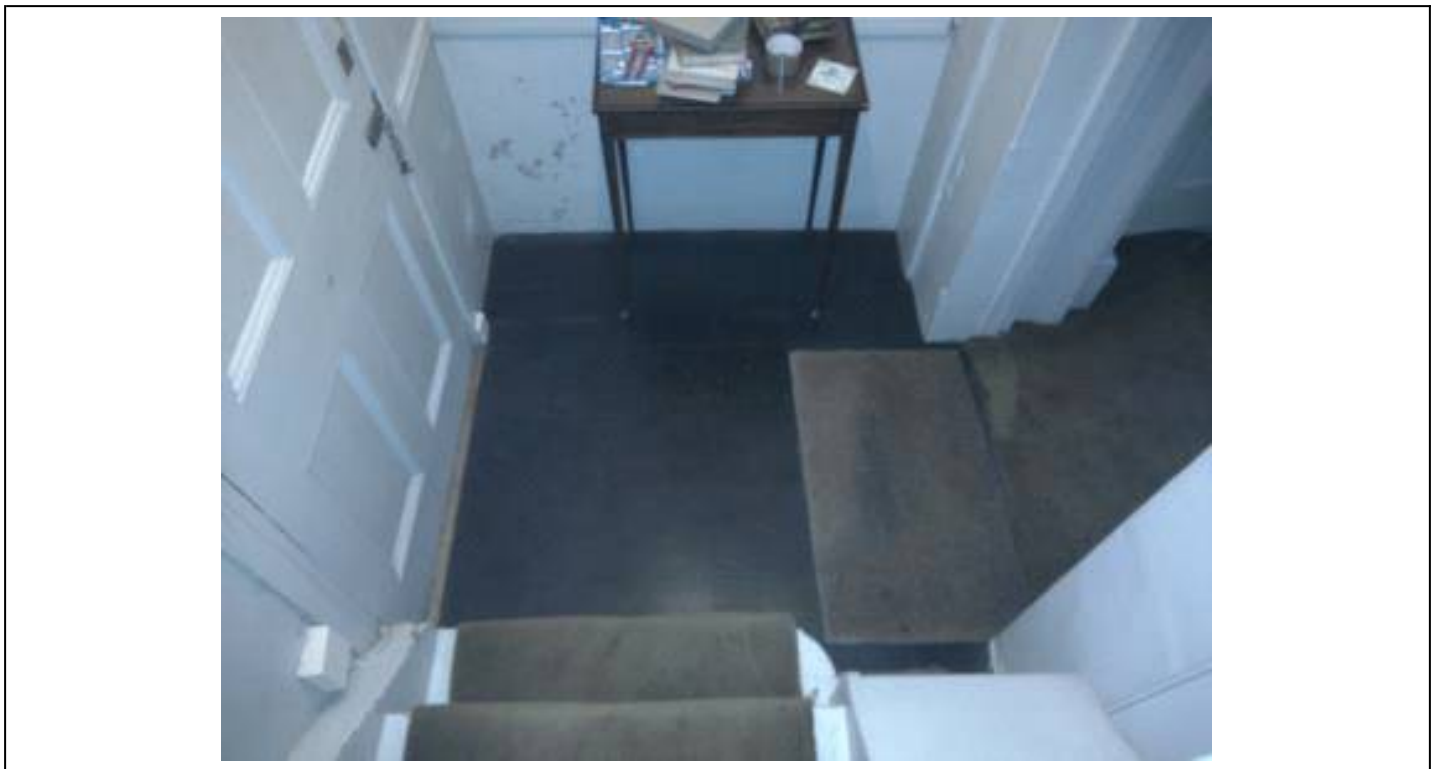
Item Number:	13 Ref Item: N/A	Sample Reference	AD000832
Item Description:	Vinyl tiles	Approx. Quantity:	2m ²
Position:	to entrance floor	Identification:	Identified
Item Material:	Reinforced Composite	Asbestos Present:	Chrysotile

MATERIAL ASSESSMENT (MA)		PRIORITY ASSESSMENT (PA)	
Product Type:	1	Maintenance Activity:	0
Damage:	0	Occupant Activity:	0
Treatment:	0	Likelihood of Disturbance:	1
Asbestos Type:	1	Human Exposure Potential:	1
MA Score:	2	PA Score:	2

Total Assessment:	4	Very Low	
Comments:			
Recommendation:	Remove under Controlled Conditions	Timescale	12 Months

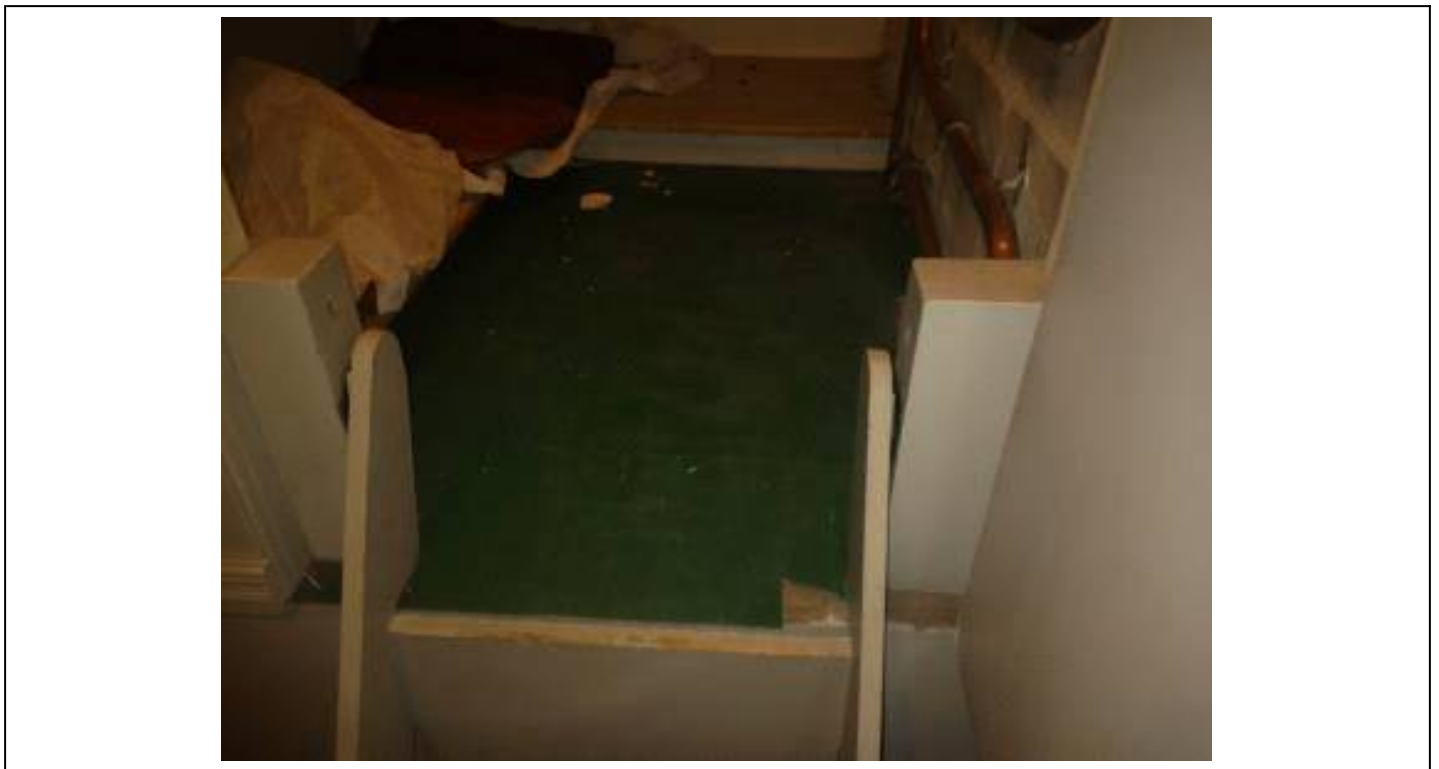
Item Number:	14 Ref Item: N/A	Sample Reference	AD000830
Item Description:	Vinyl tiles	Approx. Quantity:	>1m ²
Position:	to timber floor	Identification:	Identified
Item Material:	Reinforced Composite	Asbestos Present:	Chrysotile

MATERIAL ASSESSMENT (MA)		PRIORITY ASSESSMENT (PA)	
Product Type:	1	Maintenance Activity:	0
Damage:	1	Occupant Activity:	0
Treatment:	0	Likelihood of Disturbance:	2
Asbestos Type:	1	Human Exposure Potential:	1
MA Score:	3	PA Score:	3

Total Assessment:	6	Very Low	
Comments:	Green		
Recommendation:	Remove under Controlled Conditions	Timescale	12 Months

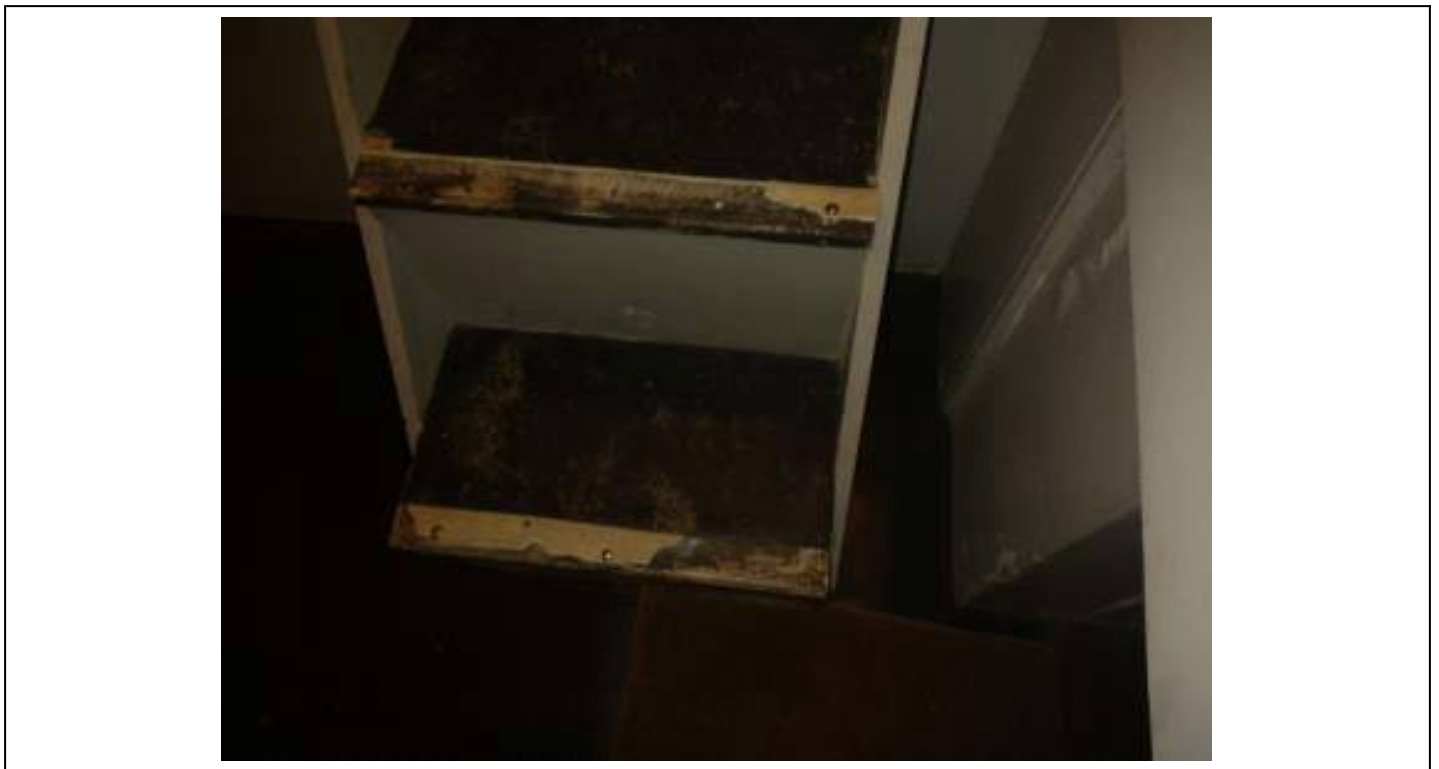
MATERIAL ASSESSMENT (MA)		PRIORITY ASSESSMENT (PA)	
Product Type:	N/A	Maintenance Activity:	N/A
Damage:	N/A	Occupant Activity:	N/A
Treatment:	N/A	Likelihood of Disturbance:	N/A
Asbestos Type:	No Asbestos Detected	Human Exposure Potential:	N/A
MA Score:	N/A	PA Score:	N/A

Total Assessment:	N/A	N/A	
Comments:	white		
Recommendation:	No further action required	Timescale	N/A

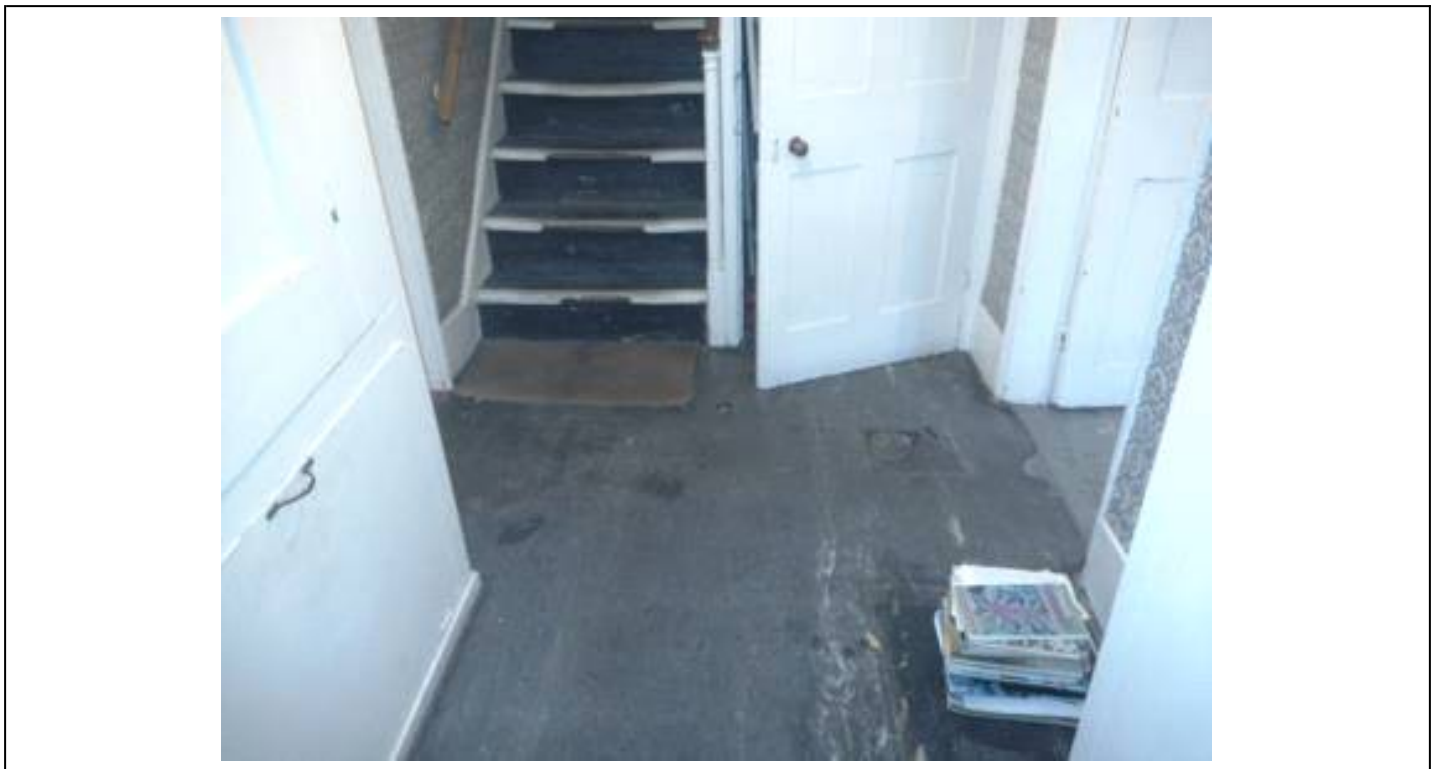
MATERIAL ASSESSMENT (MA)		PRIORITY ASSESSMENT (PA)	
Product Type:	N/A	Maintenance Activity:	N/A
Damage:	N/A	Occupant Activity:	N/A
Treatment:	N/A	Likelihood of Disturbance:	N/A
Asbestos Type:	No Asbestos Detected	Human Exposure Potential:	N/A
MA Score:	N/A	PA Score:	N/A

Total Assessment:	N/A	N/A	
Comments:			
Recommendation:	No further action required	Timescale	N/A

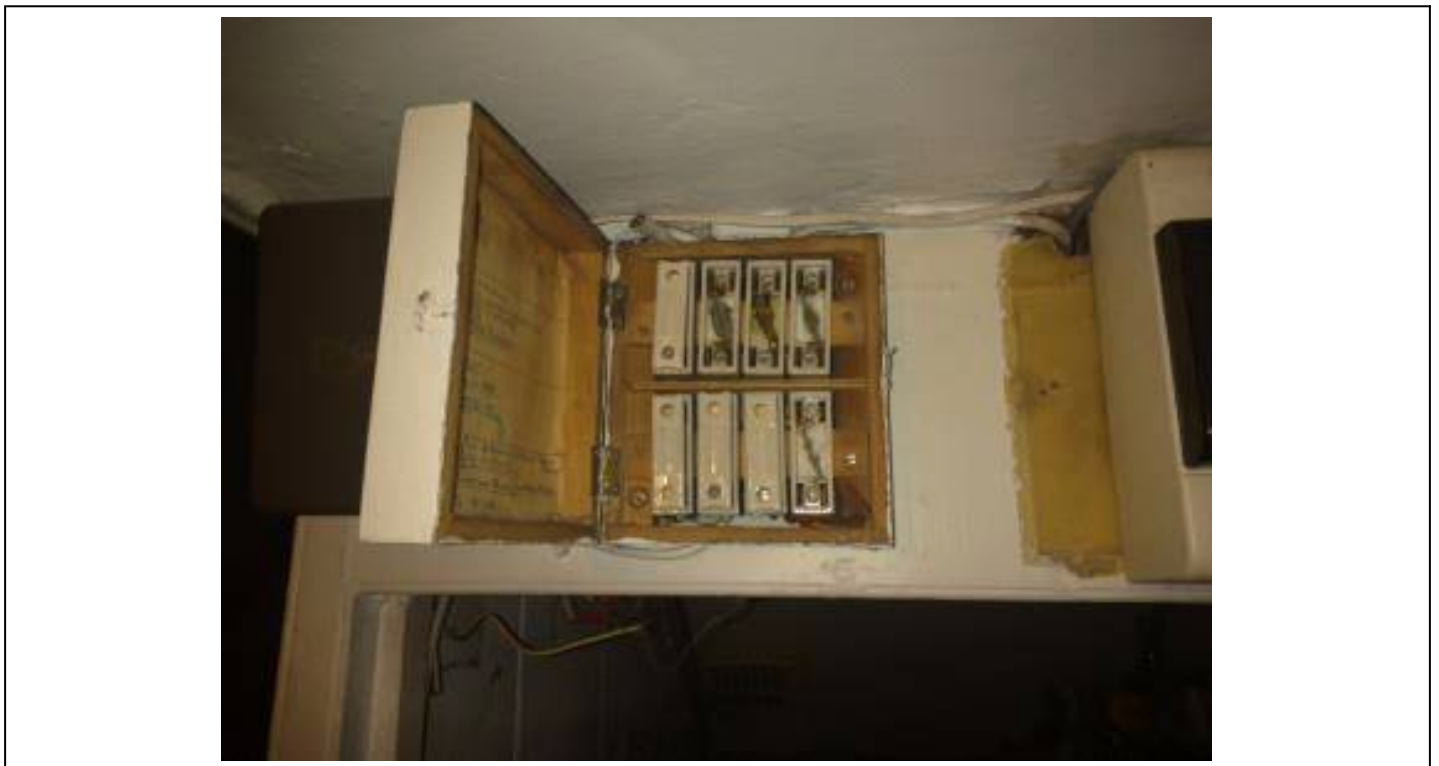
MATERIAL ASSESSMENT (MA)		PRIORITY ASSESSMENT (PA)	
Product Type:	2	Maintenance Activity:	0
Damage:	1	Occupant Activity:	1
Treatment:	2	Likelihood of Disturbance:	1
Asbestos Type:	1	Human Exposure Potential:	1
MA Score:	6	PA Score:	3

Total Assessment:	9	Low
Comments:		
Recommendation:	Remove under Fully Controlled Conditions	Timescale 12 Months

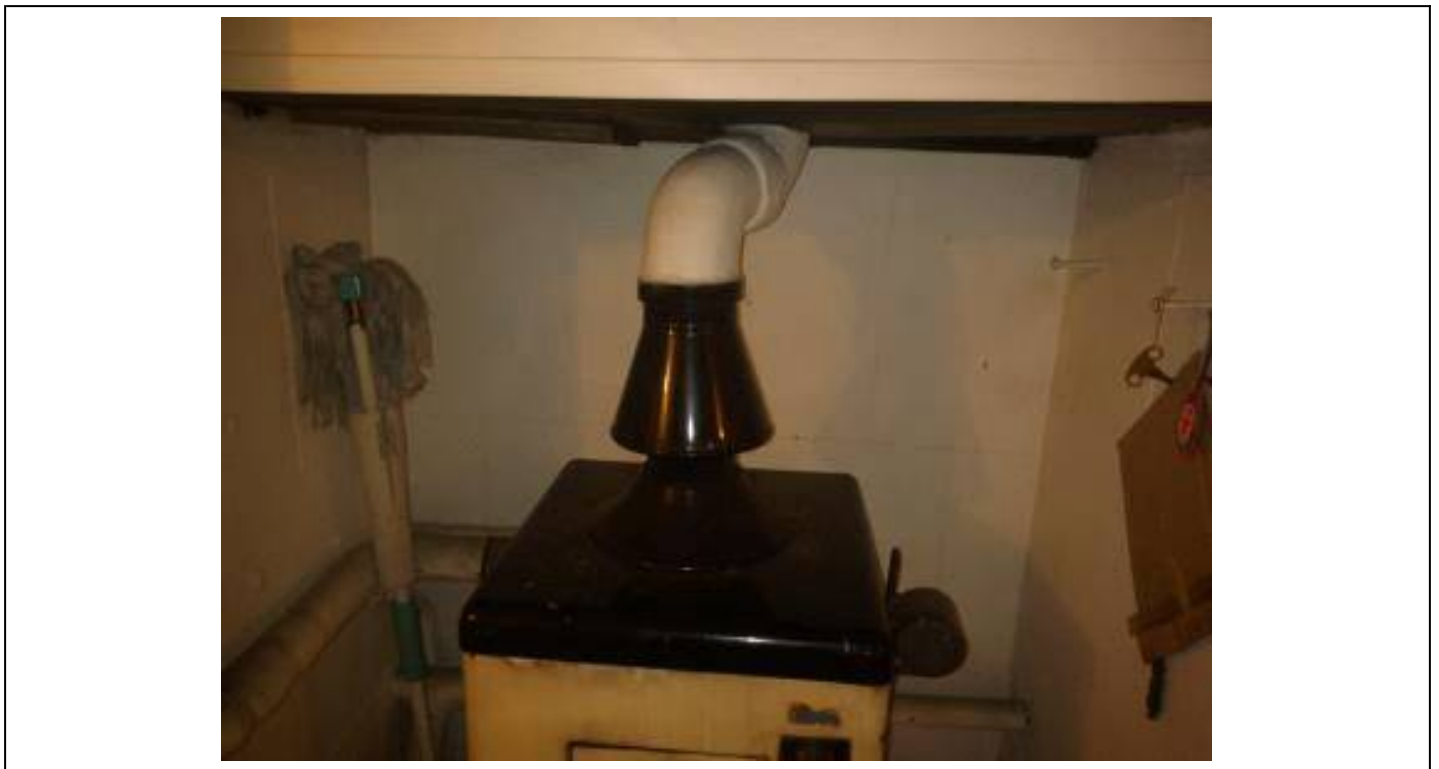
MATERIAL ASSESSMENT (MA)		PRIORITY ASSESSMENT (PA)	
Product Type:	1	Maintenance Activity:	0
Damage:	1	Occupant Activity:	0
Treatment:	1	Likelihood of Disturbance:	1
Asbestos Type:	1	Human Exposure Potential:	2
MA Score:	4	PA Score:	3

Total Assessment:	7	Low	
Comments:			
Recommendation:	Remove under Controlled Conditions	Timescale	12 Months
