ARG SURVEYS LTD

5 Holly Terrace, 88 Highgate West Hill, London, N6 6LX

Refurbishment/Demolition Survey

26 Nov 2015 to 28 Nov 2015

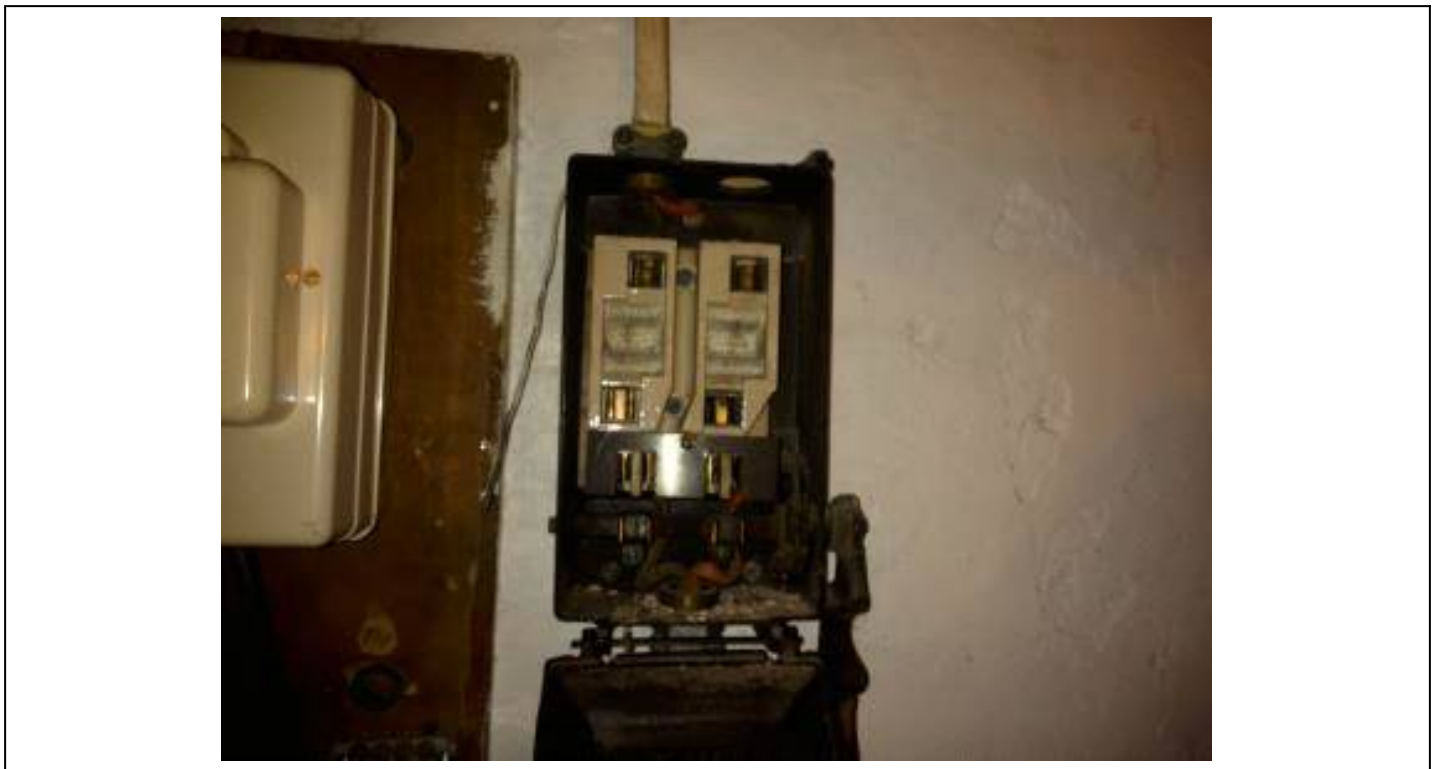
MATERIAL ASSESSMENT (MA)		PRIORITY ASSESSMENT (PA)	
Product Type:	2	Maintenance Activity:	0
Damage:	0	Occupant Activity:	0
Treatment:	2	Likelihood of Disturbance:	1
Asbestos Type:	1	Human Exposure Potential:	2
MA Score:	5	PA Score:	3

Total Assessment:	8	Low	
Comments:			
Recommendation:	Remove under Fully Controlled Conditions	Timescale	12 Months

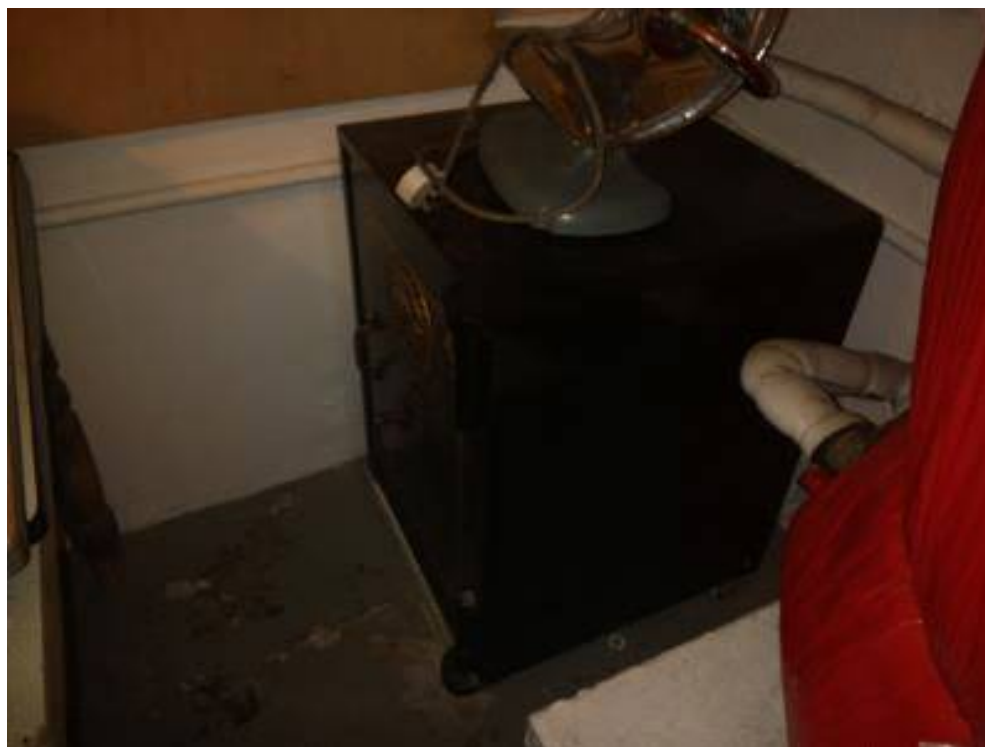
MATERIAL ASSESSMENT (MA)		PRIORITY ASSESSMENT (PA)	
Product Type:	N/A	Maintenance Activity:	N/A
Damage:	N/A	Occupant Activity:	N/A
Treatment:	N/A	Likelihood of Disturbance:	N/A
Asbestos Type:	N/A	Human Exposure Potential:	N/A
MA Score:	N/A	PA Score:	N/A

Total Assessment:	N/A	N/A	
Comments:	Inaccessible		
Recommendation:	Inspect prior to Maintenance	Timescale	N/A

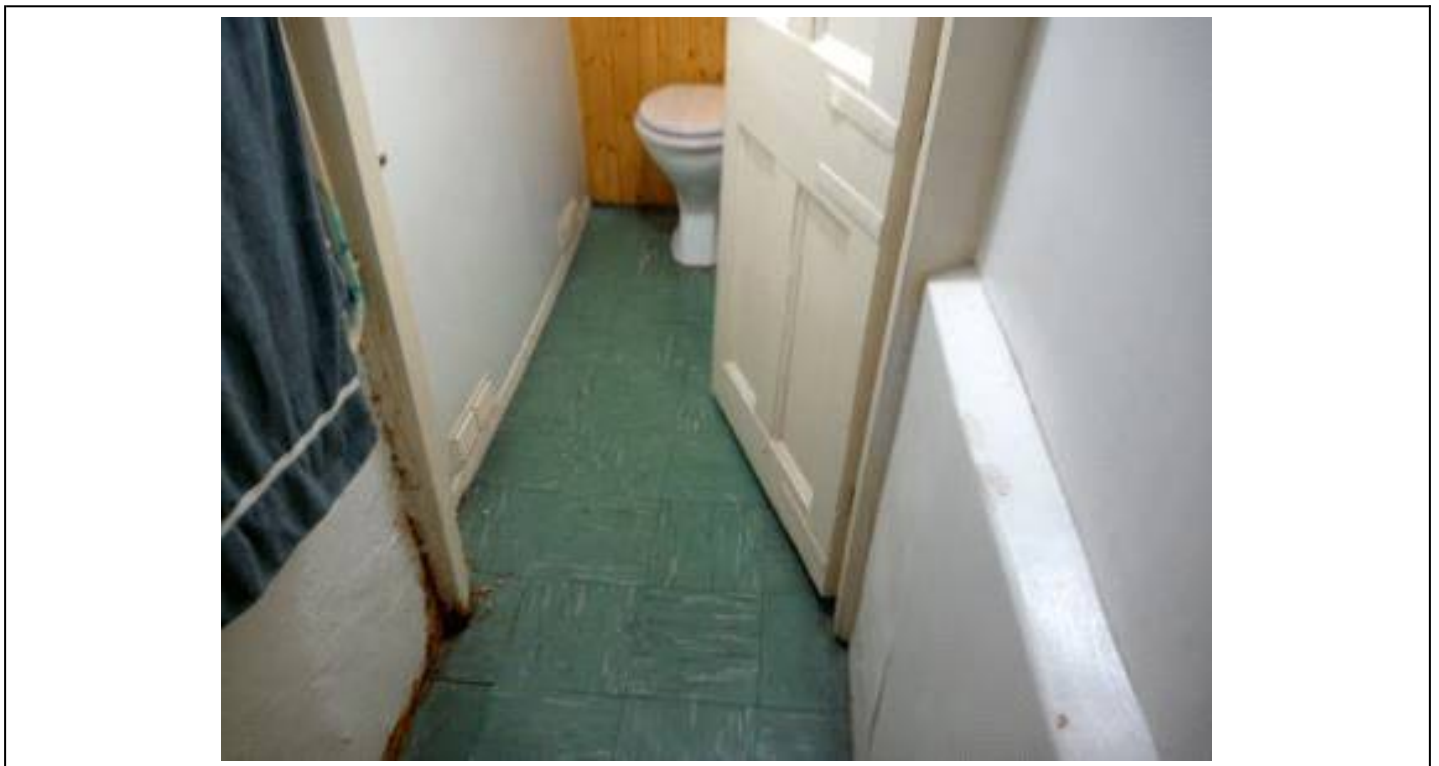
MATERIAL ASSESSMENT (MA)		PRIORITY ASSESSMENT (PA)	
Product Type:	1	Maintenance Activity:	0
Damage:	1	Occupant Activity:	0
Treatment:	0	Likelihood of Disturbance:	1
Asbestos Type:	1	Human Exposure Potential:	1
MA Score:	3	PA Score:	2

Total Assessment:	5	Very Low	
Comments:	Green		
Recommendation:	Remove under Controlled Conditions	Timescale	12 Months

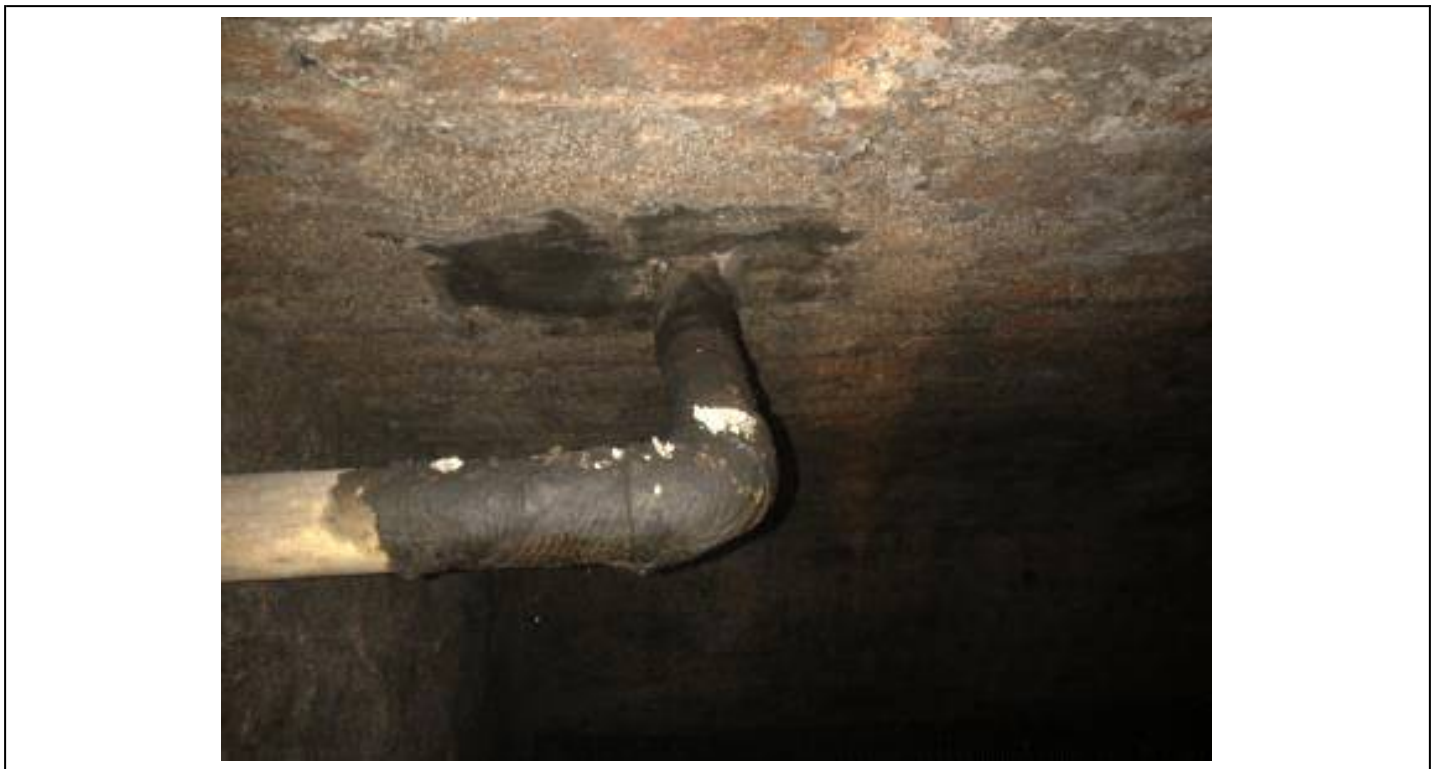
MATERIAL ASSESSMENT (MA)		PRIORITY ASSESSMENT (PA)	
Product Type:	N/A	Maintenance Activity:	N/A
Damage:	N/A	Occupant Activity:	N/A
Treatment:	N/A	Likelihood of Disturbance:	N/A
Asbestos Type:	No Asbestos Detected	Human Exposure Potential:	N/A
MA Score:	N/A	PA Score:	N/A

Total Assessment:	N/A	N/A
Comments:		
Recommendation:	No further action required	Timescale: N/A
