**FURTHER INVESTIGATION REPORT:**

11 Templewood Avenue,  
Hampstead,  
London NW3 7UY

Ref: GMT/11TWA/PCS/01

Date: 23<sup>rd</sup> December 2015

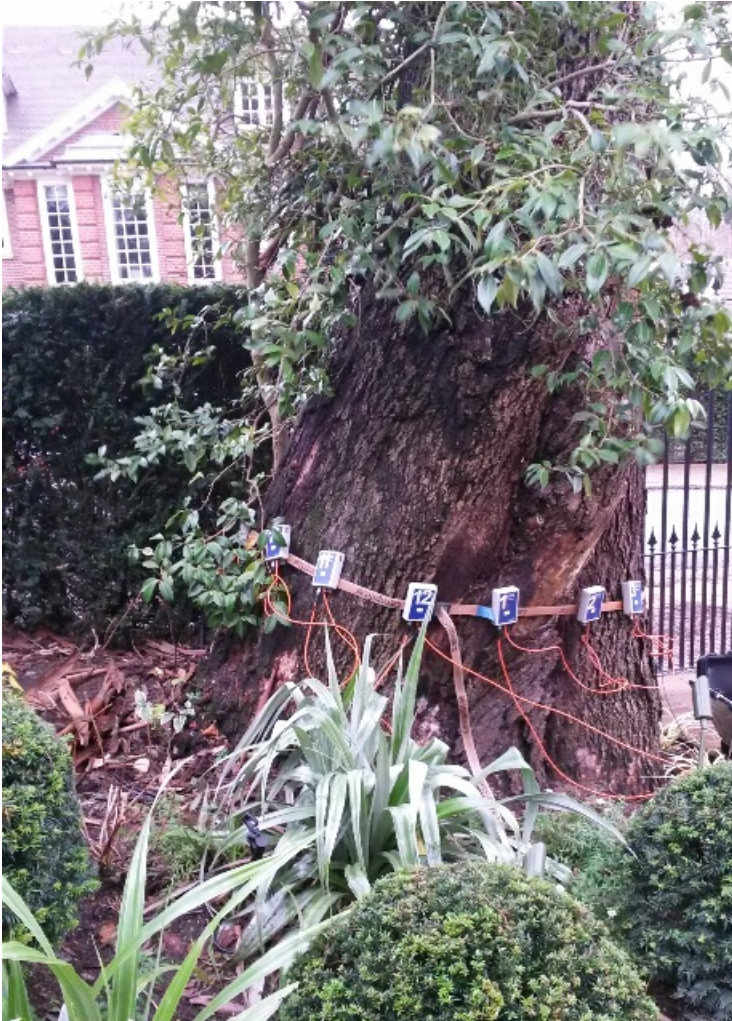
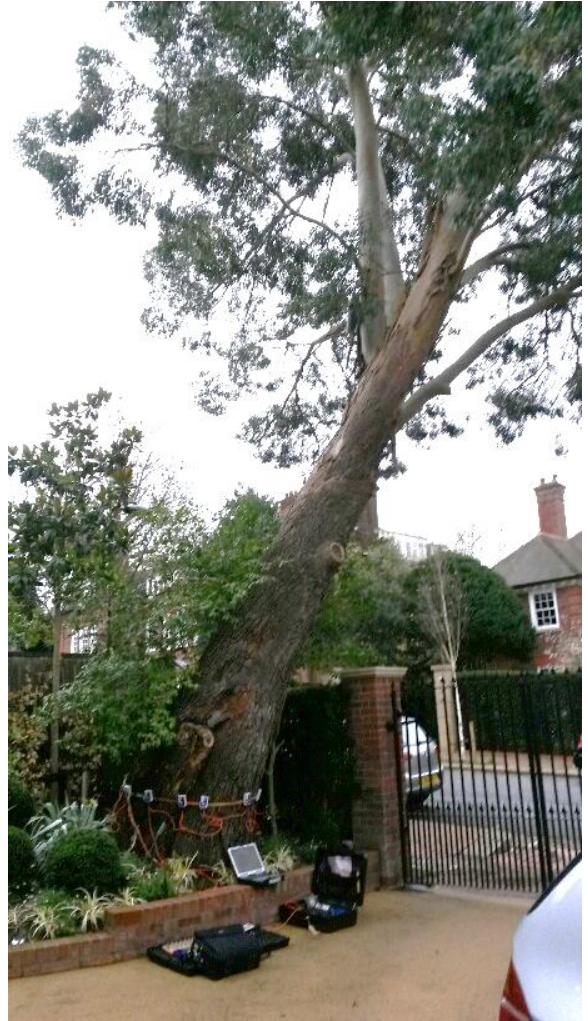
Photographs 1 & 2 Showing Picus Sonic Tomograph in position

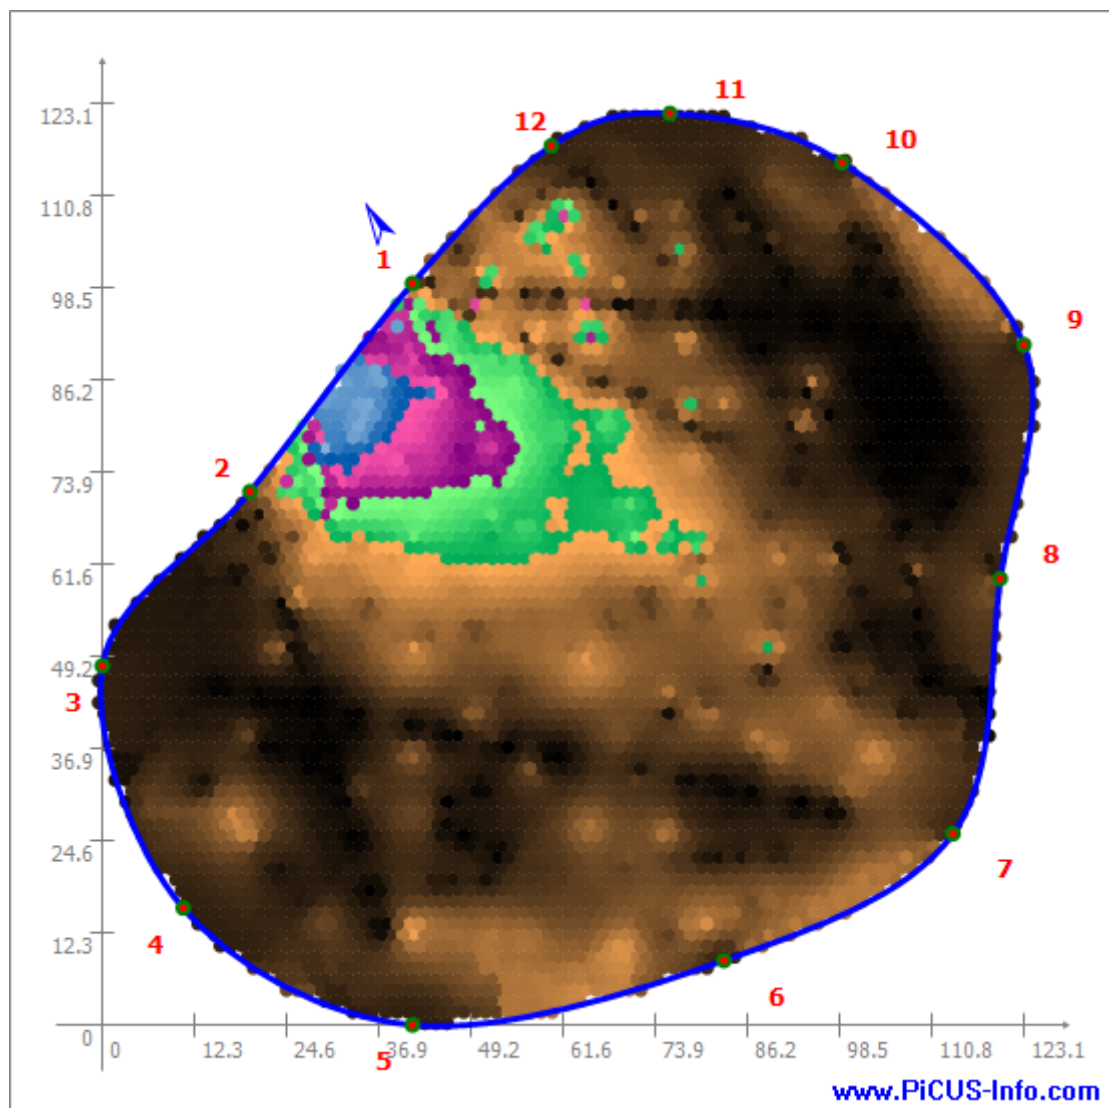
The tomograph shows an area of decay to the north of the stem with a cavity shown in blue, advanced decay coloured pink/purple and the incipient or early decay coloured green.

Image 1: Picus Tomograph result at ground level.

The area of decay is localised to the north where the stub from the removed limb has continued to decay downwards. Late stage honey fungus can cause white rot in the heartwood of the tree, although this hasn't yet manifested. The crown and leaf cover look normal, and show no sign of dieback or decline, suggesting that the root structure and cambium are still functioning. This indicates that the honey fungus is at an early stage (quite probably infecting the tree when the driveway and retaining wall were constructed).

Whilst the structural integrity of the stem is currently okay, the progressive weakening of the root system by honey fungus, will eventually cause the tree to decline; as the tree has a severe lean over the path and road it should be felled. Whilst some extenuating circumstances might be extended to an ancient oak tree, the gum is neither old, attractive nor native. To my mind, there is little to deliberate, where a known risk arises to the highway with little benefit in maintaining the tree in place.
