# Asbestos Demolition Survey Report

J078635

**For:** Kier Construction - London

**At:** Met Police Garage 1-39 Drummond  
Crescent, London

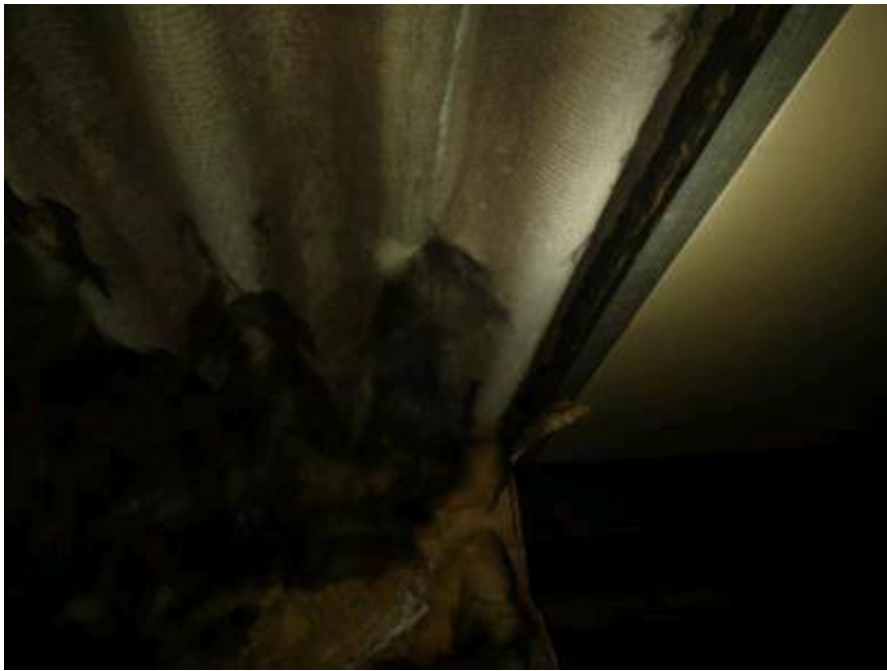
Sample N°	<b>AV000690</b>		
Location	G.01 - Garage 1

Item:	Corruated cement roof sheeting.	Identification:	Identified
Approx. Quantity:	1250m <sup>2</sup>	Accessibility:	Medium
Product Type:	Asbestos Cement		1
Extent of damage:	Low Damage		1
Surface treatment:	Surface Sealed		1
Asbestos type:	Chrysotile		1
		<b>Material Assessment Score:</b>	<b>4</b>
Action:	Remove prior to demolition or refurbishment		
Comments:	No comments

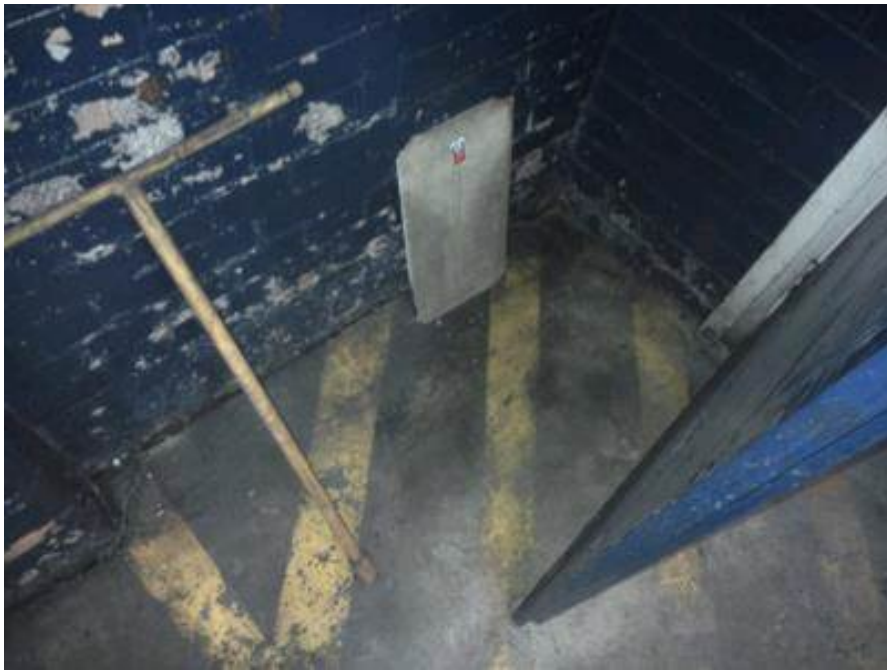
Sample N°	<b>AV000695</b>		
Location	G.03 - Garage 2

Item:	Loose cement panel to the floor.	Identification:	Identified
Approx. Quantity:	1no.	Accessibility:	Medium
Product Type:	Asbestos Cement		1
Extent of damage:	Low Damage		1
Surface treatment:	Surface Sealed		1
Asbestos type:	Chrysotile		1
		<b>Material Assessment Score:</b>	<b>4</b>
Action:	Remove prior to demolition or refurbishment		
Comments:	Adjacent gas store

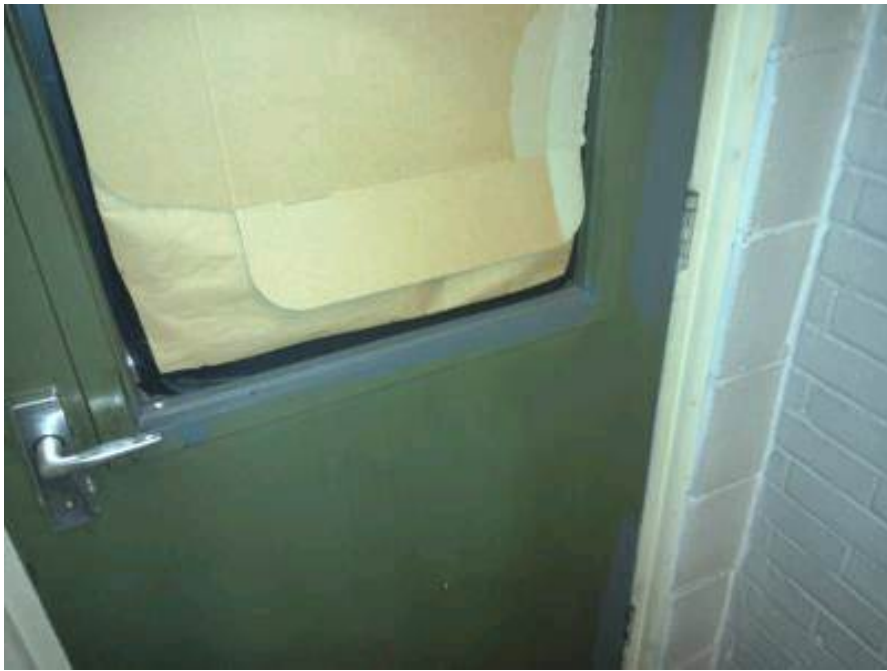
Sample N°	VC AV000689		
Location	G.06 - Store

Item:	Beading to door frame	Identification:	Visually Consistent Sample
Approx. Quantity:	3lm	Accessibility:	Easy
Product Type:	Insulating Board		0
Extent of damage:	Low Damage		0
Surface treatment:	Unsealed		0
Asbestos type:	No Asbestos Detected		0
		<b>Material Assessment Score:</b>	<b>0</b>
Action:			
Comments:	No comments

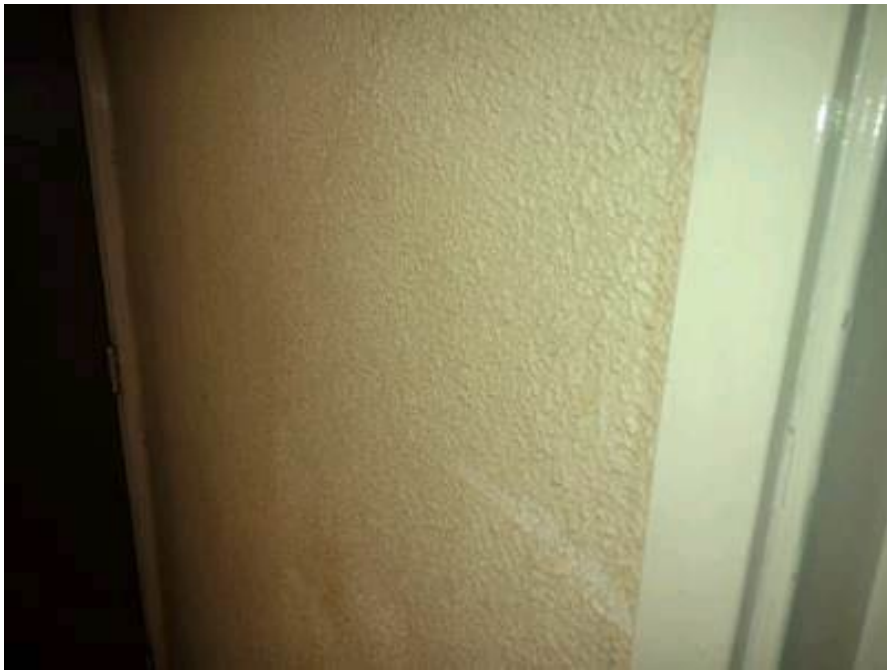
Sample N°	<b>VC AV000710</b>		
Location	G.34 - Lobby

Item:	Textured coating to walls	Identification:	Visually Consistent Sample
Approx. Quantity:	8m <sup>2</sup>	Accessibility:	Easy
Product Type:	Textured Coating		0
Extent of damage:	Low Damage		0
Surface treatment:	Surface Sealed		0
Asbestos type:	No Asbestos Detected		0
		<b>Material Assessment Score:</b>	<b>0</b>
Action:			
Comments:	No comments

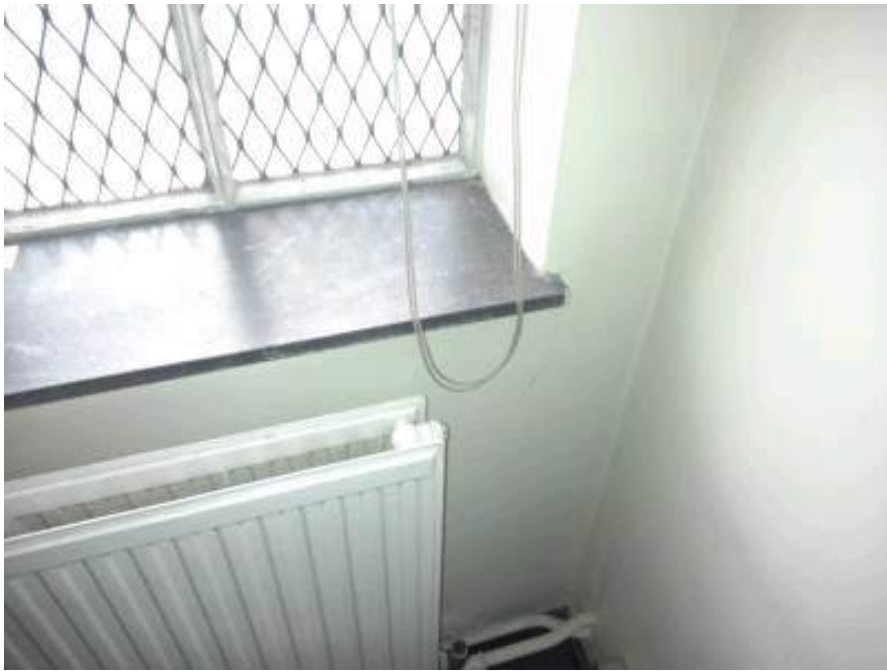
Sample N°	<b>VC AV000697</b>		
Location	G.41 - Store

Item:	Eternite window sill	Identification:	Visually Consistent Sample
Approx. Quantity:	1lm	Accessibility:	Medium
Product Type:	Reinforced Composite		1
Extent of damage:	Low Damage		1
Surface treatment:	Completely Sealed		0
Asbestos type:	Chrysotile		1
		<b>Material Assessment Score:</b>	<b>3</b>
Action:	Remove prior to demolition or refurbishment		
Comments:	No comments

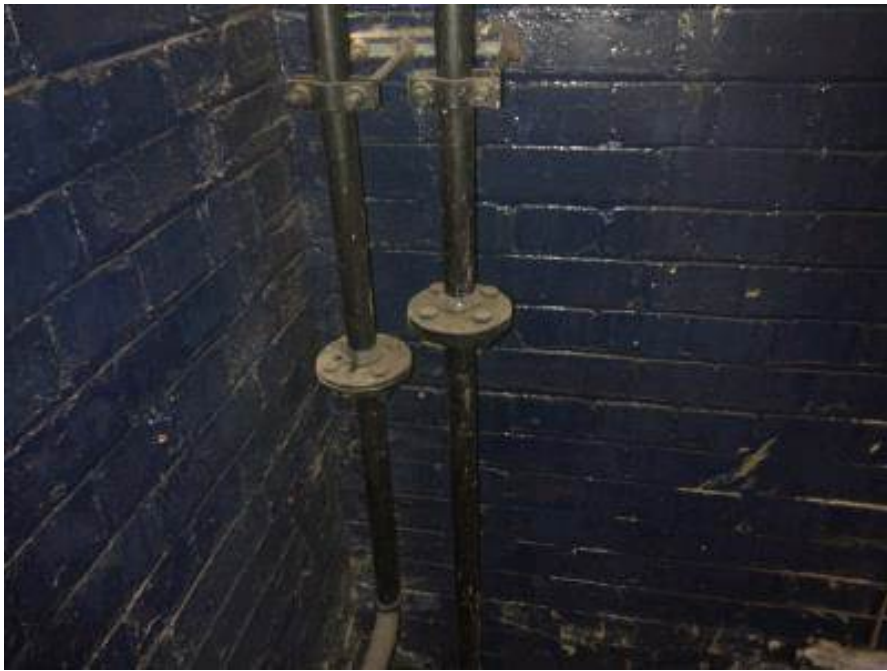
Sample N°	<b>AV000713</b>		
Location	G.03 - Garage 2

Item:	Gaskets to small pipework flanges	Identification:	Identified
Approx. Quantity:	2no.	Accessibility:	Medium
Product Type:	Gasket		1
Extent of damage:	Low Damage		1
Surface treatment:	Surface Sealed		1
Asbestos type:	Chrysotile		1
		<b>Material Assessment Score:</b>	<b>4</b>
Action:	Remove prior to demolition or refurbishment		
Comments:	No comments

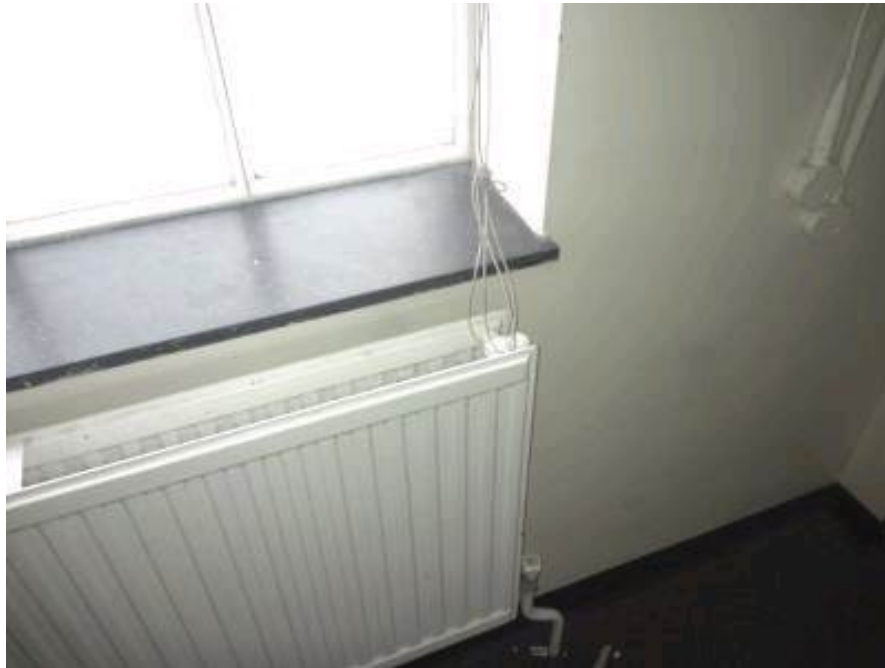
Sample N°	<b>AV000714</b>
Location	1.01 - Store

Item:	Eternite window sill	Identification:	Identified
Approx. Quantity:	1lm	Accessibility:	Medium
Product Type:	Reinforced Composite		1
Extent of damage:	Low Damage		1
Surface treatment:	Completely Sealed		0
Asbestos type:	Chrysotile		1
			<b>Material Assessment Score: 3</b>

Action:	Remove prior to demolition or refurbishment
---------	---

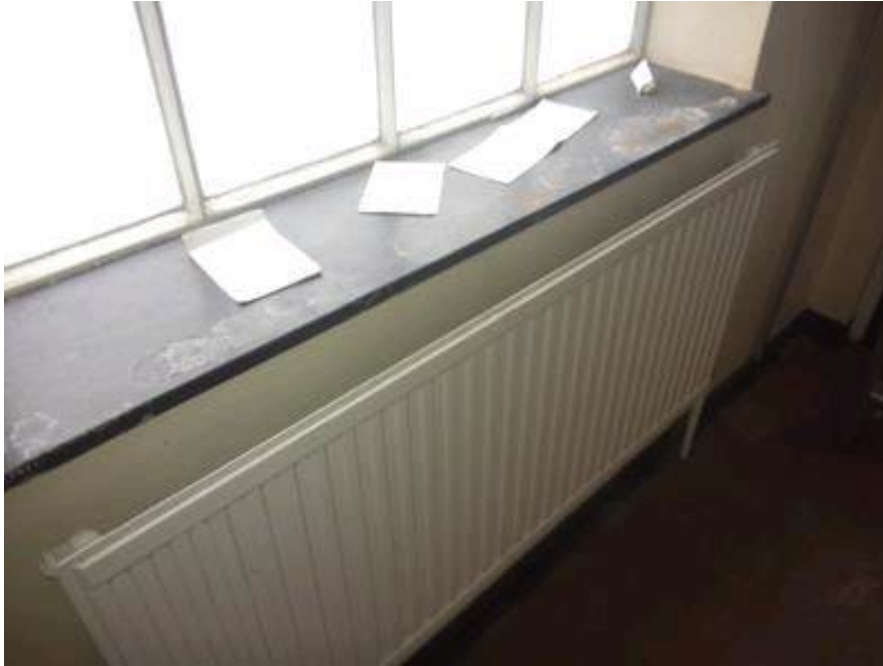
Sample N°	<b>VC AV000714</b>
Location	1.02 - Stairwell

Item:	Eternite window sill	Identification:	Visually Consistent Sample
Approx. Quantity:	1lm	Accessibility:	Medium
Product Type:	Reinforced Composite		1
Extent of damage:	Low Damage		1
Surface treatment:	Completely Sealed		0
Asbestos type:	Chrysotile		1
			<b>Material Assessment Score: 3</b>

Action:	Remove prior to demolition or refurbishment
---------	---

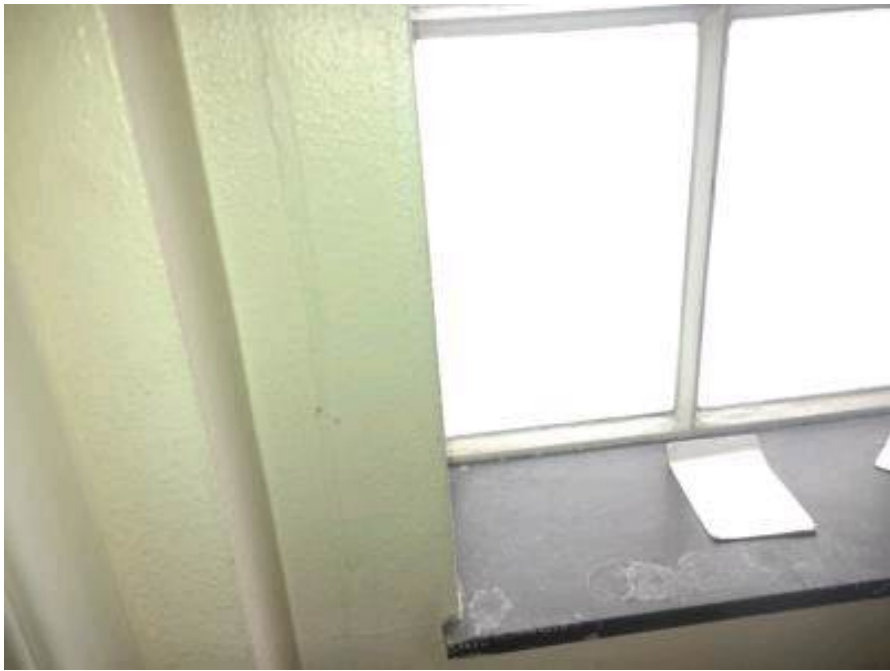
Sample N°	<b>AV000715</b>		
Location	1.02 - Stairwell

Item:	Textured coating to the walls	Identification:	Identified
Approx. Quantity:	18m <sup>2</sup>	Accessibility:	Medium
Product Type:	Textured Coating		0
Extent of damage:	Low Damage		0
Surface treatment:	Surface Sealed		0
Asbestos type:	No Asbestos Detected		0
		<b>Material Assessment Score:</b>	<b>0</b>
Action:			
Comments:	No comments

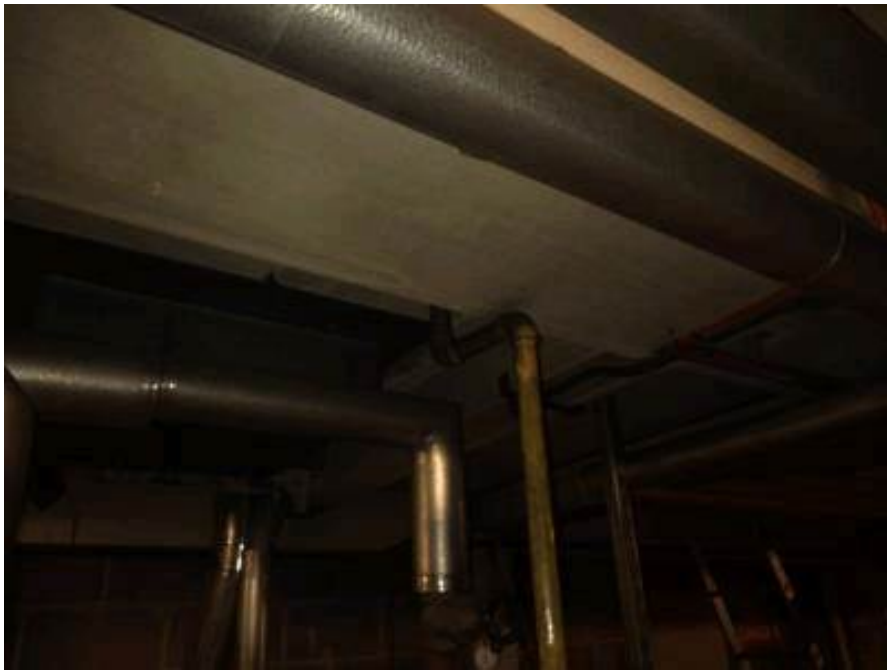
Sample N°	VC AV000717		
Location	1.12 - Plant Room

Item:	Board boxing to support framework	Identification:	Visually Consistent Sample
Approx. Quantity:	Unknown	Accessibility:	Medium
Product Type:	Insulating Board		0
Extent of damage:	Low Damage		0
Surface treatment:	Unsealed		0
Asbestos type:	No Asbestos Detected		0
		<b>Material Assessment Score:</b>	<b>0</b>
Action:			
Comments:	No comments

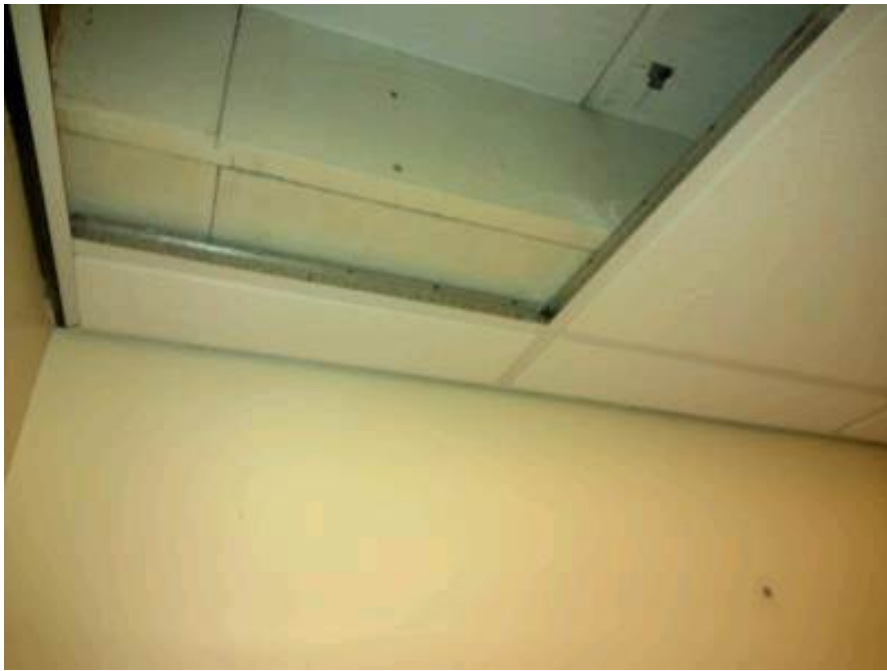
Sample N°	VC AV000717		
Location	1.15 - Office

Item:	Board boxing to support beams	Identification:	Visually Consistent Sample
Approx. Quantity:	10m <sup>2</sup>	Accessibility:	Medium
Product Type:	Insulating Board		0
Extent of damage:	Low Damage		0
Surface treatment:	Unsealed		0
Asbestos type:	No Asbestos Detected		0
		<b>Material Assessment Score:</b>	<b>0</b>
Action:			
Comments:	No comments

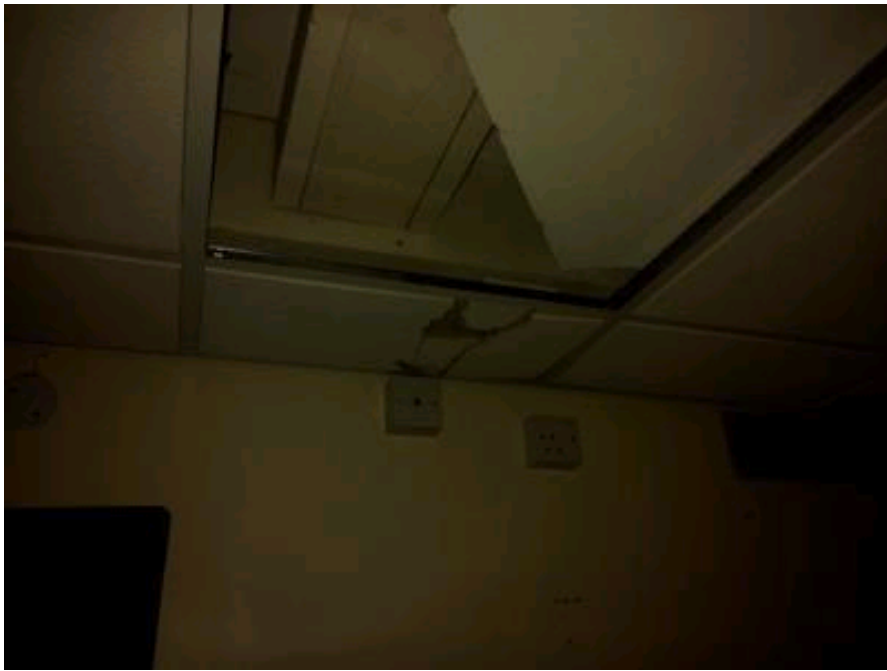
Sample N°	VC AV000717		
Location	1.16 - Office

Item:	Board boxing to support beams	Identification:	Visually Consistent Sample
Approx. Quantity:	6m <sup>2</sup>	Accessibility:	Medium
Product Type:	Insulating Board		0
Extent of damage:	Low Damage		0
Surface treatment:	Unsealed		0
Asbestos type:	No Asbestos Detected		0
		<b>Material Assessment Score:</b>	<b>0</b>
Action:			
Comments:	No comments

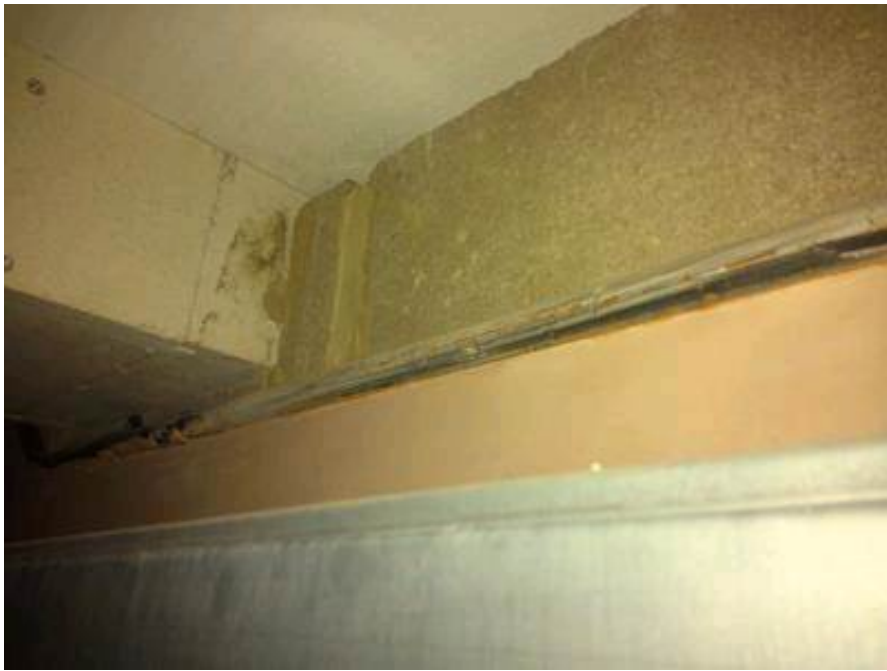
Sample N°	<b>VC AV000717</b>		
Location	1.17 - Shower room

Item:	Board boxing to support beams	Identification:	Visually Consistent Sample
Approx. Quantity:	4m <sup>2</sup>	Accessibility:	Medium
Product Type:	Insulating Board		0
Extent of damage:	Low Damage		0
Surface treatment:	Unsealed		0
Asbestos type:	No Asbestos Detected		0
		<b>Material Assessment Score:</b>	<b>0</b>
Action:			
Comments:	No comments

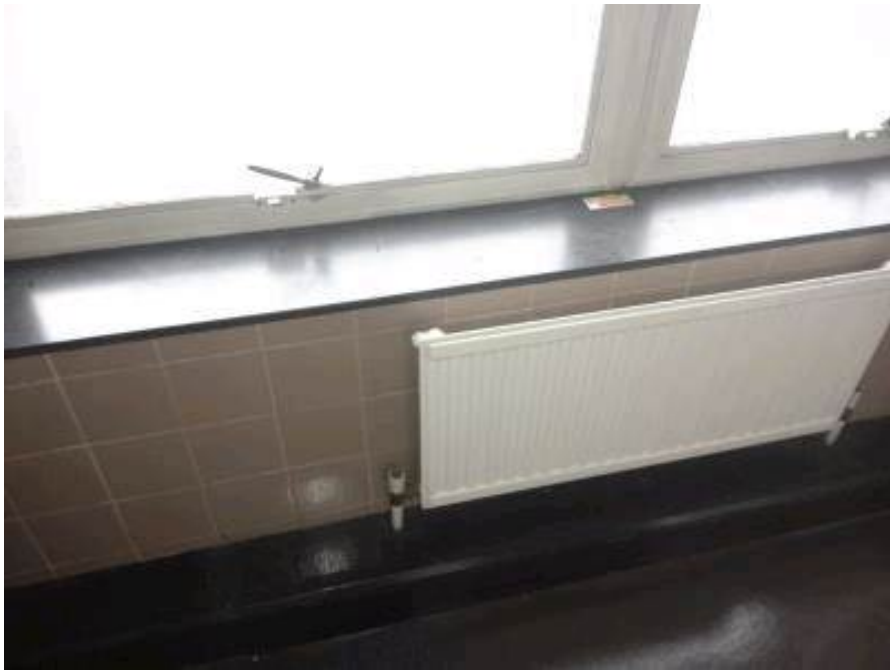
Sample N°	<b>VC AV000714</b>		
Location	1.22 - Office and WC

Item:	Eternite window sill	Identification:	Visually Consistent Sample
Approx. Quantity:	4lm	Accessibility:	Medium
Product Type:	Reinforced Composite		1
Extent of damage:	Low Damage		1
Surface treatment:	Completely Sealed		0
Asbestos type:	Chrysotile		1
		<b>Material Assessment Score:</b>	<b>3</b>
Action:	Remove prior to demolition or refurbishment		
Comments:	No comments

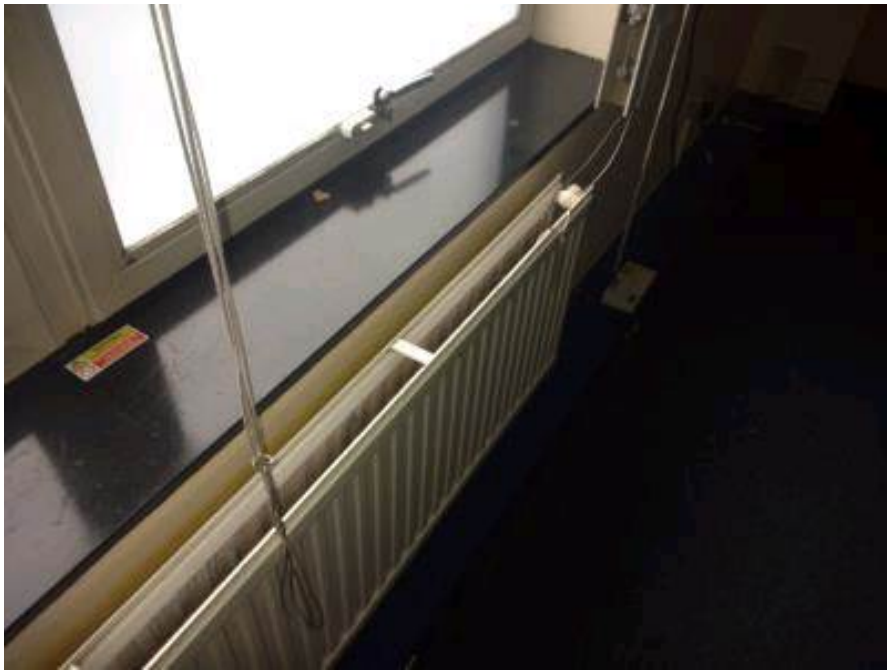
Sample N°	VC AV000714		
Location	1.25 - Office

Item:	Eternite window sill	Identification:	Visually Consistent Sample
Approx. Quantity:	2lm	Accessibility:	Medium
Product Type:	Reinforced Composite		1
Extent of damage:	Low Damage		1
Surface treatment:	Completely Sealed		0
Asbestos type:	Chrysotile		1
		<b>Material Assessment Score:</b>	<b>3</b>
Action:	Remove prior to demolition or refurbishment		
Comments:	No comments

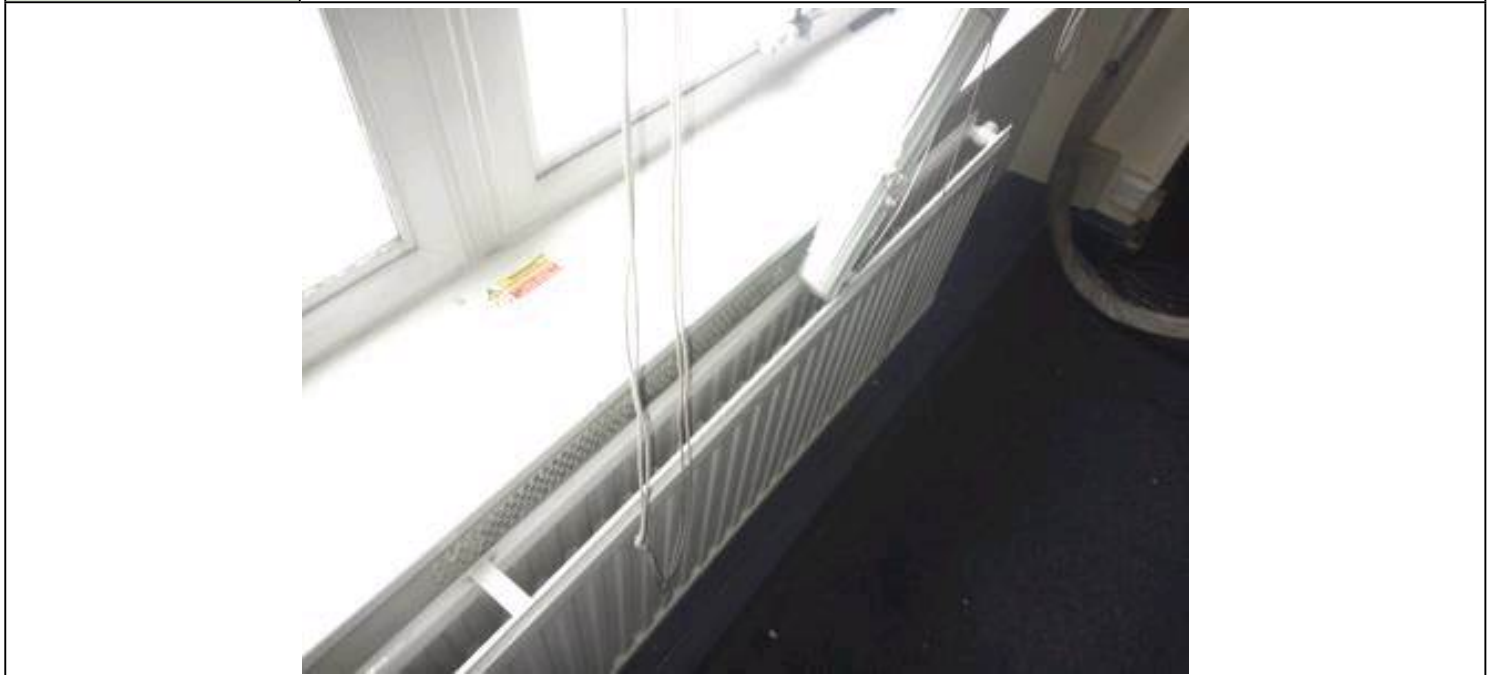
Sample N°	VC AV000714
Location	1.26 - Office

Item:	Eternite window sill	Identification:	Visually Consistent Sample
Approx. Quantity:	2lm	Accessibility:	Medium
Product Type:	Reinforced Composite		1
Extent of damage:	Low Damage		1
Surface treatment:	Completely Sealed		0
Asbestos type:	Chrysotile		1
			<b>Material Assessment Score: 3</b>

Action:	Remove prior to demolition or refurbishment
---------	---

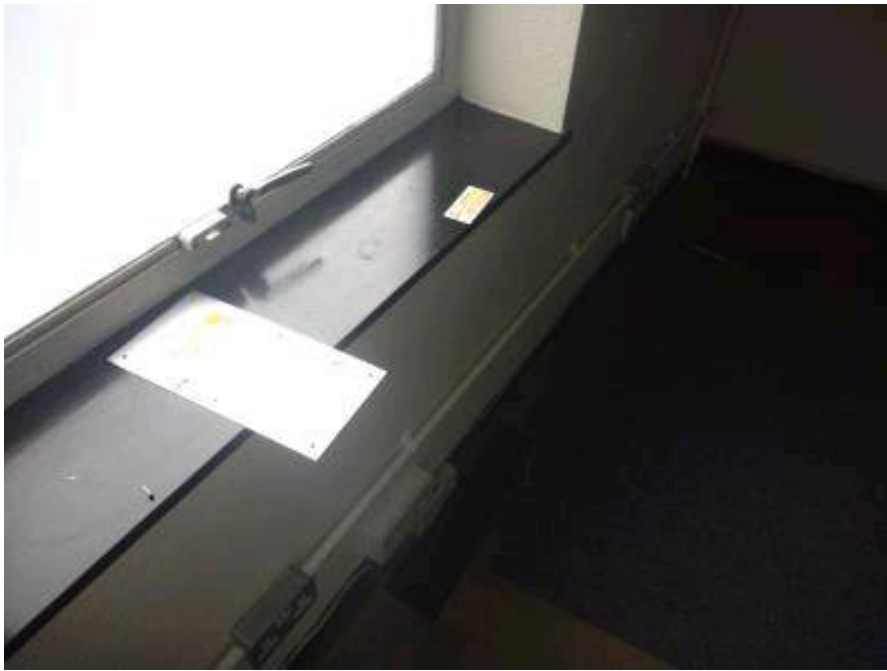
Sample N°	VC AV000714		
Location	1.28 - Office

Item:	Eternite window sill	Identification:	Visually Consistent Sample
Approx. Quantity:	2lm	Accessibility:	Medium
Product Type:	Reinforced Composite		1
Extent of damage:	Low Damage		1
Surface treatment:	Completely Sealed		0
Asbestos type:	Chrysotile		1
		<b>Material Assessment Score:</b>	<b>3</b>
Action:	Remove prior to demolition or refurbishment		
Comments:	No comments
