# SCHEDULE OF WORKS

## **Project: Proposed Fabric Repairs**

Re-building of 4No pilasters to Albany Street entrance and replacement of existing (and introduction of new) brackets to support front elevation stone cornice / balcony

**At:** No 2 Marylebone Road, London NW1 4DF

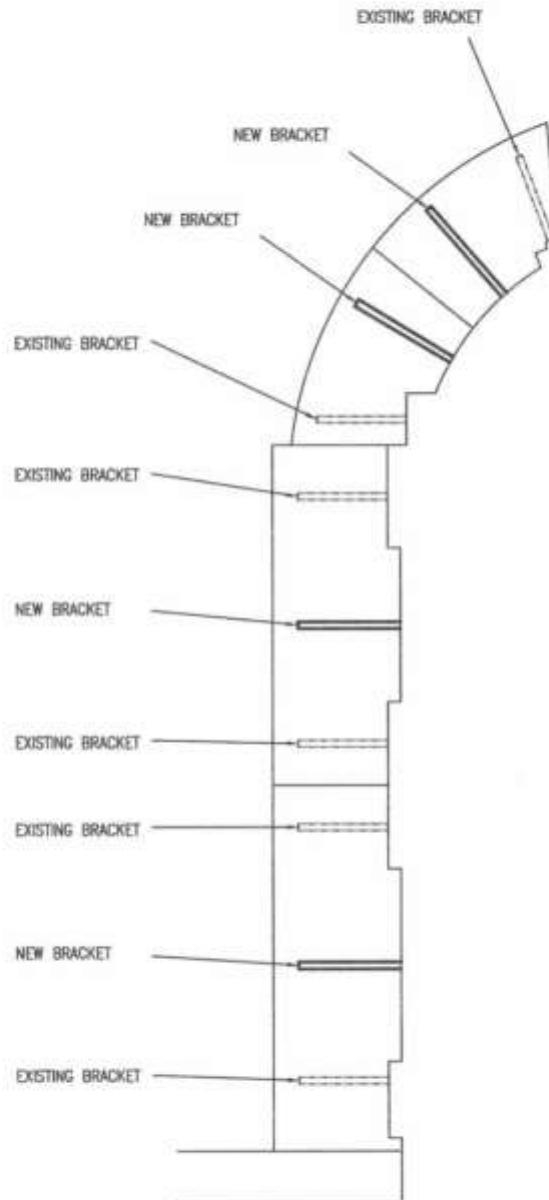
### PROPOSED BRACKET LOCATION

On initial inspection there is no support to the cracked section of stone at the West end - this explains the significant step indicating it had dropped and presumably wedged in place; perhaps because the balustrade hangers had snapped or another event. It is fortunate that this had not collapsed.

Whilst the slabs appear to be stable, because of the lack of restraint at windows, the assessment is that this must be because of a combination of support from the balustrade (which relies on lead pockets and the misaligned baluster posts and hangers) and continuity between the restrained sections of stone between windows. Unfortunately this cannot be relied upon in the long term; the balustrade posts and hangers are prone to corrosion, the lead seating does not provide a robust fixing and, with the pattern of cracking, the slabs cannot be justified to span under their own weight between the cantilever brackets which are undersize for the load being carried.

Install additional cantilever brackets – see sketches in the Appendix.
