Project name:  
**55 Lancaster Grove**

Contract number:  
**T8286**

Date:  
**15/12/2015**

## Inspection report

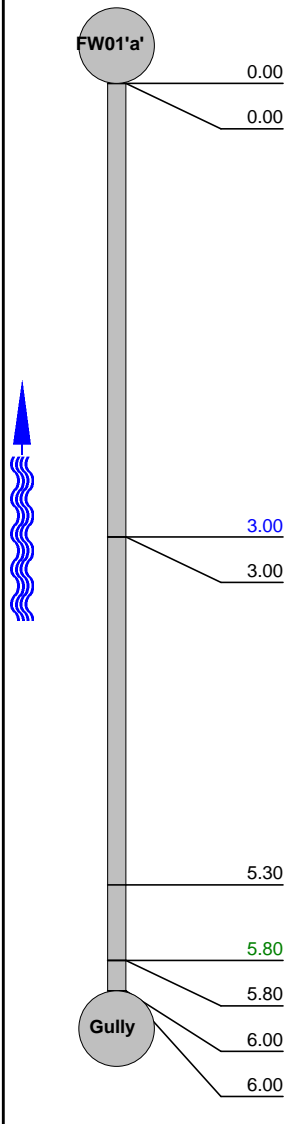
<p style="text-align: center;">+03.0mtr 3 m // 00:00:00</p>
	0.00	WL	Water level 00 % height/diameter	0	
	3.00	CC	Crack Circumferential from 02 to 10 o'clock	2

<p style="text-align: center;">+05.8mtr 5.8 m // 00:00:00</p>
	3.00	GP	General Condition photograph	0	
	5.30	DER	Settled deposits coarse 0 % cross-sectional area loss		
	5.80	RF	Fine Roots	1	
	5.80	GP	General Condition photograph	0	
	6.00	JN	Junction at 06 o'clock dia 100 mm Remark: Trap	0	
	6.00	REM	General remark, Remark: Survey Finished at Trap

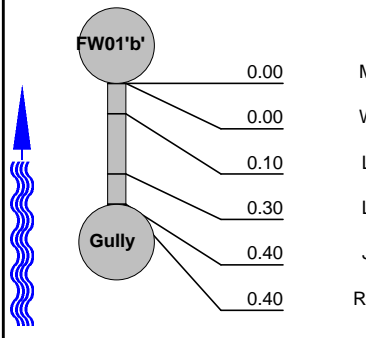
1:25	position	code	observation	grade
	0.00	MH	Start node type, manhole, reference number: FW01'b'	0
	0.00	WL	Water level 00 % height/diameter	0
	0.10	LU	Line of drain/sewer deviates up	
	0.30	LD	Line of drain/sewer deviates down	
	0.40	JN	Junction at 06 o'clock dia 100 mm Remark: Trap	0
	0.40	REM	General remark, Remark: Survey Finished at Line Up

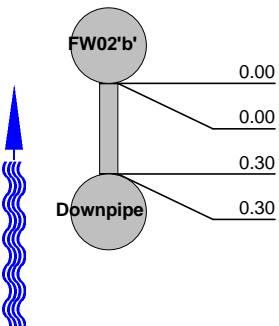
1:25	position	code	observation	grade
	0.00	MH	Start node type, manhole, reference number: FW02'b'	0
	0.00	WL	Water level 00 % height/diameter	0
	0.30	LU	Line of drain/sewer deviates up	
	0.30	REM	General remark, Remark: Survey Finished at Line Up

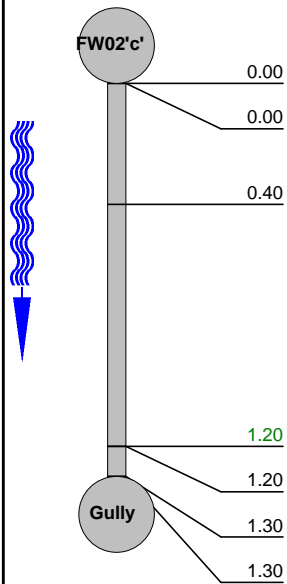
1:25	position	code	observation	grade
	0.00	MH	Start node type, manhole, reference number: FW02'c'	0
	0.00	WL	Water level 00 % height/diameter	0
	0.40	DEEJ	Attached deposits encrustation at joint from 03 to 09 o'clock 05 % cross-sectional area loss	
	1.20	JDM	Joint displaced medium	1
	1.20	GP	General Condition photograph	0
	1.30	LU	Line of drain/sewer deviates up	
	1.30	REM	General remark, Remark: Survey Finished at Line Up

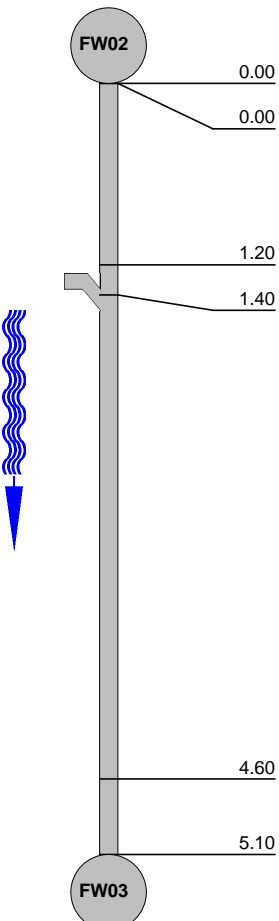
1:50	position	code	observation	grade
	0.00	MH	Start node type, manhole, reference number: FW02	0
	0.00	WL	Water level 00 % height/diameter	0
	1.20	DER	Settled deposits coarse 05 % cross-sectional area loss	
	1.40	JN	Junction at 02 o'clock dia 100 mm	0
	4.60	LD	Line of drain/sewer deviates down	
	5.10	MHF	Finish node type, manhole, reference number: FW03
