BS5837 ARBORICULTURAL REPORT,

ARBORICULTURAL IMPACT ASSESSMENT

| OUR REFERENCE | AC.2015.147 |
| SITE | Flat 1, 242 Grafton Rd, London, NW5 4AU |

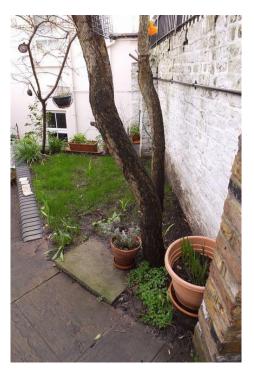
Image 3 Stems of T1 and T2 showing their proximity to the wall.

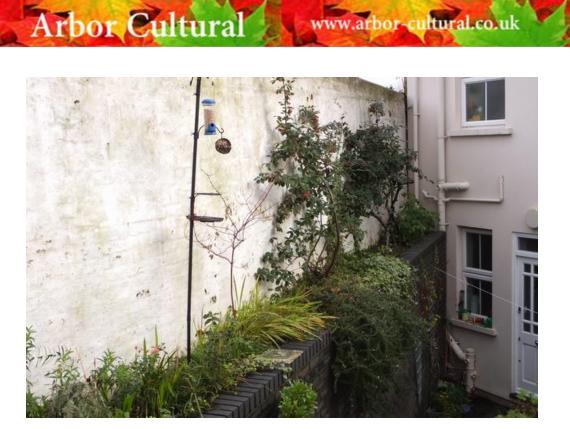
Image 5 G1, further along the northern raised bed

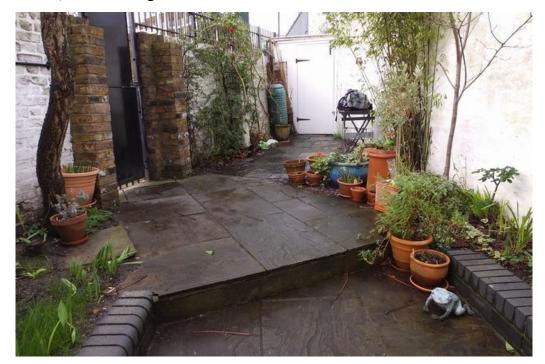
Image 6 Relatively flat area to the west to be used for storage area

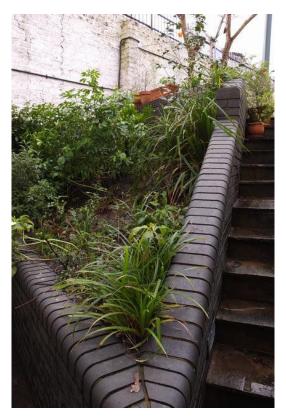
- **3.6.2** As the trees are contained in raised beds with significant level changes to the areas outside it is likely that only a small number of minor roots of less than 5mm diameter will be encountered during foundation construction. Any severance of a small number of minor roots found in these reduced levels will have an insignificant effect on the future growth and health of the retained trees.

Image 7 Showing the significant drop between the raised beds

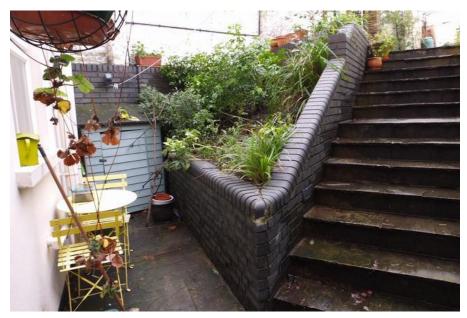
Image 8 Showing ground level at the rear of the building and steps leading to the west
