## SITE INVESTIGATION FACTUAL REPORT

Report No: 169984  
Client: Cunningham Lindsey - Maidstone  
Site: 99 Greencroft Gardens, London  
Client Ref: 7498207-  
Date of Visit: 11/01/2014

# Investigation Layout Plan

# Underground Drainage Report

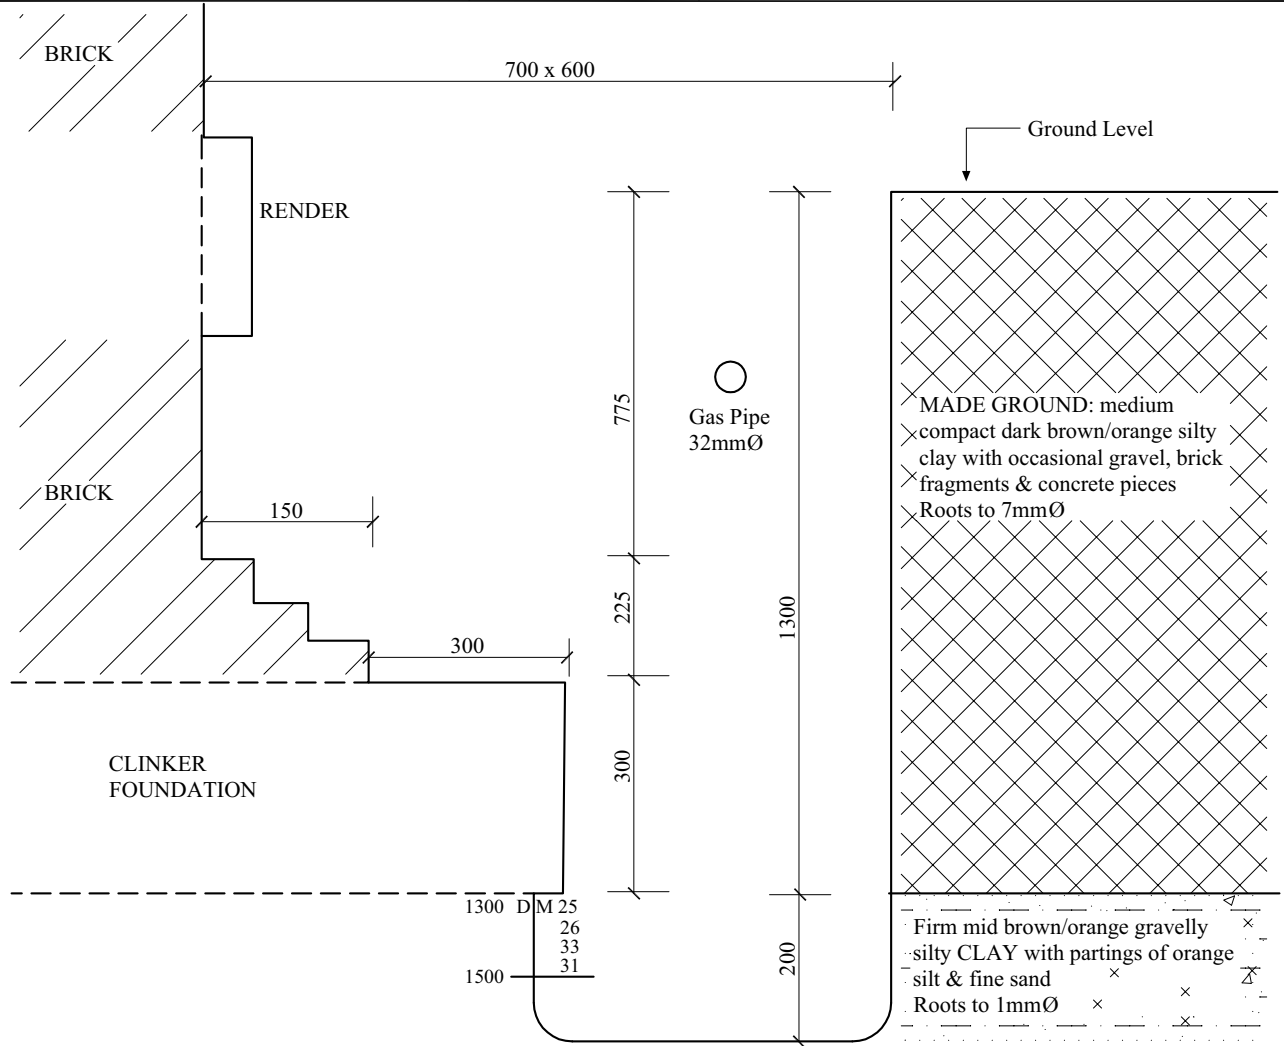
# Trial Pit No: 1

FOR STRATA BELOW 1500mm SEE BH LOG 1

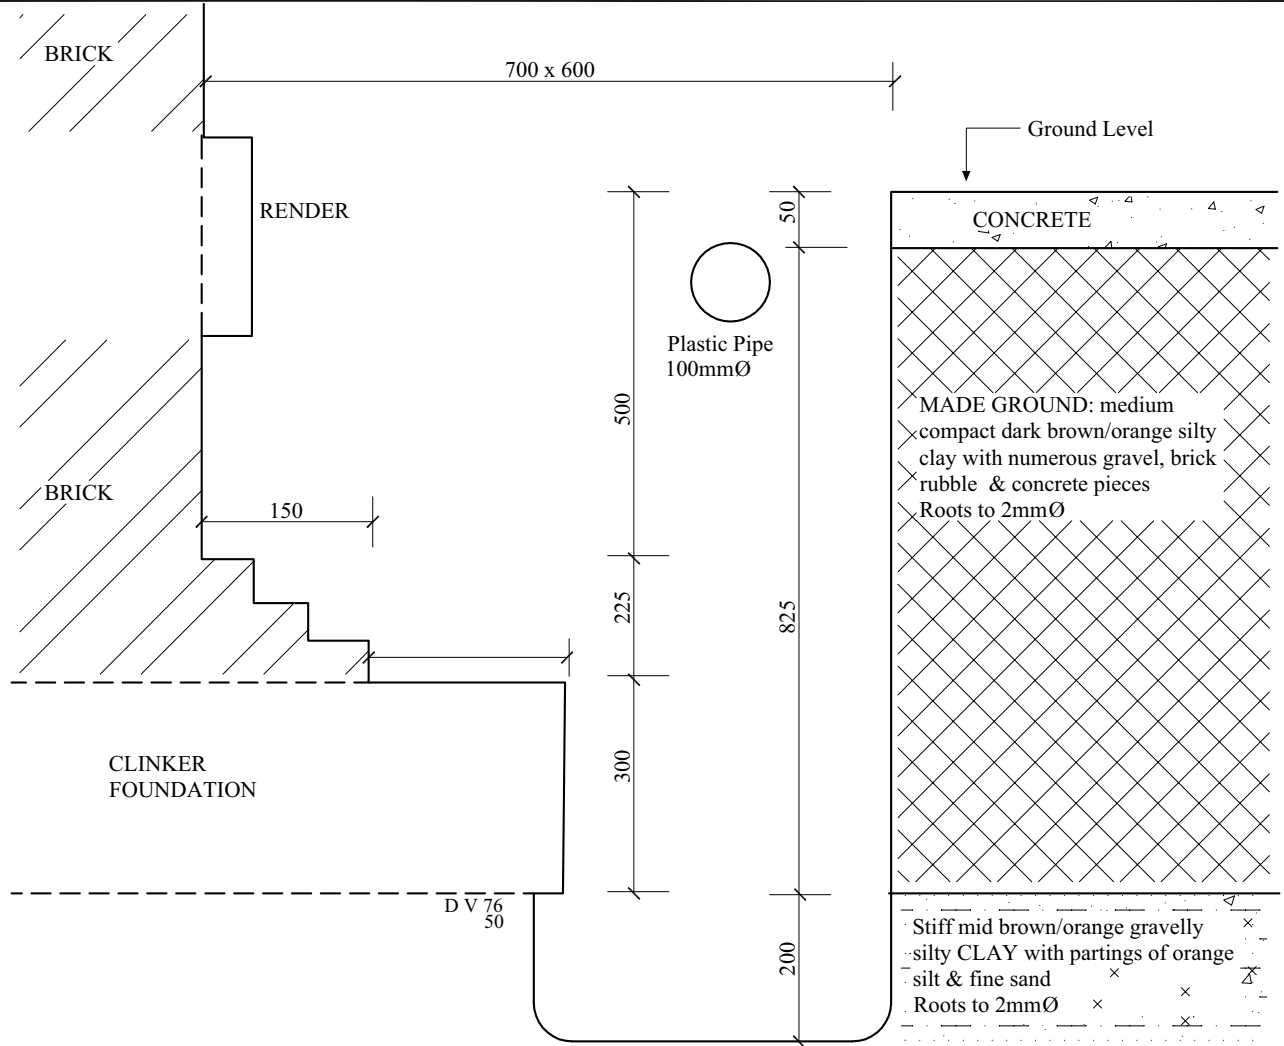
# Trial Pit No: 2

FOR STRATA BELOW 1125mm SEE BH LOG 2

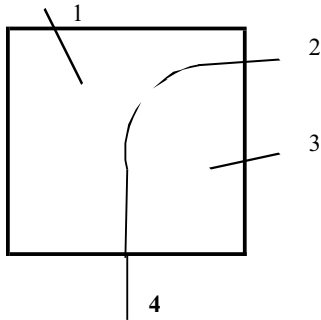
M/H: 1 Depth: 350mm

As built

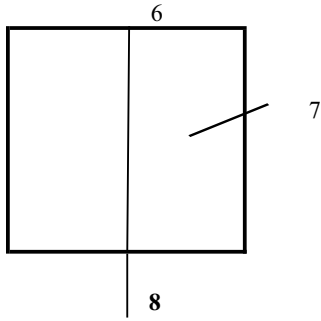
M/H: 3 Depth: 1000mm

As built

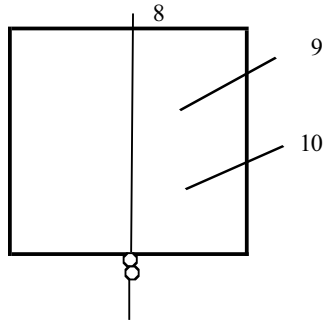
M/H: 4 Depth: 1250mm

As built
