Arboricultural Assessment Report

Summary Report on Trees

For:	Client:	Oriel Services Limited
	Insurer:	
Site:	Policyholder:	
	Risk Address:	99 Greencroft Gardens, London NW6 3PG
Refs:	OCA Ref:	55750
	Client Ref:	7624361
	Insurer Ref:

Survey By:	Dave O'Connell		
Title:	Technician	Date:	10 March 2014
Report By:	Gemma Holmes		
Title:	Technician	Date:	27 March 2014

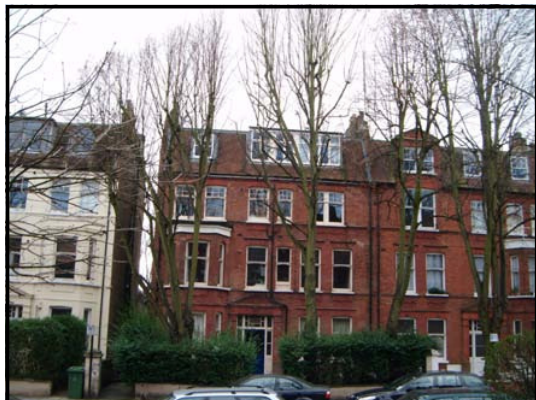
1. View of front

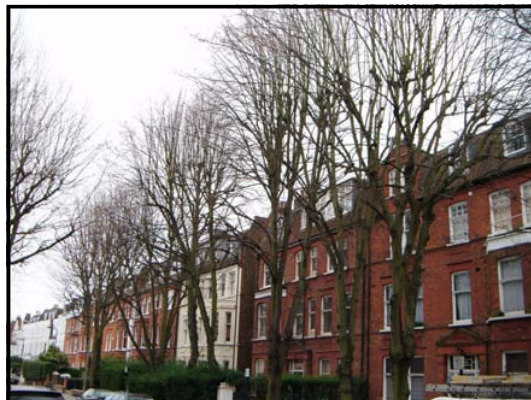
2. View of front

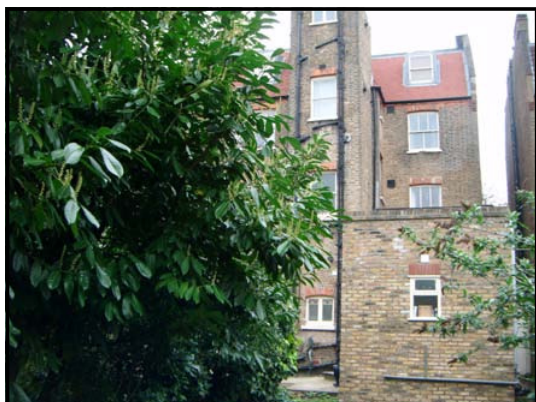
3. View of rear

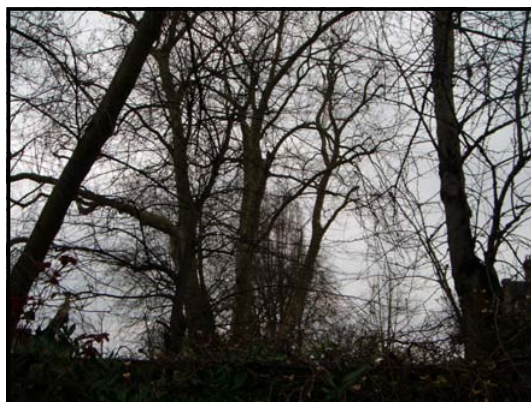
4. View through Limes G3 to London Plane T4

Tree No:	Species	Works Required
G4	Lime	Fell and treat stump
G5	Lime	Fell and treat stump
T4	London Plane	Fell and treat stump

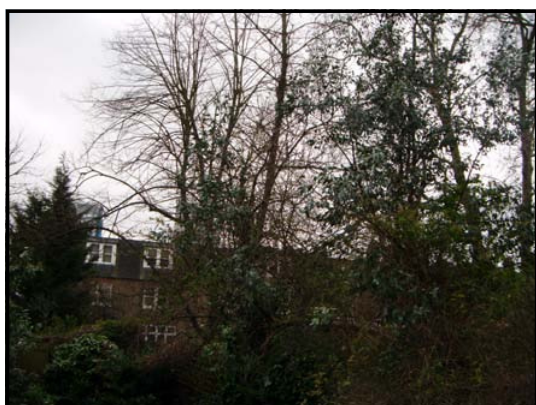
5. View of neighbouring property in No. 101

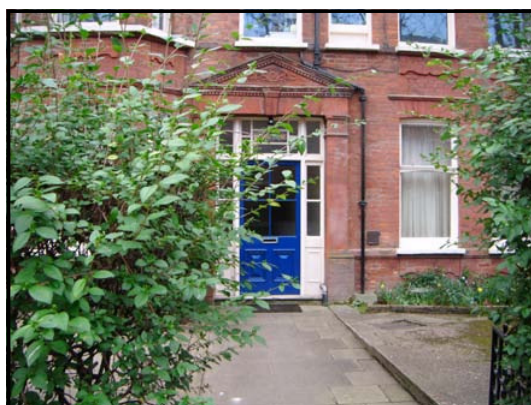
6. H1 Privet
