SITE INVESTIGATION FACTUAL REPORT

Report No: 169984
Client: Cunningham Lindsey - Maidstone
Site: 99 Greencroft Gardens, London
Client Ref: 7498207-
Date of Visit: 11/01/2014

Home Emergency Response - Subsidence Investigation - Drainage Services – Crack & Level Monitoring – Property Video Surveys

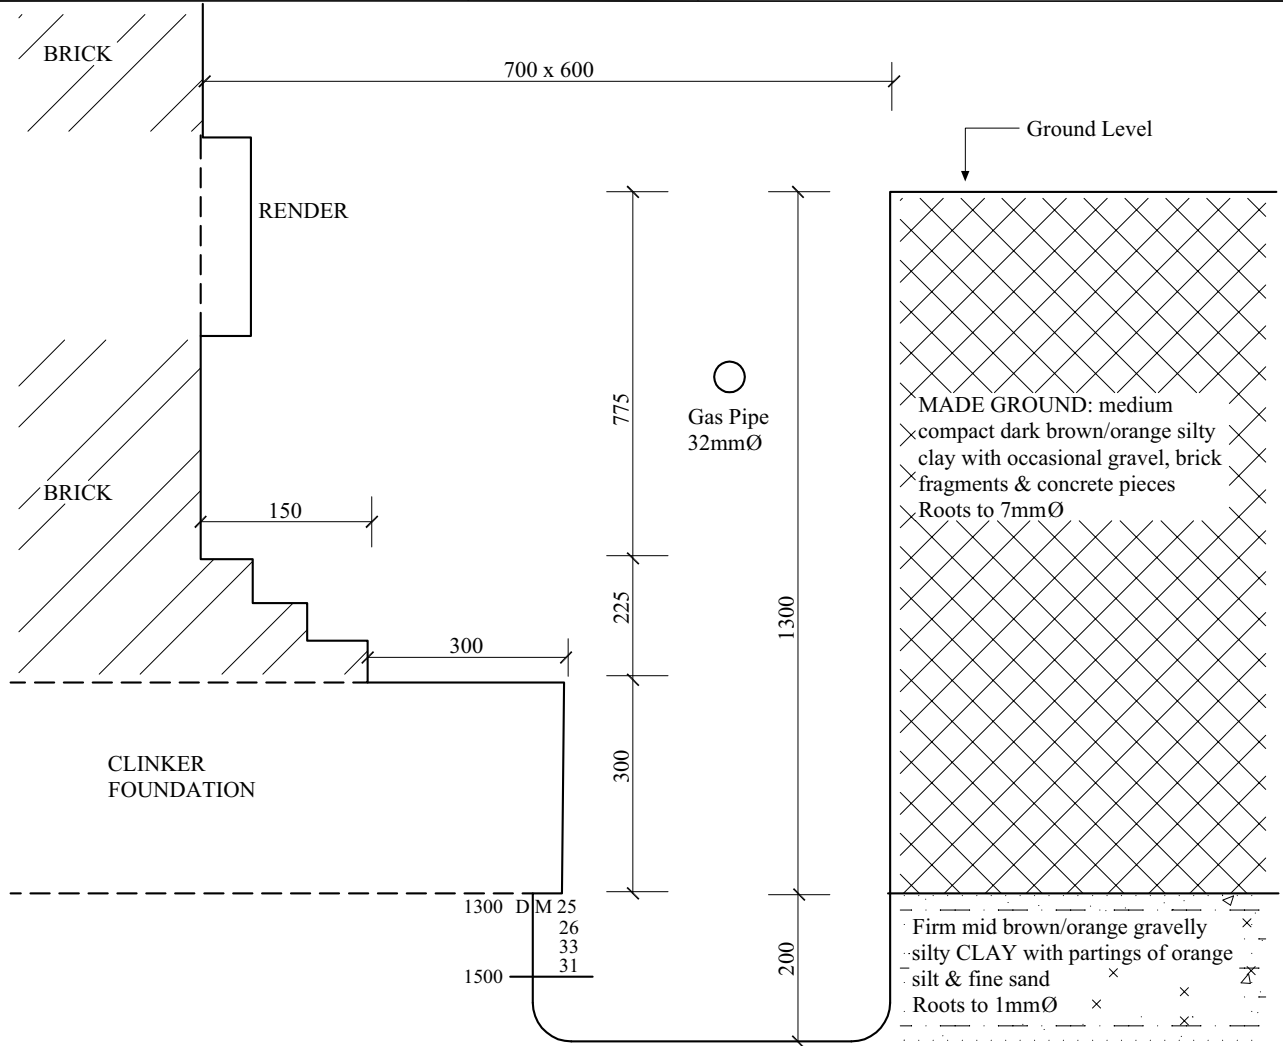
Trial Pit No: 1

FOR STRATA BELOW 1500mm SEE BH LOG 1

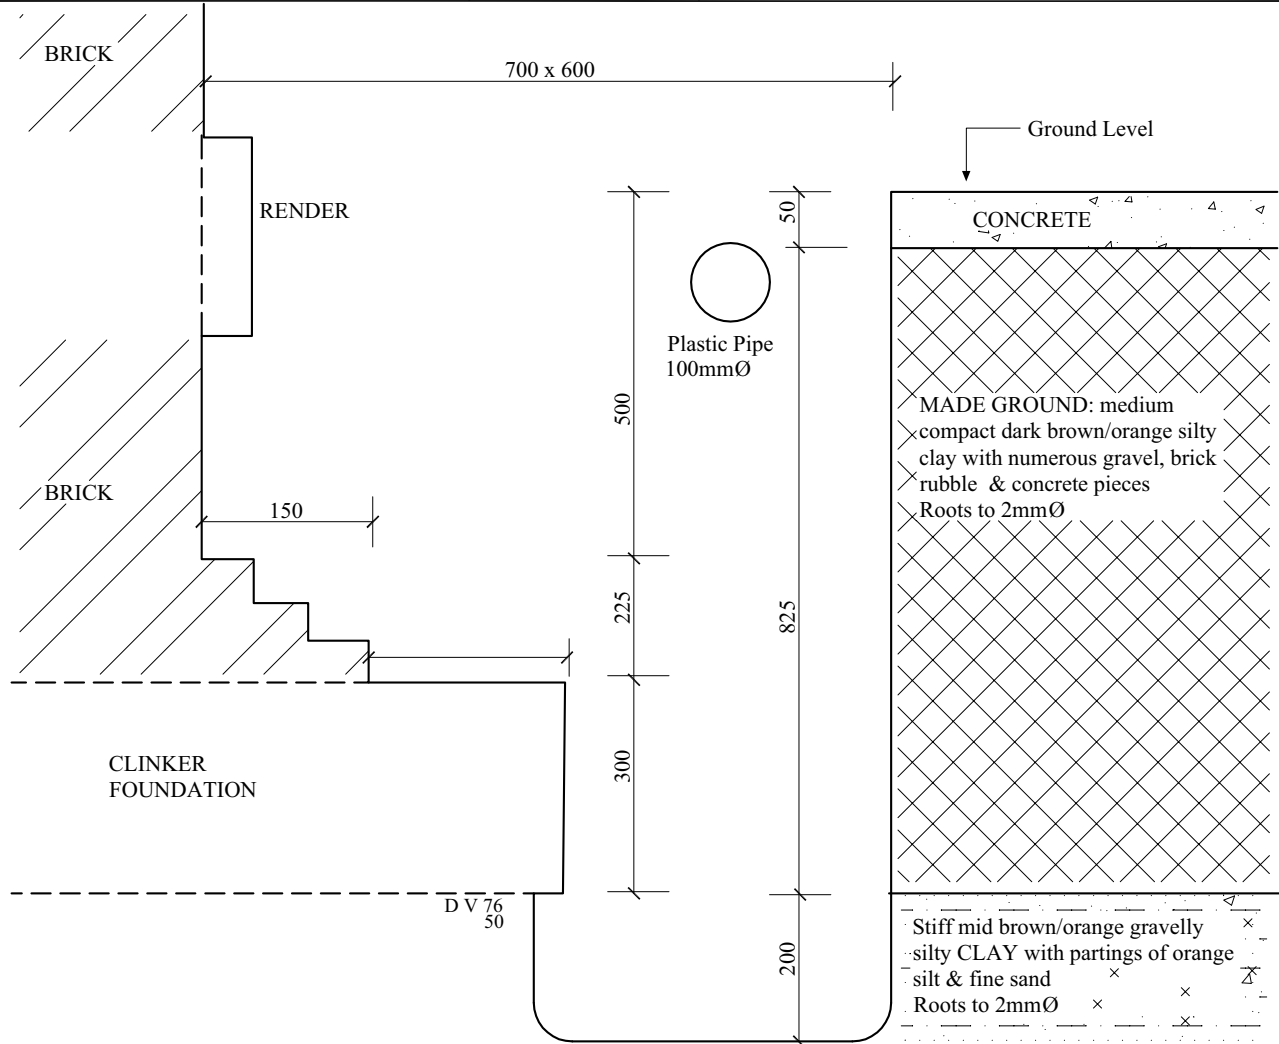
Trial Pit No: 2

FOR STRATA BELOW 1125mm SEE BH LOG 2

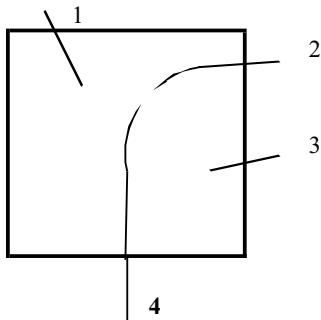
M/H: 1 Depth: 350mm

As built

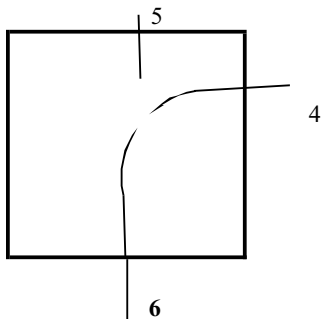
M/H: 2 Depth: 775mm

Run 5 500mm _____

As built

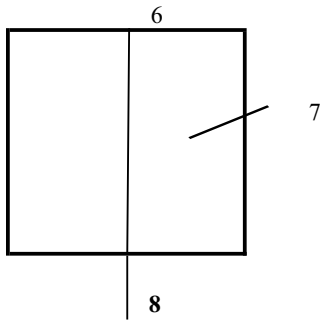
M/H: 3 Depth: 1000mm

As built

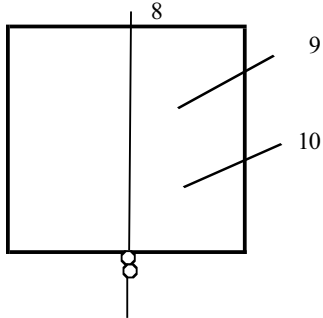
M/H: 4 Depth: 1250mm

As built
