Arboricultural Assessment Report

Summary Report on Trees

For:	Client:	Oriel Services Limited
	Insurer:	
Site:	Policyholder:	
	Risk Address:	99 Greencroft Gardens, London NW6 3PG
Refs:	OCA Ref:	55750
	Client Ref:	7624361
	Insurer Ref:

Survey By:	Dave O'Connell		
Title:	Technician	Date:	10 March 2014
Report By:	Gemma Holmes		
Title:	Technician	Date:	27 March 2014

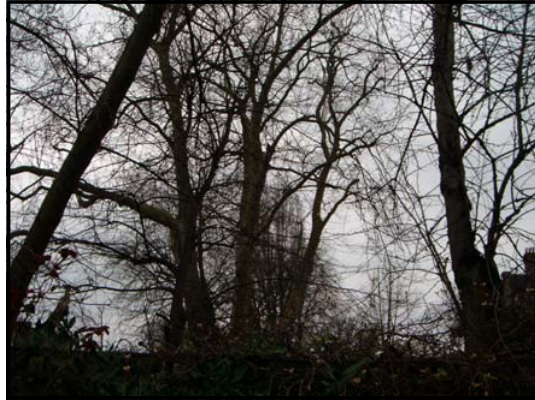
4. View through Limes G3 to London Plane T4

Tree No:	Species	Works Required
G4	Lime	Fell and treat stump
G5	Lime	Fell and treat stump
T4	London Plane	Fell and treat stump

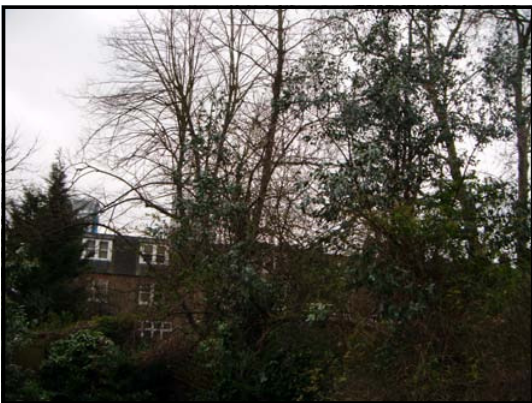
5. View of neighbouring property in No. 101

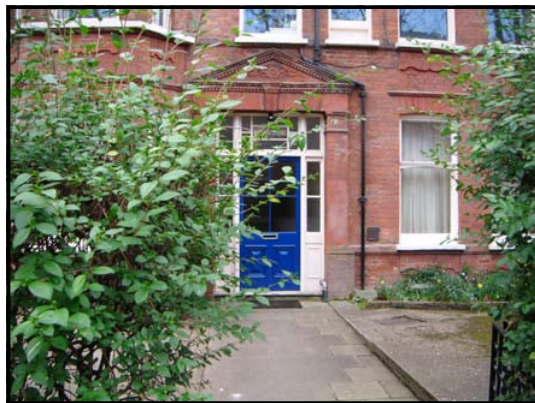
6. H1 Privet
