ARBORICULTURAL ASSESSMENT REPORT

For:	Client:	Oriel Services Limited
	Insurer:	
Site:	Policyholder:	
	Risk Address:	15 Fairhazel Gardens, London NW6 3QJ
Refs:	OCA Ref:	57572
	Client Ref:	7850065
	Insurer Ref:

Report By:	Margaret MacQueen		
Title:	Consultant Arborist	Date:	31 December 2014

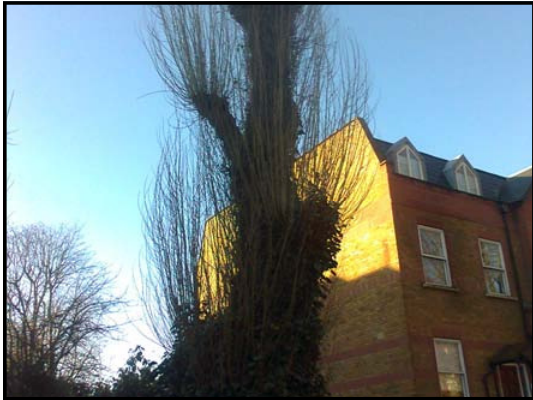
1. T1 Lombardy Poplar

Tree No	Common Name	Age Class	Condition	Height (m)	Crown Spread (m)	Stem diam. (mm)	Dist to bldg (m)	Pruning history	Recommendation	Tree work constraints	Notes	Owner address	Owner
T1	Lombardy Poplar	OM	P	14	3	800	8	Pollard. 2 years' regrowth.	Fell and treat stump.	None	Topped out at 12m	15 Fairhazel Gardens, London, NW6 3QJ	PH
T2	London Plane	MA	F	18	10	600	0.25	Reduced >5 years ago	Fell and treat stump.	None	Past topped out at 10m	70 Aberdare Gardens, London, NW6 3QD	P3P
T3	London Plane	MA	F	18	10	600	3	Reduced >5 years ago	No work required.	N/A		70 Aberdare Gardens, London, NW6 3QD	P3P
T4	London Plane	MA	F	18	10	600	5	Reduced >5 years ago	No work required.	N/A		70 Aberdare Gardens, London, NW6 3QD	P3P
T5	London Plane	MA	F	18	10	600	8	Reduced >5 years ago	No work required.	N/A		70 Aberdare Gardens, London, NW6 3QD	P3P
T6	London Plane	MA	F	18	10	600	12	No significant past tree works	No work required.	N/A		70 Aberdare Gardens, London, NW6 3QD	P3P

Tree No:	Species	Works Required
T1	Lombardy Poplar	Fell and treat stump
T2	London Plane	Fell and treat stump

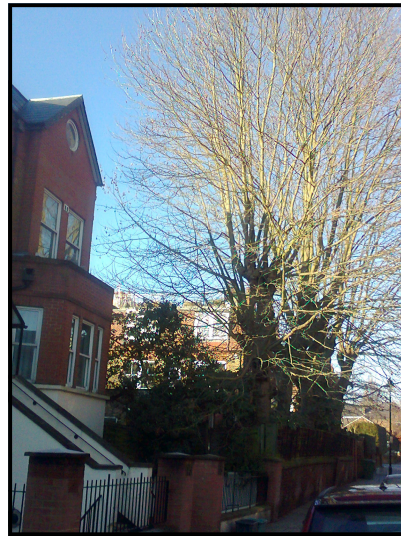
4. T2 to T7 looking north

T7	London Plane	MA	F	18	10	600	14	Reduced >5 years ago	No work required.	N/A		70 Aberdare Gardens, London, NW6 3QD	P3P
