## Asbestos Management Survey

**36 Flask Walk,  
London,  
NW3 1HE.**

**28<sup>th</sup> January 2015**

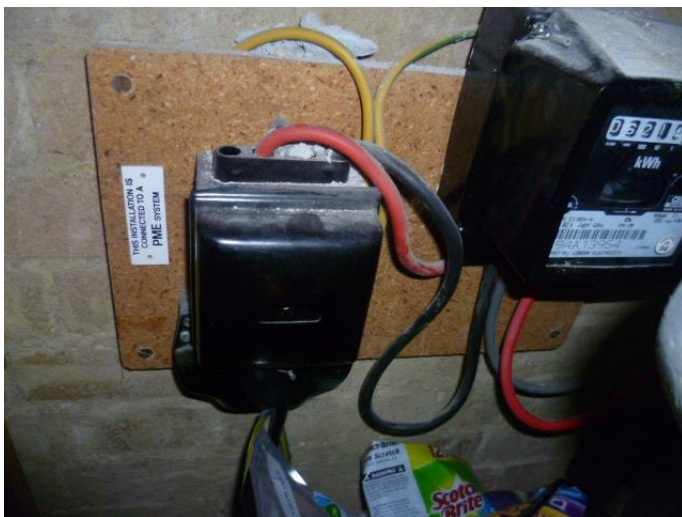
Survey Address	36 Flask Walk, London, NW3 1HE
Building	Residential house
Location	Under stairs, electrics cupboard
Survey Ref	5115/101130
Sample Ref	5115/101130/01

Asbestos Type	Chrysotile (White)	Product/Use	Asbestos content paper / flash guards
Condition	Presumed good	Treatment	Monitor
Identified Risk	Very low	Action	D
Extent		As seen	
Accessibility		Sealed in electrics belonging to electricity supply company

Sample reference	Location	Asbestos content	Asbestos product	Material description	Condition	Recommendation
5115/101130/01	Under stairs electrics cupboard	Chrysotile (White)	Asbestos content paper / flash guards	Paper	Presumed Good	D

Asbestos containing materials in good or reasonable condition, adequately surface treated and requiring no attention unless disturbed or condition deteriorates.
