DESIGN AND ACCESS STATEMENT FOR THE REPLACEMENT

GALLERIES 42-45  
WHITE WING  
BRITISH MUSEUM  
GREAT RUSSELL STREET  
LONDON WC1B 3DG

## ROOF CONDITION REPORT

WHITE WING  
BRITISH MUSEUM  
GREAT RUSSELL STREET  
LONDON WC1B 3DG

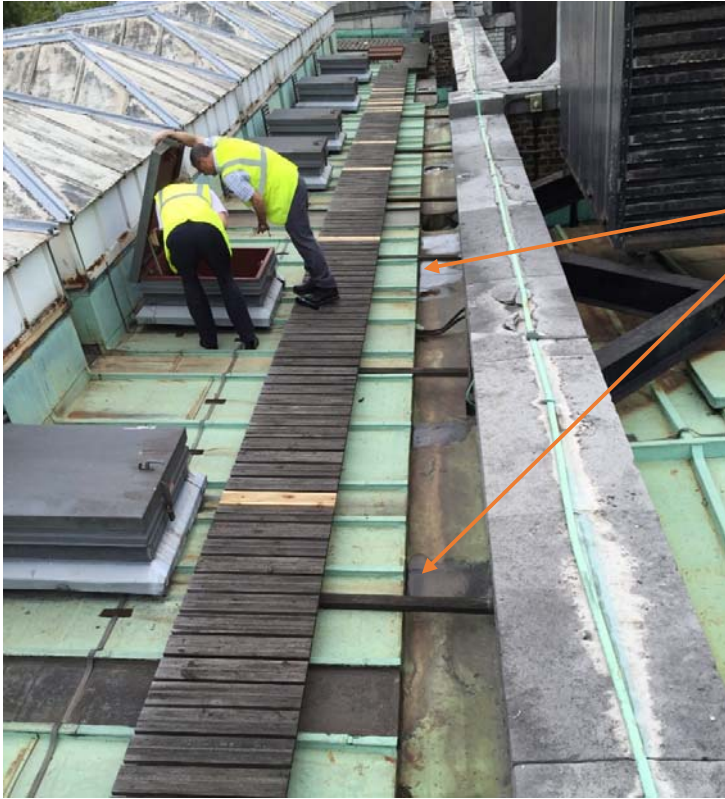
The difficulty of providing falls, drips, cesspools etc. in long gutters leads to a reduced number being provided. Excess thermal movement can be the result. However on the roof of the White Wing, some ponding is evident caused by insufficient falls, or back falls.

Insufficient falls or back falls causing ponding in the gutters.

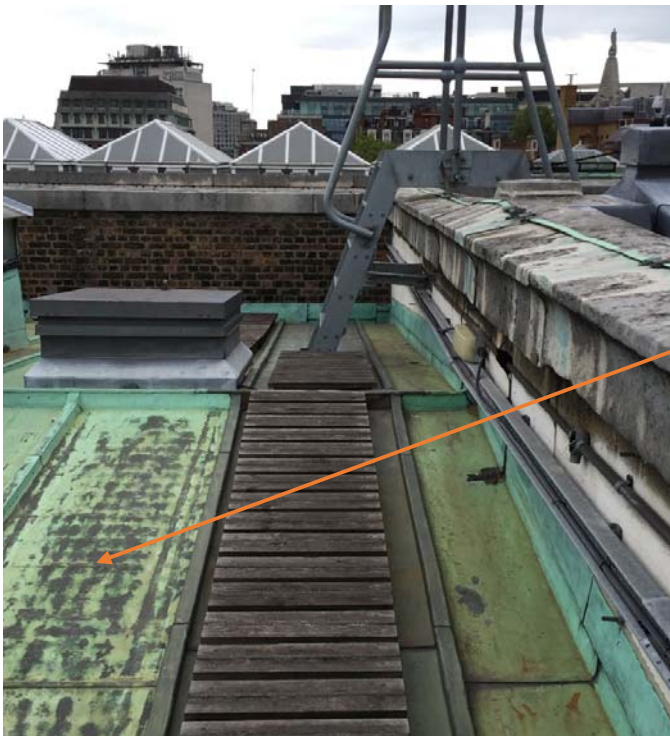
Restriction of thermal movement can be caused by the utilisation of incorrect underlay. The use of roofing felt and wood-wool underlay, introduced in the 1960s, has led to the premature failure of some roof coverings. The copper roofs over the White Wing are not tightly fitted to the substrate. The copper exhibits the lines of joints in the substrate boarding. It seems likely therefore that there are problems with the underlay which have in turn caused problems with the roof covering.

Copper sheet has taken on the form of the substrate. The surface is no longer smooth.

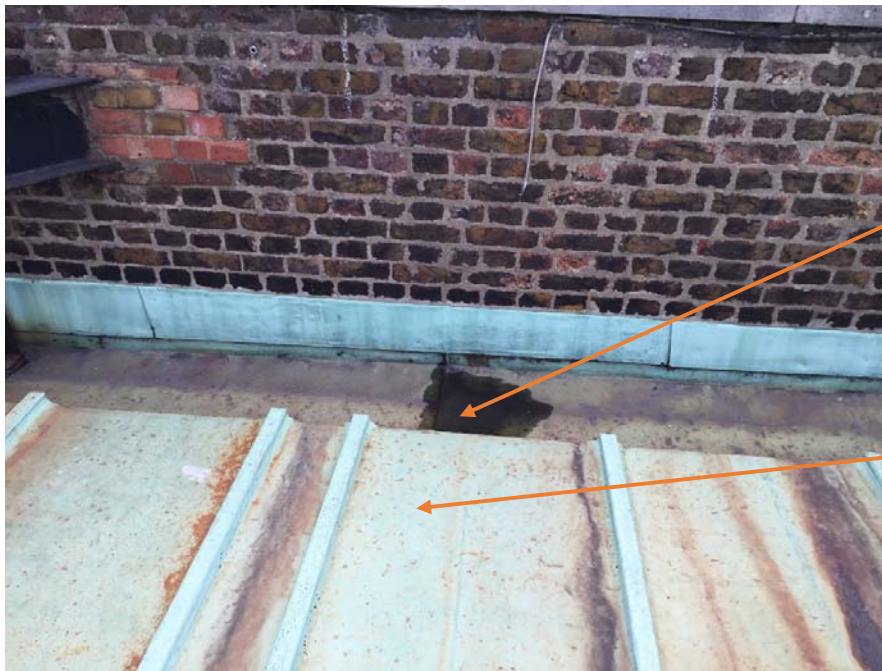
The surface of the copper is pitted and the numerous small indents hold the surface water. The exact cause of the pitting is unknown. Damage to vents was also noted.

Ponding in gutter.

Pitting of sheet surface where water can lie.

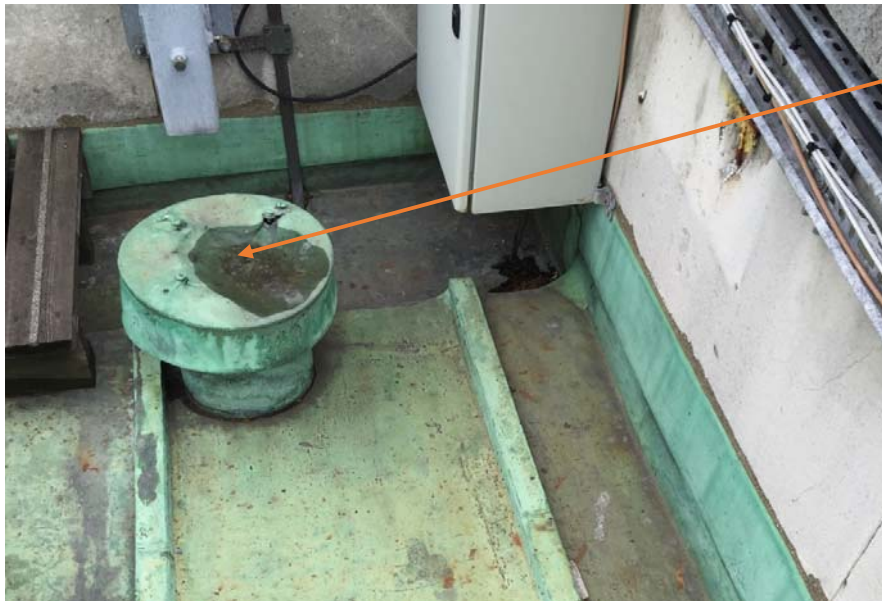
Damaged vent.

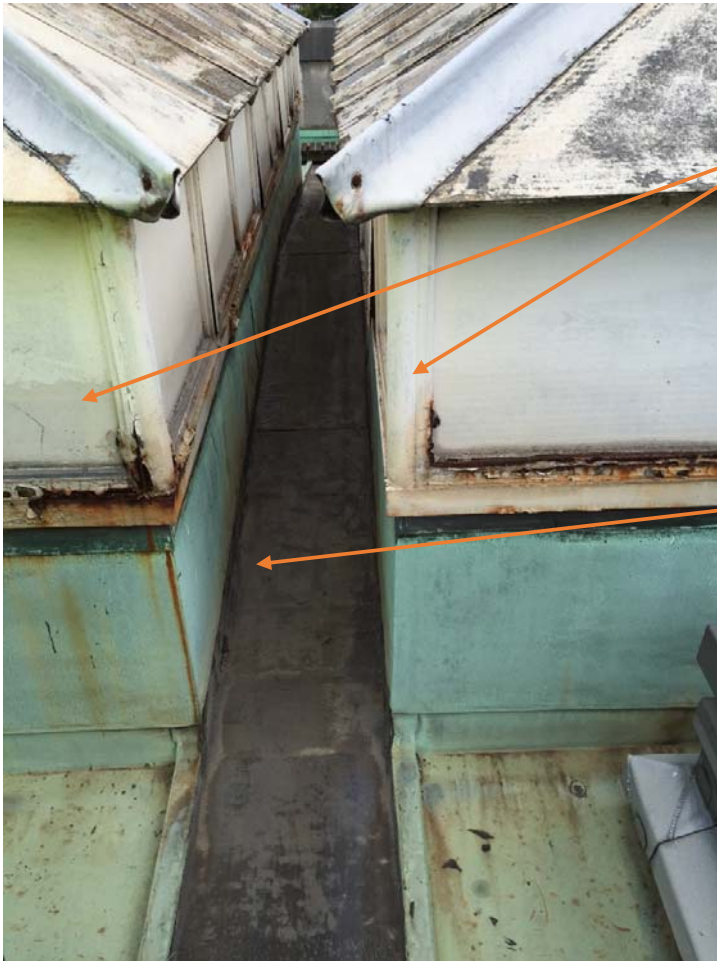
The patina found on weathered copper roofs produces a protective layer. When acid run-off occurs the patina breaks down and the protection is subsequently reduced. Acid water run-off from glass draining from roof lights and lanterns and caused by acid pollution leads to thinning and perforation of copper roofing. This is a likely explanation for the defects occurring to the bays between the roof lanterns and the junctions between the upstands of the lanterns and the roof hatches. Temporary repairs using sheet lead and bitumastic products are in evidence.

Badly corroded roof lanterns.

Liquid bitumen applied to copper surface.

In addition, the roof lanterns have reached the end of their serviceable lives and require immediate replacement in order to avoid problems of water penetration.

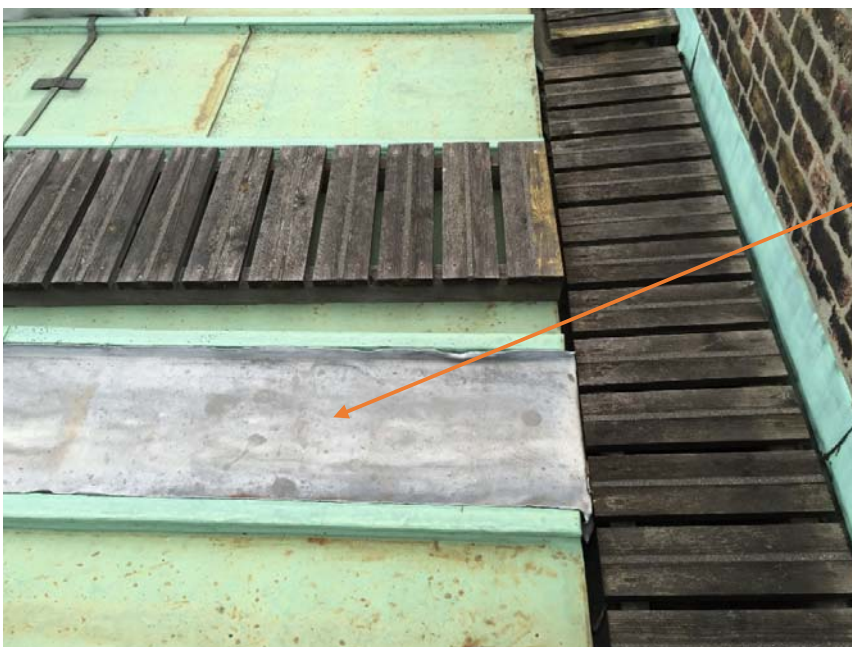
Loose laid lead sheet over copper.

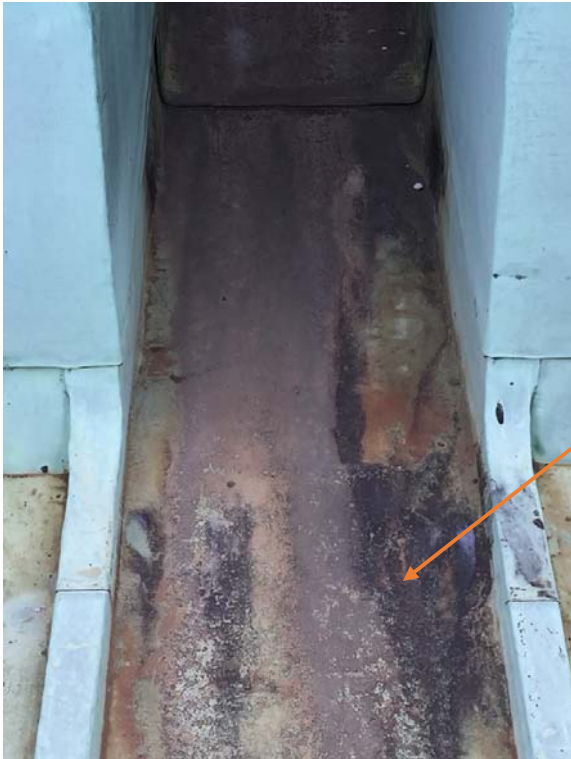
Staining is also common defect of copper roofs. It does not reduce the weathering capabilities of copper, but can significantly affect the visual appearance of the roof. Run-off from other metals, particularly those subject to oxidation, leaves metal oxide deposits in the patination layer, changing its colour. The roofs over the White Wing exhibit a large amount of brown staining which has run off the corroded steel roof lanterns. This is very severe in some places.

Heavy staining between  
roof lantern upstands.

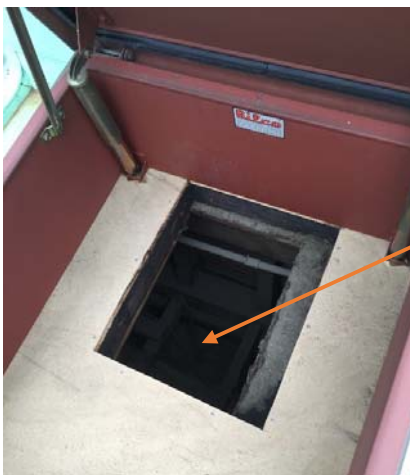
Deterioration of the structure or underlay to the roofing can be caused by condensation if ventilation of the substrate is inadequate. Deterioration may also be due to earlier failure of the roofing as described above. A very limited inspection of the roof space was made possible by opening some of the roof hatches over the White Wing. There was evidence of previous leaks but no damp smell or visible evidence of rot or beetle attack. Whilst it is not possible to completely discount this without proper inspection, it does not appear to be a contributory factor to the roofing defects.

Limited view into roof  
void via access  
hatches.

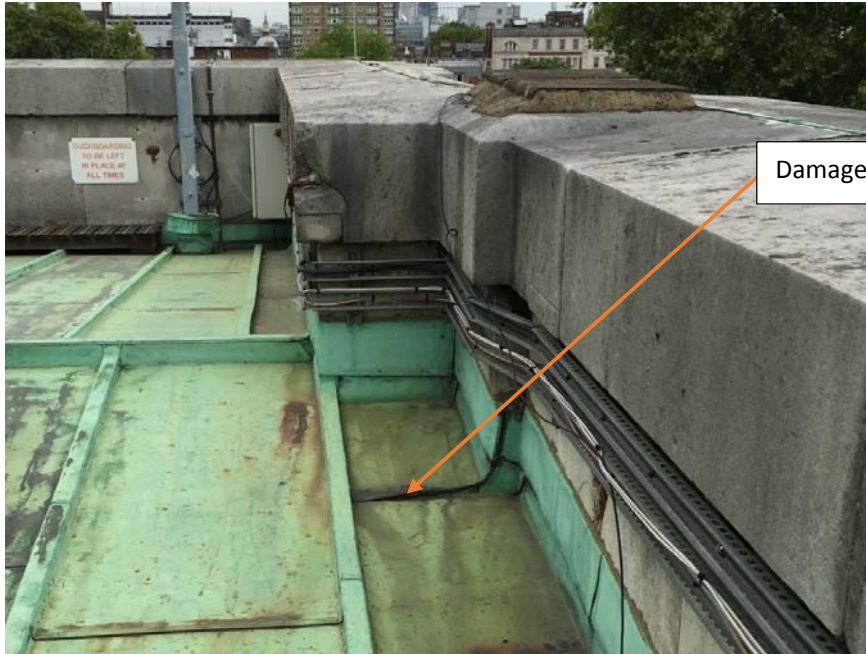
Other defects noted during the inspection were damage to welthed seam, low points on the roof itself, leading to ponding and some areas of missing pointing above the copper flashings.

Damaged welthed seam.

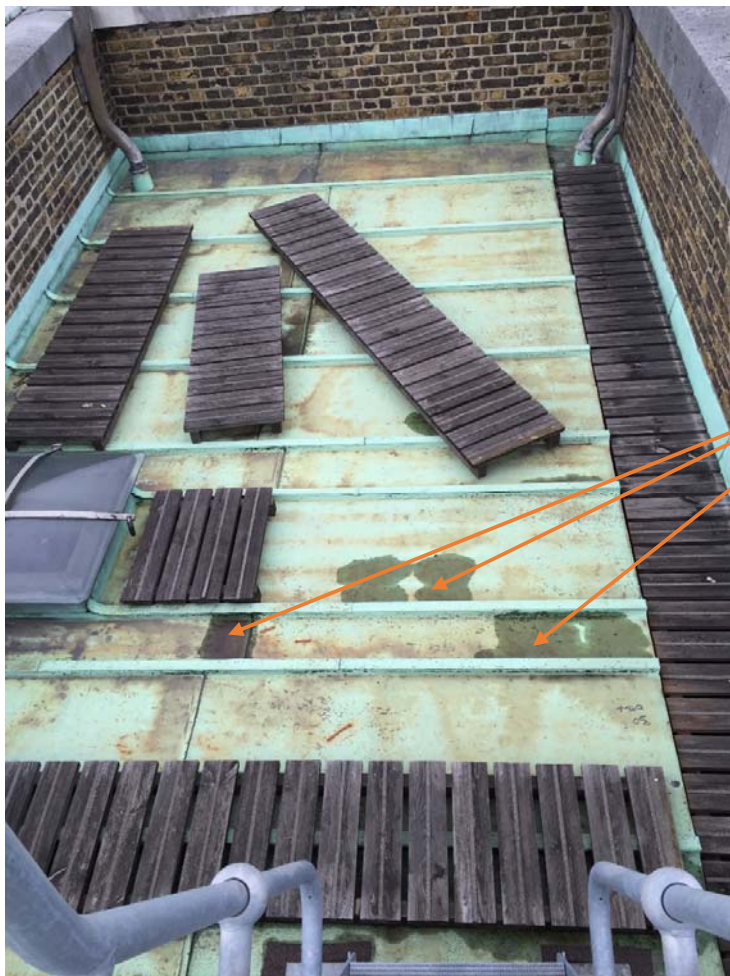
Low points on roof where ponding occurs.

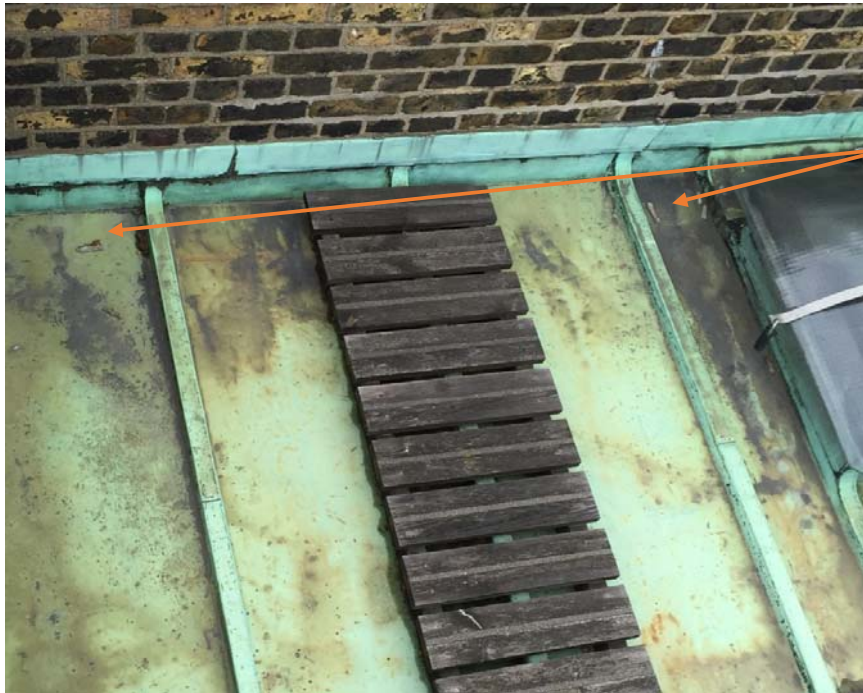
Loose and missing pointing.
