Belsize Park Fire Station.

Visual Structural Assessment.

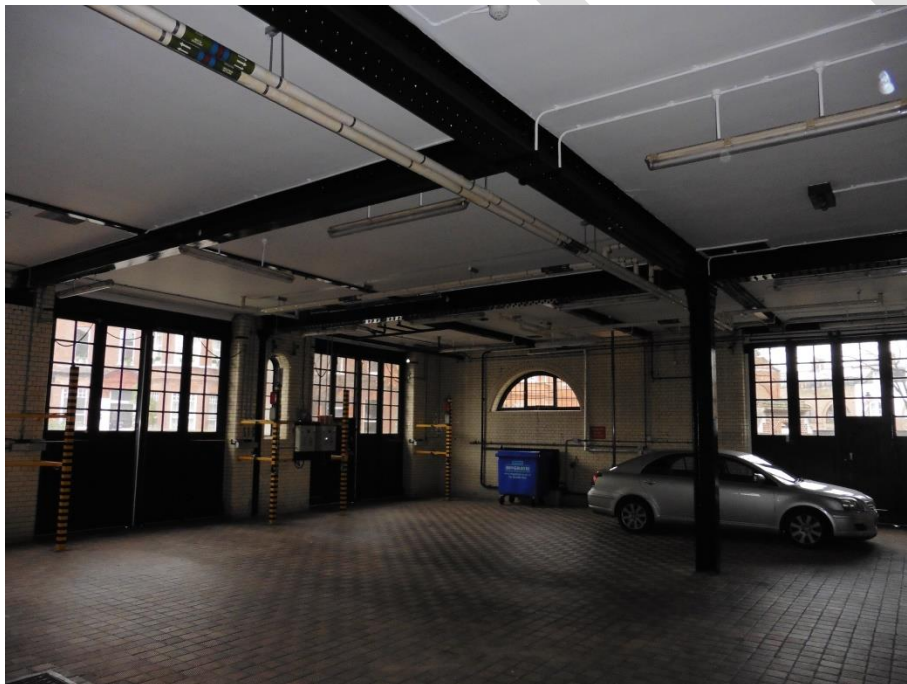
The concrete first floor over the garage is supported on a grillage of rolled section and built-up steel beams. The beams, in addition to the floor, also support a number of masonry walls.

First floor slab and steelwork over garage.

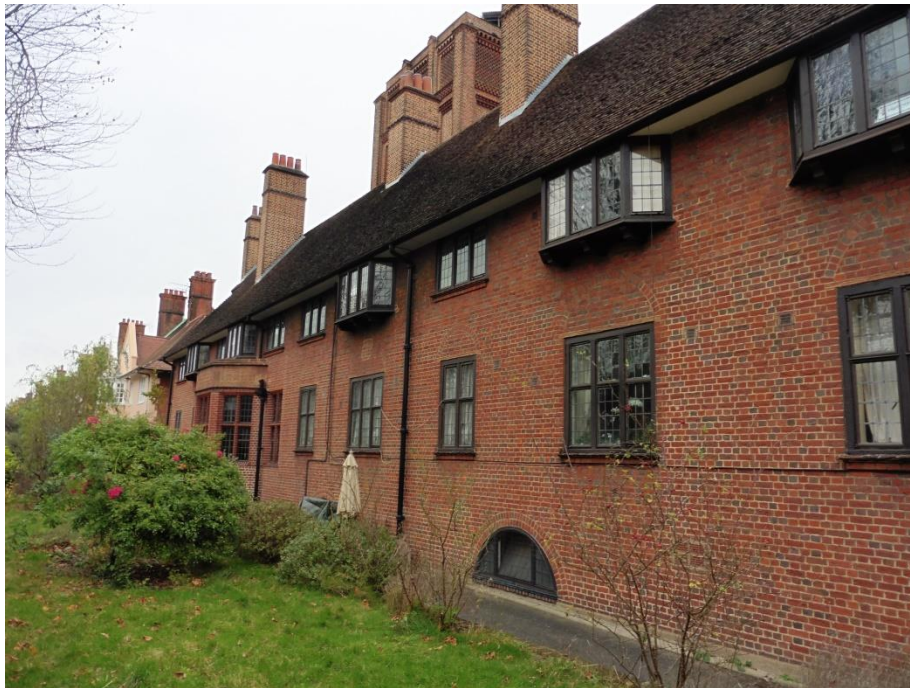
Rear elevation with overhanging eaves.

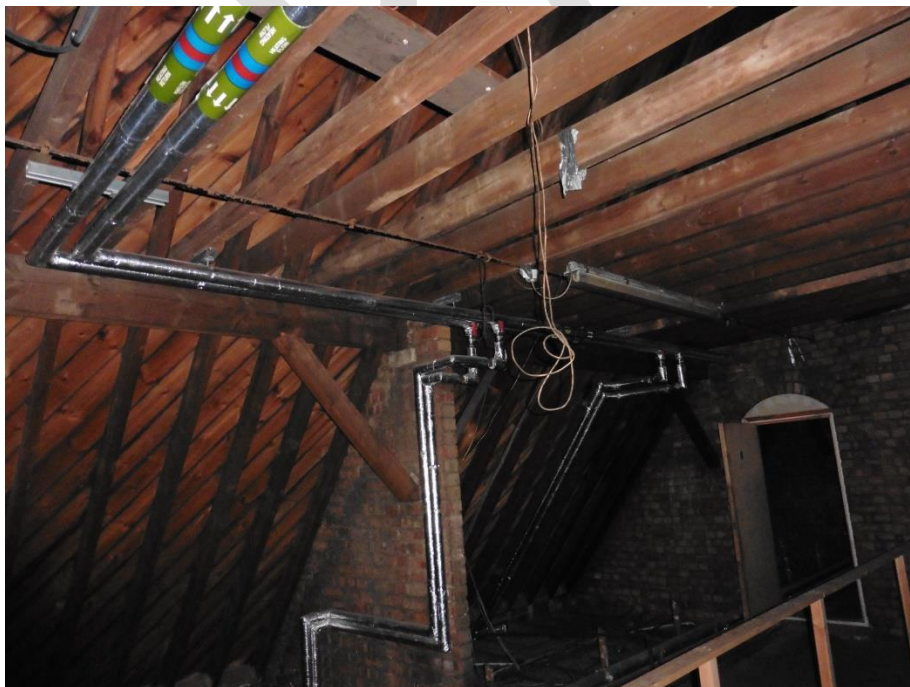
The roof is formed with jack rafters and collars bearing on propped purlins which in turn bear on stub walls. The upper floor ceilings are timber joists and plaster.

Stub walls supporting propped purlins.

The form of the roof can be discreetly altered internally, without alteration to the external profile of the roof, to provide a more flexible space by replacing the brick stub walls with cranked steel beams supporting new steel purlins and ridge beams to allow the braces and collars to be removed.

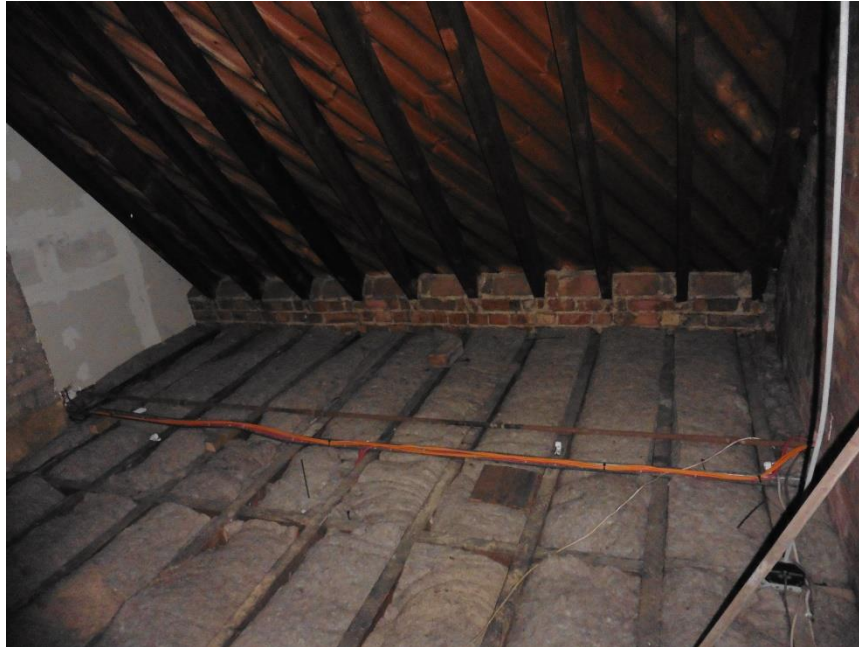
The roof incorporates a raised wall plate supporting the rafters with the ceiling joists appearing to pass through the wall to form the overhanging eaves.

Ceiling joists and jack rafters passing through masonry to form overhanging eaves.

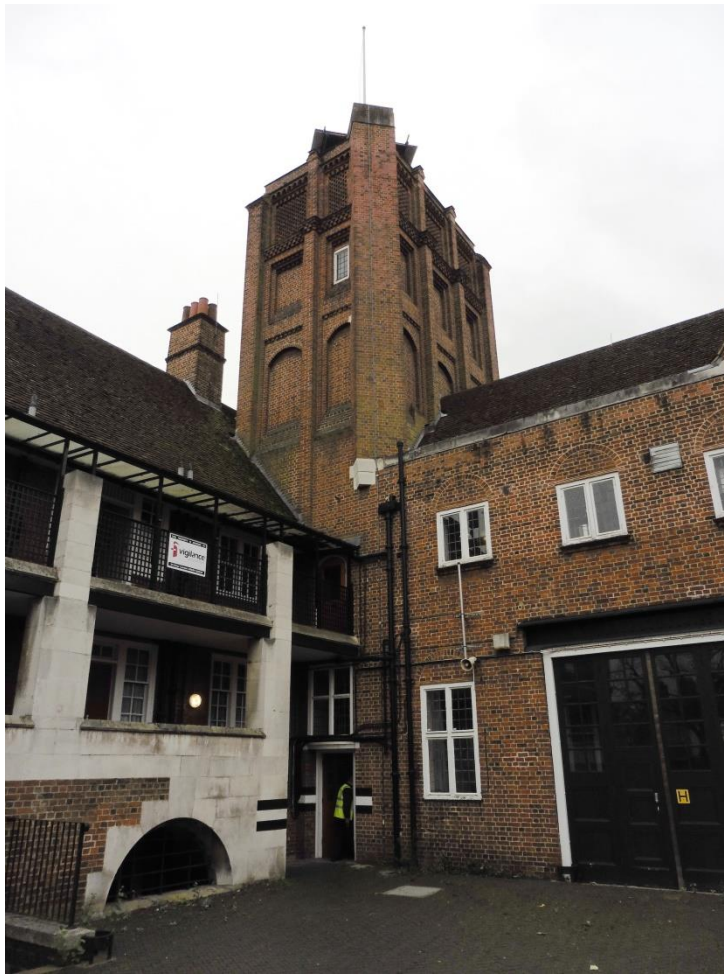
Central Tower.

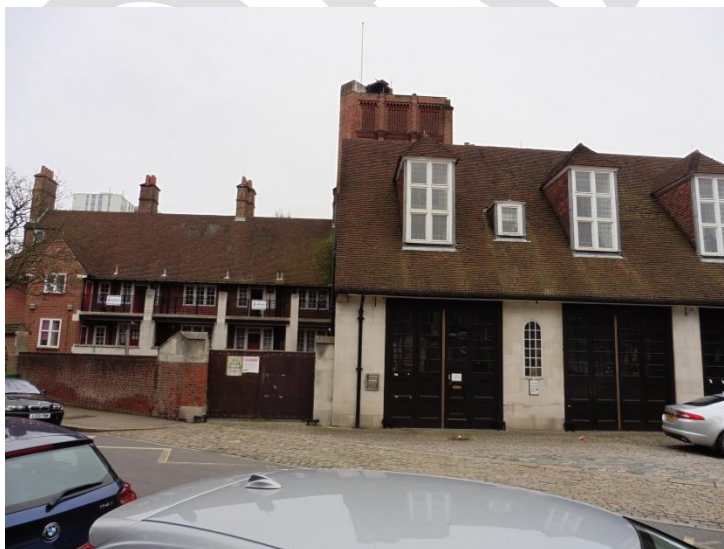
Garage elevation with tower behind.
